DELAWARE RIVER BASIN
MILLTOWN DAM
WEST CHESTER AREA MUNICIPAL AUTHORITY

NDI NO. PA-00218
DER NO. 15-146

CHESTER COUNTY, PENNSYLVANIA
PHASE I INSPECTION REPORT
NATIONAL DAM INSPECTION PROGRAM

JULY 1981

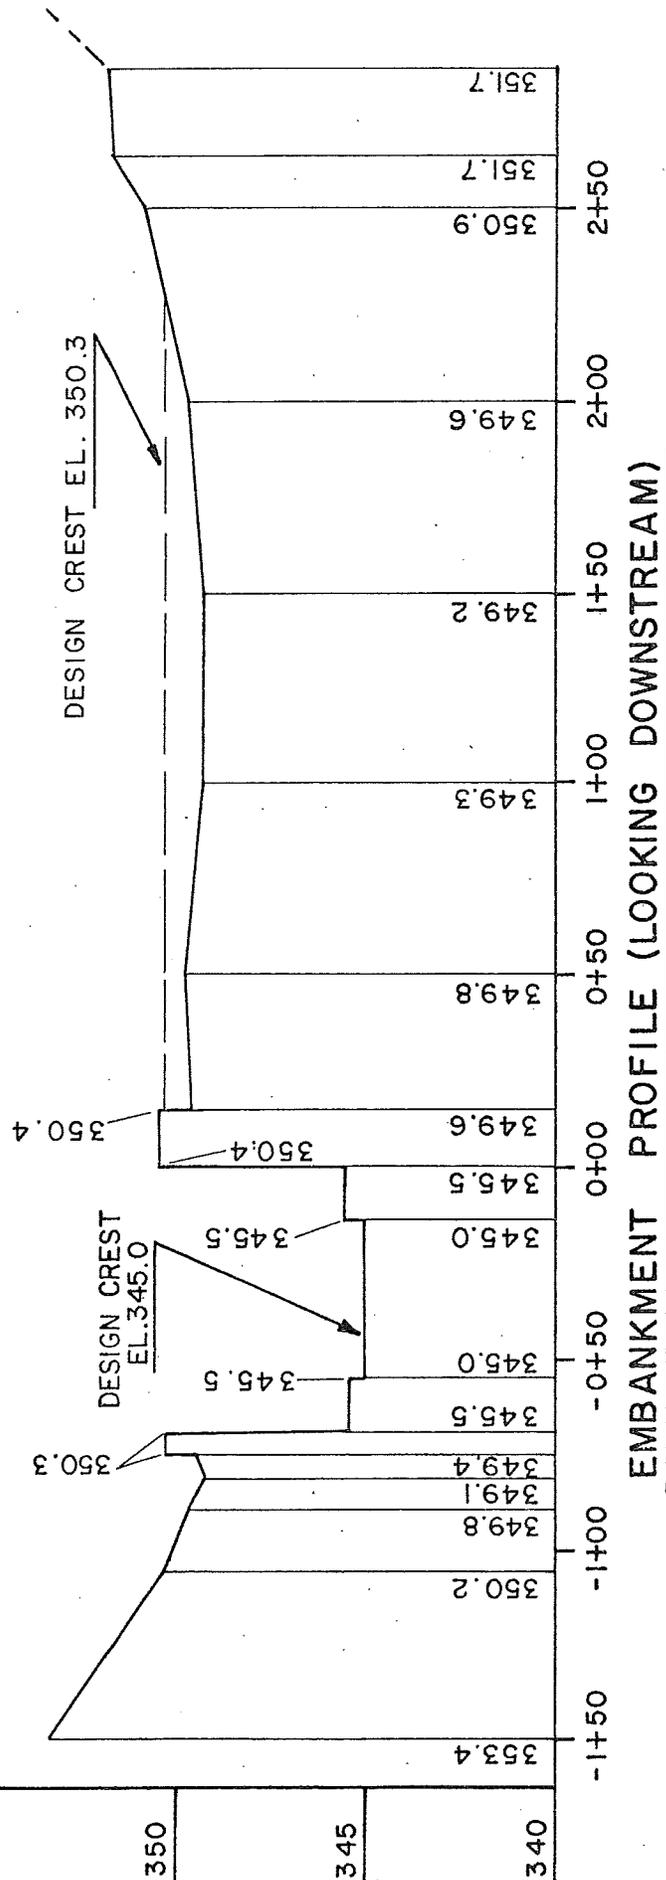
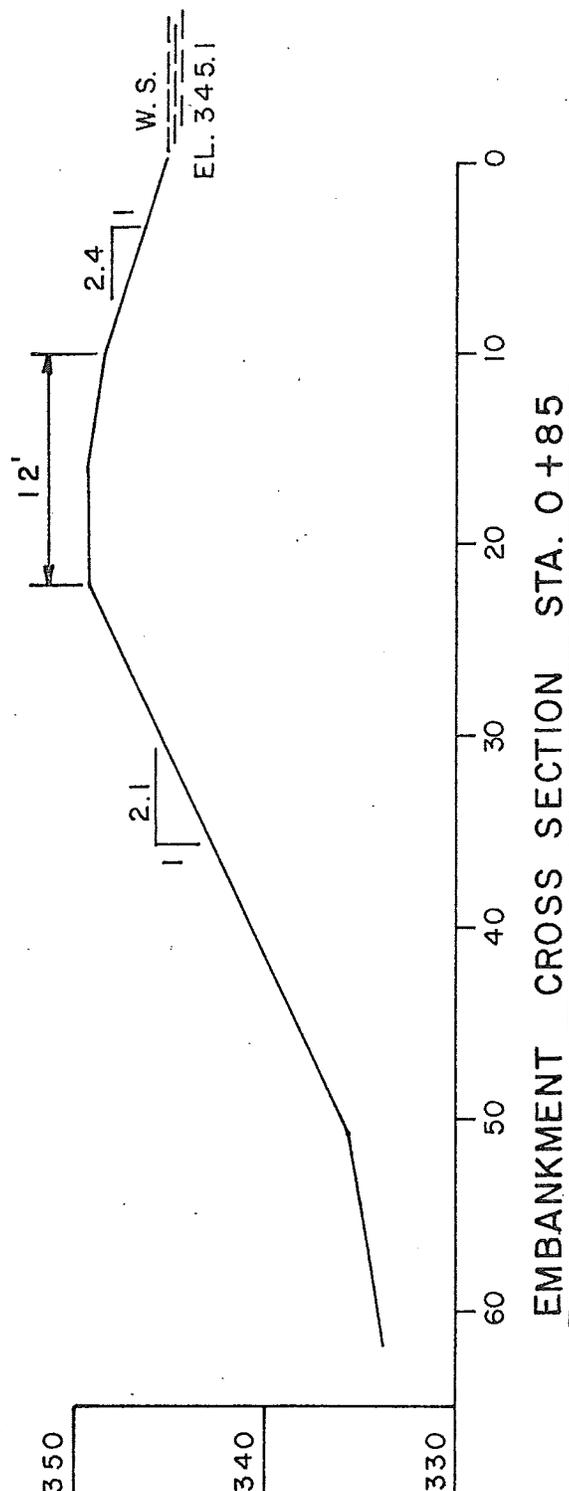
MILLTOWN DAM
 PA-00218
 INSPECTION SURVEY
 PLATE A-II

D. ALIGNMENT OF CREST: HORIZONTAL: VERTICAL:	Horizontal - straight line--no movement visible. Vertical - refer to Profile, Plate A-II.
E. RIPRAP FAILURES	None observed. Weed and brush cover to water's edge on upstream slope.

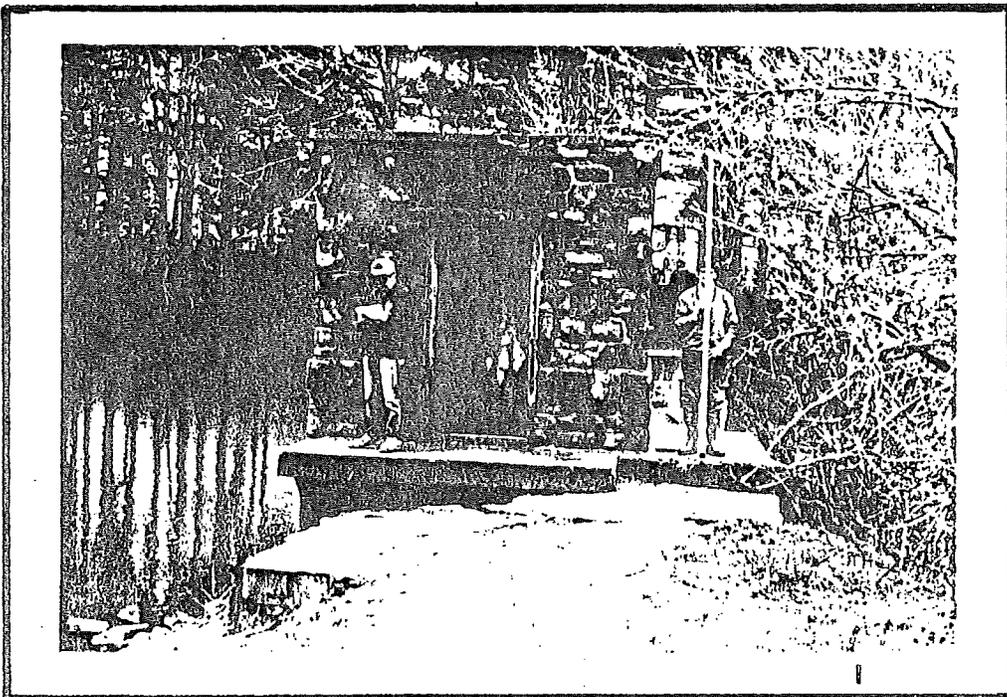
The intake control structure is located in the right spillway wall and is in fair condition. The downstream valve on the drawdown line has not been operated in many years.

CONTROL TOWER - NO. 5
NOTE: CONCRETE SLABS
