2015 ANNUAL INSPECTION REPORT

MILLTOWN DAM

DEP ID No. D15-146

East Branch Chester Creek, Chester County, Pennsylvania

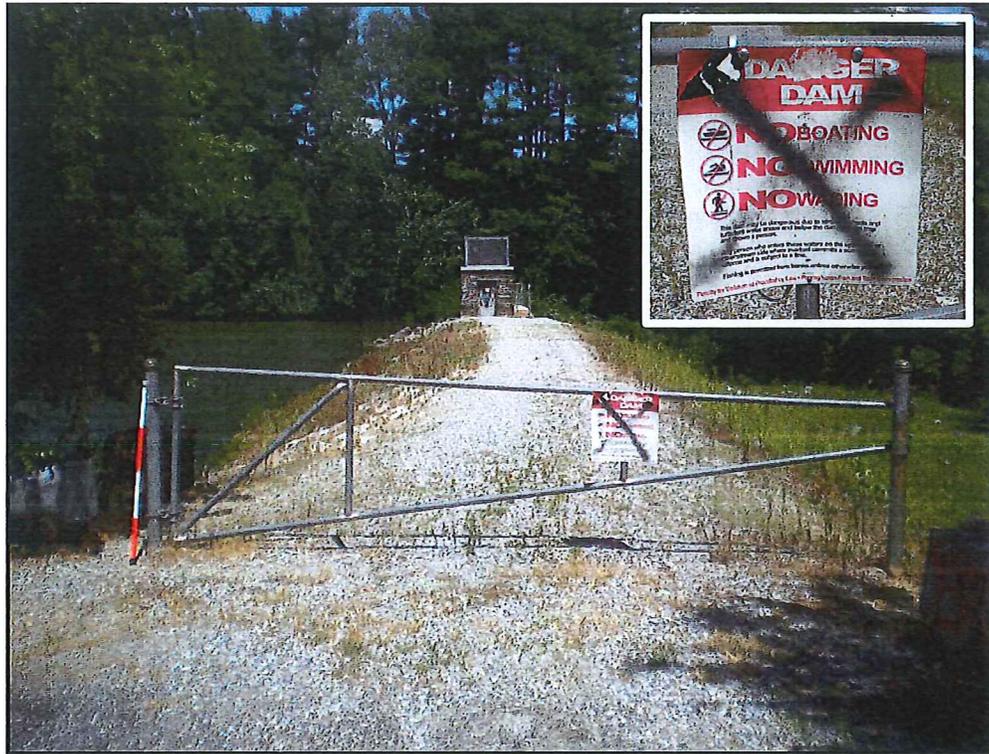
7	Warning Signs	One warning sign observed on swing gate at right abutment. Sign contains graffiti but remains legible (refer to Photo 1). See note below.	<input checked="" type="checkbox"/>	<input type="checkbox"/>	<input checked="" type="checkbox"/>
8			<input type="checkbox"/>	<input type="checkbox"/>	<input type="checkbox"/>
9			<input type="checkbox"/>	<input type="checkbox"/>	<input type="checkbox"/>

Photo No. 1
View of right embankment crest looking toward spillway and Valve House.
Inset shows condition of Danger Sign.

Item 7: Maintain warning sign(s) in a condition which is legible and clearly displayed to the public. **Recommend** removing graffiti from warning sign or replacing sign. **Recommend** adding warning sign(s) at left abutment. **Recommend** monitoring area for unauthorized activities.

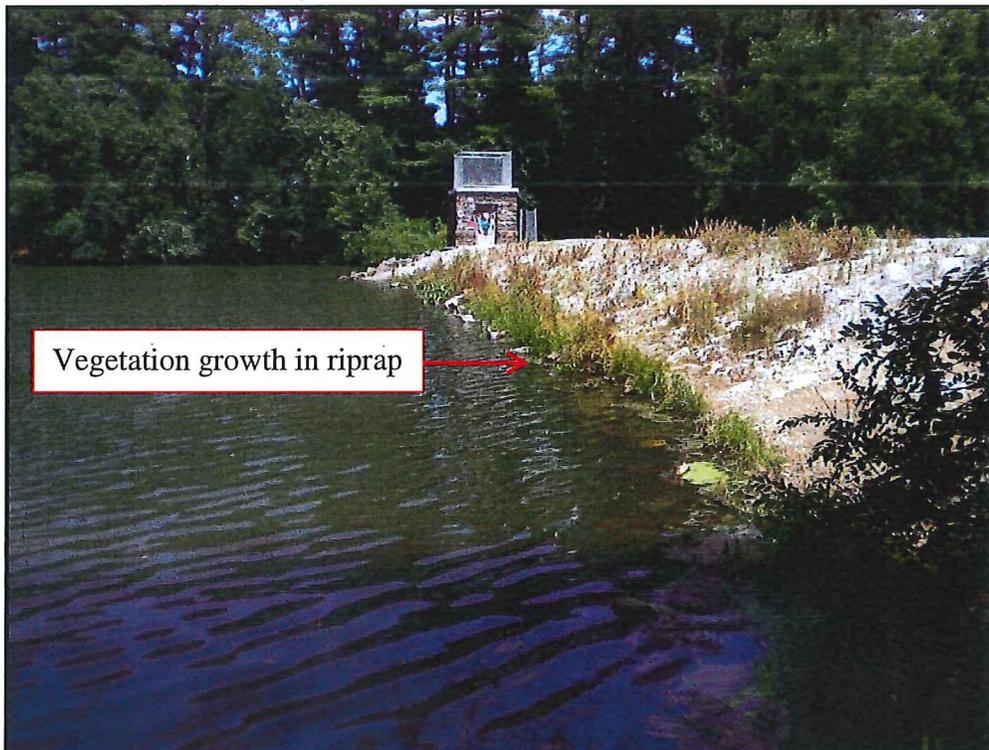
Item 11: Surface of upstream right embankment is covered with riprap which has been chinked with aggregate. Riprap on left embankment is not chinked with aggregate.

Photo No. 2
View of upstream slope of right embankment.

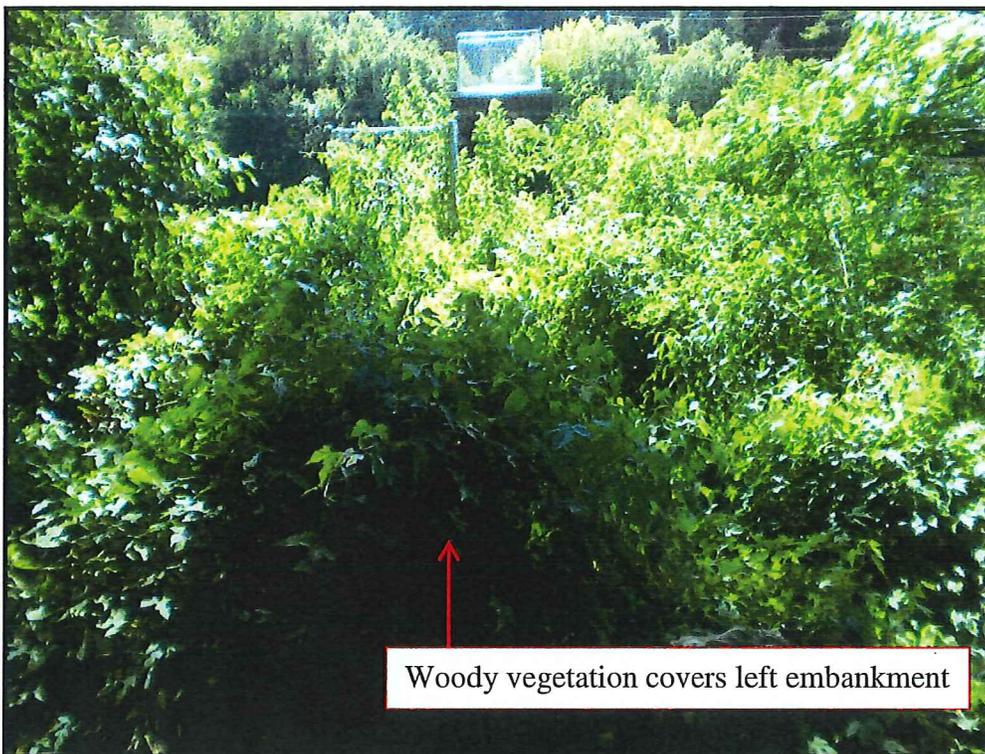
Item 6: Woody vegetation observed on left embankment crest. **Recommend** removing woody vegetation to prevent root intrusion into the embankment, eliminate cover for burrowing animals and allow visual observation of the embankment crest.

**Photo No. 4
View of left embankment crest looking toward spillway. Valve House visible
in top center of photograph. Note woody vegetation on left embankment.**

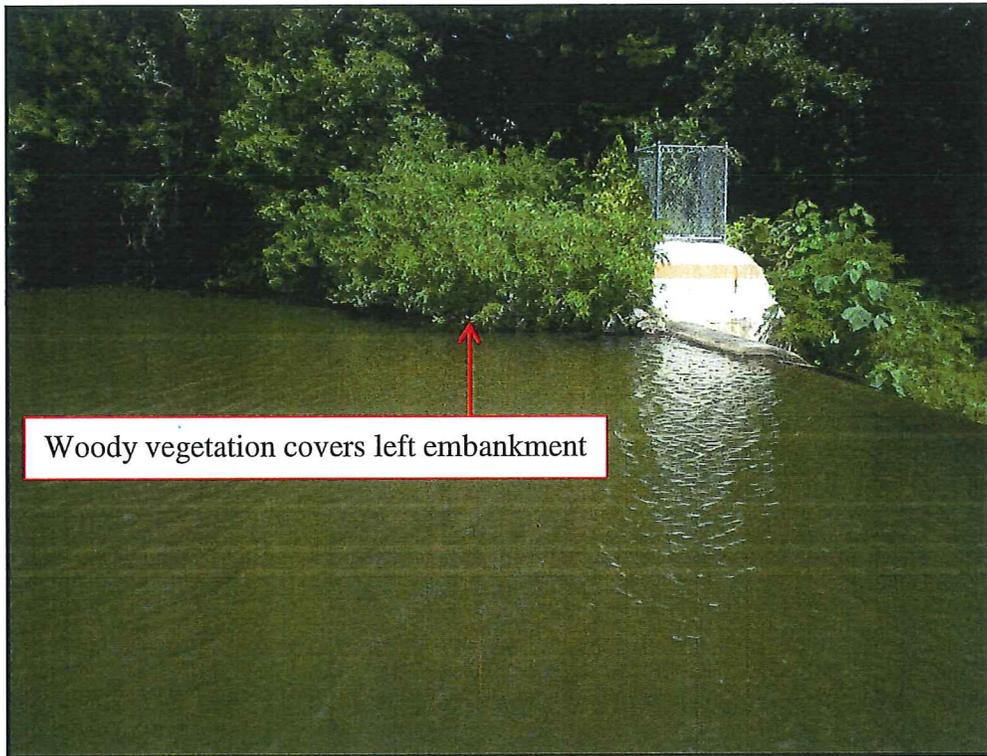
Item 15: Spotty low vegetation growth observed in right rock-lined embankment. Township reports that vegetation is controlled by spraying several times per year. Woody vegetation observed on left embankment (refer to Photo 5) and on right embankment at abutment interface (refer to Photo 18). **Recommend** removing vegetation to prevent root intrusion into the embankment, eliminate cover for burrowing animals and allow for visual observation. **Recommend** removing trees in their entirety, including the root system. Backfill voids left by root system removal with impervious earthfill, compact and replace riprap cover.

Woody vegetation covers left embankment

**Photo No. 5
View of upstream slope of left embankment. Note woody vegetation.**

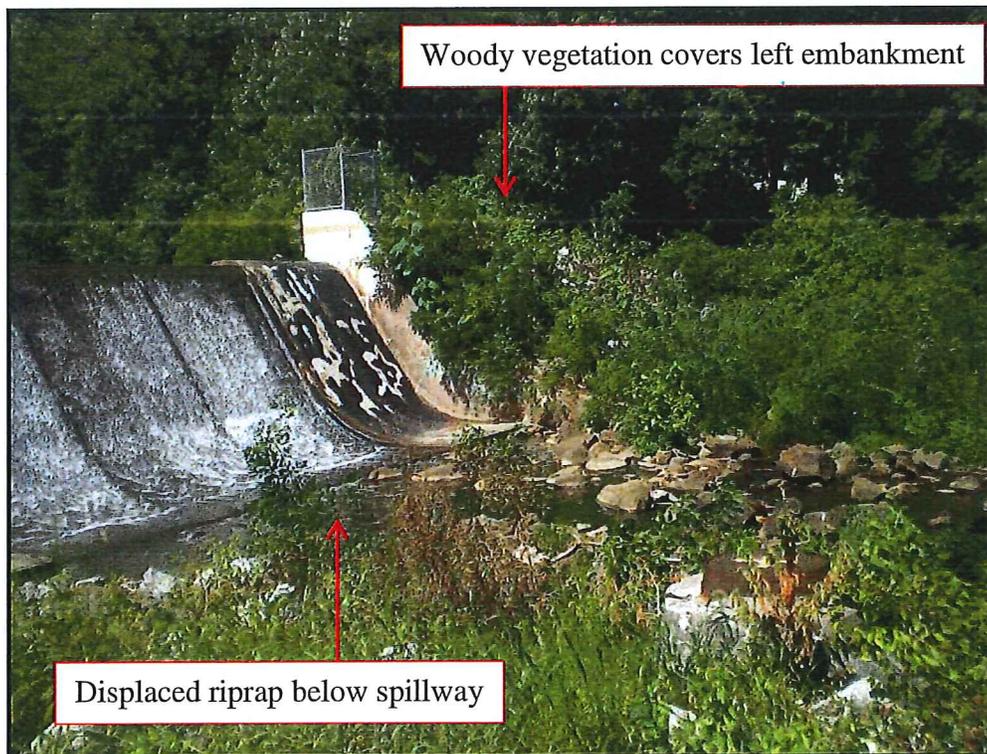
Item 25: Spotty low vegetation growth observed in right rock-lined embankment. Township reports that vegetation is controlled by spraying several times per year. Woody vegetation observed on left embankment (refer to Photo 6) and on right embankment at abutment interface (refer to Photo 17). **Recommend** removing vegetation to prevent root intrusion into the embankment, eliminate cover for burrowing animals and allow for visual observation of the embankment.

Item 55: Rock scour protection between concrete spillway apron and concrete sill is partially dislodged and moved downstream (refer to Photo 6). Voids in riprap up to two feet in depth observed immediately downstream of concrete spillway apron. **Recommend** replacement of scour protection to replicate the original design intent and to protect the concrete apron from undermining.

Woody vegetation covers left embankment

Displaced riprap below spillway

**Photo No. 6
View of downstream slope of left embankment and riprap scour protection below spillway.**

Recommend removing trees in their entirety, including the root system. Backfill voids left by root system removal with impervious earthfill, compact and replace riprap cover.

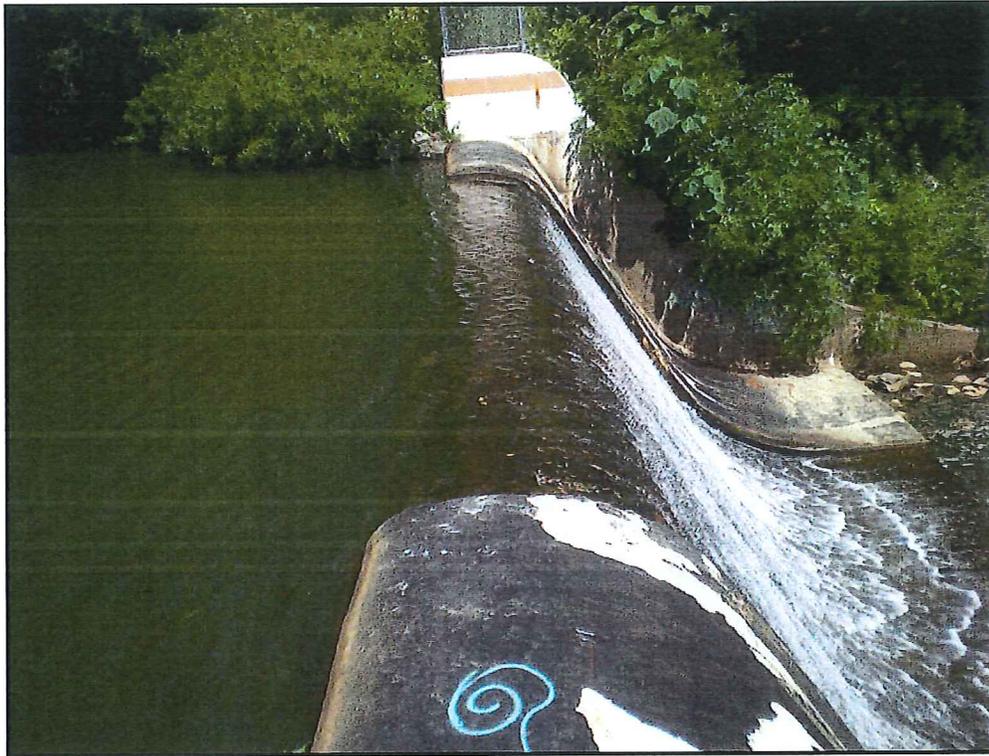
Photo No. 7

**View of ogee spillway crest with low flow notch (looking towards left abutment).
Note horizontal paint markings on left abutment which relate to EAP trigger elevations.**

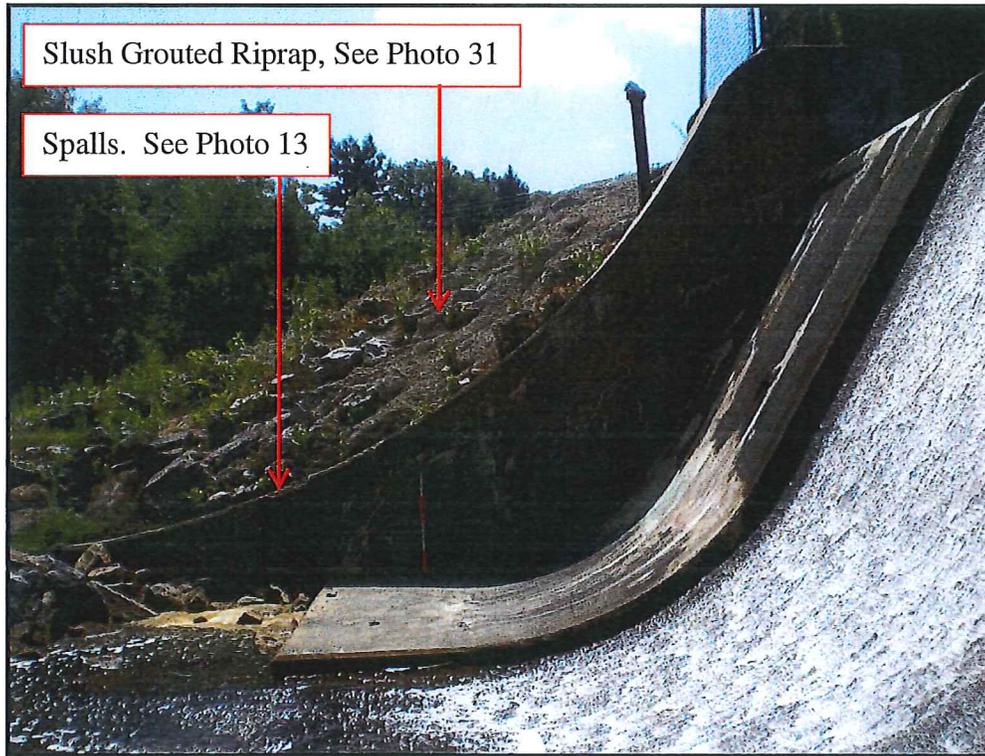
Item 20: Area of riprap on downstream right embankment is slush grouted with concrete. Owner reports slush grout was placed to prevent movement of riprap (refer to Photos 11 and 31).

Item 50: Hairline cracking with efflorescence observed on the vertical portions of both the left and right spillway training walls (refer to Photos 11, 12, 15 & 16). Several spalls observed near downstream end of right spillway training wall (refer to Photo 13). **Recommend** monitoring concrete for changes in condition which may require additional repairs.

**Photo No. 11
View of right spillway training wall.**

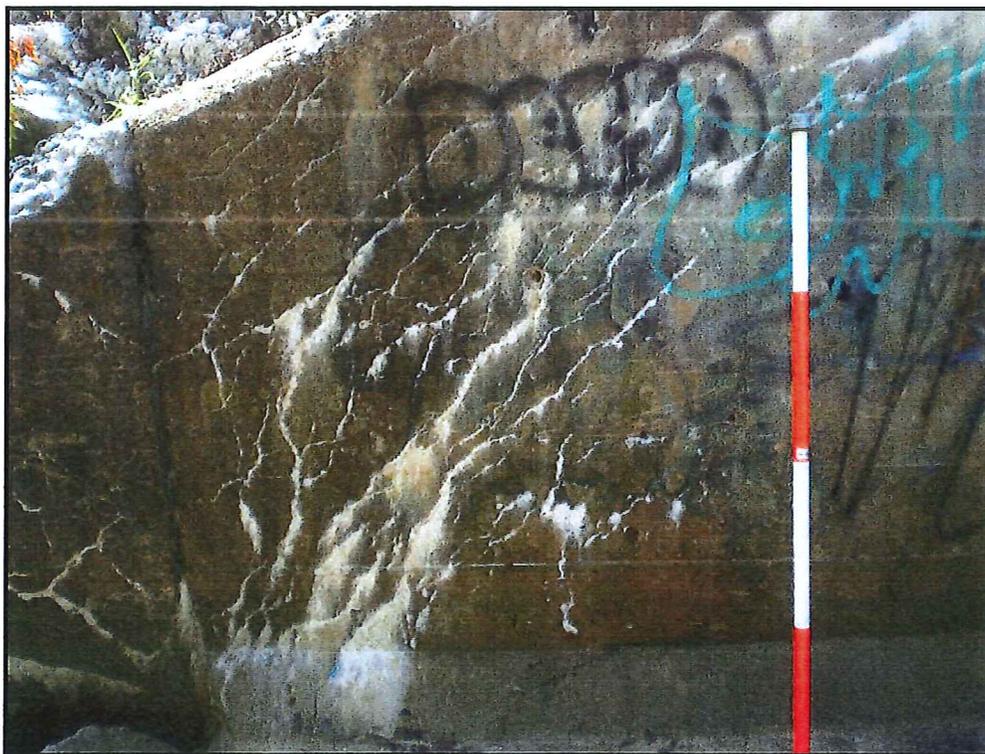
**Photo No. 12
View of right spillway training wall. Note hairline cracking with efflorescence (typical throughout wall).**

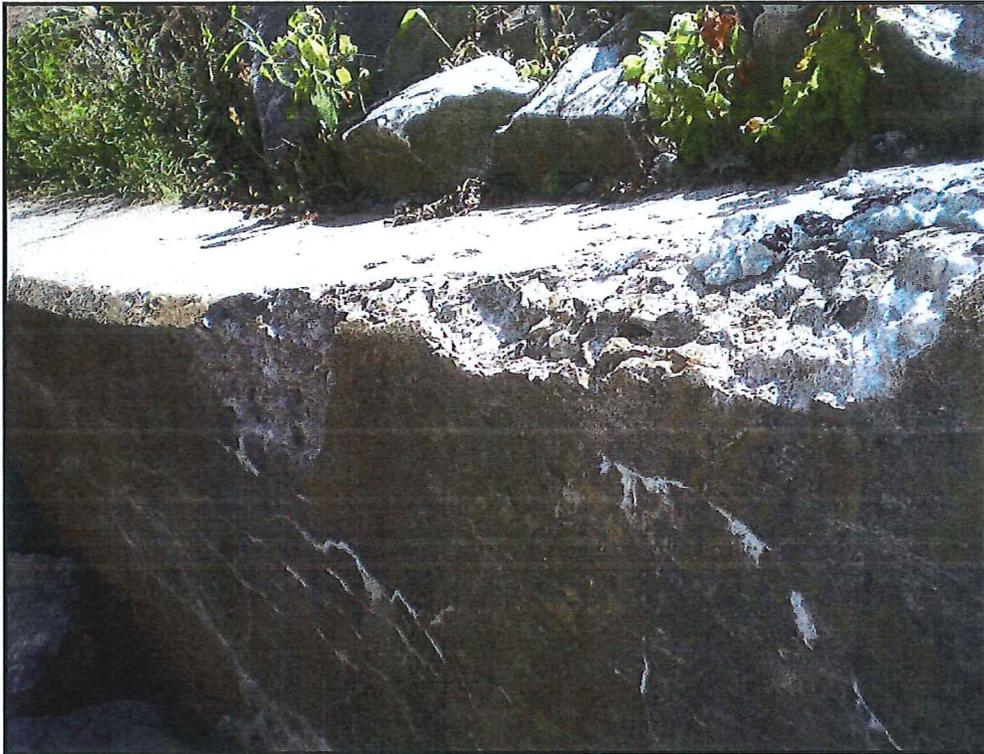
Photo No. 13

View of downstream end of right spillway training wall. Note spalls on top of wall.

Recommend repairing spalled concrete on right spillway training wall.

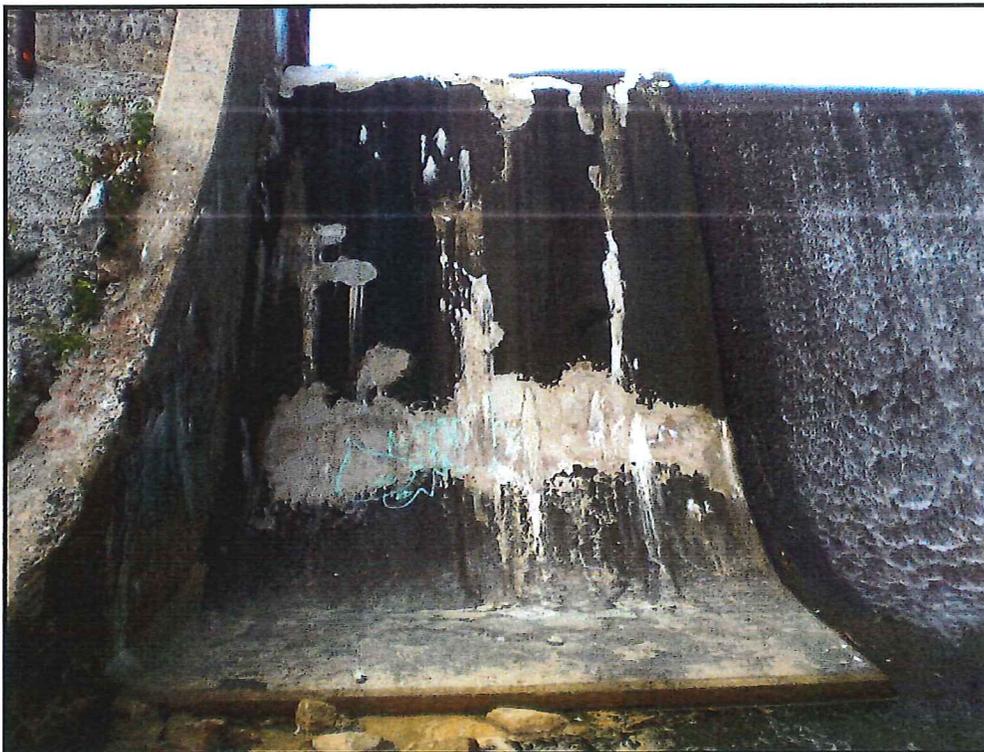
Photo No. 14

Item 51: Epoxy coating on ogee spillway face installed in 2013 observed to be failing. Multiple areas observed where the coating has peeled away from the concrete (refer to Photos 14 and 15). Various other areas of surface patchwork observed. Township reports that the epoxy coating will be repaired this fall. **Recommend** replacing the epoxy coating as currently planned by the Township.

View of right half of downstream face of the concrete spillway. Note patchwork and areas where epoxy coating (black material) has peeled.

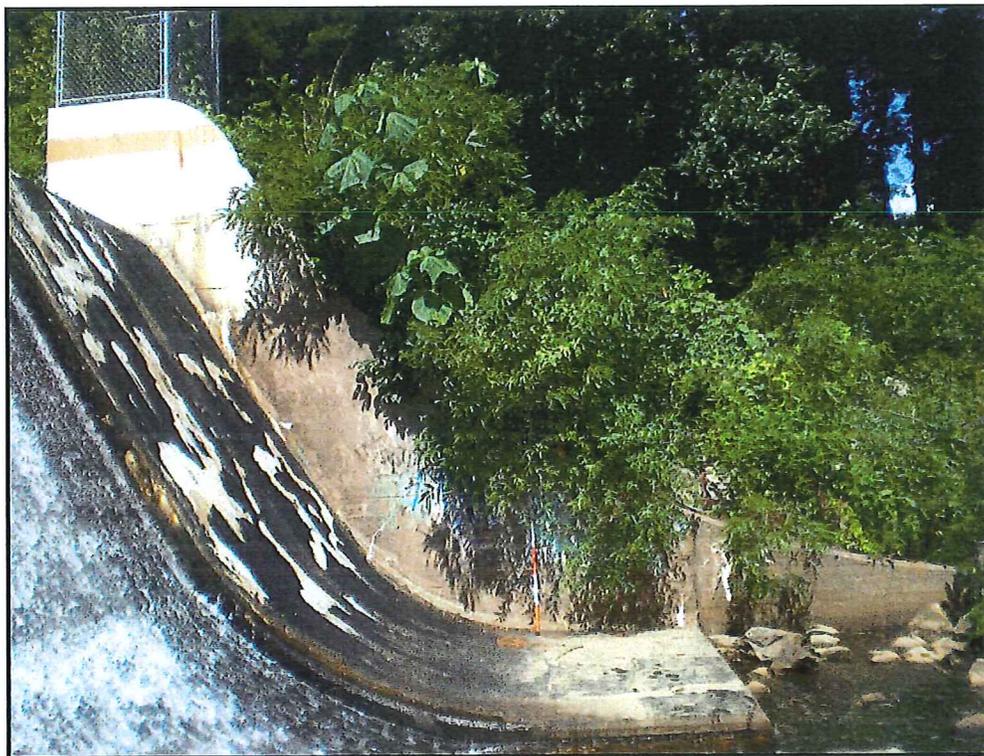
**Photo No. 15
View of left spillway training wall.**

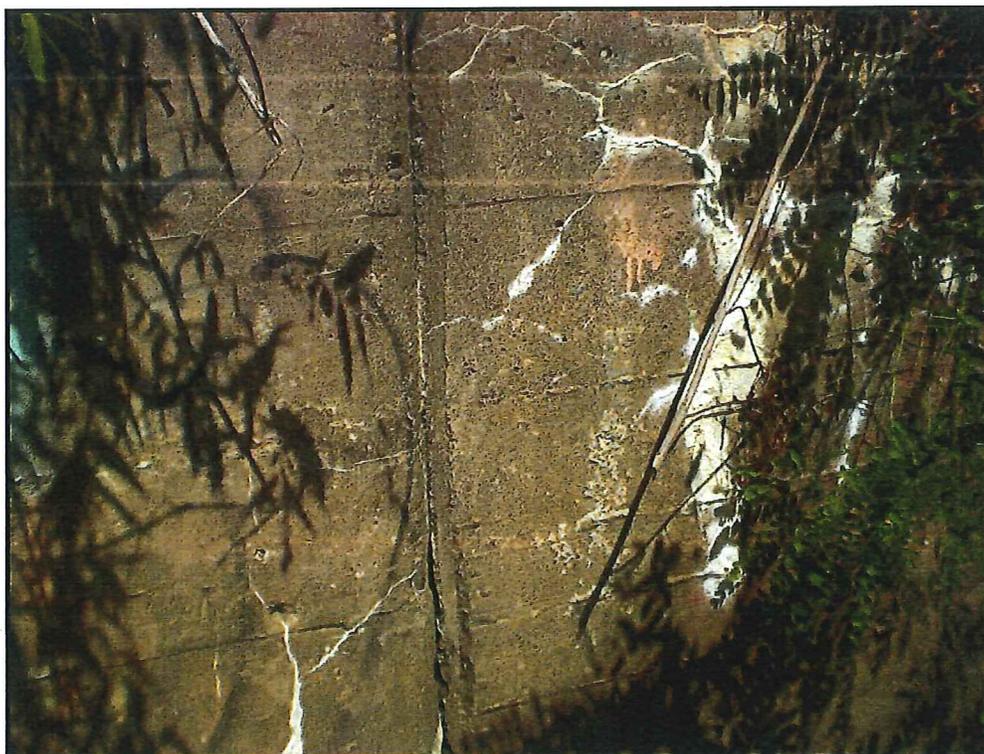
**Photo No. 16
View of left spillway training wall. Note hairline cracking with efflorescence (typical throughout wall).**

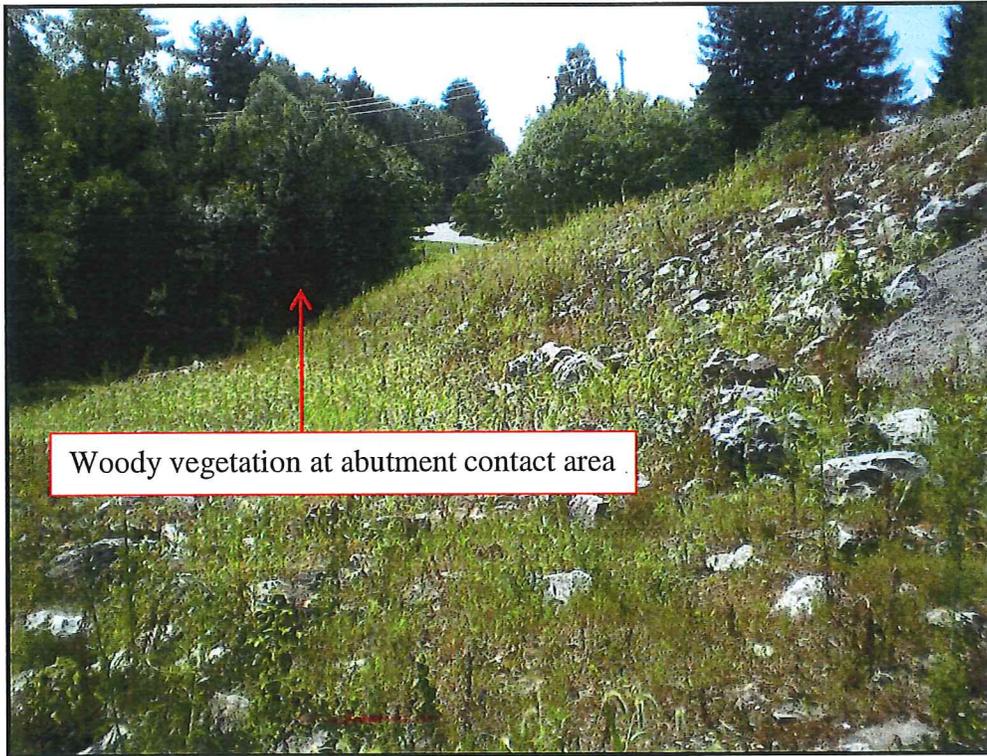
Photo 17

Woody vegetation at abutment contact area

View of downstream slope of right embankment.

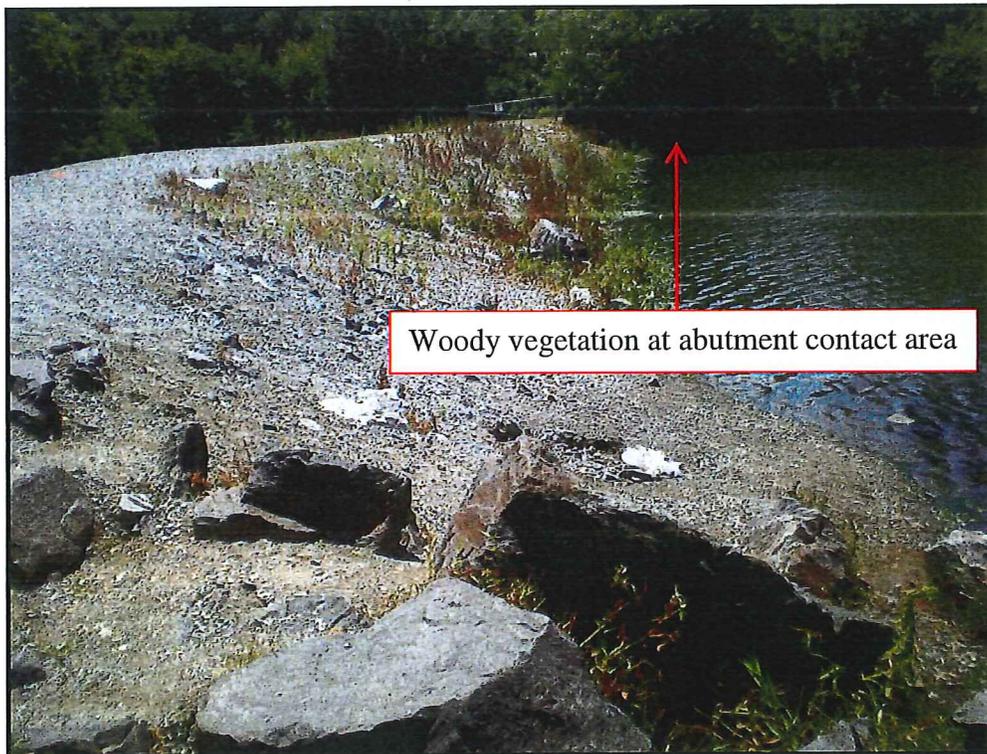
Photo 18

Woody vegetation at abutment contact area

View of upstream face of right embankment.

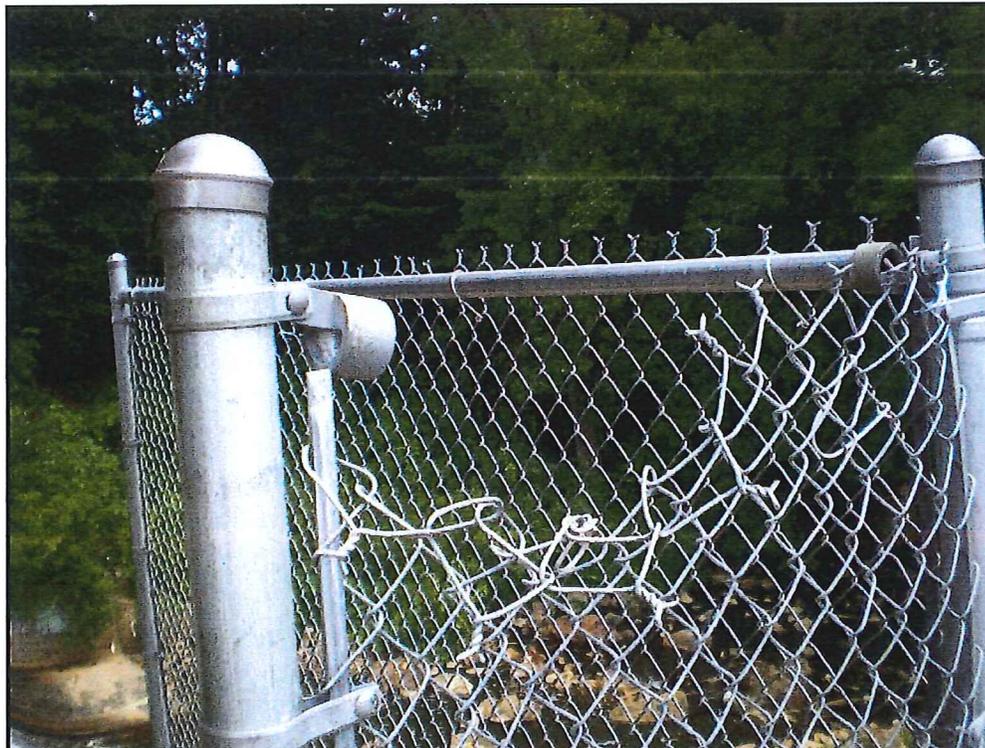
Item 46: Refer to Item 7 for warning sign recommendations. Top support post on chain-link fence at Valve House is missing (refer to Photo 20). **Recommend** repairing fence.

**Photo No. 20
Chain link fence on downstream side of Valve House. Note missing top rail.**

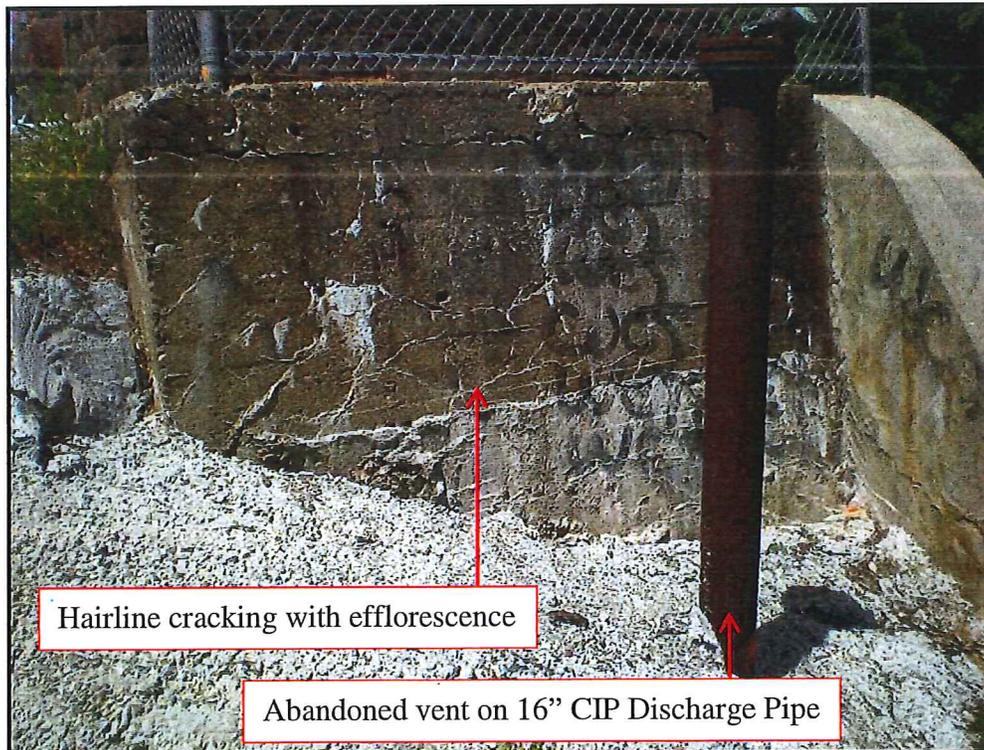
**Photo No. 22
View of downstream face of exposed valve chamber. Note hairline cracking with efflorescence.**

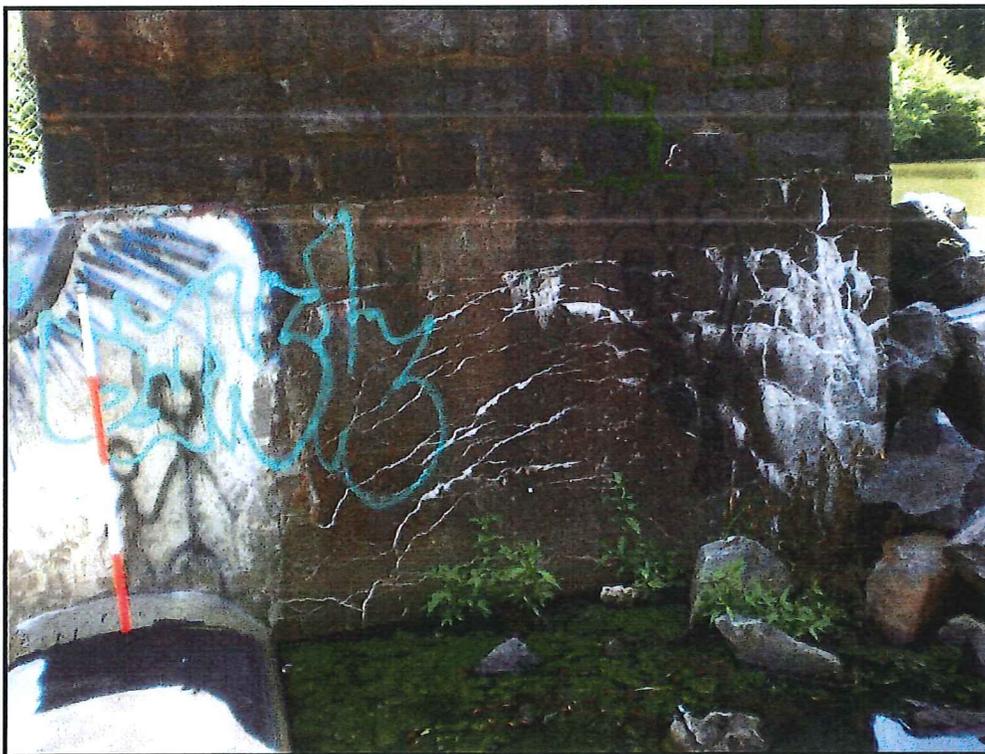
**Photo No. 24
View of left face of Valve House and exposed portions of the valve chamber. Note hairline cracking with efflorescence throughout exposed portion of concrete valve chamber.**

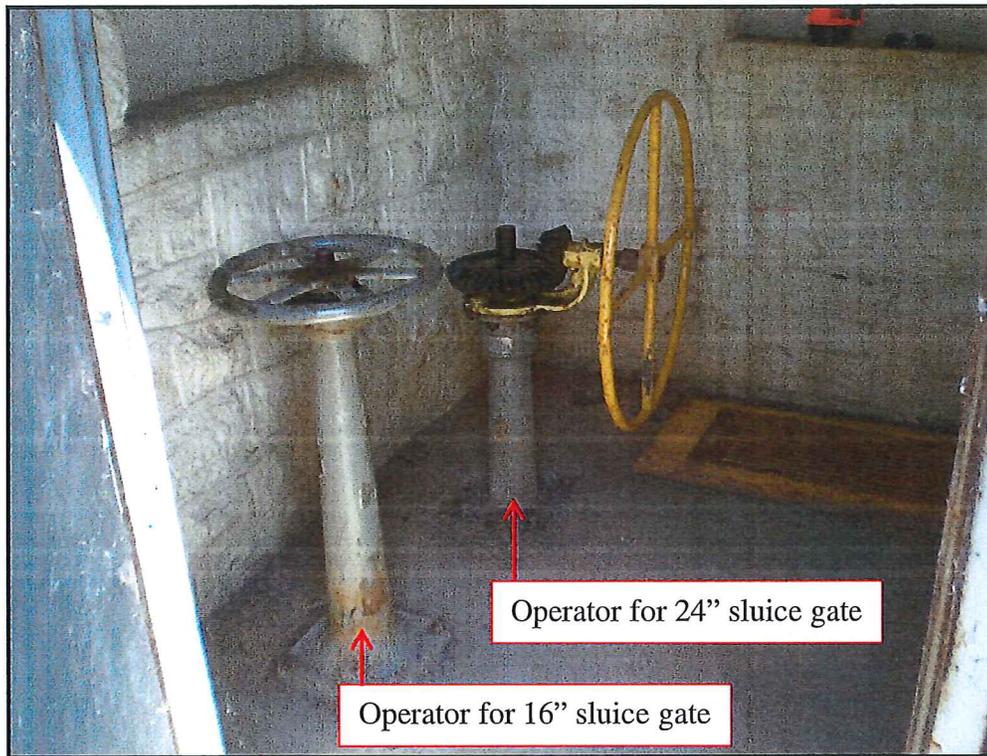
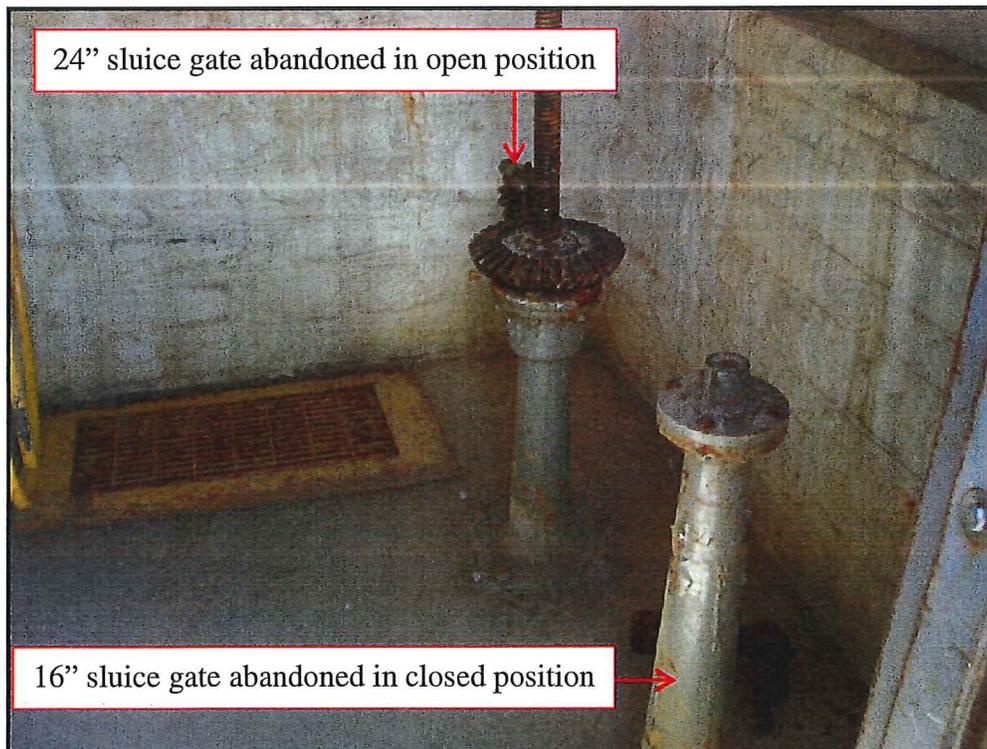
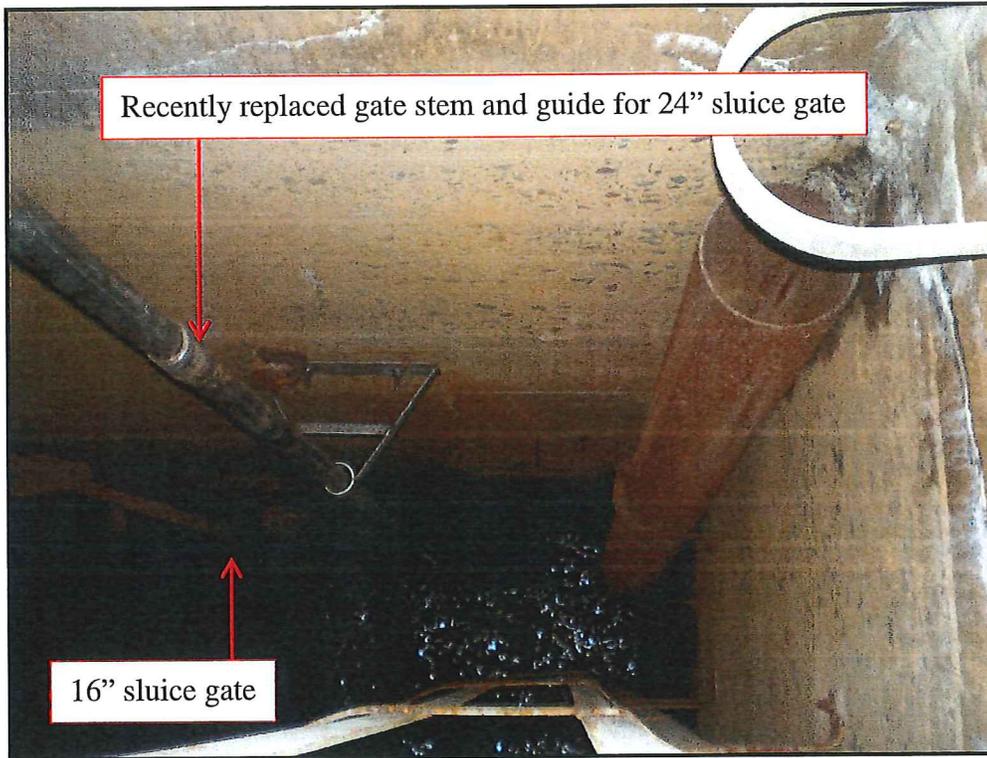
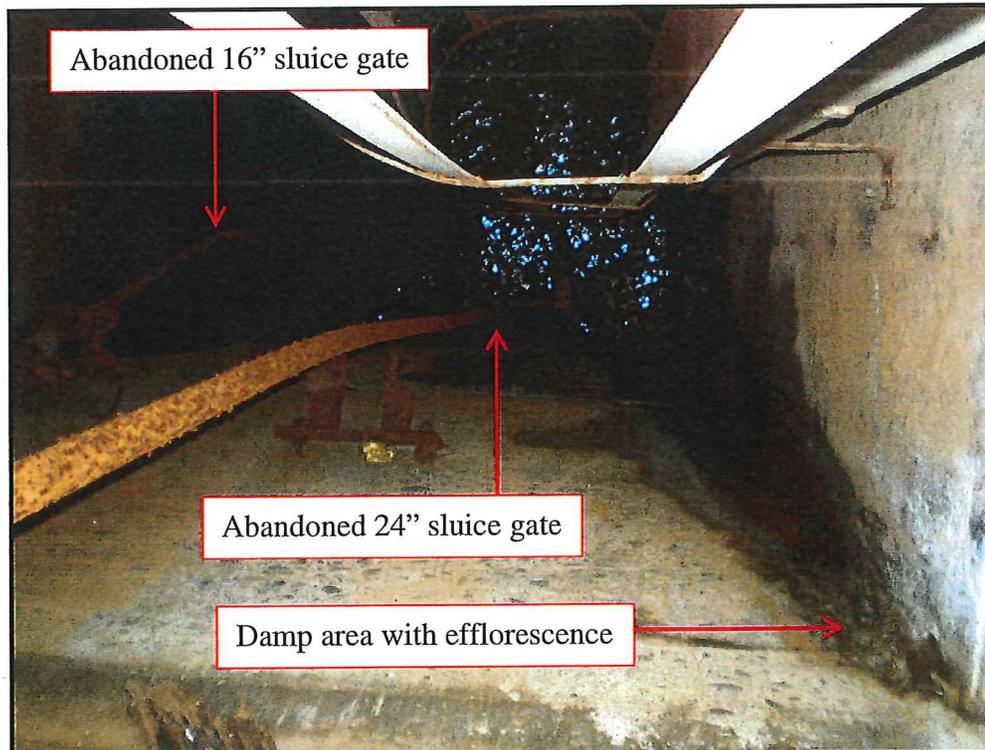
Item 59: Sluice gates were observed on the 16" and 24" CIPs entering and leaving the Valve House (four gates total) controlled by manually operated handwheels (refer to Photos 25, 26, 27 & 28). The upstream 16" sluice gate was operated at time of inspection. The upstream 24" sluice gate was unsuccessfully operated due to connection failure between the gate stem and gate. *Post inspection note: Township reported on 8/19/15 that 24" gate has been repaired and is operable.* Downstream gates are inoperable with the 16" gate frozen in the closed position and the 24" gate frozen in the open position. Downstream gates are not required for the operation of the low level dewatering system. East Goshen Township reports that the downstream 16" CIP has been abandoned and plugged at an unknown location downstream of the dam. Valve House constructed of masonry with lockable door and observed to be in fair condition (refer to Photos 19, 21 & 23). Hairline cracks with efflorescence observed on exposed exterior portions of the valve chamber (refer to Photos 22, 23 & 24). Dampness with efflorescence observed in the interior downstream left corner of the concrete valve chamber (refer to Photo 28). **Recommend** monitoring the condition of the concrete valve chamber for changes in condition which may warrant repairs.

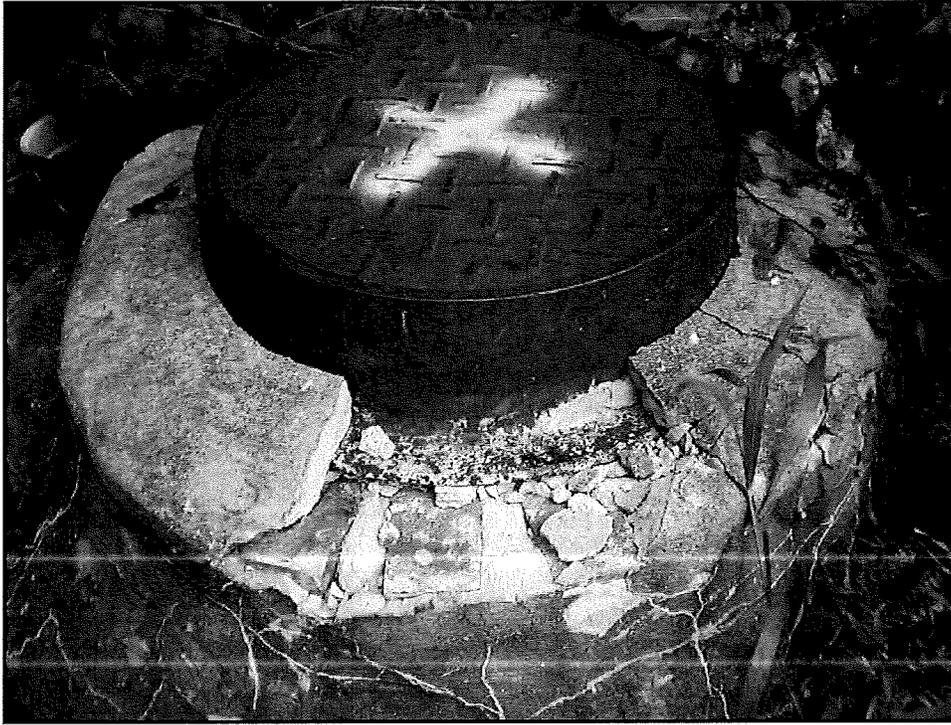
Photo 29

Item 65: Loss of mortar observed around frame and cover of valve manhole located immediately upstream of the discharge outlet of the 24" CIP low level dewatering system (refer to Photo 29). **Recommend** repairing mortar to keep manhole frame and cover operable and to prevent further deterioration of the structure.

Valve manhole on 24" CIP low level dewatering pipe. Note loss of mortar around frame and cover.

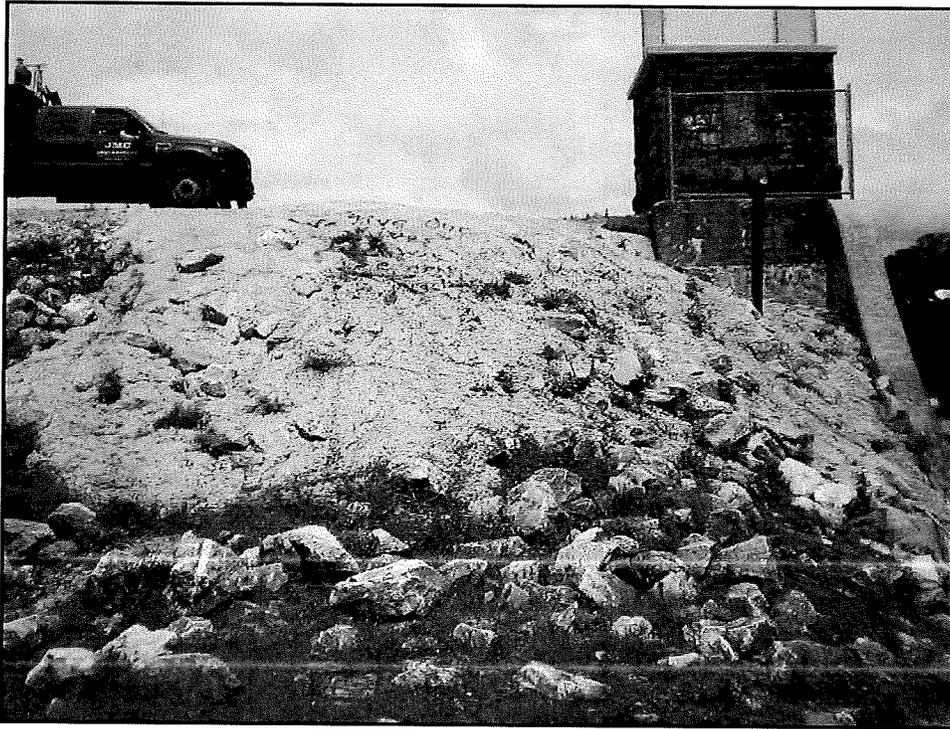
Photo 31

**Slush grouted riprap on downstream right embankment near Valve House.
(Photograph taken on June 19, 2015)**
