DAM INSPECTION CHECKLIST
Department of Environmental Protection
Bureau of Waterways Engineering
Division of Dam Safety

NAME OF DAM: Hershey Mill Dam

DEP DAM NO.: 15-125

HERSHEY MILL DAM INSPECTION REPORT PHOTO LOG

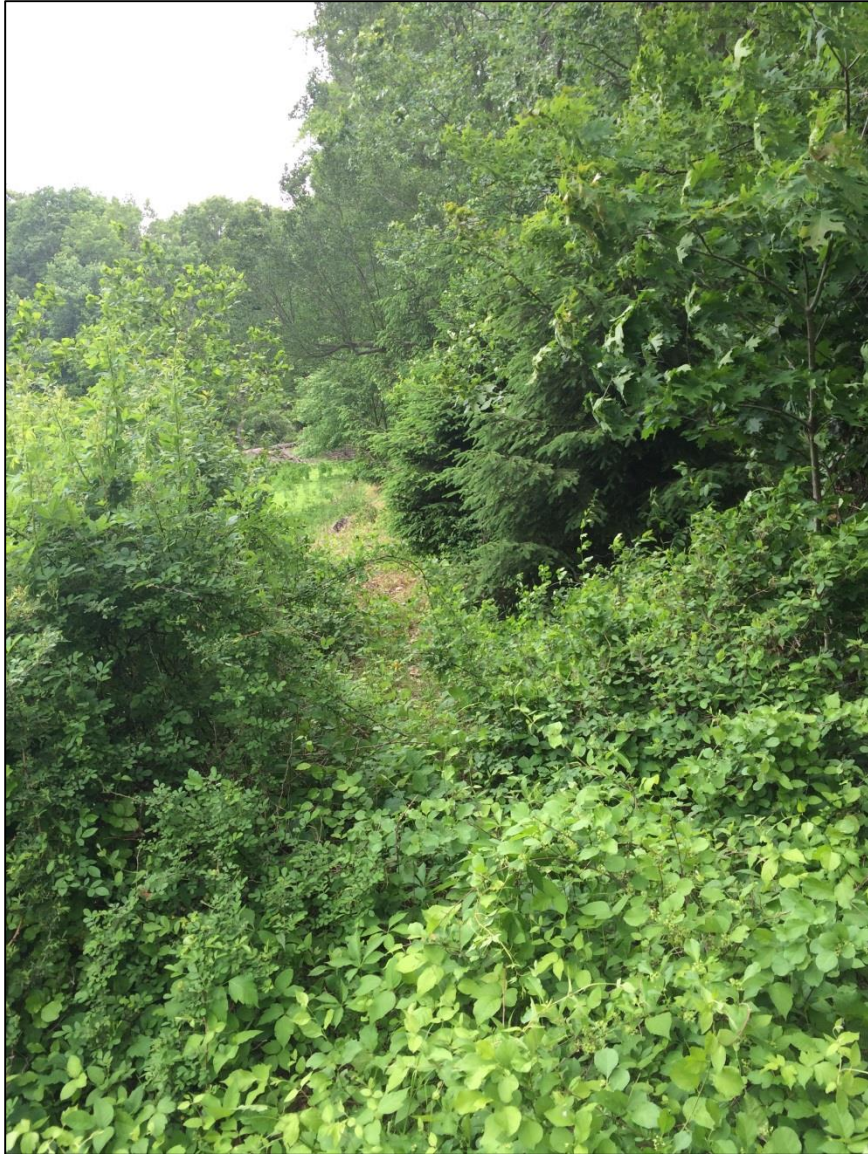
Photo 1. Dam Crest Looking Northeast

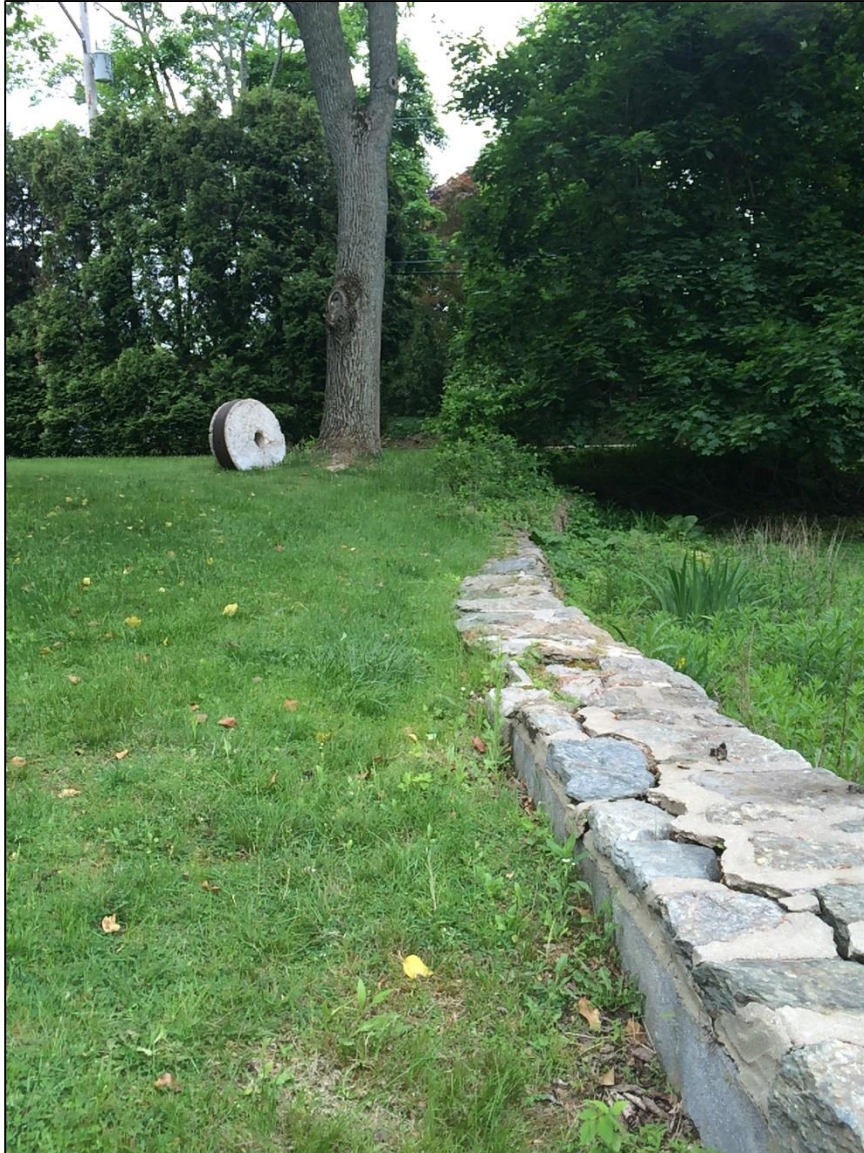
Photo 2. Dam Crest Looking West

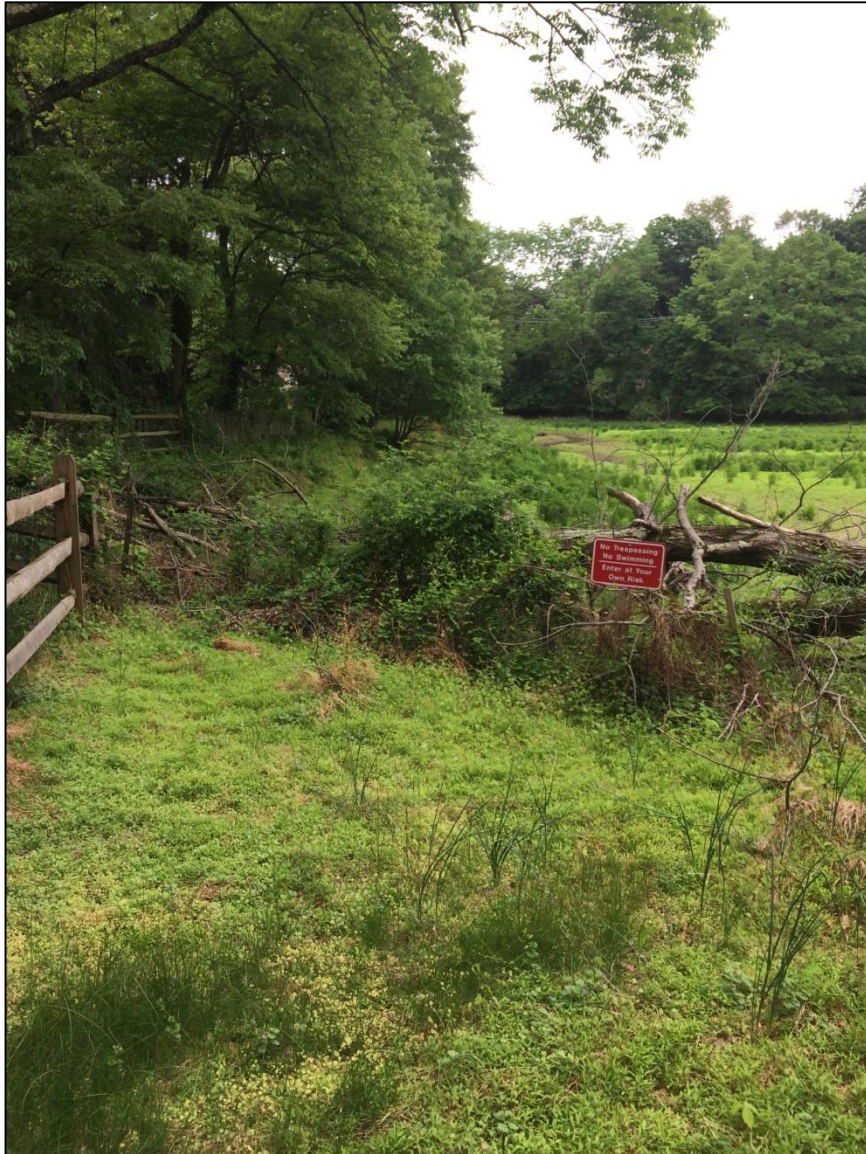
Photo 3. Warning Sign in Northeast Corner

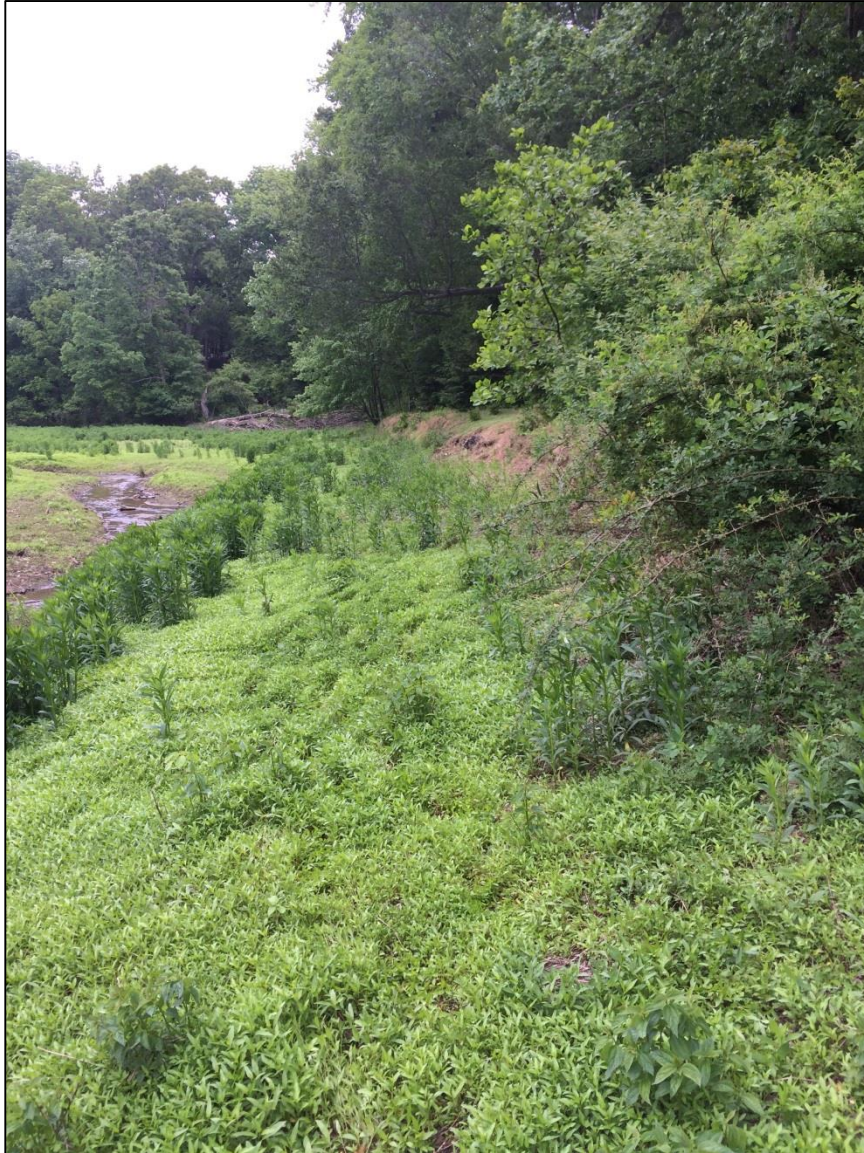
Photo 4. Upstream Face Looking Northeast

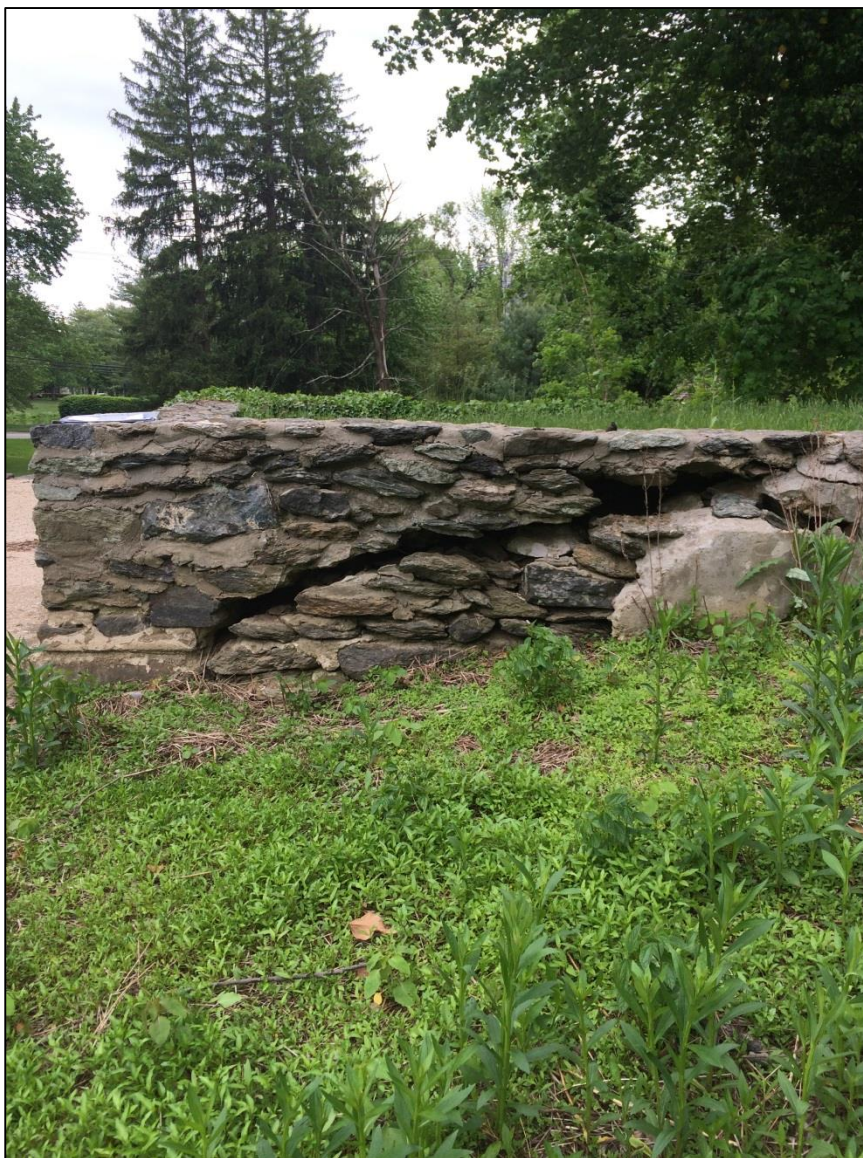
Photo 5. Upstream Face on West Side Facing South at Spillway

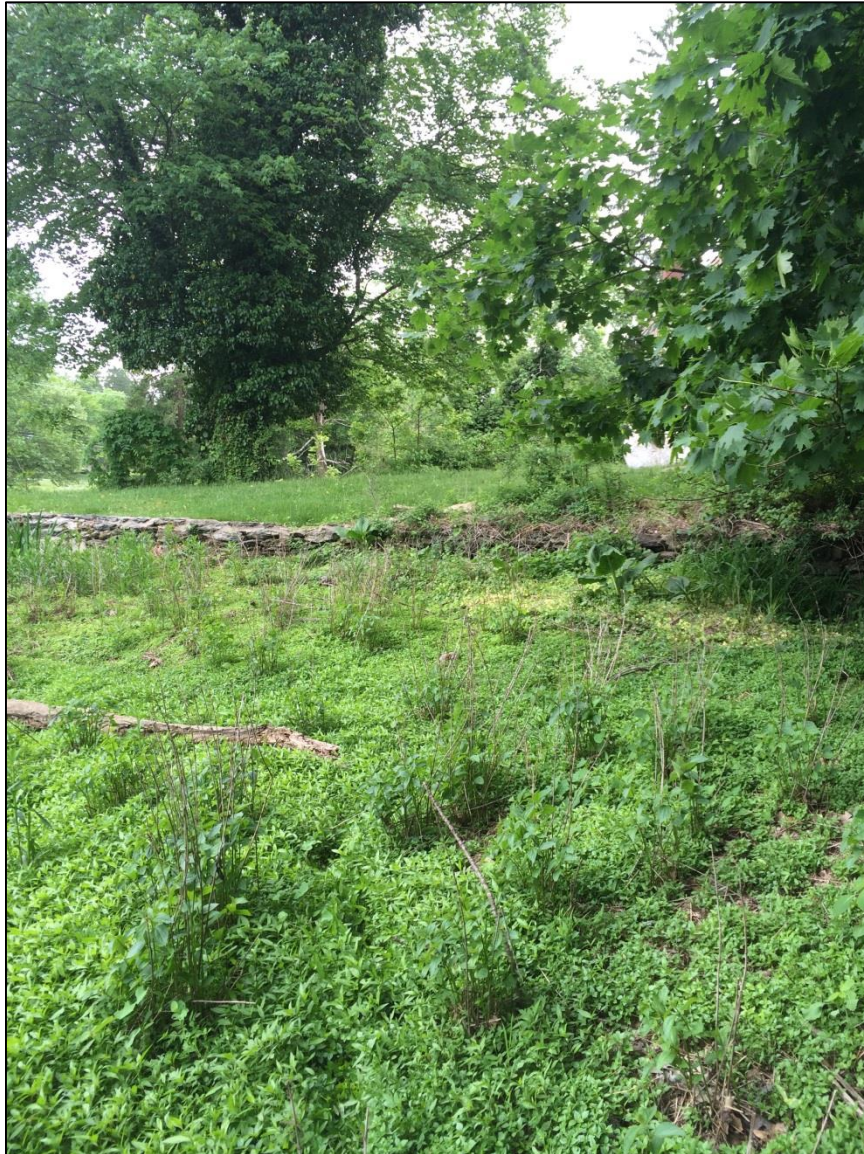
Photo 6. Upstream Face on West Side Looking South

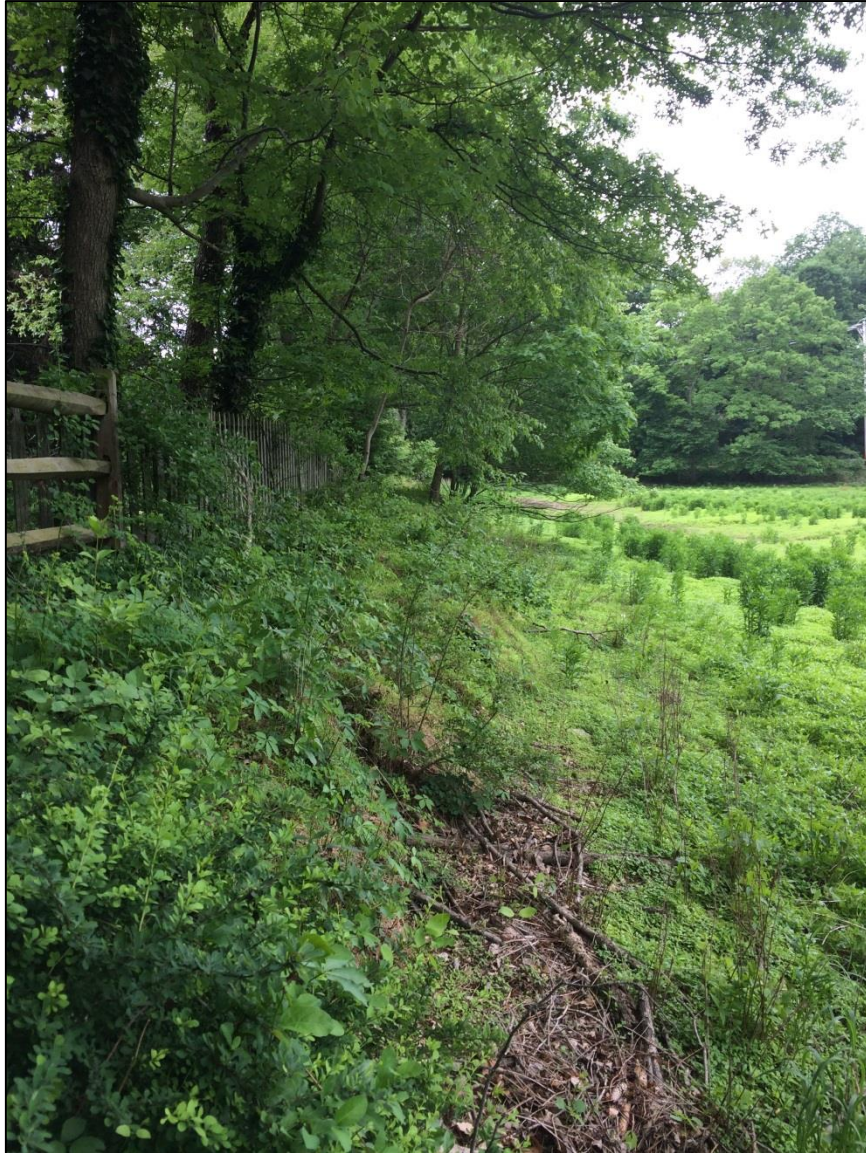
Photo 7. Upstream Face Northeast Side Looking West

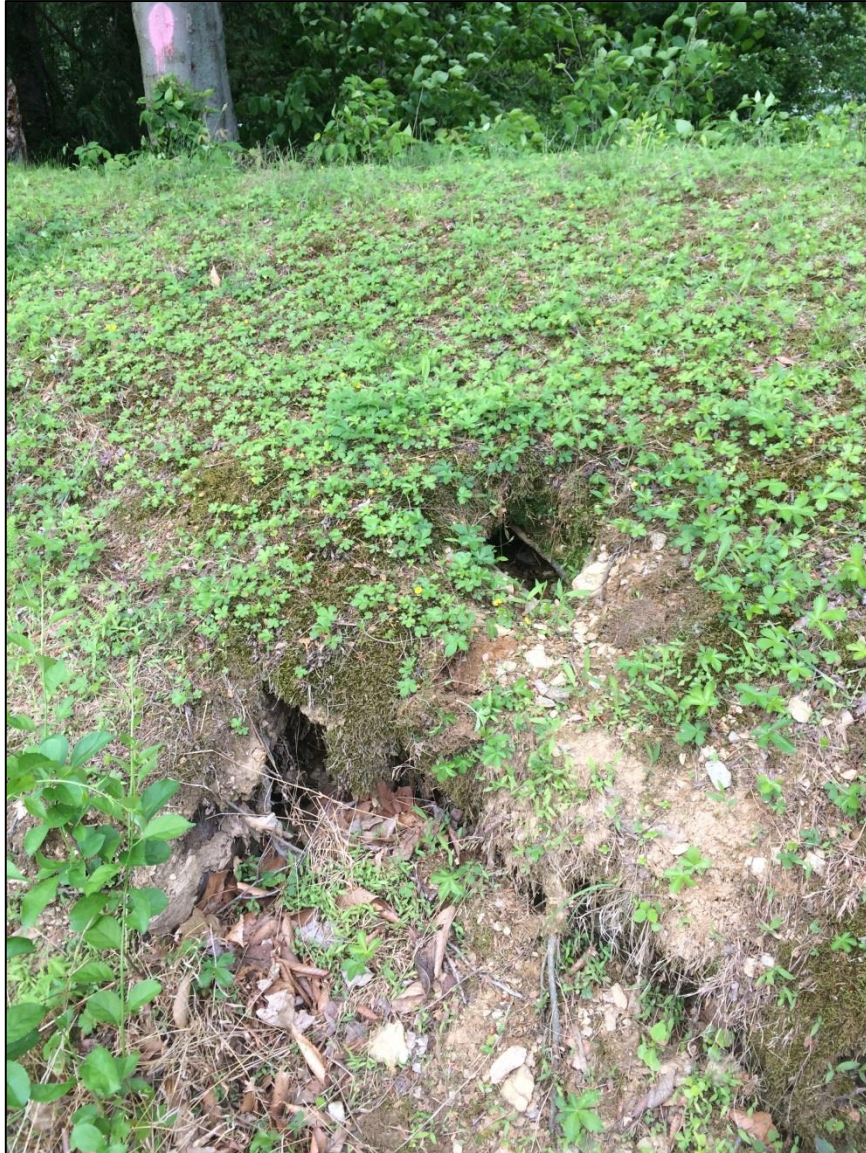
Photo 8. Upstream Face Northeast Side – Typical Void

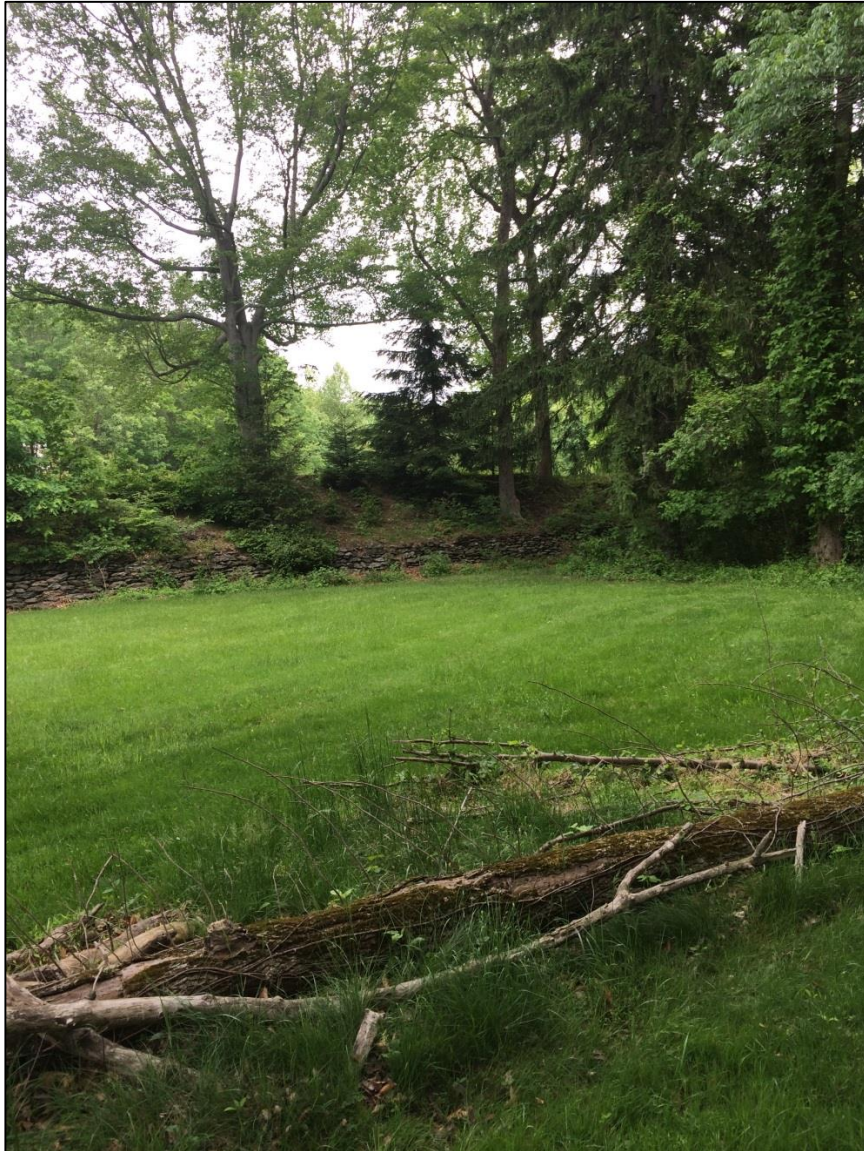
Photo 9. Downstream Face Northeast Side Looking South

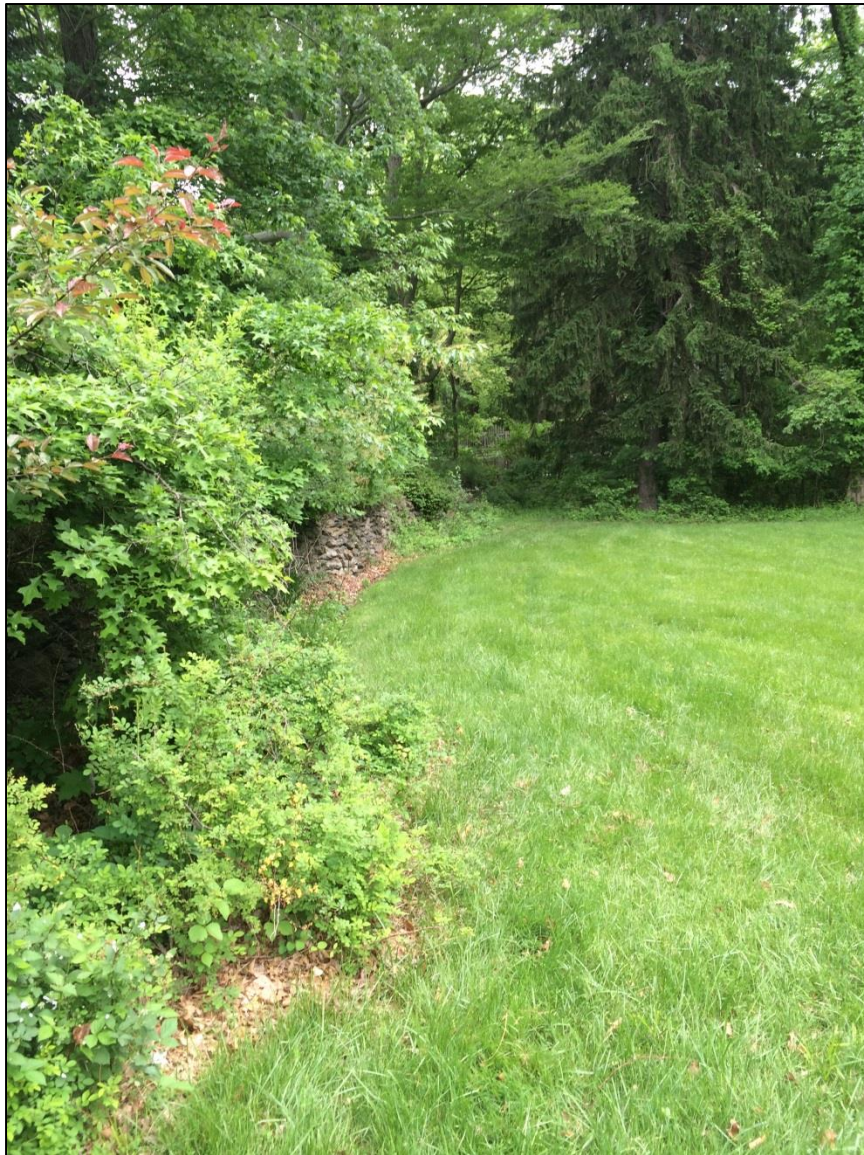
Photo 10. Downstream Face Looking Northeast

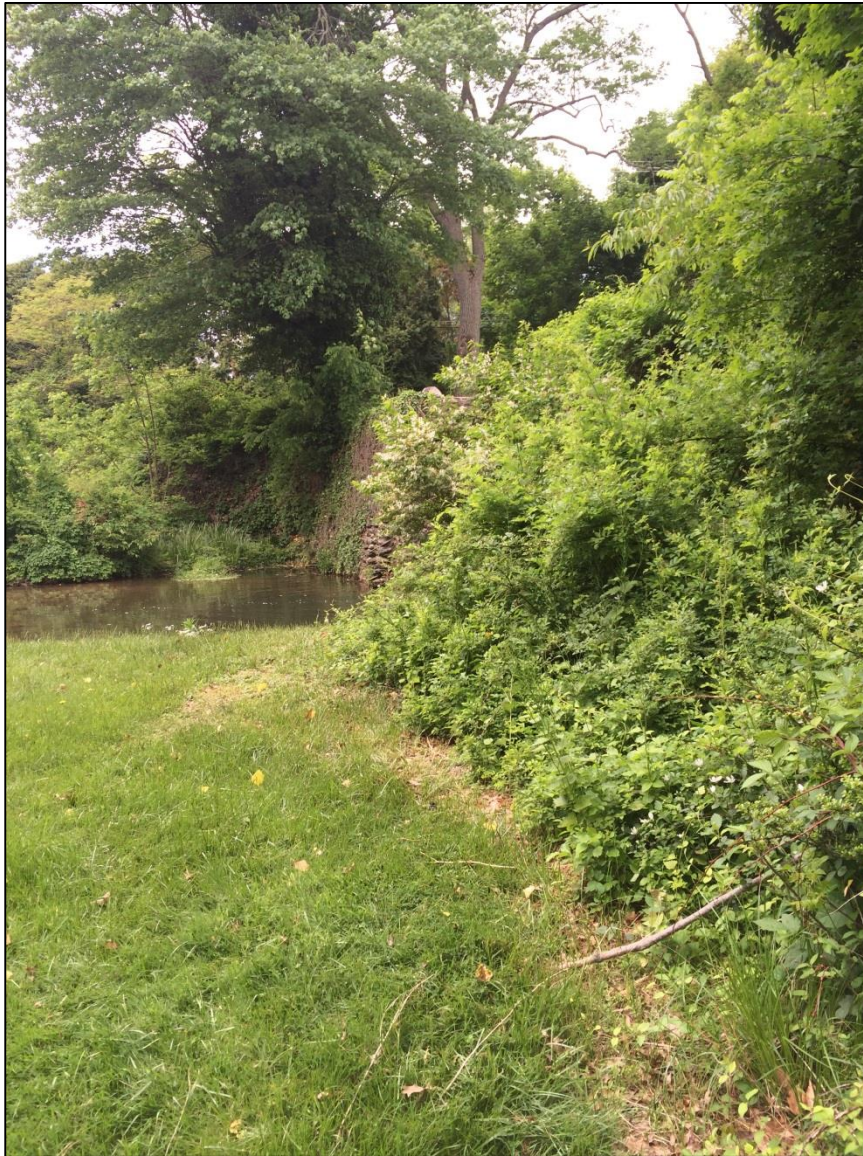
Photo 11. Downstream Face Looking West

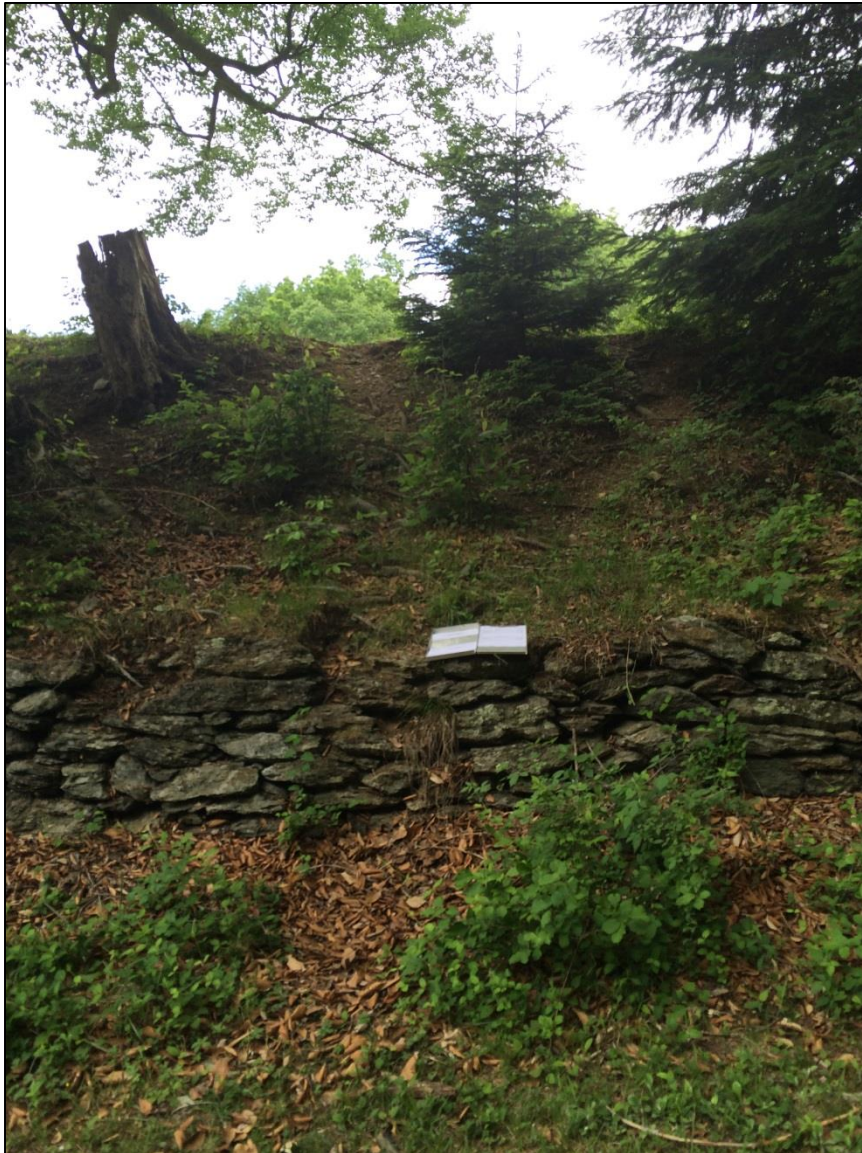
Photo 12. Downstream Face Northeast Side – Slope Erosion

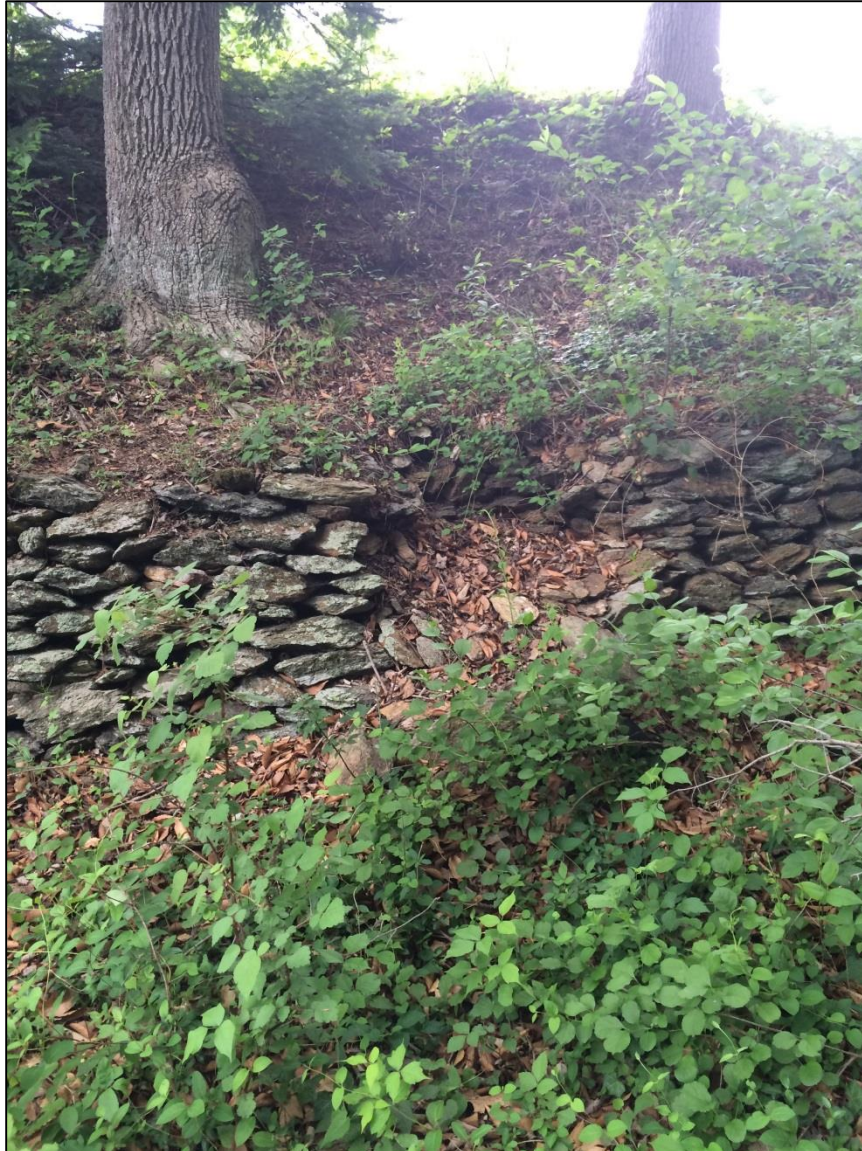
- See Photograph Nos. 9 to 11 for general condition of downstream face.
- Item 24 - Portion of downstream face stone wall in disrepair, see Photograph 13. Apparent depression in ground surface at base of stone wall approximately 75 feet to the northeast of the spillway, see Photograph 14.

Photo 13. Downstream Face Northeast Side – Wall Disrepair

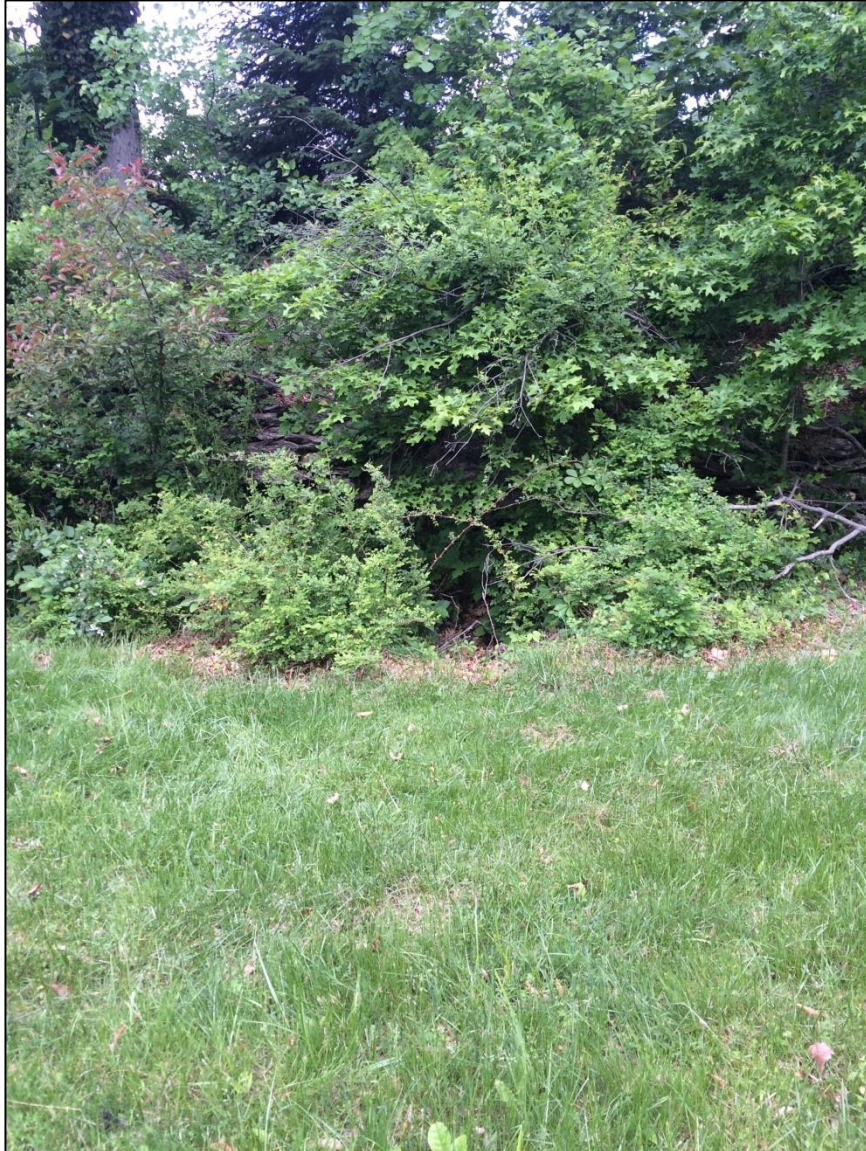
Photo 14. Downstream Face Northeast Side – Depression at Toe

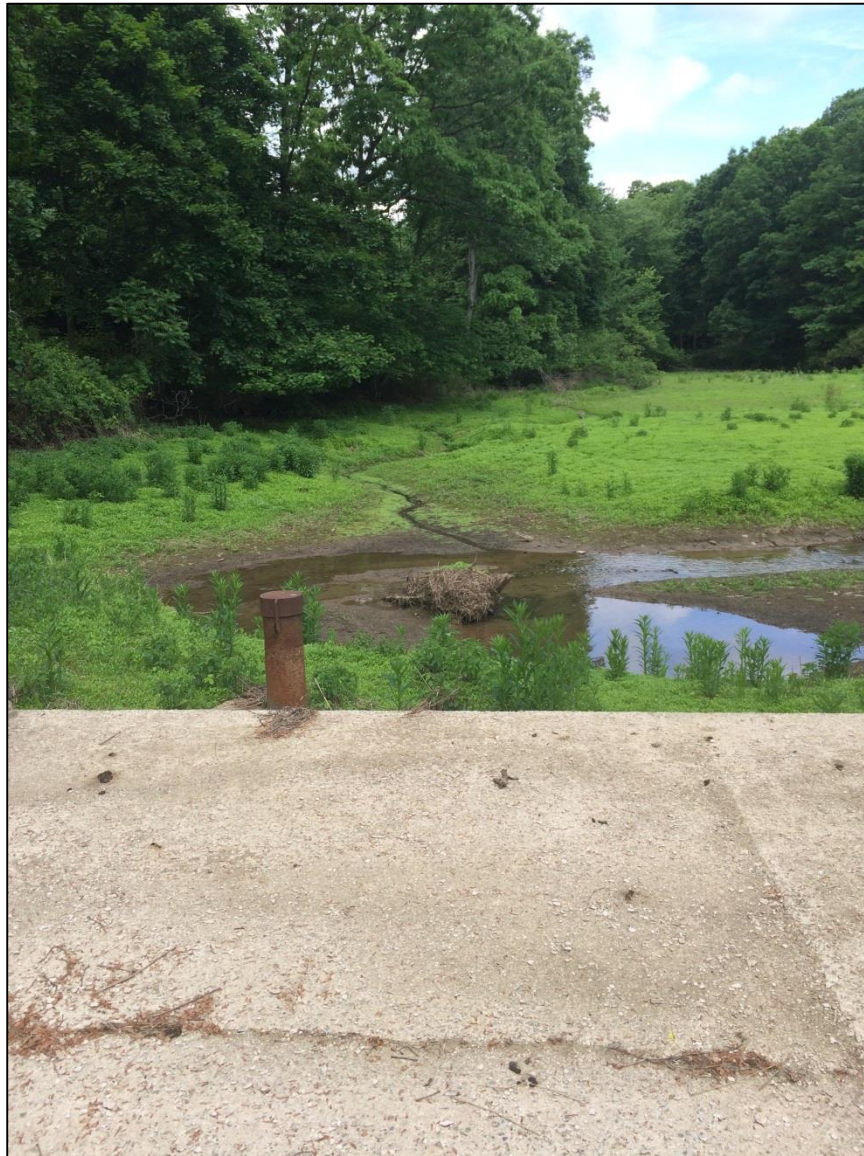
Photo 15. Outlet Control Valve Housing on Upstream Side of Spillway

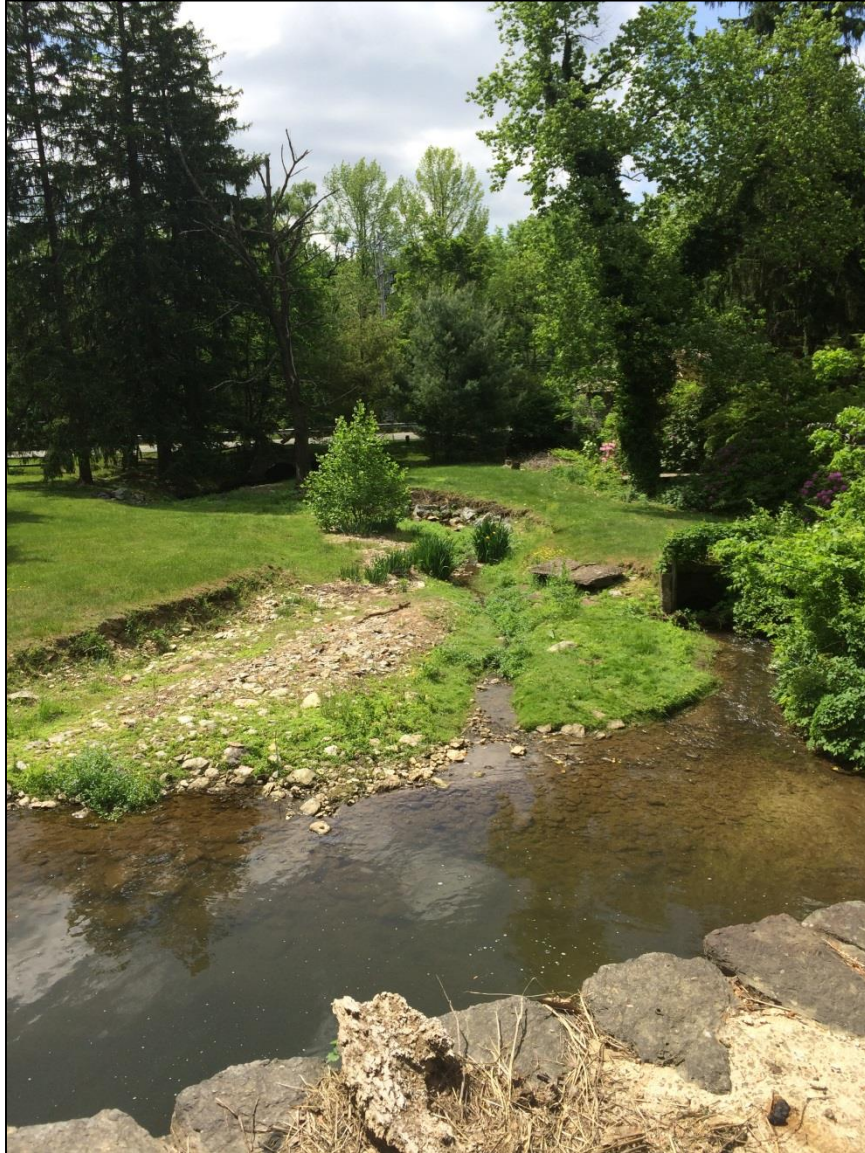
- Item 41 – spillway outlets into stream which partially flows into pipe which outlets on the south side of Greenhill Road. Entrance to pipe is partially blocked with debris. See Photograph 16 & 17.

Photo 16. Downstream Area from Spillway

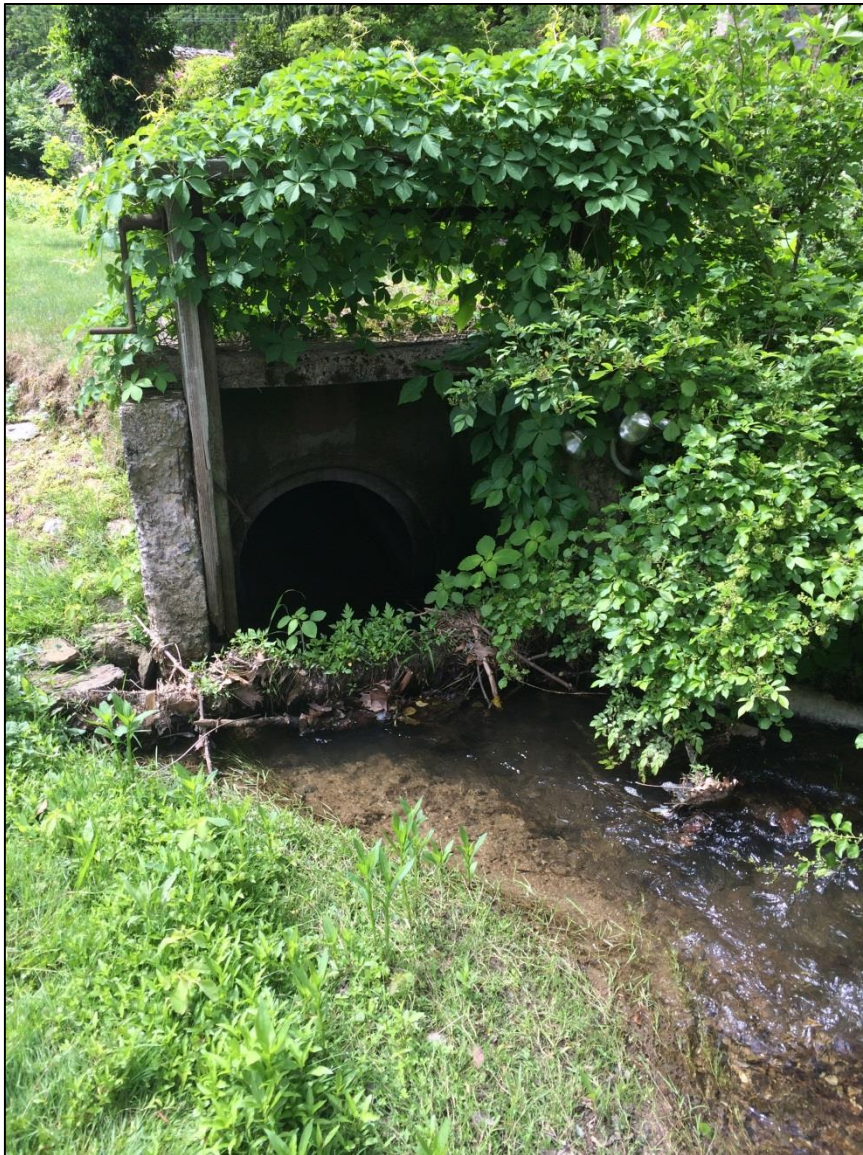
Photo 17. Downstream Pipe

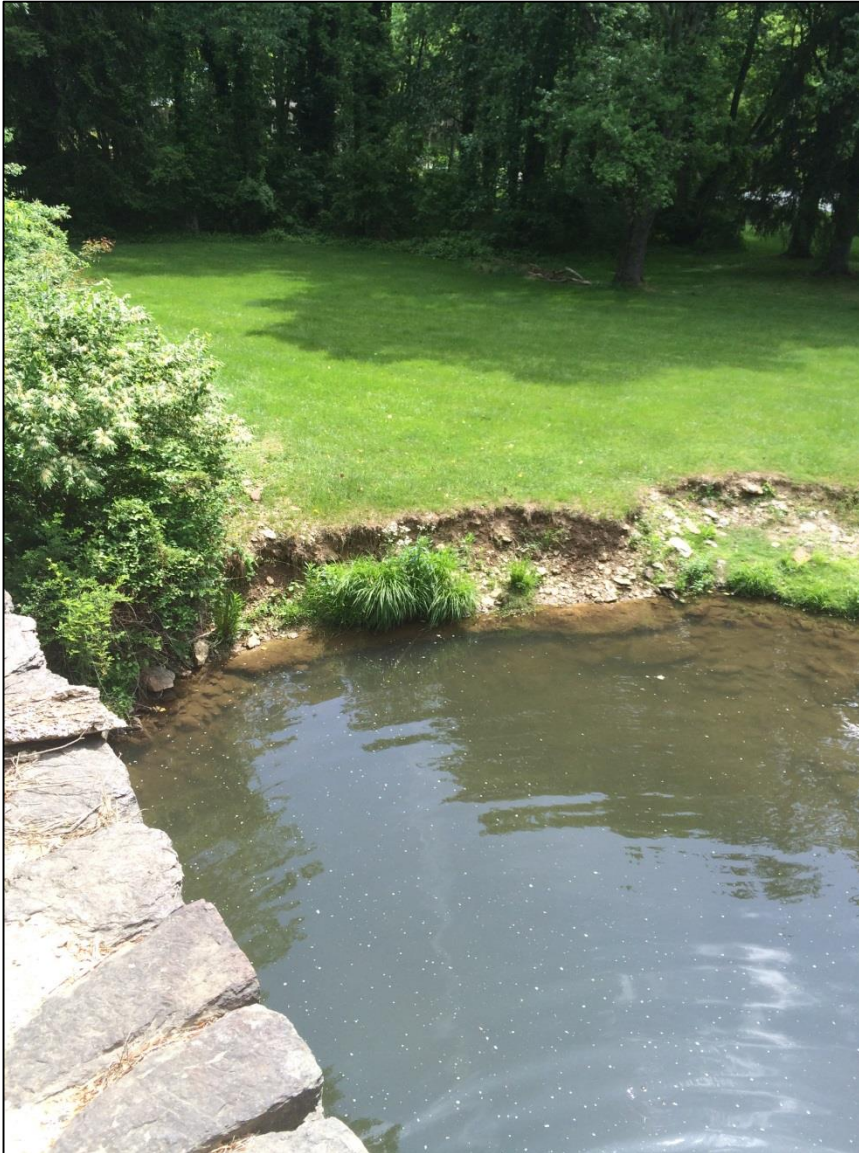
Photo 18. Downstream Pool Looking Northeast

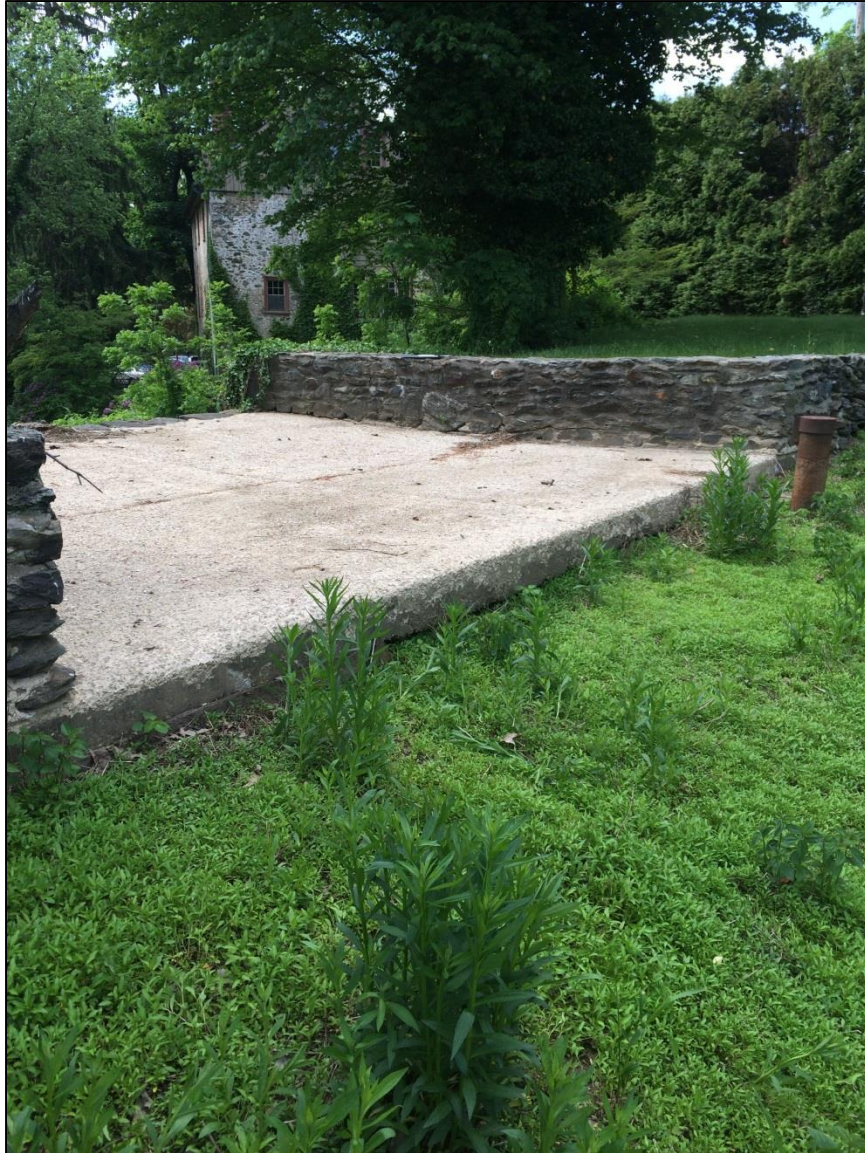
Photo 19. Spillway Slab Looking West

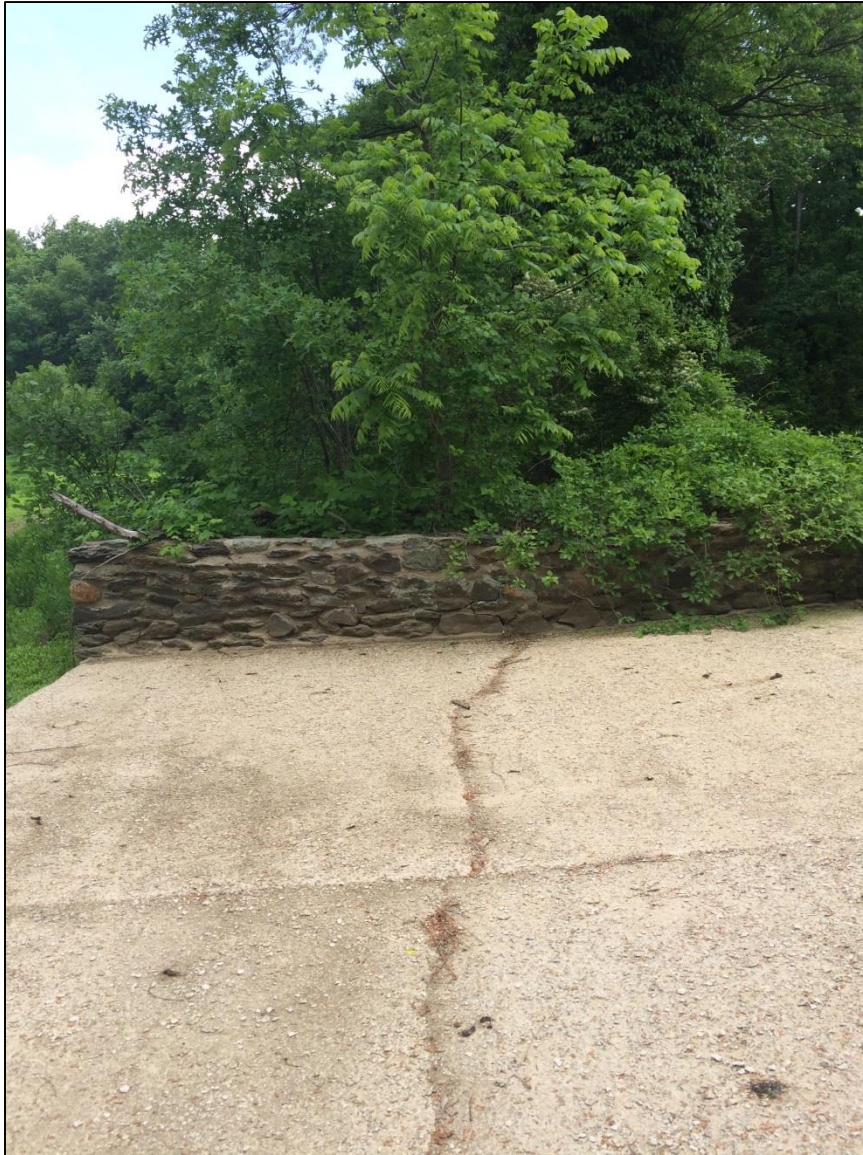
Photo 20. Spillway Northeast Wall

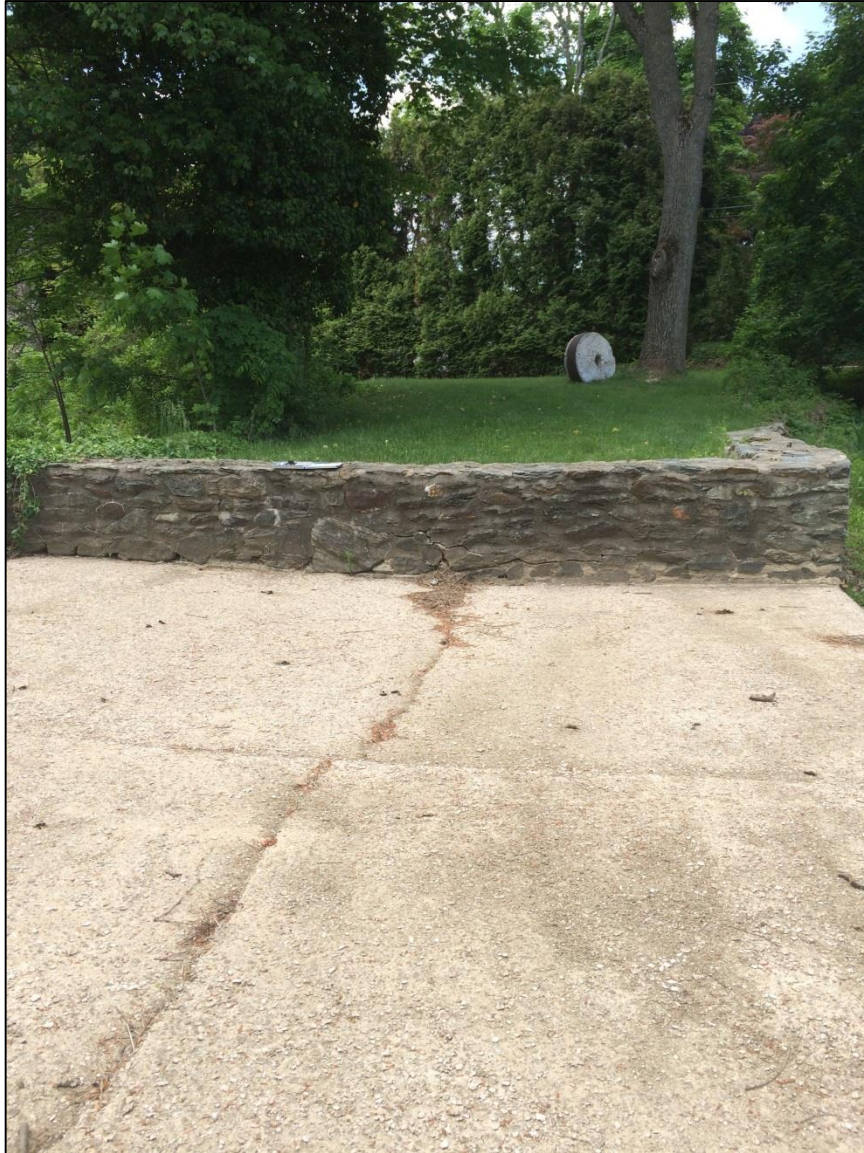
Photo 21. Spillway West Wall

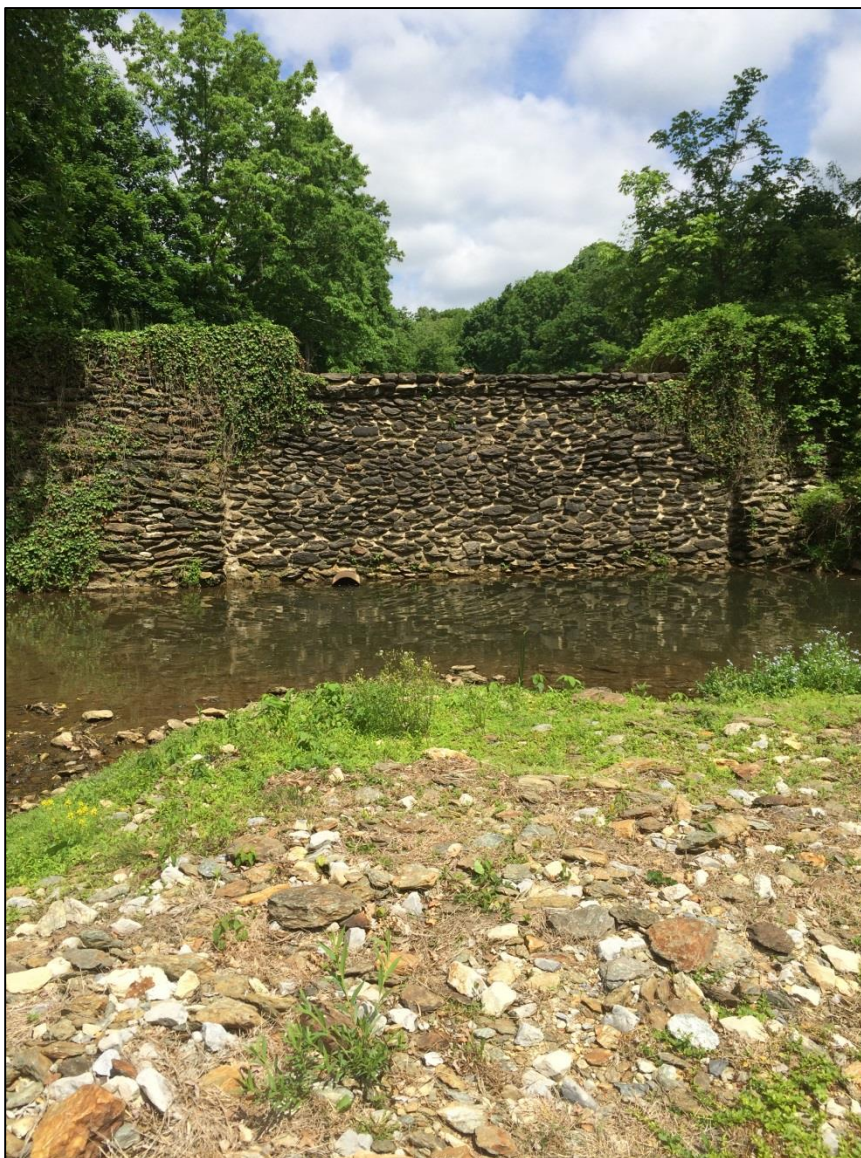
Photo 22. Spillway Downstream Face
