DAM INSPECTION CHECKLIST
Department of Environmental Protection
Bureau of Waterways Engineering
Division of Dam Safety

NAME OF DAM: Hershey Mill Dam

DEP DAM NO.: 15-125

HERSHEY MILL DAM INSPECTION REPORT PHOTO LOG

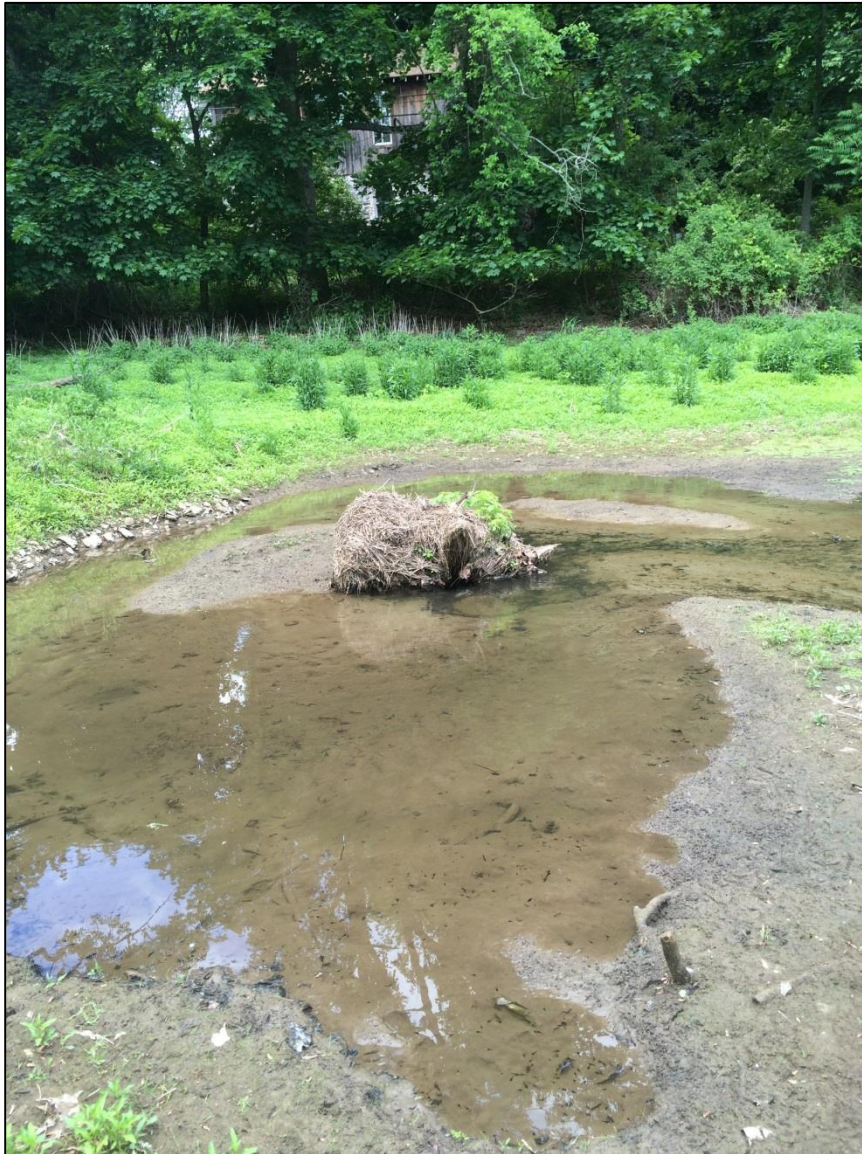
ITEM	CONDITION	COMMENTS	MONITOR	INVESTIGATE	REPAIR
OUTLET WORKS					
70	Intake Structure	Covered with debris, see Photograph 23	<input type="checkbox"/>	<input type="checkbox"/>	<input checked="" type="checkbox"/>
71	Trashrack	Does not appear to be present, see Photograph 23	<input type="checkbox"/>	<input type="checkbox"/>	<input checked="" type="checkbox"/>
72	Stilling Basin	See "SPILLWAYS: Erodible Channel" section above	<input type="checkbox"/>	<input type="checkbox"/>	<input type="checkbox"/>
73	Primary Closure	Does not appear to be present	<input type="checkbox"/>	<input type="checkbox"/>	<input checked="" type="checkbox"/>
74	Secondary Closure	N/A	<input type="checkbox"/>	<input type="checkbox"/>	<input type="checkbox"/>
75	Control Mechanism	See note below	<input type="checkbox"/>	<input type="checkbox"/>	<input checked="" type="checkbox"/>
76	Outlet Pipe	Only visible at outlet to spillway, see Photograph 22	<input type="checkbox"/>	<input type="checkbox"/>	<input type="checkbox"/>

Photo 23. Outlet Structure/Trashrack Upstream of Spillway
