**RE: Hershey Mill Dam
2016 Annual Inspection**

This correspondence summarizes Pennoni's recent Visual Inspection of the Hershey Mill Dam located in East Goshen Township, PA. This is considered the Township's 2016 annual inspection.

NAME OF DAM: Hershey Mill Dam

DEP DAM NO.: 15-125

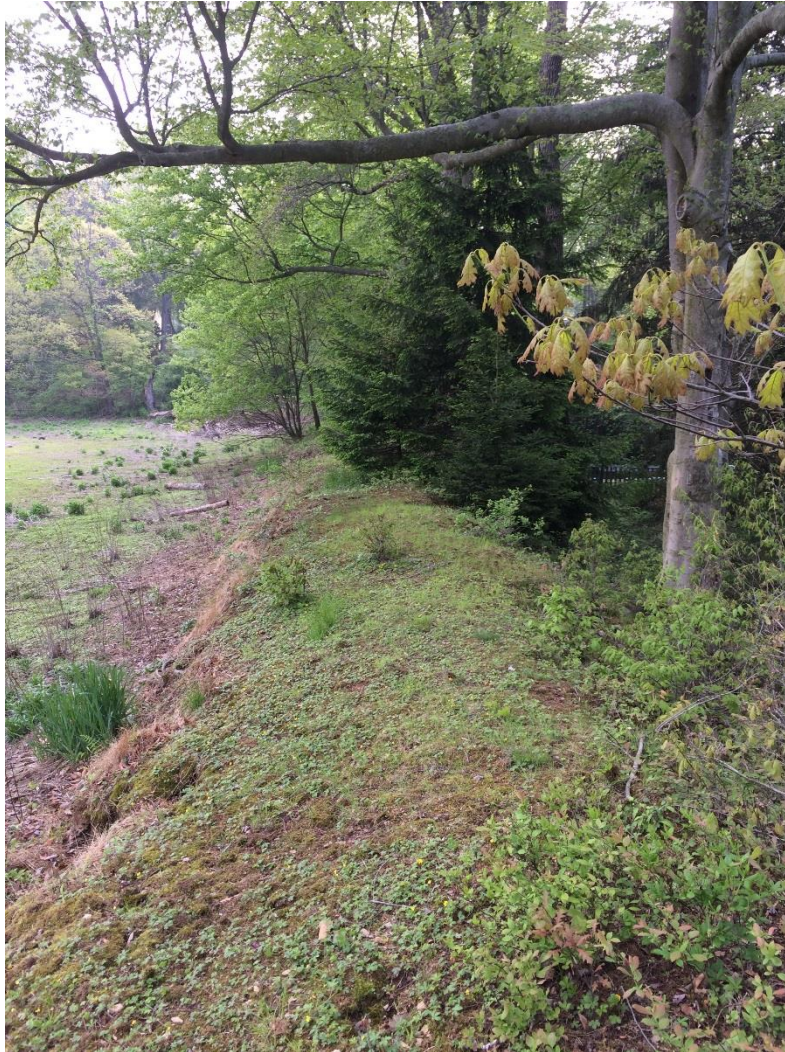
Photo 1. Dam Crest Looking Northeast (Northeast Side of Spillway)

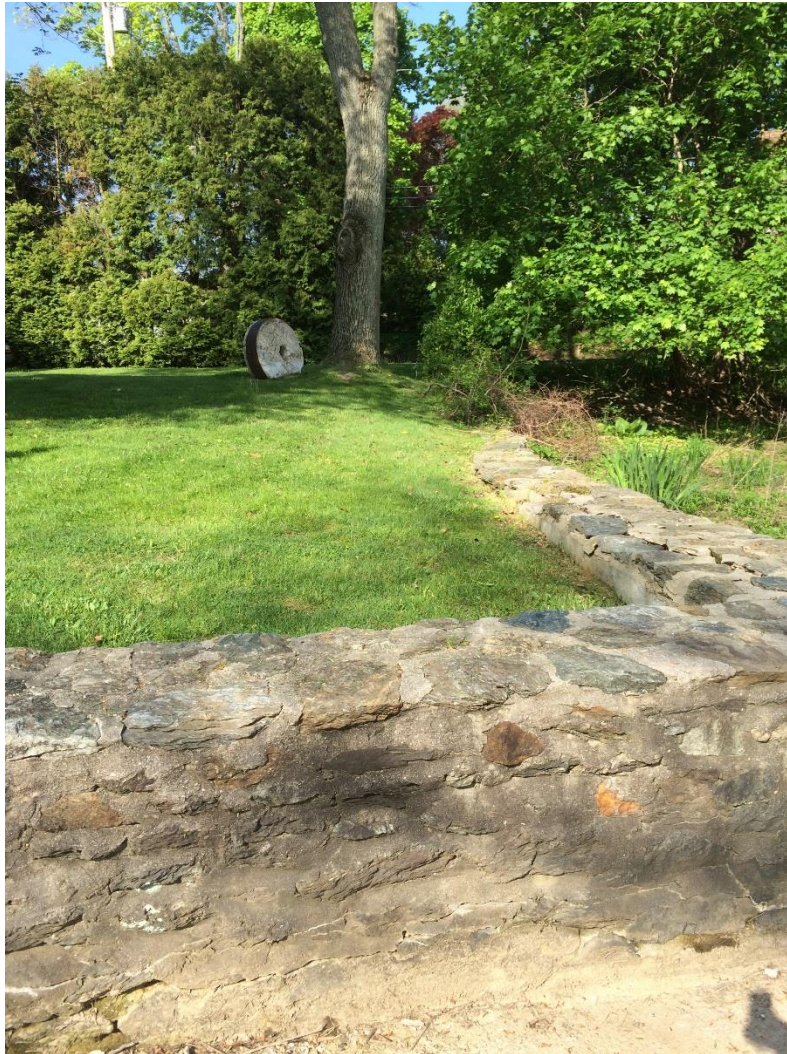
Photo 2. Dam Crest Looking West (West Side of Spillway)

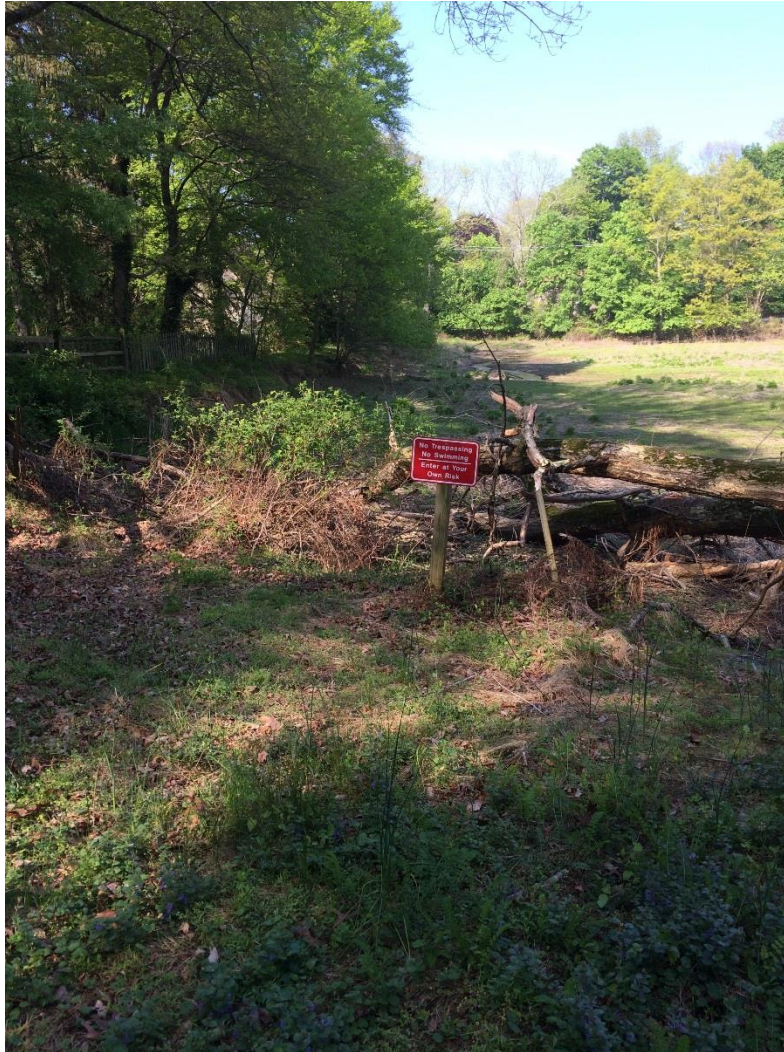
Photo 3. Warning Sign in Northeast Corner

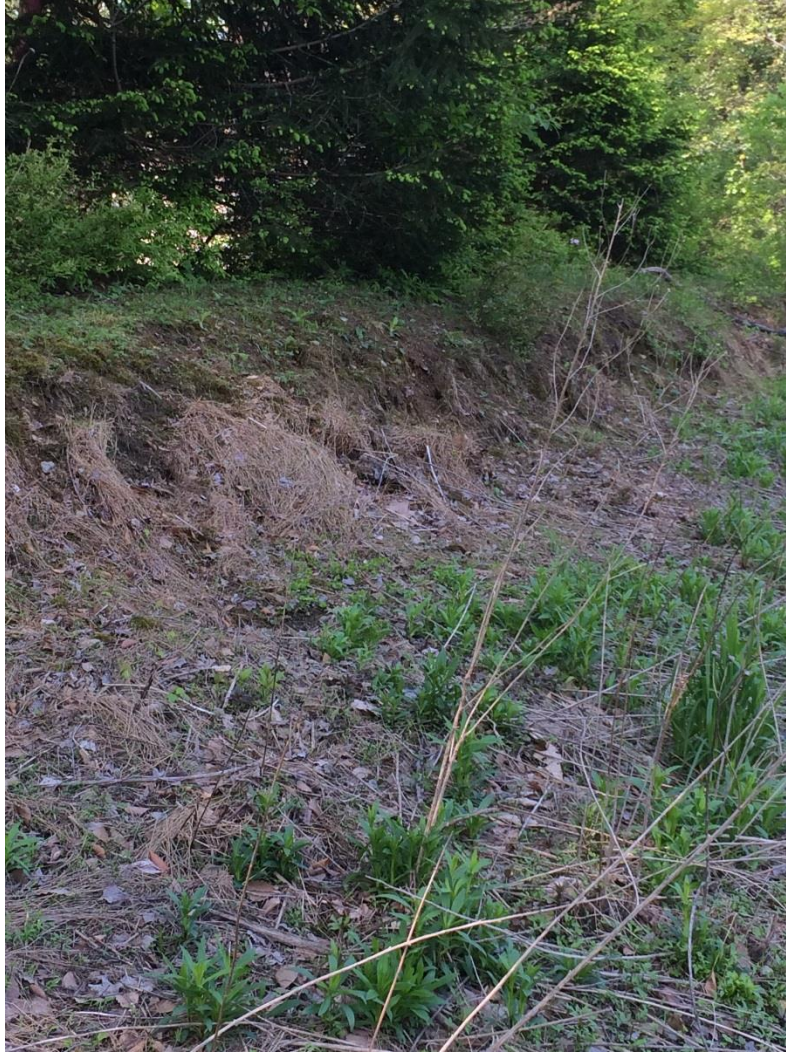
Photo 4. Upstream Face on Northeast Side of Spillway Looking Northeast

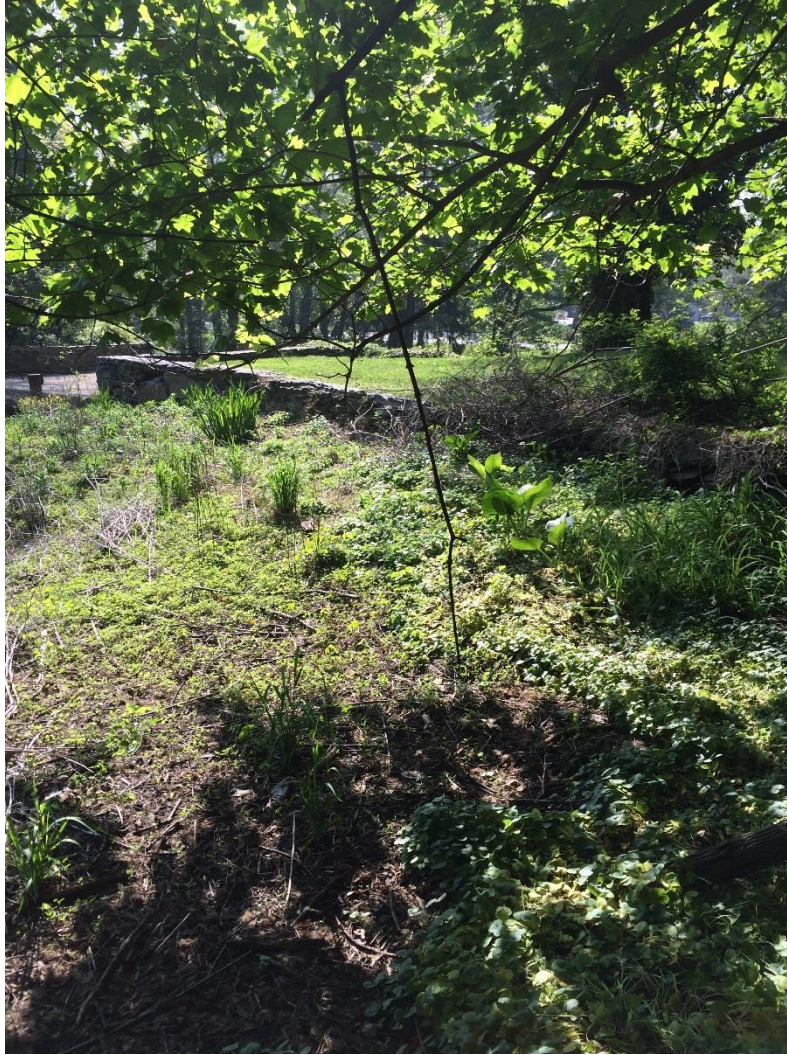
Photo 5. Upstream Face on West Side of Spillway Facing South East

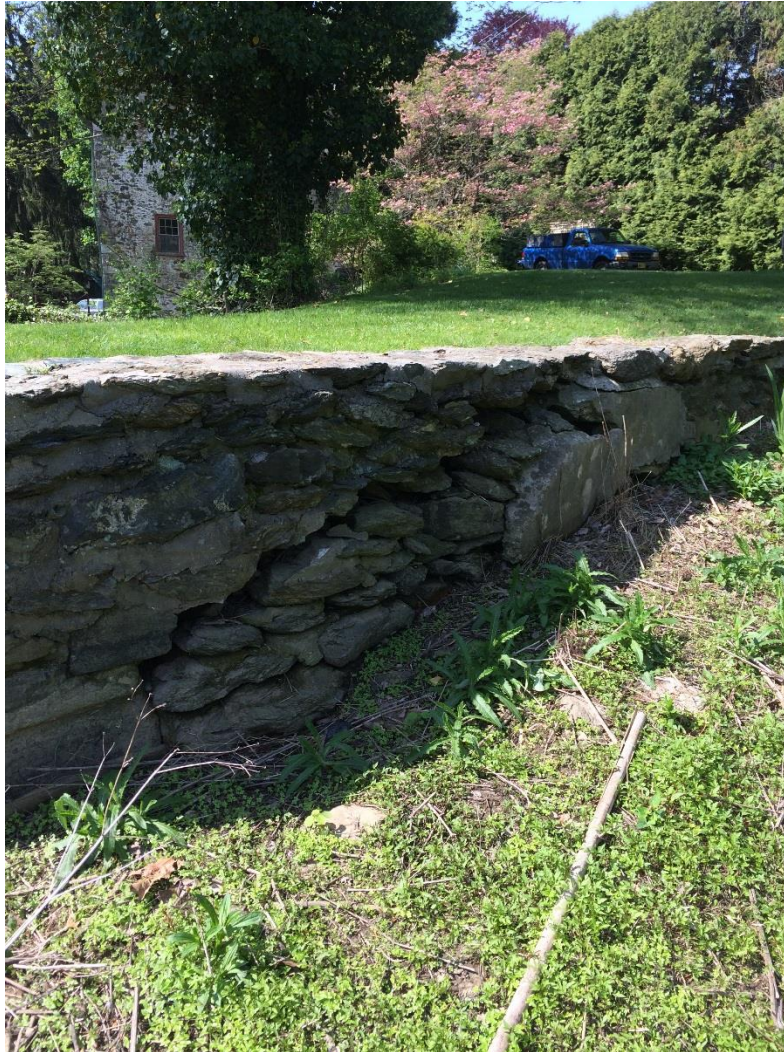
Photo 5a. Upstream Face on Northeast Side Facing Southwest

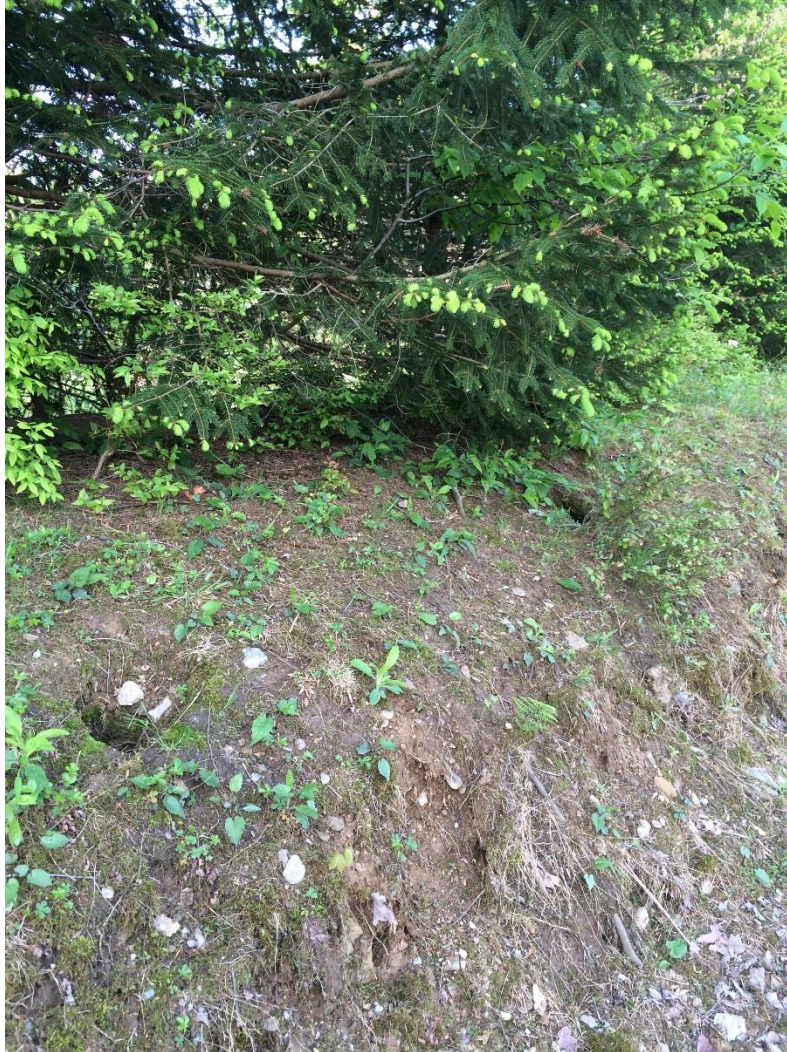
12	Sinkhole, Animal Burrow	Significant - see note below Photograph 6	<input type="checkbox"/>	<input type="checkbox"/>	<input checked="" type="checkbox"/>
13	Emb.-Abut. Contact	See comment below	<input type="checkbox"/>	<input type="checkbox"/>	<input type="checkbox"/>
14	Erosion	See comment below	<input type="checkbox"/>	<input type="checkbox"/>	<input checked="" type="checkbox"/>
15	Vegetation Condition	Northeast side of spillway- Predominately overgrown w/ some bare areas; West side of spillway – stone wall	<input type="checkbox"/>	<input type="checkbox"/>	<input checked="" type="checkbox"/>
16			<input type="checkbox"/>	<input type="checkbox"/>	<input type="checkbox"/>
17			<input type="checkbox"/>	<input type="checkbox"/>	<input type="checkbox"/>
Additional Comments (Refer to item number if applicable): - Item Nos. 10 & 14 – portions of upstream face from spillway to the northeast have vertical faces with exposed earth approximately 2 to 4 feet high (see Photograph 4). Upstream face from spillway west consists of vertical stone wall approximately 2 to 4 feet high in poor condition (numerous cracking, see Photograph 5 and 5a). Large trees present at west end of crest. - Item 13 – At northeast end of crest, grade of crest blends in to natural grade. At west end of crest stone wall terminates abruptly.

Photo 6. Typical Animal Burrows on Northeast Upstream Embankment Face

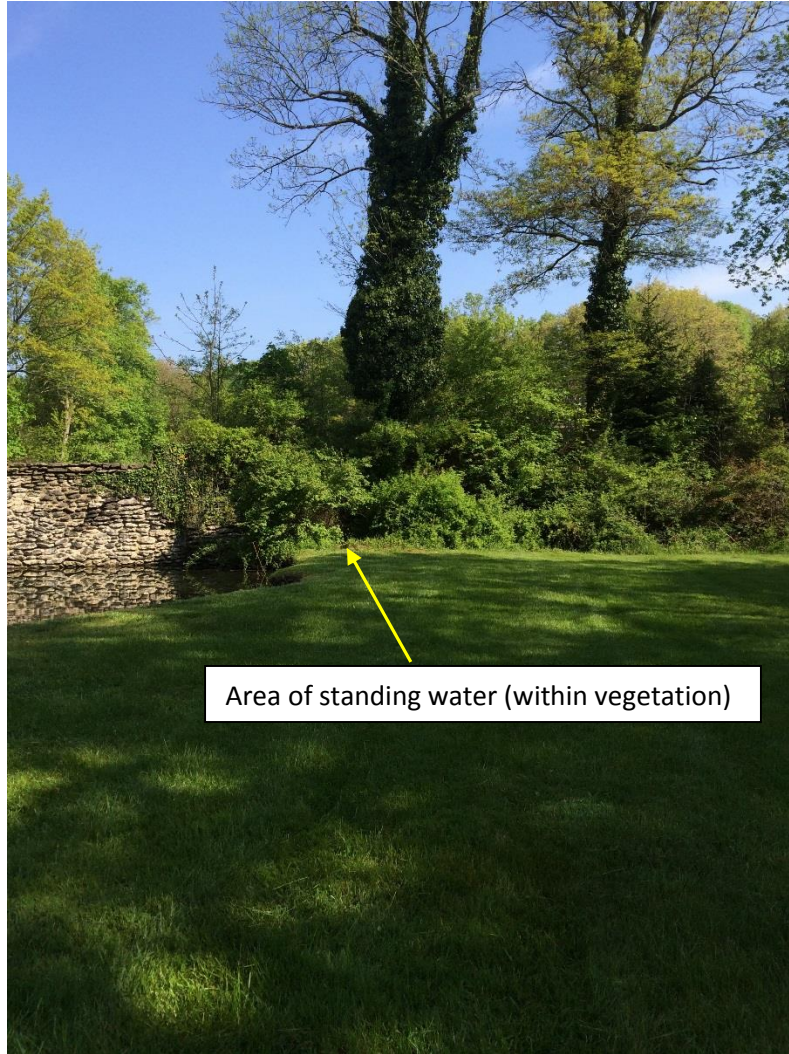
ITEM	CONDITION	COMMENTS	MONITOR	INVESTIGATE	REPAIR
EMBANKMENT: DOWNSTREAM FACE					
18	Wet Area(s) (No Flow)	Standing water from spillway edge northeast 27 ft. +/- @ toe of wall. See Photograph 7	<input type="checkbox"/>	<input type="checkbox"/>	<input checked="" type="checkbox"/>
19	Seepage	None observed	<input type="checkbox"/>	<input type="checkbox"/>	<input type="checkbox"/>
20	Slide, Slough, Scarp	Northeast side of spillway shows areas of bare earth (scarp). See Photograph 8	<input type="checkbox"/>	<input type="checkbox"/>	<input checked="" type="checkbox"/>
21	Emb. - Abut. Contact	See comments on "Upstream Face"	<input type="checkbox"/>	<input type="checkbox"/>	<input type="checkbox"/>
22	Sinkhole, Animal Burrow	Significant along downstream face northeast of spillway	<input type="checkbox"/>	<input type="checkbox"/>	<input checked="" type="checkbox"/>
23	Erosion	Moderate where no vegetation present, see Photograph 8	<input type="checkbox"/>	<input type="checkbox"/>	<input checked="" type="checkbox"/>

Photo 7. Downstream Face Northeast Side Looking North

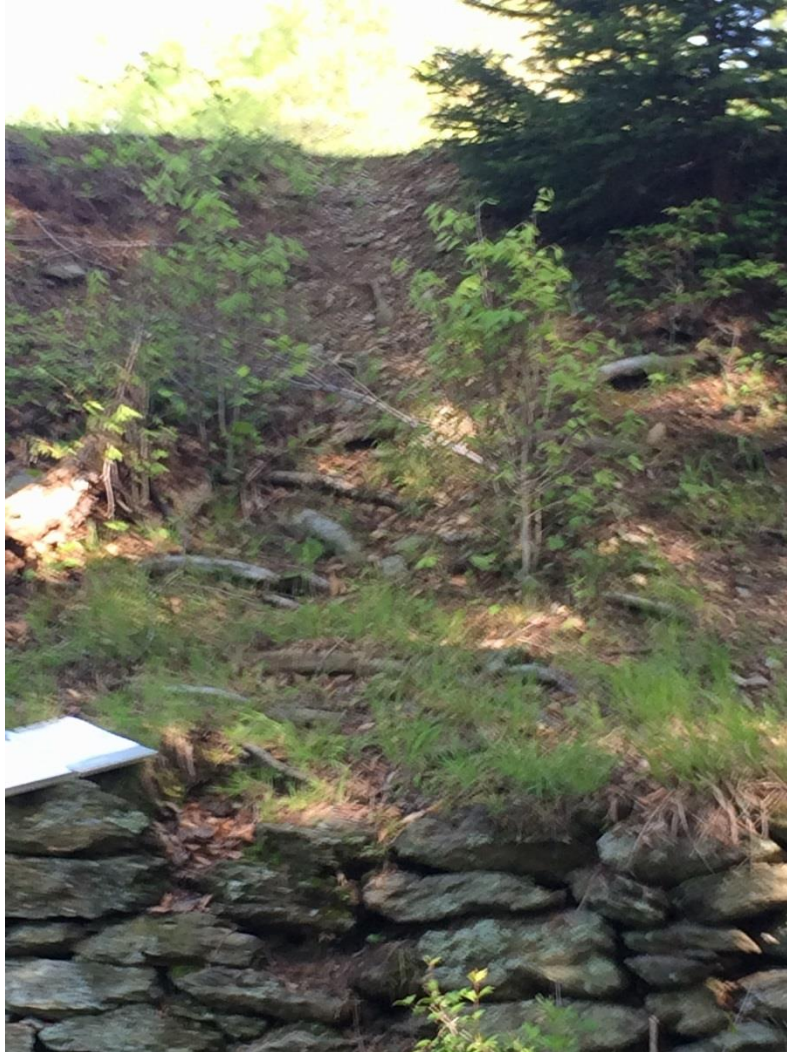
Photo 8. Downstream Face Northeast Side – Exposed Earth

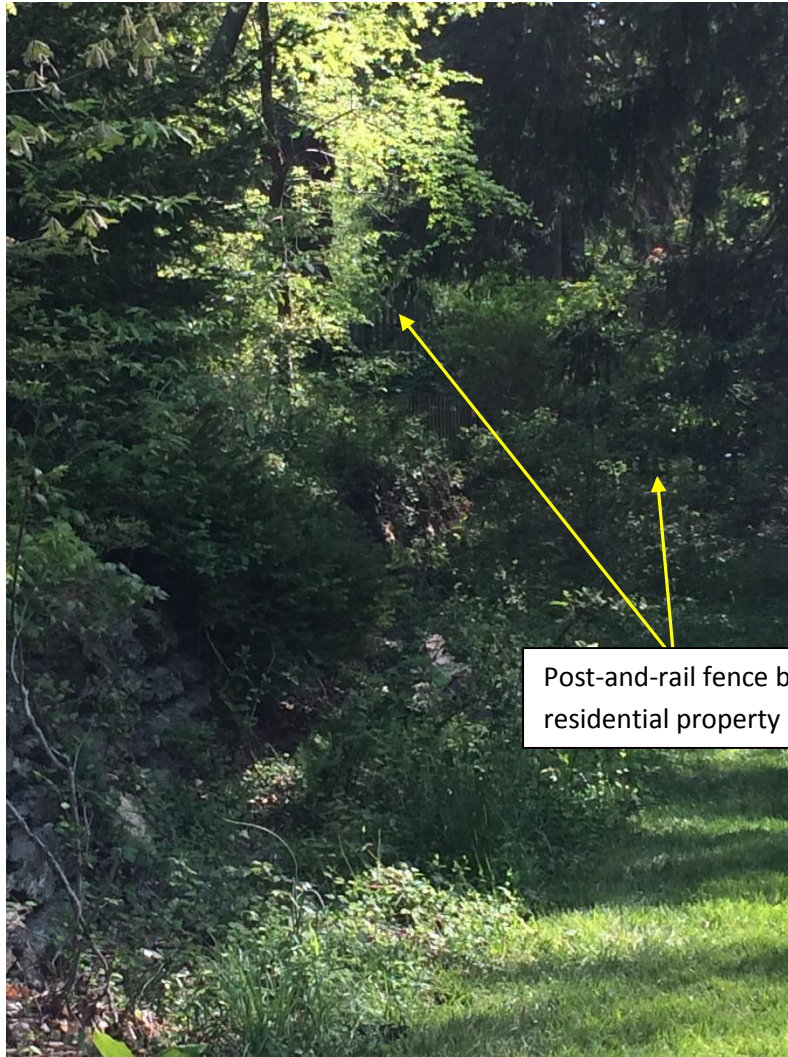
Photo 9. Downstream Face Northeast Side Looking North – Residential Property

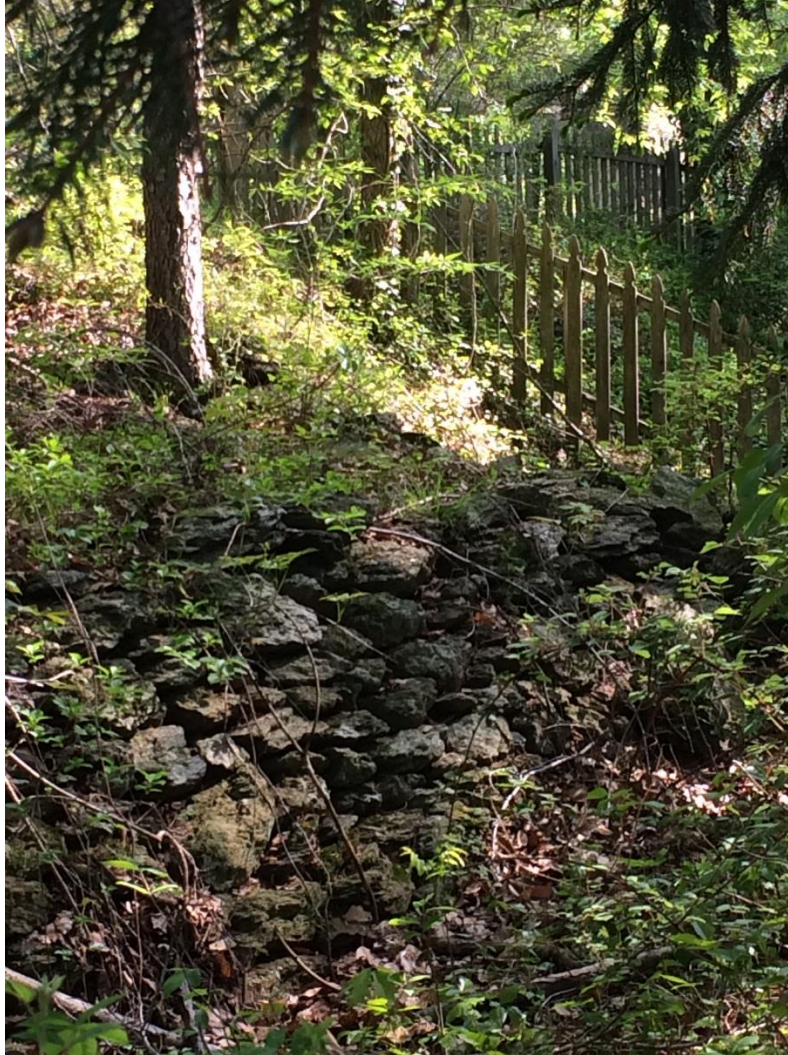
Photo 10. Downstream Face Northeast Side Looking North

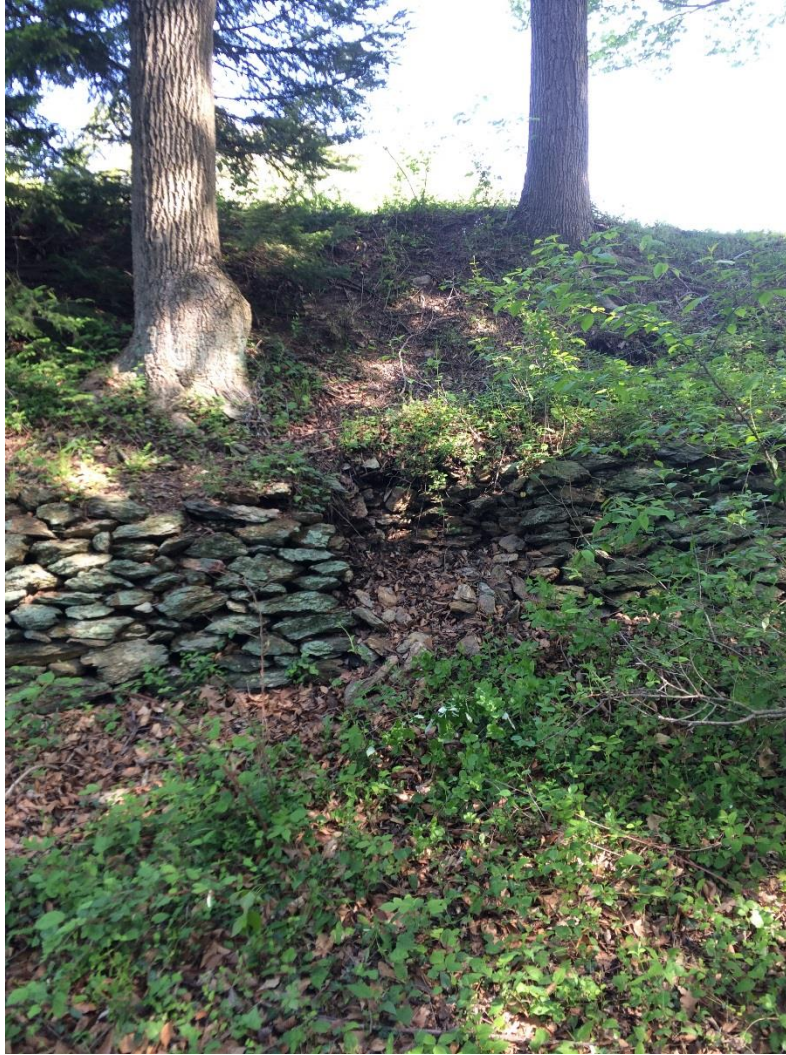
Photo 11. Downstream Face Northeast Side Looking North – Stone Wall in Disrepair

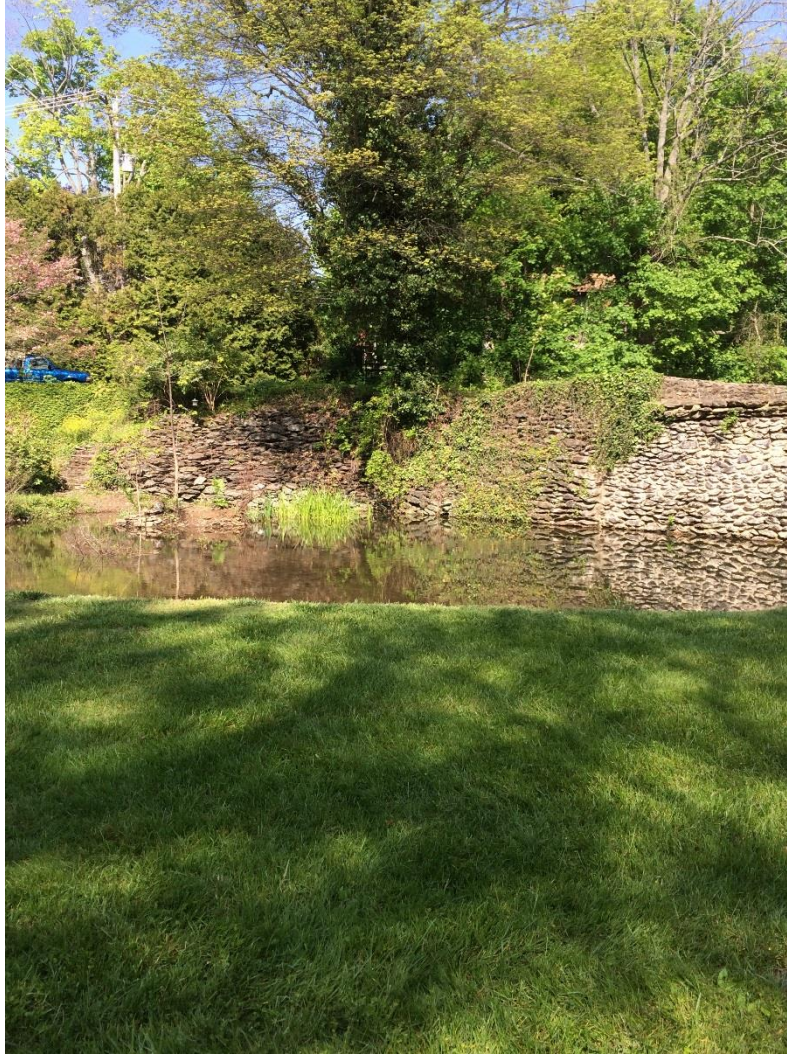
24	Unusual Movement	See note below	<input type="checkbox"/>	<input type="checkbox"/>	<input checked="" type="checkbox"/>
25	Vegetation Control	Severely overgrown	<input type="checkbox"/>	<input type="checkbox"/>	<input checked="" type="checkbox"/>
26			<input type="checkbox"/>	<input type="checkbox"/>	<input type="checkbox"/>
27			<input type="checkbox"/>	<input type="checkbox"/>	<input type="checkbox"/>
Additional Comments (Refer to item number if applicable): <ul style="list-style-type: none"> - See Photograph Nos. 7 to 10 for general condition of downstream face. - Item 24 - Portion of downstream face stone wall in disrepair, see Photograph 11. Apparent depression in ground surface at base of stone wall approximately 35-45 feet to the northeast of the spillway (previously noted as 75 ft. +/- in 2015 report), see Photograph 7. - Downstream face on west side of spillway is a vertical stone wall 15 ft. +/- high. See Photograph 12.

Photo 12. Downstream Face West Side Facing West

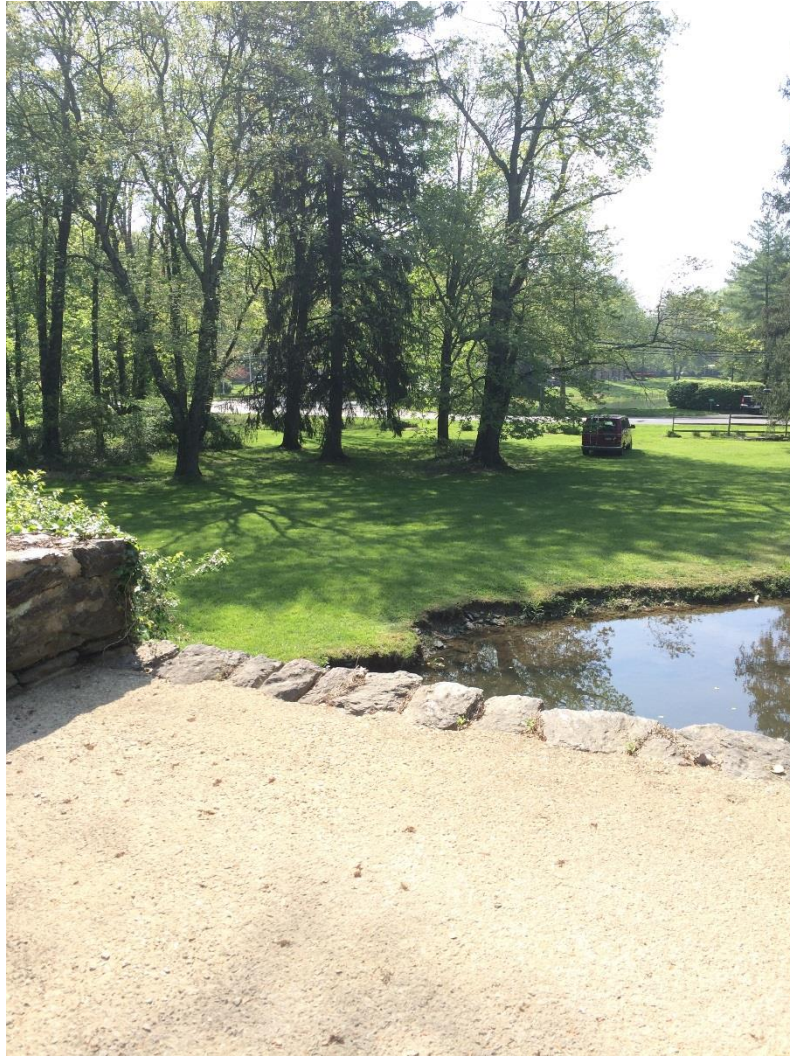
- Photograph Nos. 13 to 15 illustrate downstream area.
- Item 41 – spillway outlets into stream which partially flows into pipe which outlets on the south side of Greenhill Road. See Photograph 14.

Photo 13. Downstream Side of Dam Facing Southeast

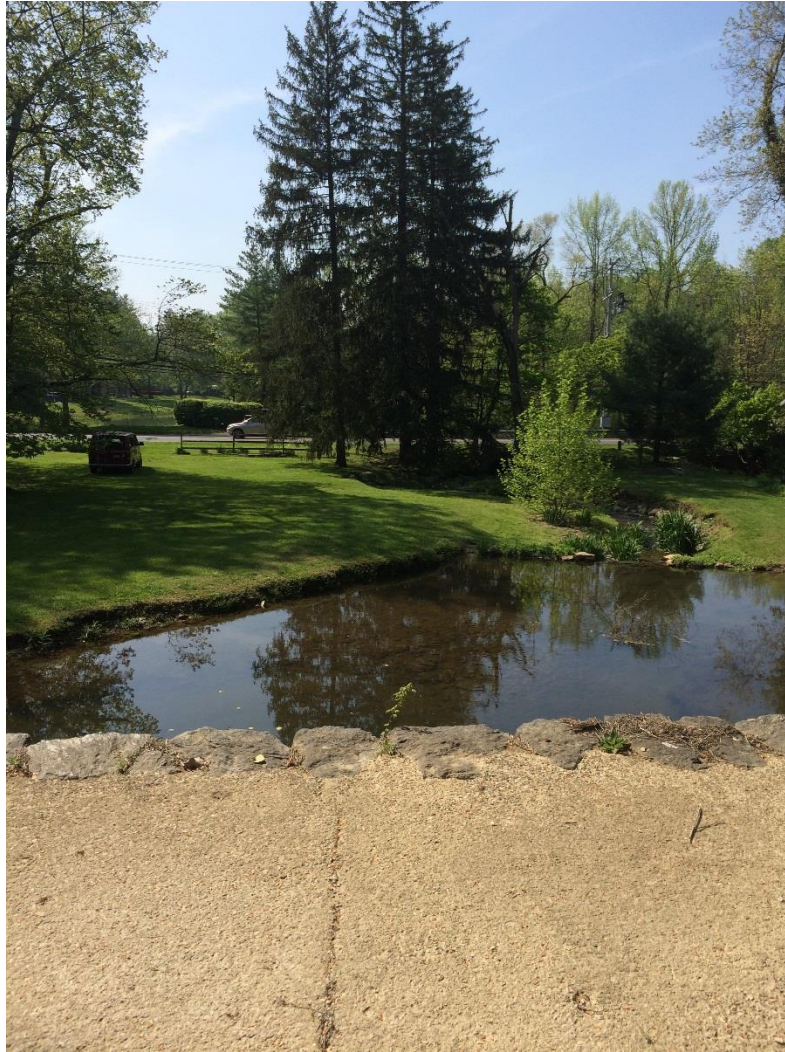
Photo 14. Downstream Side of Dam Facing South

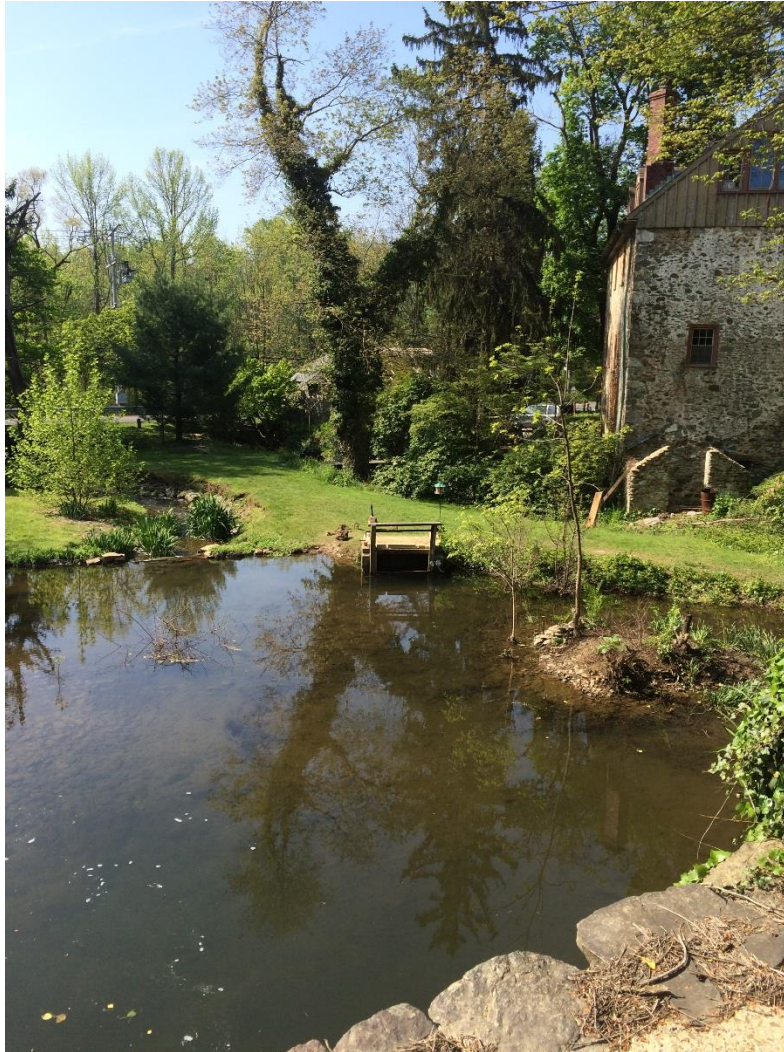
Photo 15. Downstream Side of Dam Facing Southwest

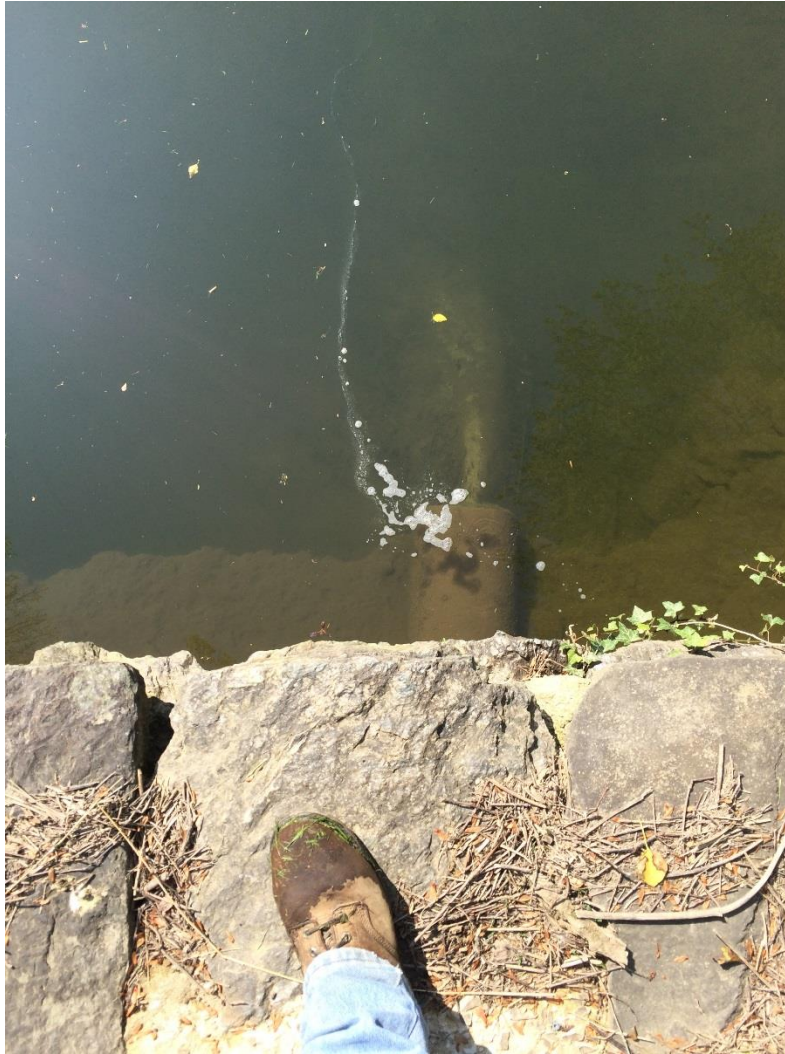
- This section refers to downstream area from dam spillway and downstream. See Photograph Nos. 13 to 15 and 16 & 17 for general condition of downstream pool and stream.

Photo 16. Downstream Outlet Pipe Through Dam

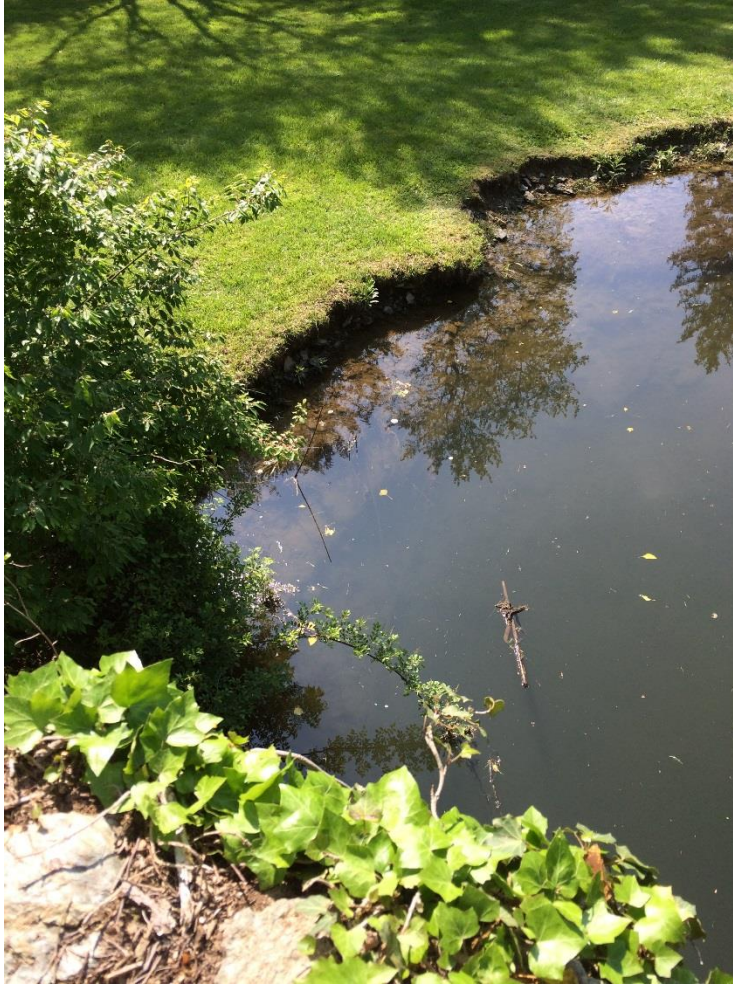
Photo 17. Downstream Edge of Discharge Pool

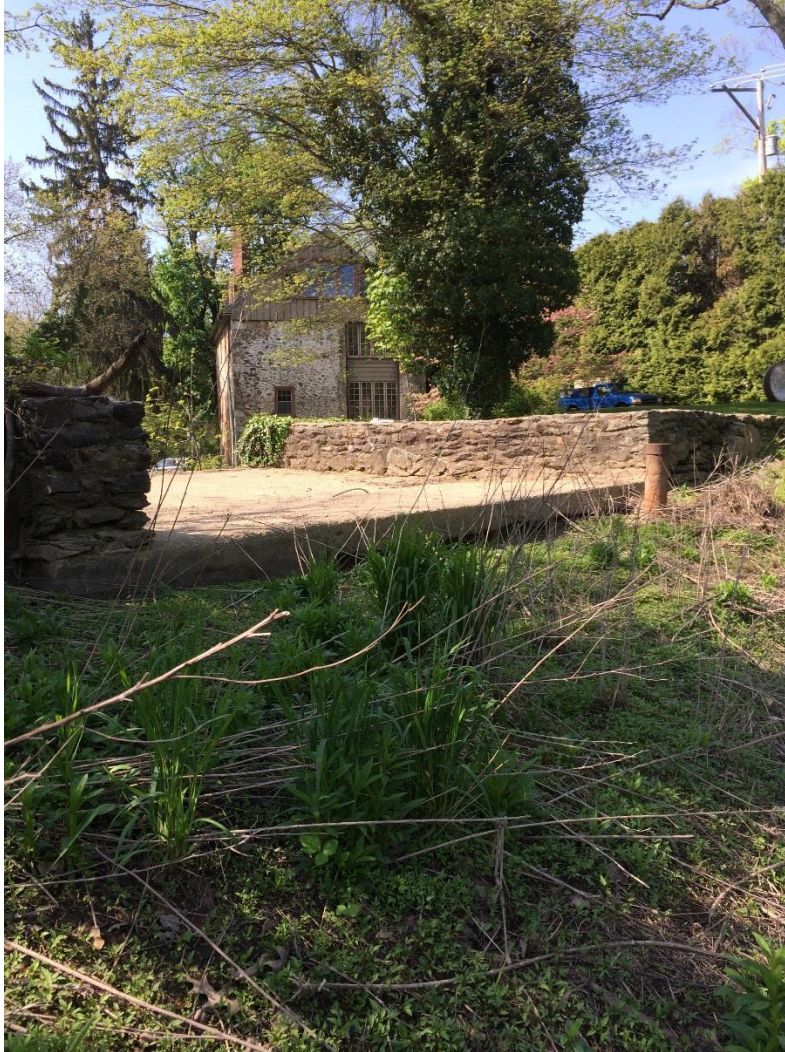
- See Photograph Nos. 17 to 19
- Item 59 – an apparent flat steel sheet was observed beneath the concrete spillway floor on the reservoir side of the spillway. The steel sheet appears to be prevent water from entering and/or erosion from occurring beneath the concrete spillway.

Photo 18. Edge of Concrete Spillway Facing Southwest

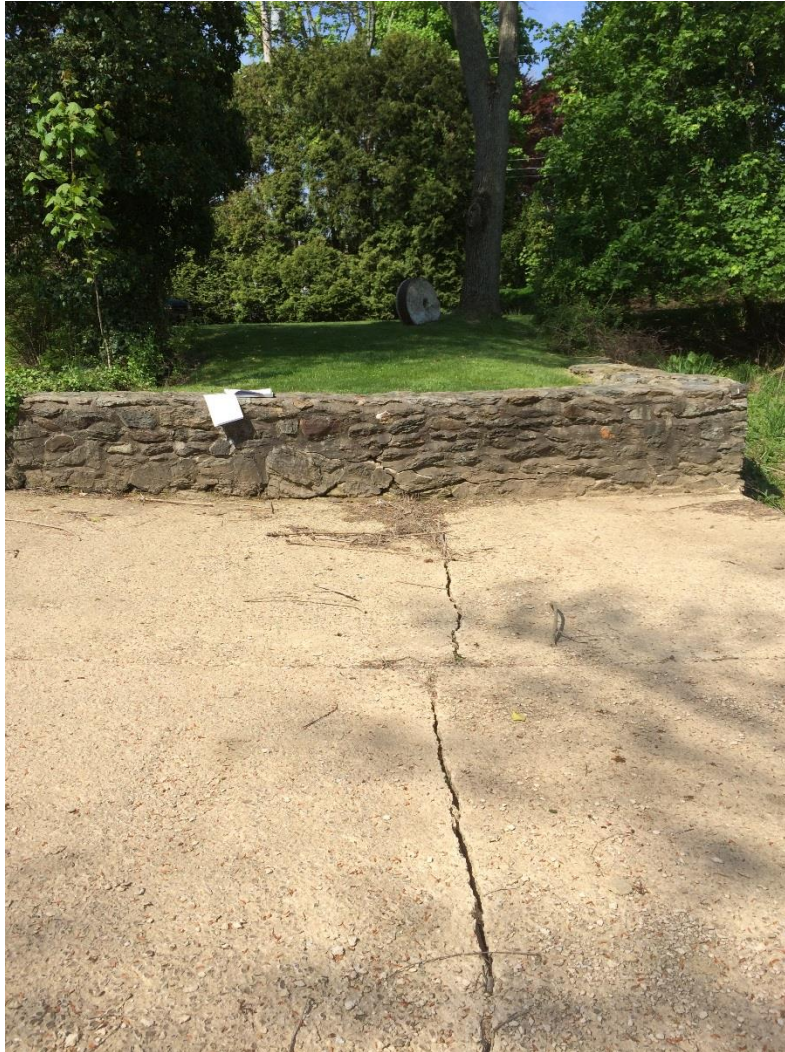
Photo 19. Spillway Slab Looking West

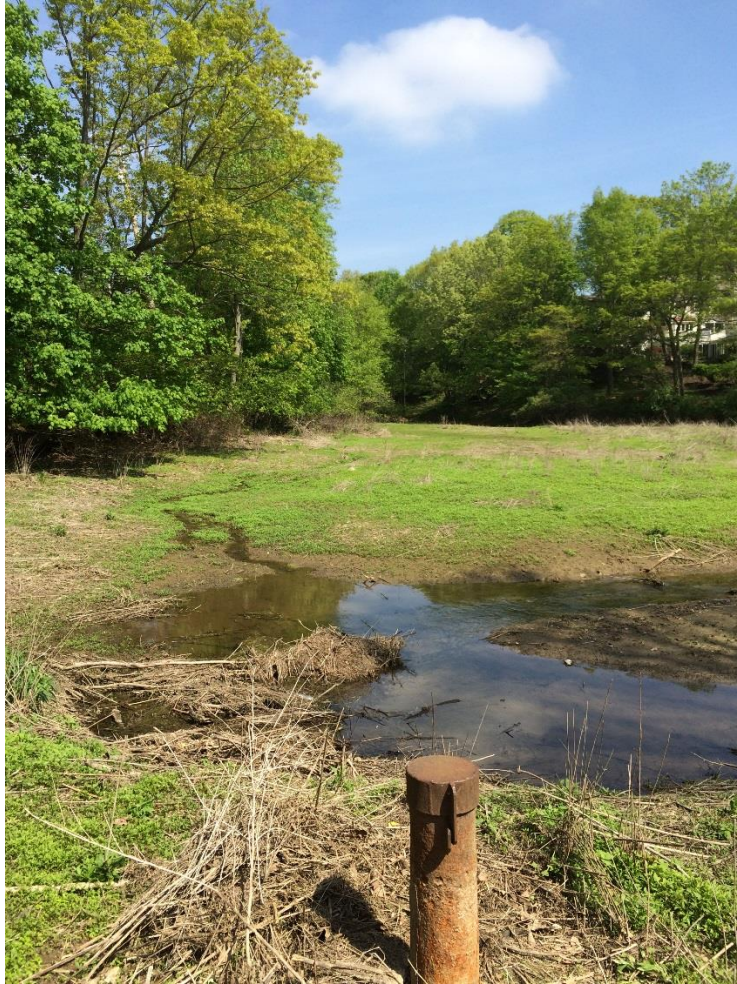
70	Intake Structure	Covered with debris, see Photograph 20	<input type="checkbox"/>	<input type="checkbox"/>	<input checked="" type="checkbox"/>
71	Trashrack	Covered with debris (not visible), see Photograph 20	<input type="checkbox"/>	<input type="checkbox"/>	<input checked="" type="checkbox"/>
72	Stilling Basin	See “SPILLWAYS: Erodible Channel” section above	<input type="checkbox"/>	<input type="checkbox"/>	<input type="checkbox"/>
73	Primary Closure	Does not appear to be present	<input type="checkbox"/>	<input type="checkbox"/>	<input checked="" type="checkbox"/>
74	Secondary Closure	N/A	<input type="checkbox"/>	<input type="checkbox"/>	<input type="checkbox"/>
75	Control Mechanism	See Item 81	<input type="checkbox"/>	<input type="checkbox"/>	<input checked="" type="checkbox"/>
76	Outlet Pipe	Only visible at outlet to spillway, see Photograph 16	<input type="checkbox"/>	<input type="checkbox"/>	<input type="checkbox"/>

- Item 81 – See Photograph 20. An approximately 8 inch diameter steel riser pipe is present immediately upstream of the concrete spillway towards the west side. The riser pipe does not appear to have any inner casing. The height from top of 8 inch diameter steel riser to pipe bottom is approximately 7.75 feet (soft bottom). Depth from top of riser to water level approximately 5 feet. The water depth was approximately 27 inches. This riser pipe reportedly provides access to a gate valve which allows control of the intake structure.

- See Photograph 20 for typical photograph of reservoir
- Item 104 – The dam does not currently impound water. Two small streams are present which drain into the intake structure. Fine grained sediments are present throughout the reservoir area to depths of a couple feet.

Photo 20. Reservoir Area Facing North
