# 2016 ANNUAL INSPECTION REPORT

## MILLTOWN DAM

NDI ID No. PA-00218

DEP ID No. D15-146

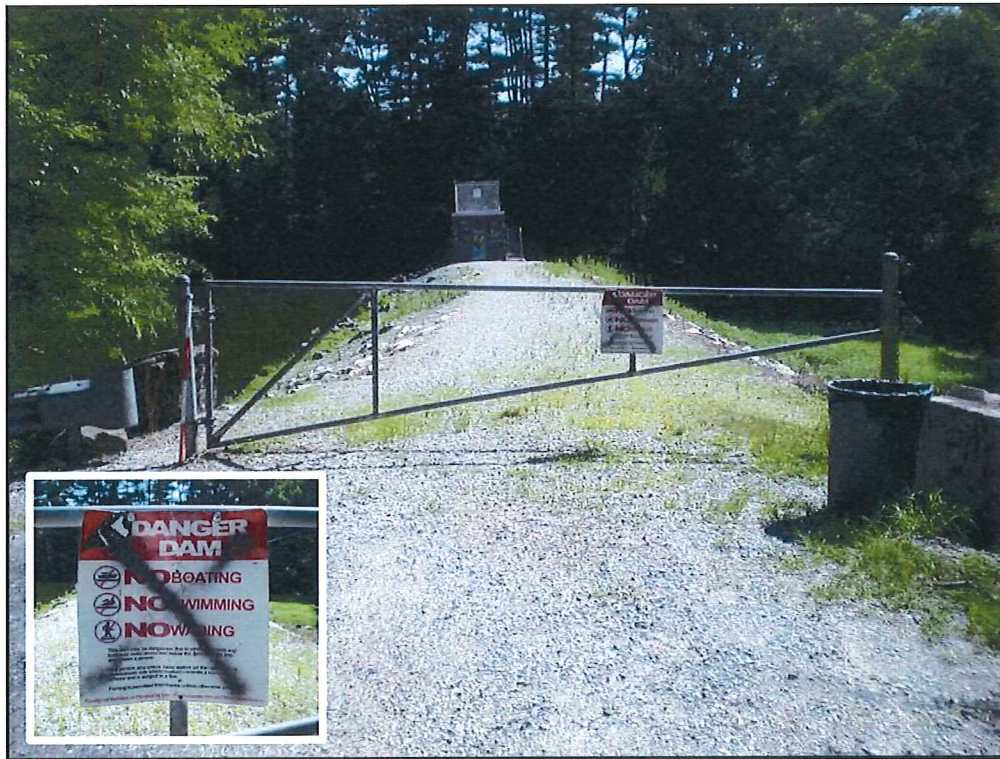
**Photo No. 1**

7	Warning Signs	One warning sign observed on swing gate at right abutment and one warning sign observed at Valve House (refer to Photos 1 and 25). Sign on swing gate contains graffiti but remains legible. See note below.	<input checked="" type="checkbox"/>	<input type="checkbox"/>	<input checked="" type="checkbox"/>
8			<input type="checkbox"/>	<input type="checkbox"/>	<input type="checkbox"/>
9			<input type="checkbox"/>	<input type="checkbox"/>	<input type="checkbox"/>
<p>Additional Comments (Refer to item number if applicable):</p> <p>Item 3: Topographic survey performed by Gannett Fleming in July, 2015 indicates that the right embankment crest varies in elevation from El. 347.5 at the valve house, which is the design top of dam elevation, to El. 349.2 near Reservoir Road. The Gannett Fleming survey found the crest of the left embankment to be near the design top of dam elevation. Survey confirms normal pool at El. 342.2.</p> <p>Item 6: Woody vegetation observed on left embankment crest. <b>Recommend</b> removing woody vegetation to prevent root intrusion into the embankment, eliminate cover for burrowing animals and allow visual observation of the embankment crest.</p> <p>Item 7: Maintain warning sign(s) in a condition which is legible and clearly displayed to the public. <b>Recommend</b> removing graffiti from warning sign on swing gate or replacing sign. Warning sign on Valve House added since the 2015 Annual Dam Inspection. Owner reports vandalism as a recurring problem. <b>Recommend</b> monitoring area for unauthorized activities.</p>

**View of right embankment crest looking toward spillway and Valve House.  
Inset shows condition of Danger Sign located on swing gate.**

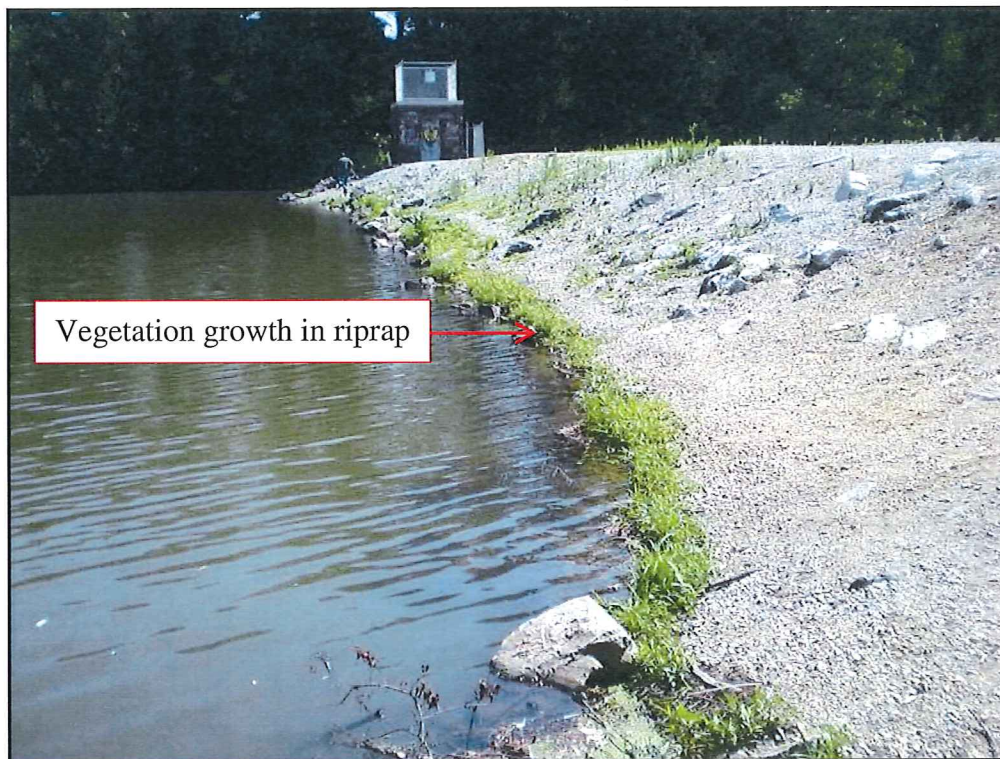
**Photo No. 2**

ITEM	CONDITION	COMMENTS	MONITOR	INVESTIGATE	REPAIR
<b>EMBANKMENT: UPSTREAM FACE</b>					
10	Slide, Slough, Scarp	None observed.	<input type="checkbox"/>	<input type="checkbox"/>	<input type="checkbox"/>
11	Slope Protection	Upstream face of left and right embankments armored with riprap (refer to Photos 2 & 7). See note below.	<input type="checkbox"/>	<input type="checkbox"/>	<input type="checkbox"/>
12	Sinkhole, Animal Burrow	None observed.	<input type="checkbox"/>	<input type="checkbox"/>	<input type="checkbox"/>
13	Emb.-Abut. Contact	No deficiencies observed. Refer to Item 15 for vegetation condition.	<input type="checkbox"/>	<input type="checkbox"/>	<input type="checkbox"/>
14	Erosion	None observed.	<input type="checkbox"/>	<input type="checkbox"/>	<input type="checkbox"/>
15	Vegetation Condition	Woody vegetation observed on left and right embankments. See note below.	<input type="checkbox"/>	<input type="checkbox"/>	<input checked="" type="checkbox"/>

**View of upstream slope of right embankment.**

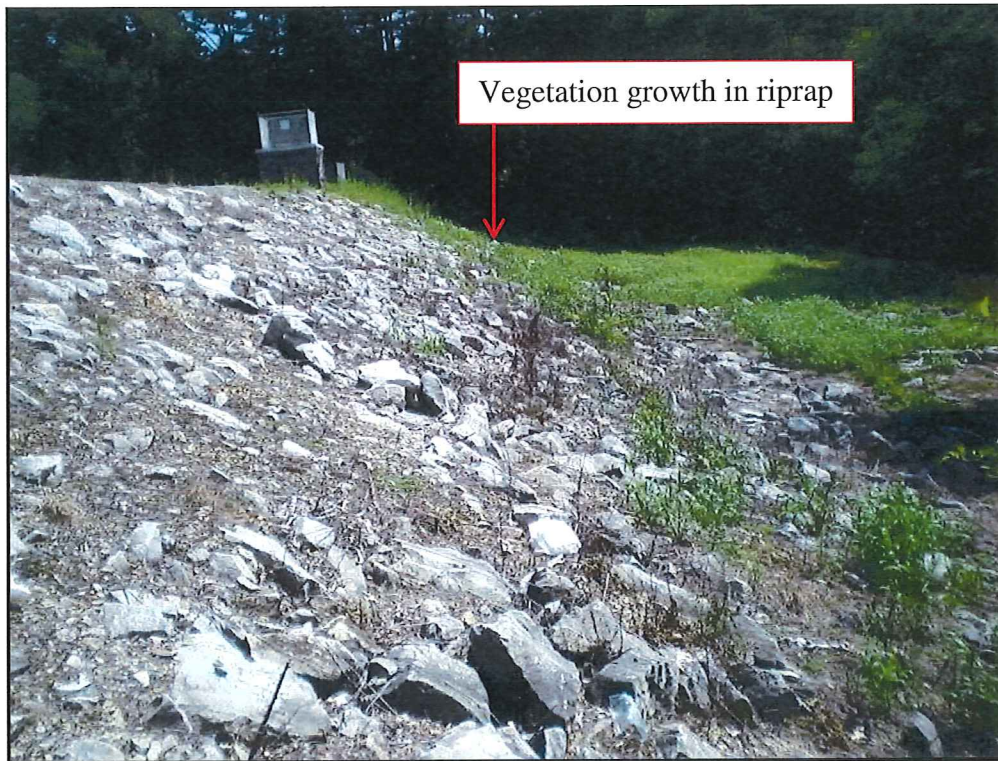
**Photo No. 3  
View of downstream slope of right embankment.**

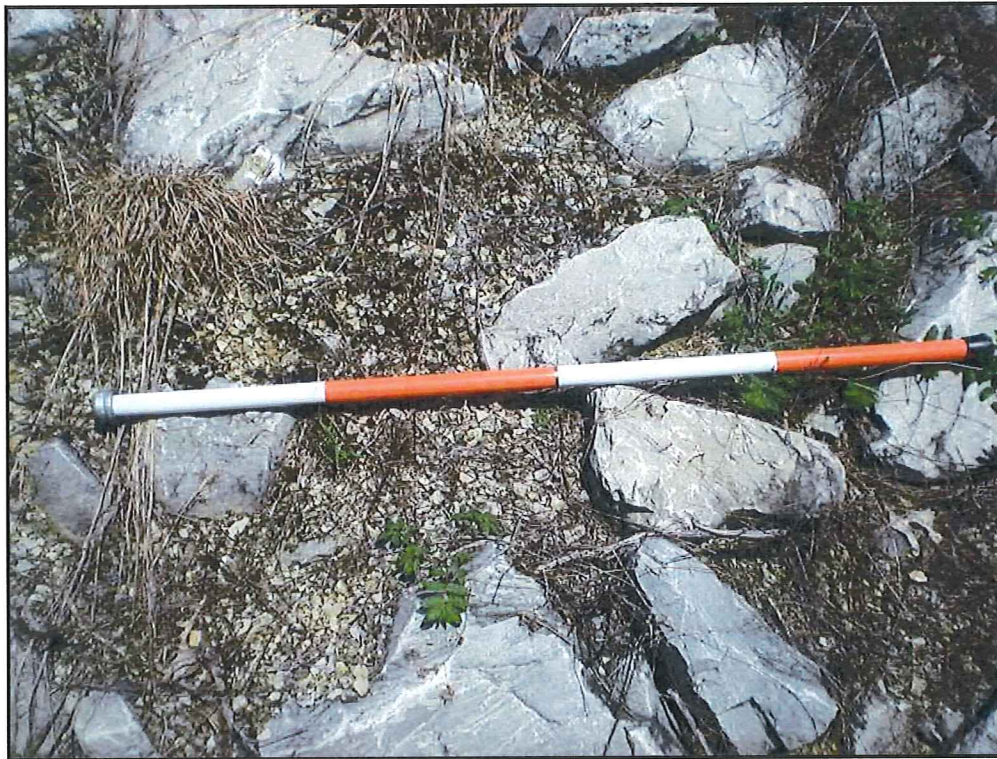
**Photo No. 4  
Typical riprap condition on downstream slope of right embankment.  
Note riprap has been choked with aggregate.**

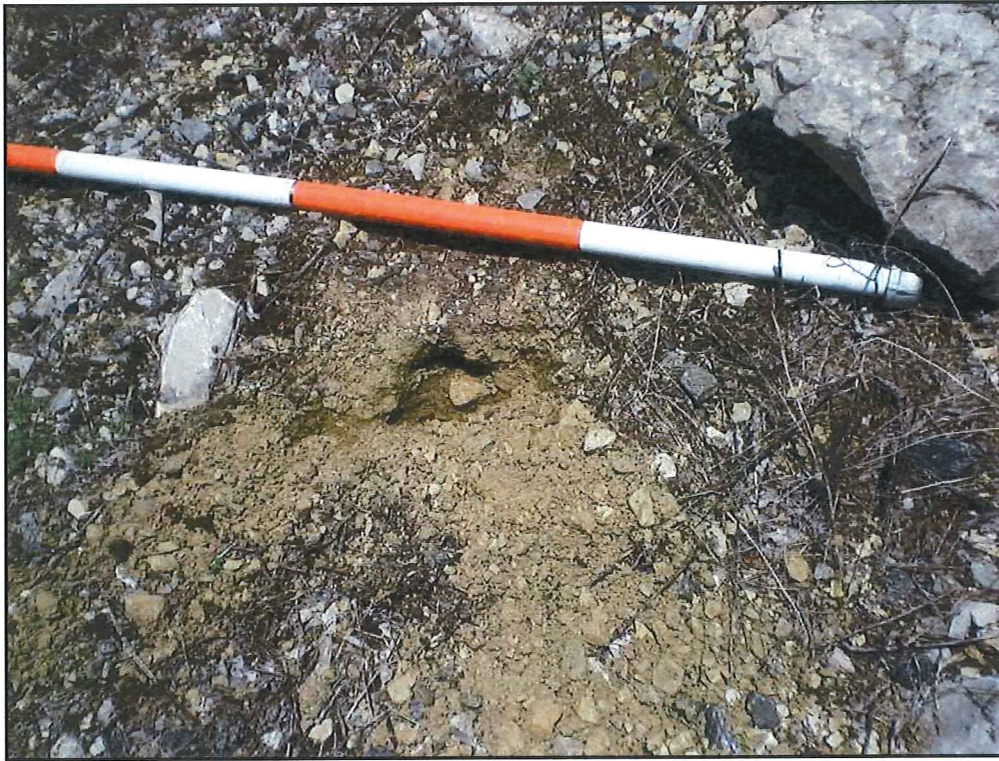
**Photo No. 5**

**Start of animal burrow on downstream slope of right embankment.**

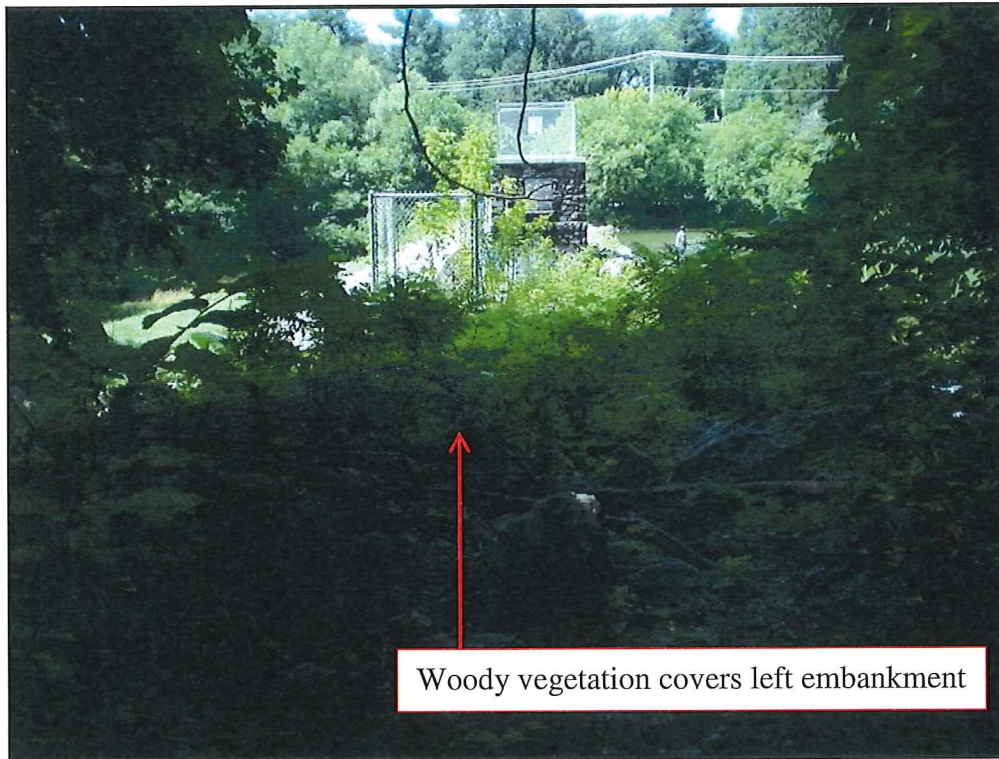
**Photo No. 6**

ITEM	CONDITION	COMMENTS	MONITOR	INVESTIGATE	REPAIR
<b>EMBANKMENT: CREST</b>					
1	Surface Cracking	None observed. Right embankment crest paved with aggregate. Left embankment crest armored with riprap (refer to Photos 1 & 6).	<input type="checkbox"/>	<input type="checkbox"/>	<input type="checkbox"/>
2	Sinkhole, Animal Burrow	None observed.	<input type="checkbox"/>	<input type="checkbox"/>	<input type="checkbox"/>
3	Low Area(s)	None observed. See note below.	<input type="checkbox"/>	<input type="checkbox"/>	<input type="checkbox"/>
4	Horizontal Alignment	No deficiencies observed.	<input type="checkbox"/>	<input type="checkbox"/>	<input type="checkbox"/>
5	Ruts and/or Puddles	None observed.	<input type="checkbox"/>	<input type="checkbox"/>	<input type="checkbox"/>
6	Vegetation Condition	Right embankment crest paved with aggregate (refer to Photo 1). Left embankment crest armored with riprap. Woody vegetation observed on left embankment crest (refer to Photo 6).	<input type="checkbox"/>	<input type="checkbox"/>	<input checked="" type="checkbox"/>

**View of left embankment crest looking toward spillway. Valve House visible in top center of photograph. Note woody vegetation on left embankment.**

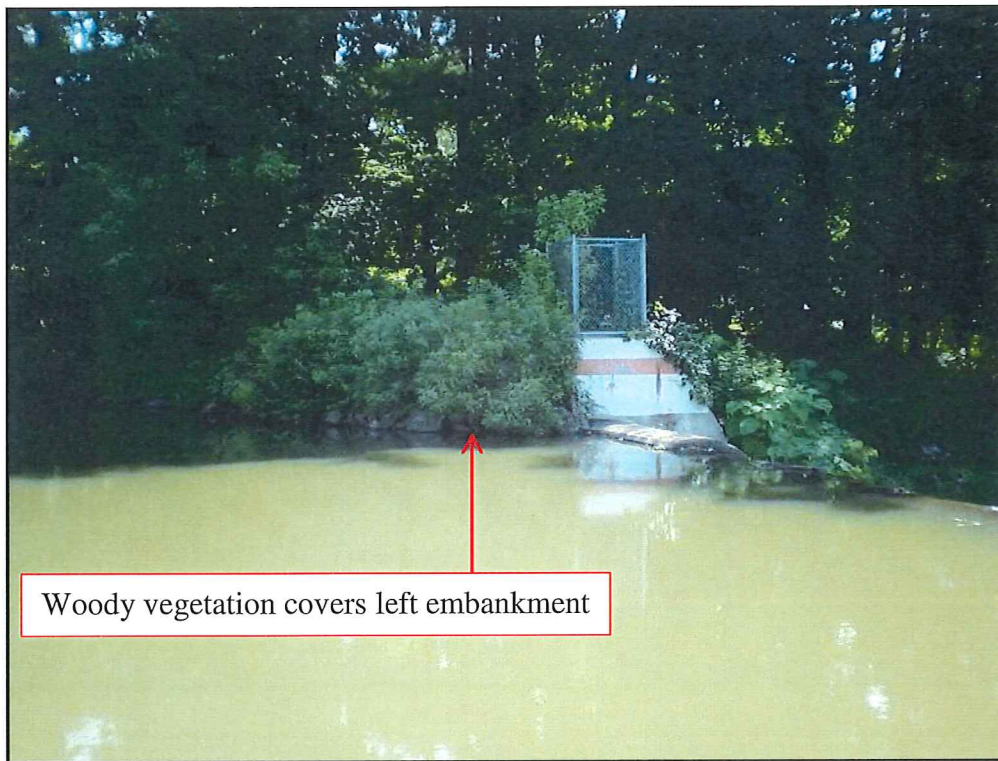
**Photo No. 7**  
**View of upstream slope of left embankment. Note woody vegetation.**

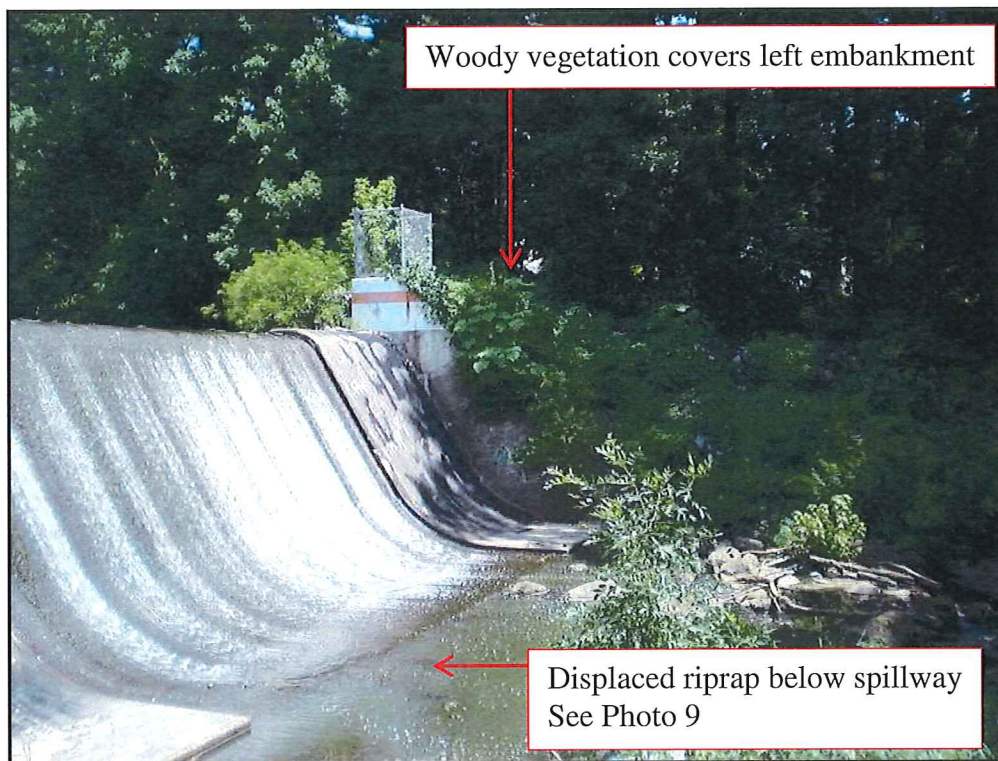
Item 55: Rock scour protection between concrete spillway apron and concrete sill is partially dislodged and moved downstream (refer to Photos 8 and 9). Voids in riprap up to two feet in depth observed immediately downstream of concrete spillway apron. Lack of scour protection may lead to further erosion and undermining of the spillway apron and possible failure of the spillway structure itself. **Recommend** replacement of scour protection to replicate the original design intent and to protect the concrete apron from undermining.

**Photo No. 8**  
**View of downstream slope of left embankment and riprap scour protection below spillway.**

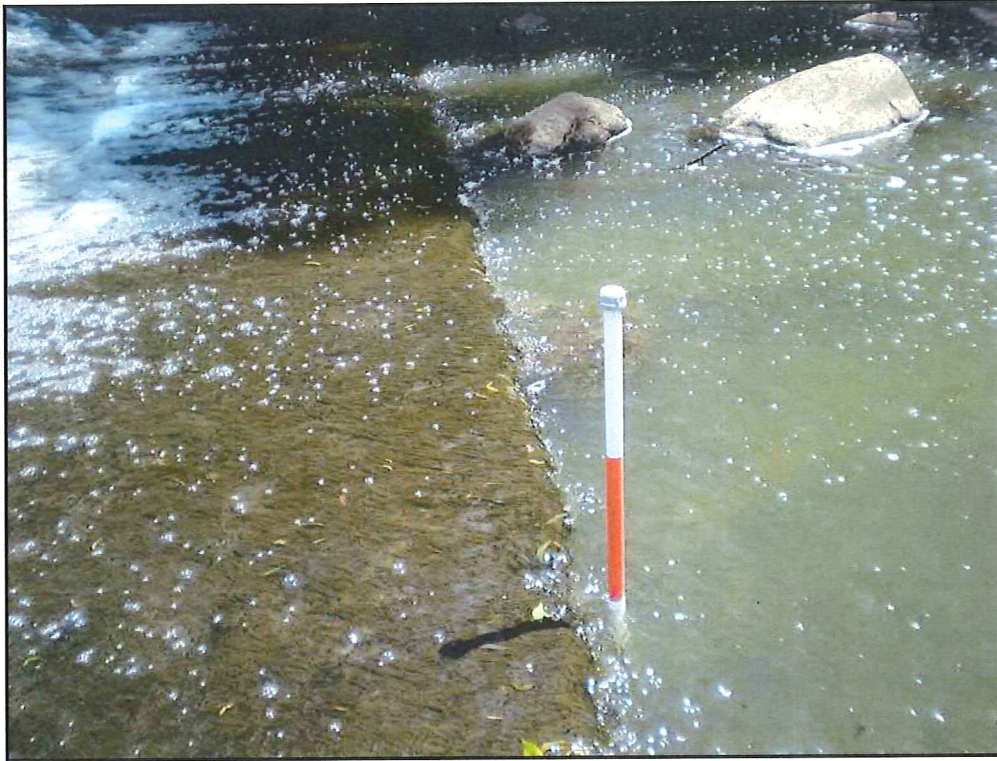
**Photo No. 9**

**View of downstream end of spillway. Loss of riprap observed (up to two feet in depth).**

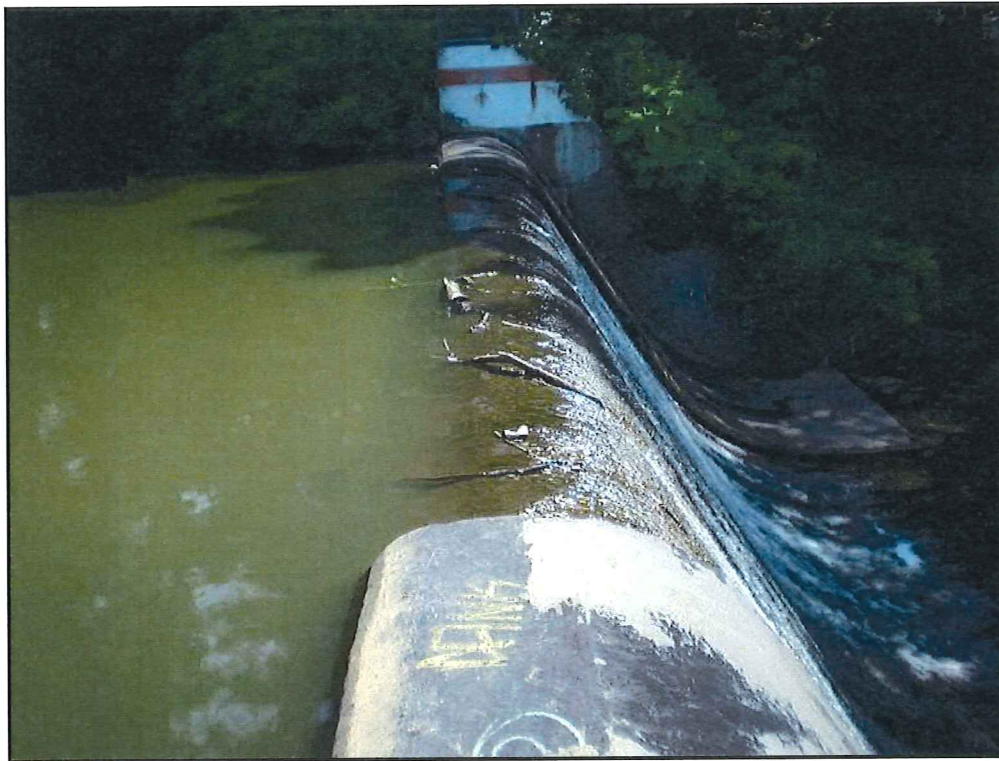
**Photo No. 10**

**View of ogee spillway crest with low flow notch (looking towards left abutment).  
Note horizontal paint markings on left spillway abutment which relate to EAP trigger elevations.**

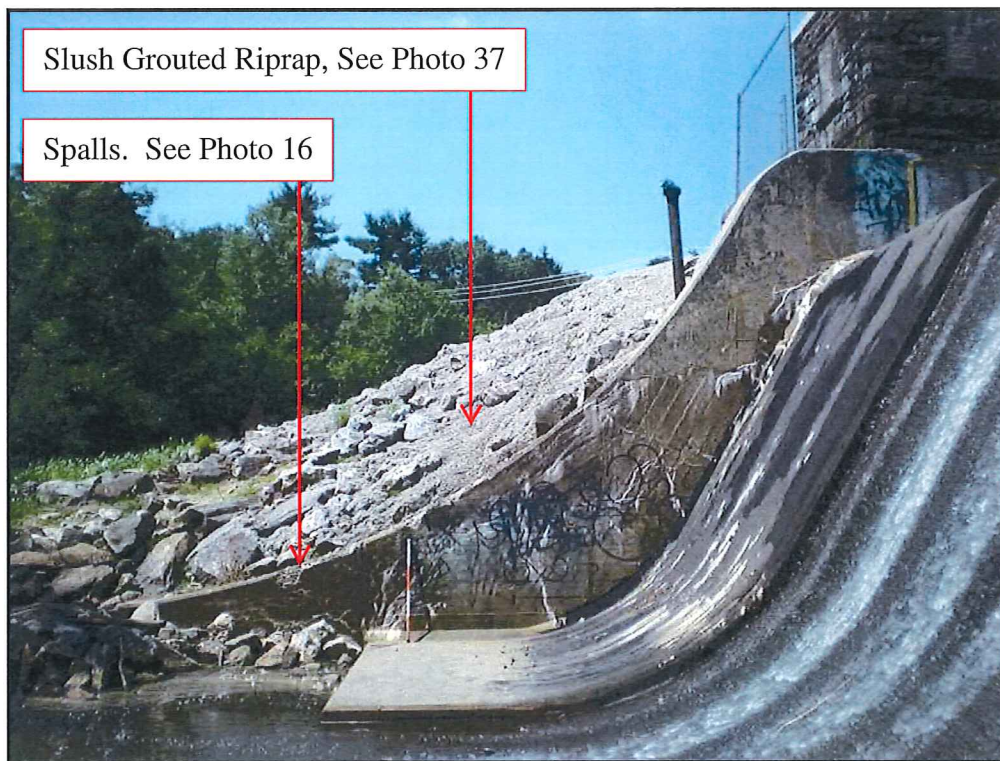
**Photo No. 14**

Item 50: Hairline cracking with efflorescence observed on the vertical portions of both the left and right spillway training walls (refer to Photos 14, 15, 19 & 20). Several spalls observed near downstream end of right spillway training wall (refer to Photo 16). **Recommend** monitoring concrete for changes in condition which may require additional repairs.  
**Recommend** repairing spalled concrete on right spillway training wall.

**View of right spillway training wall.**

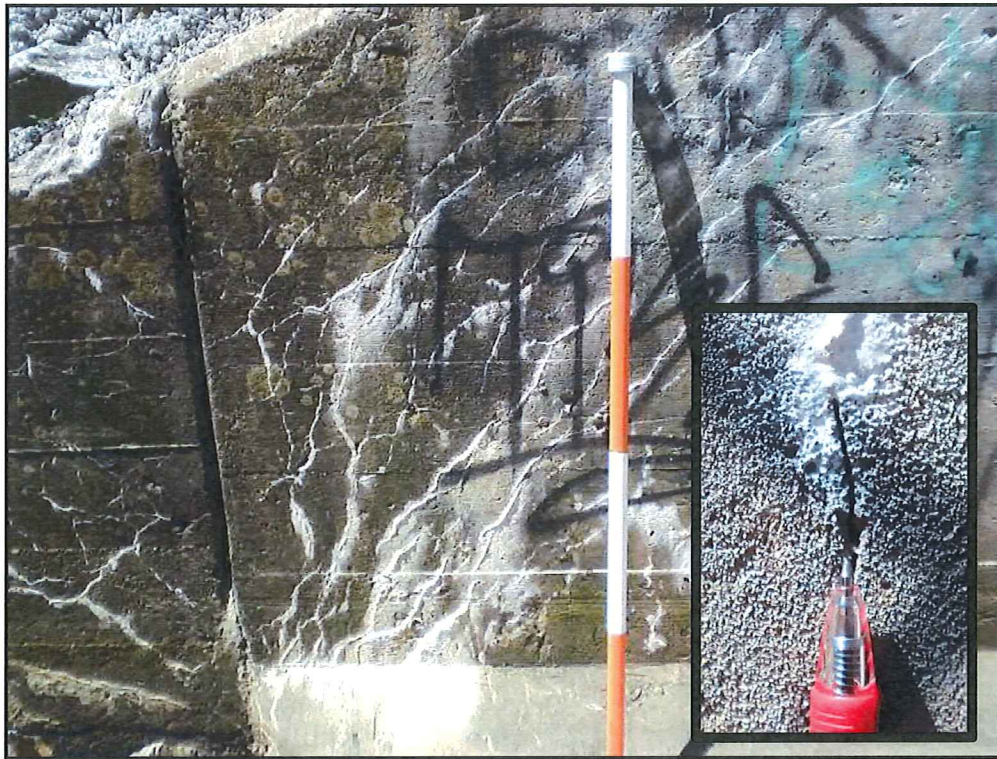
**Photo No. 15**

**View of right spillway training wall. Note hairline cracking with efflorescence.  
Inset shows typical hairline crack with efflorescence.**

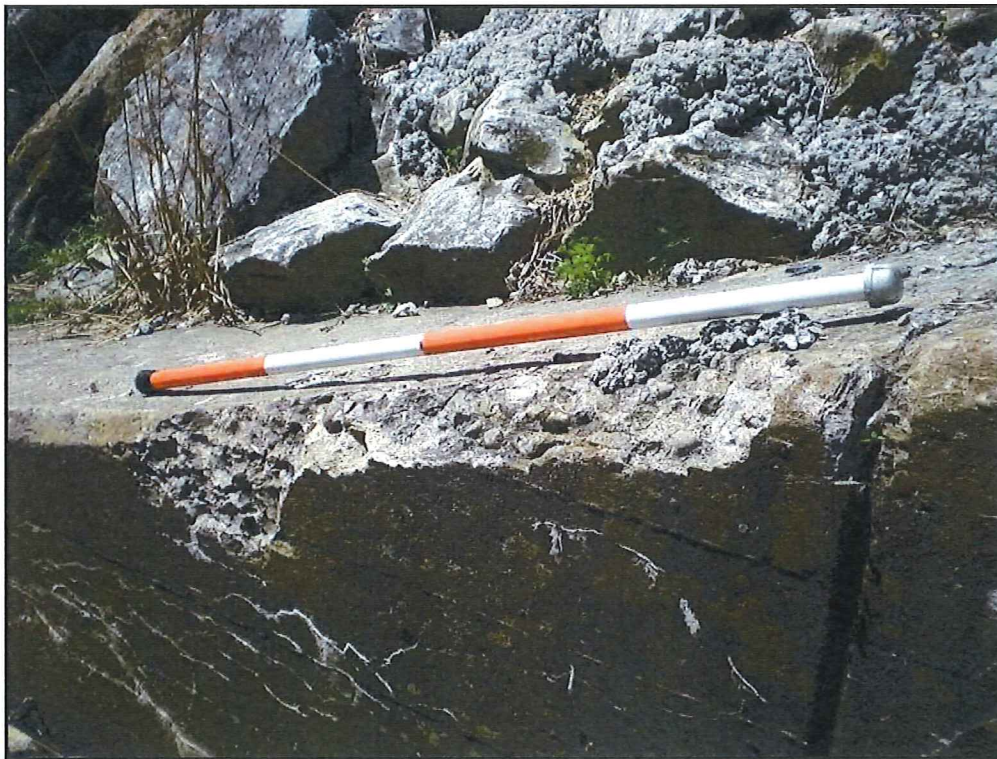
**Photo No. 16**

**View of downstream end of right spillway training wall. Note spalls on top of wall.**

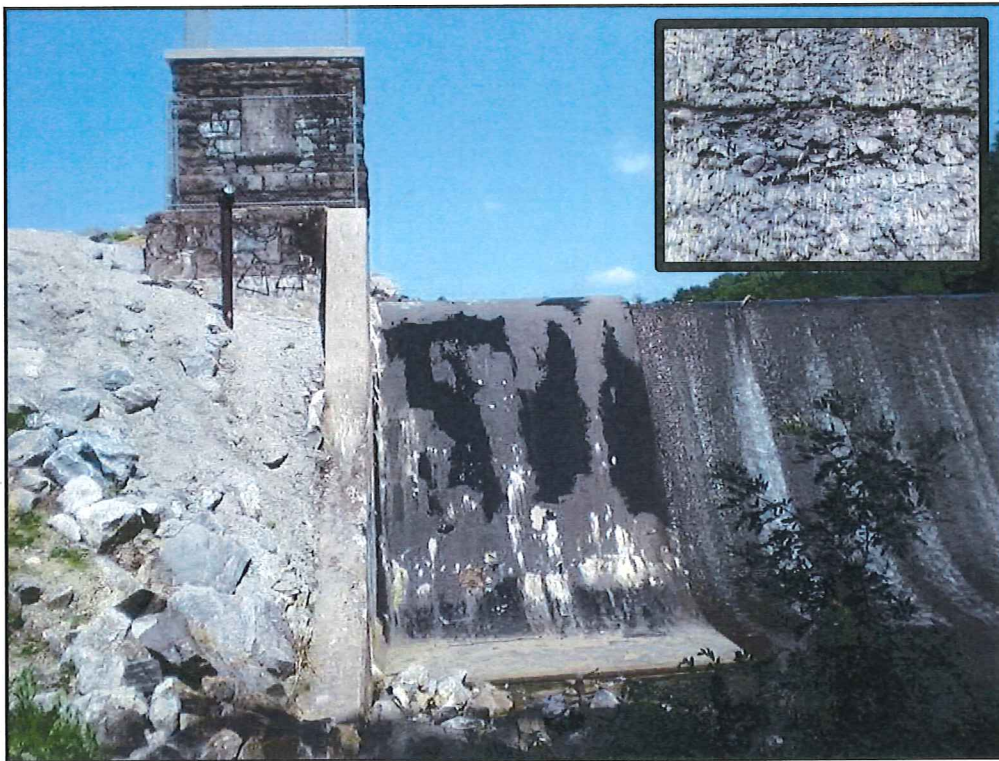
**Photo No. 17**

Item 51: Epoxy coating on ogee spillway face installed in 2013 and repaired in 2015 (refer to Photos 17 and 21). Areas of the epoxy coating installed in 2013 observed to be peeling away from the concrete (refer to Photo 18). **Recommend** monitoring condition of epoxy coating and concrete for changes in condition that may require additional repairs.

Item 54: Crest and downstream face of concrete spillway low flow notch obscured by flow. 2015 Annual Inspection reported exposed aggregate on downstream face of concrete low flow notch (refer to Photo 17 inset). **Recommend** monitoring concrete surface for deterioration that may warrant repairs.

**View of right half of downstream face of the concrete spillway. Darker black areas represent locations where the epoxy coating was replaced in the fall of 2015.**

**Inset shows condition of surface concrete within low flow notch (inset photo from June 2015).**

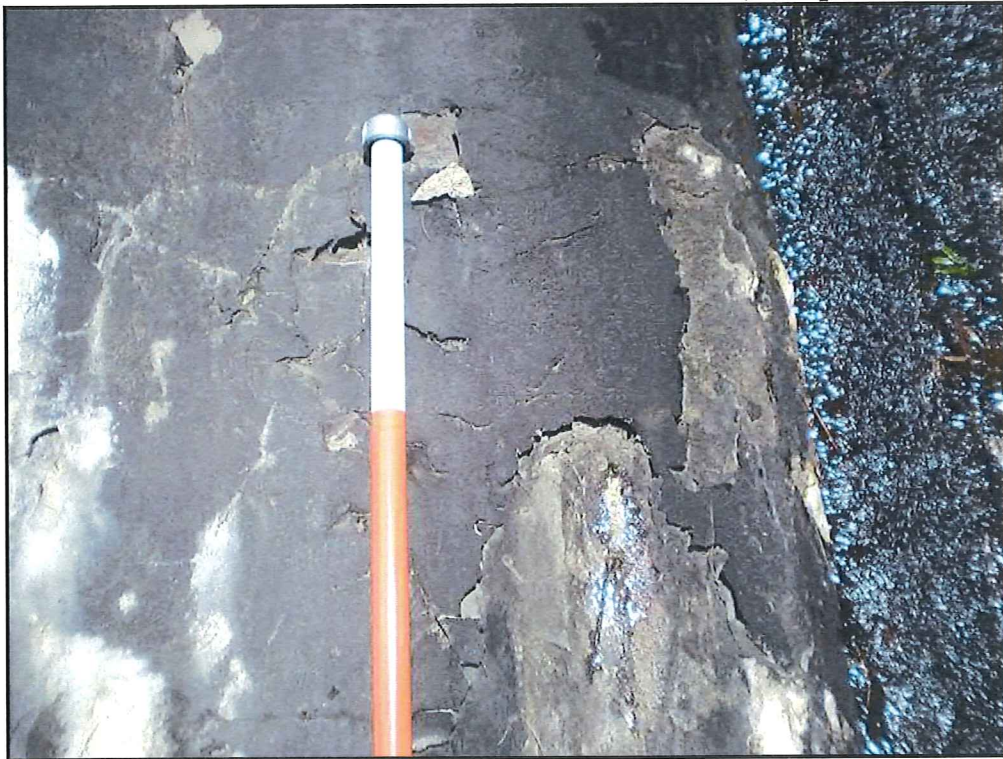
**Photo No. 18**

**View of right half of downstream face of concrete spillway and areas where the epoxy coating has peeled.**

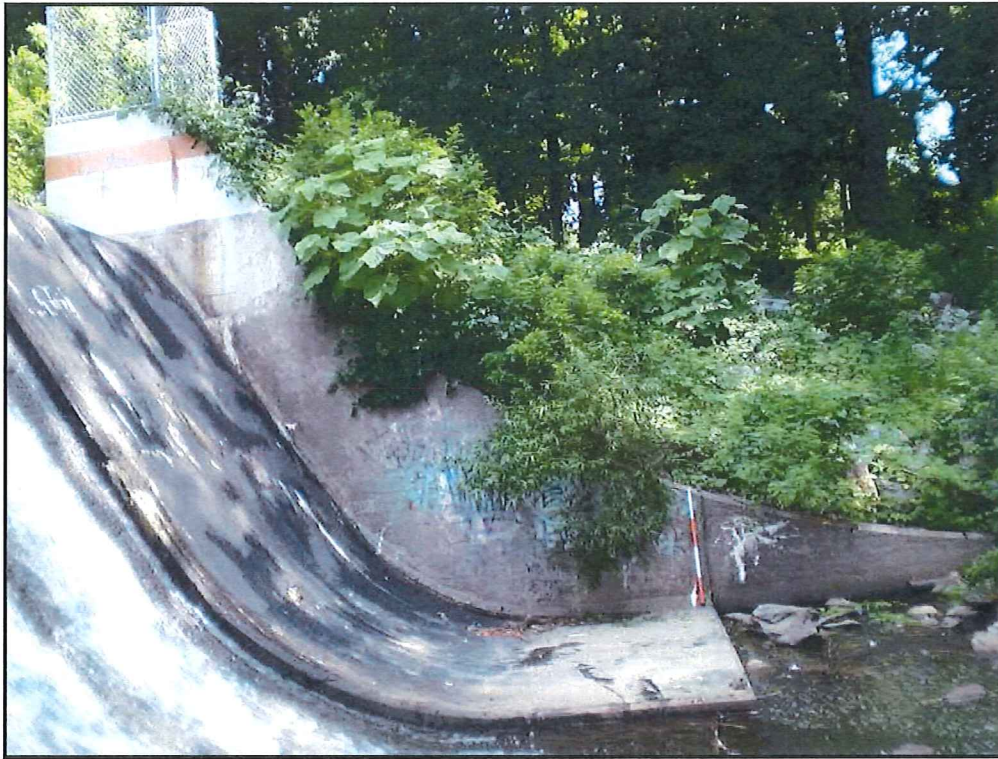
**Photo No. 19  
View of left spillway training wall.**

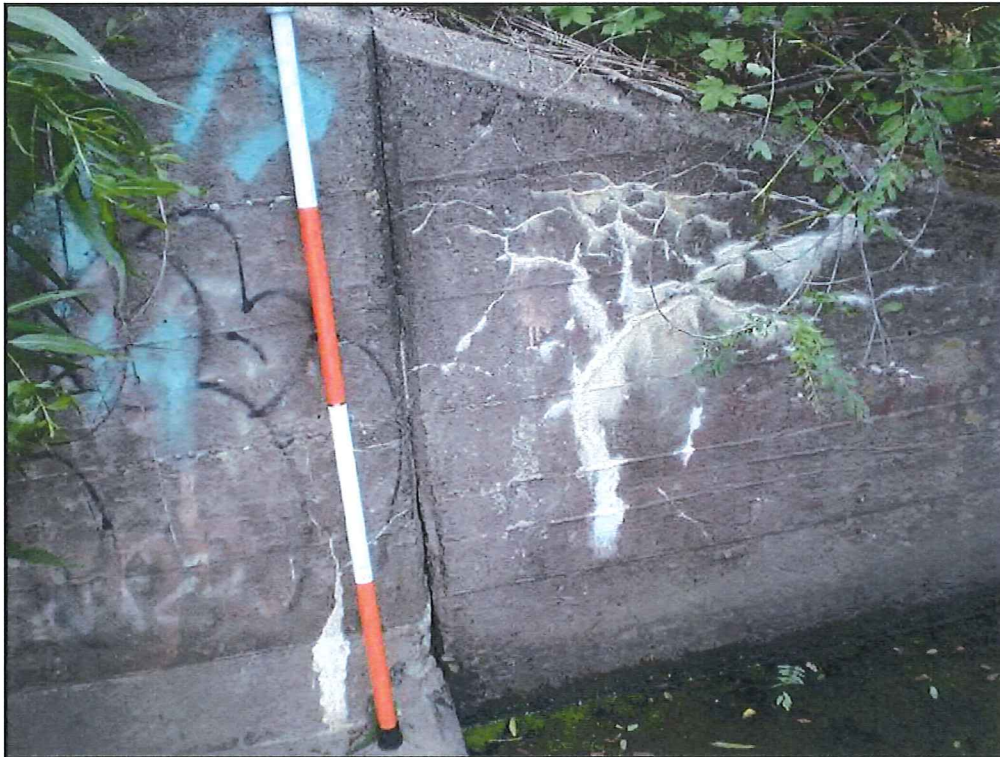
**Photo No. 20  
View of left spillway training wall. Note hairline cracking with efflorescence (typical throughout wall).**

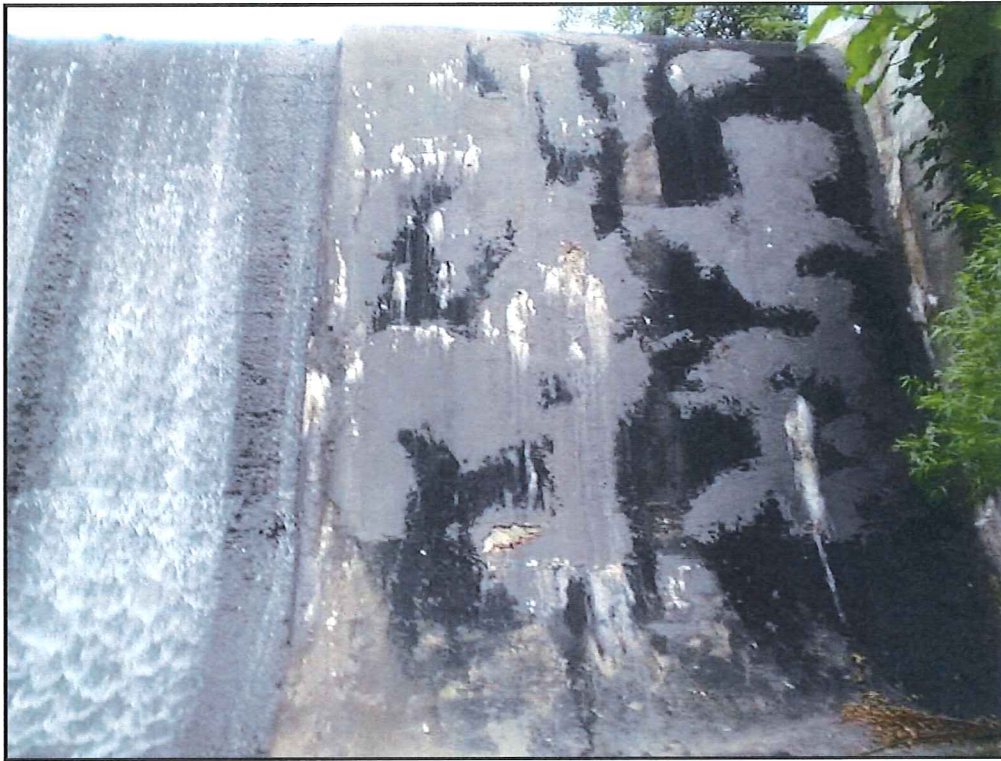
**Photo No. 21**

**View of left half of downstream face of the concrete spillway. Darker black areas represent locations where the epoxy coating was replaced in the fall of 2015.**

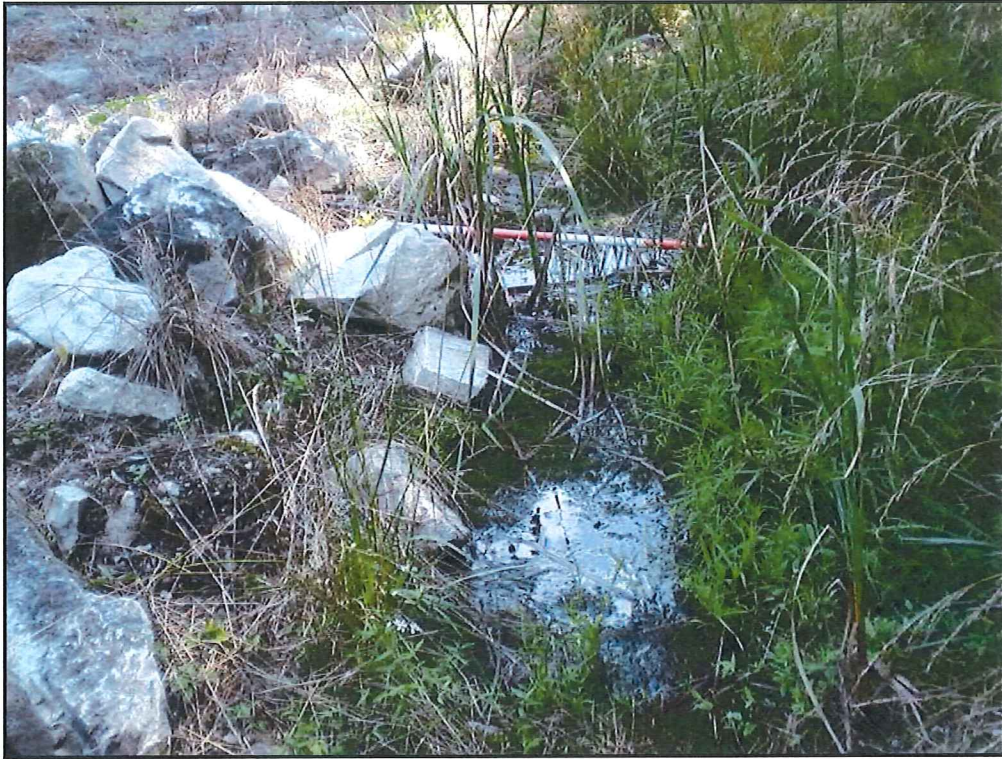
**Photo 23**

**Standing water downstream of right embankment at edge of riprap.**

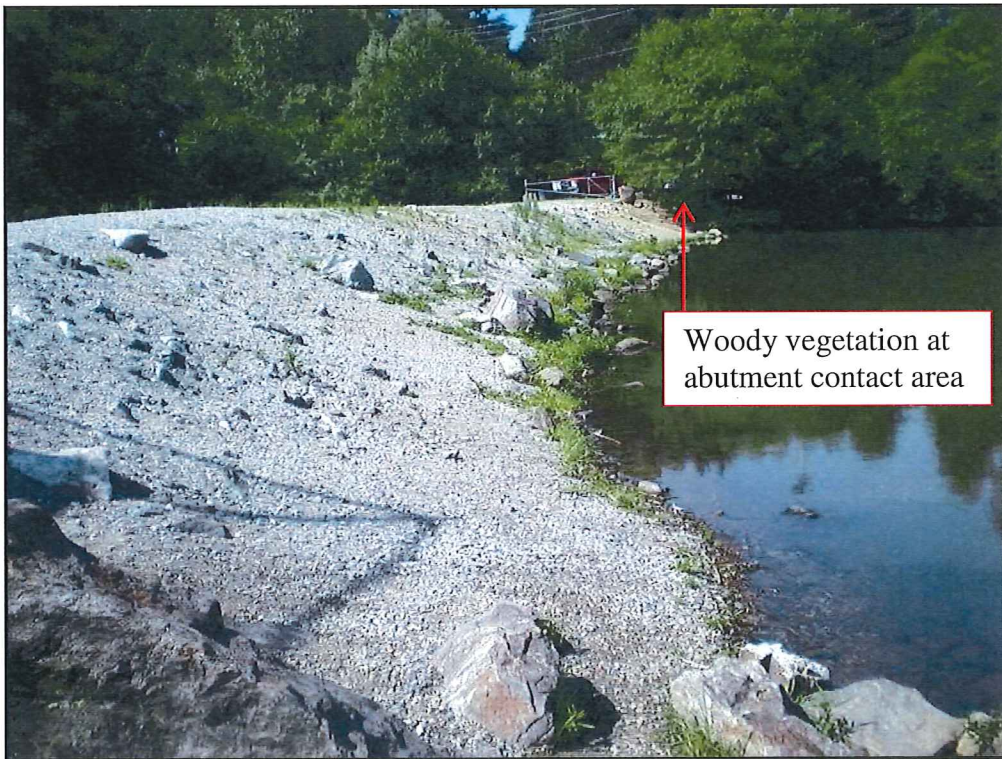
**Photo 24**

**View of upstream face of right embankment.**

Woody vegetation at  
abutment contact area

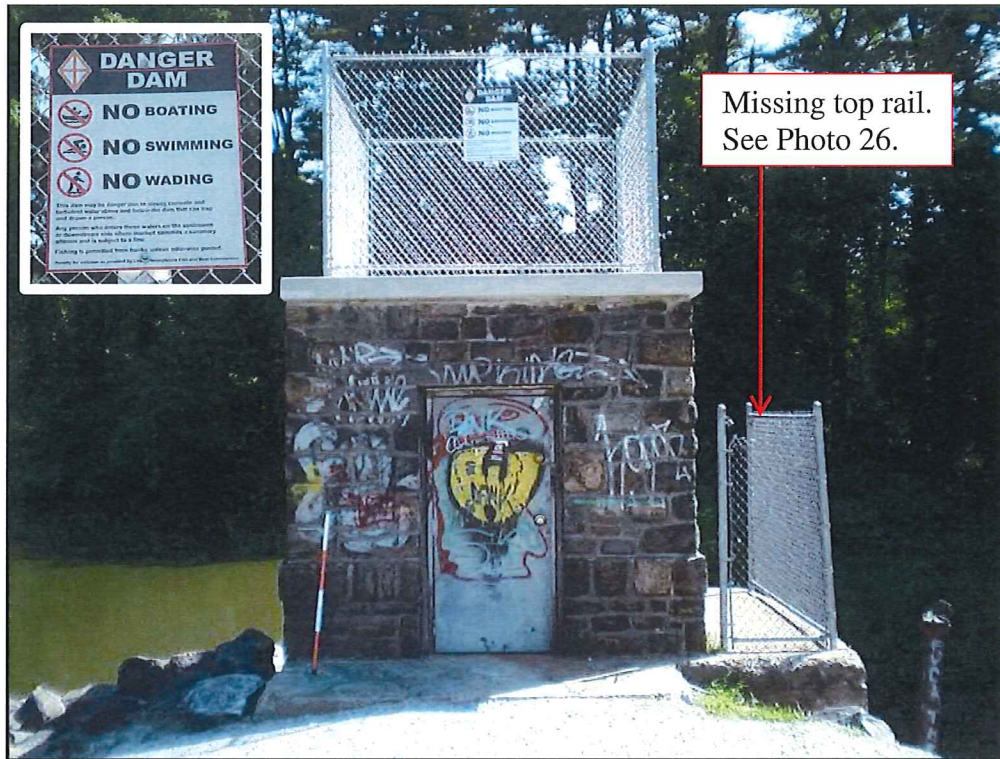
**Photo 25**

66	Outlet Tower	Concrete valve chamber with masonry stone Valve House (refer to Photo 25).	<input type="checkbox"/>	<input type="checkbox"/>	<input type="checkbox"/>
67	Outlet Structure	See Item No. 66.	<input type="checkbox"/>	<input type="checkbox"/>	<input type="checkbox"/>
68	Seepage	None observed.	<input type="checkbox"/>	<input type="checkbox"/>	<input type="checkbox"/>
69	Unusual Movement	None observed.	<input type="checkbox"/>	<input type="checkbox"/>	<input type="checkbox"/>
70			<input type="checkbox"/>	<input type="checkbox"/>	<input type="checkbox"/>
71			<input type="checkbox"/>	<input type="checkbox"/>	<input type="checkbox"/>

**View of Valve House. Inset shows warning sign which has been added since 2015 Annual Dam Inspection.**

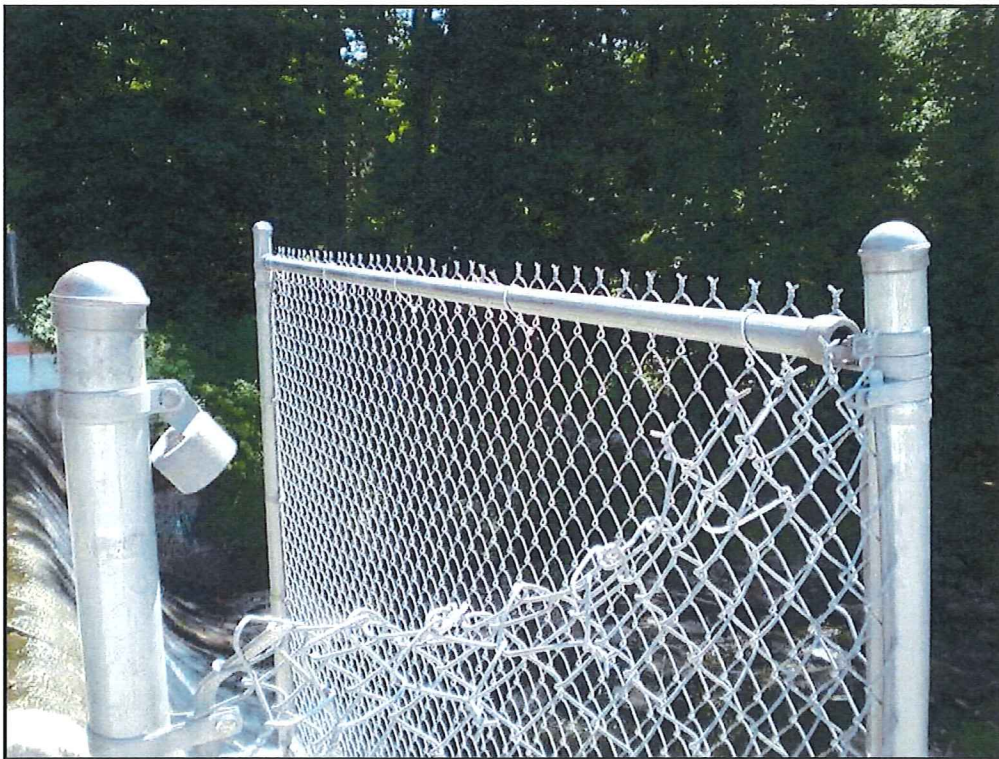
**Photo No. 26**

48			<input type="checkbox"/>	<input type="checkbox"/>	<input type="checkbox"/>
49			<input type="checkbox"/>	<input type="checkbox"/>	<input type="checkbox"/>
<p>Additional Comments (Refer to item number if applicable):</p> <p>Item 41: East Branch Chester Creek flows under Route 3 approximately 600 feet downstream of Milltown Dam.</p> <p>Item 43: The 2013 Annual Dam Inspection reported standing water in the same general area. Standing water appears to be due to poor surface drainage. <b>Recommend</b> continued monitoring of this area for changes in flow.</p> <p>Item 46: Top support post on chain-link fence at Valve House is missing (refer to Photo 26). <b>Recommend</b> repairing fence.</p>

**Chain link fence on downstream side of Valve House. Note missing top rail.**

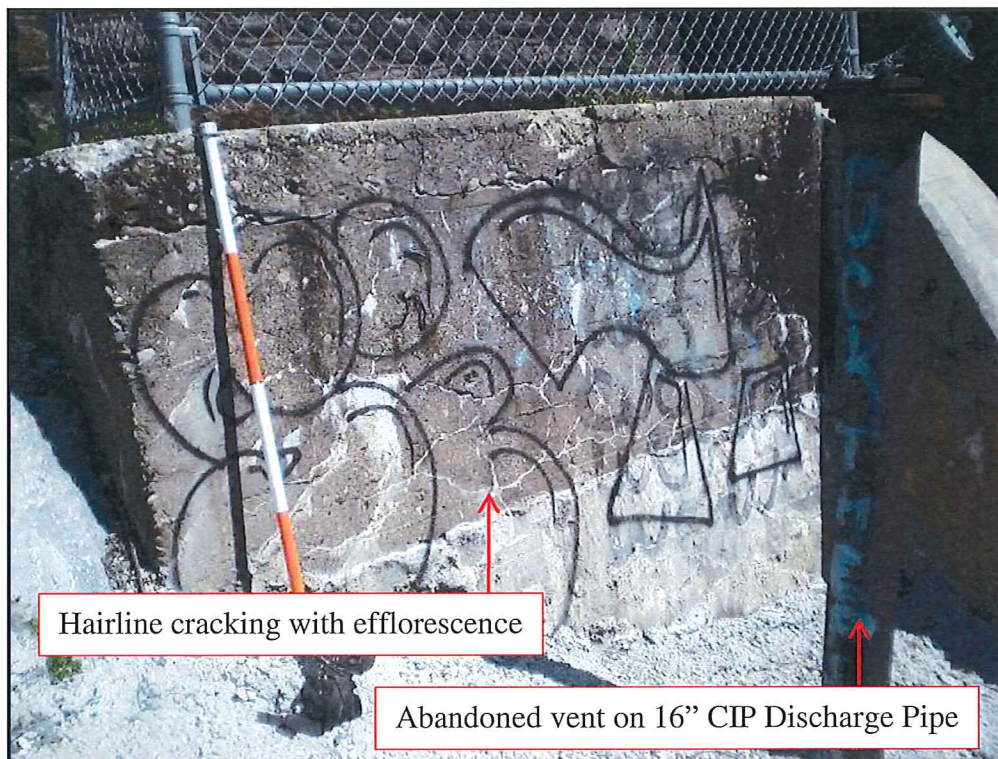
**Photo No. 28  
View of downstream face of exposed valve chamber. Note hairline cracking with efflorescence.**

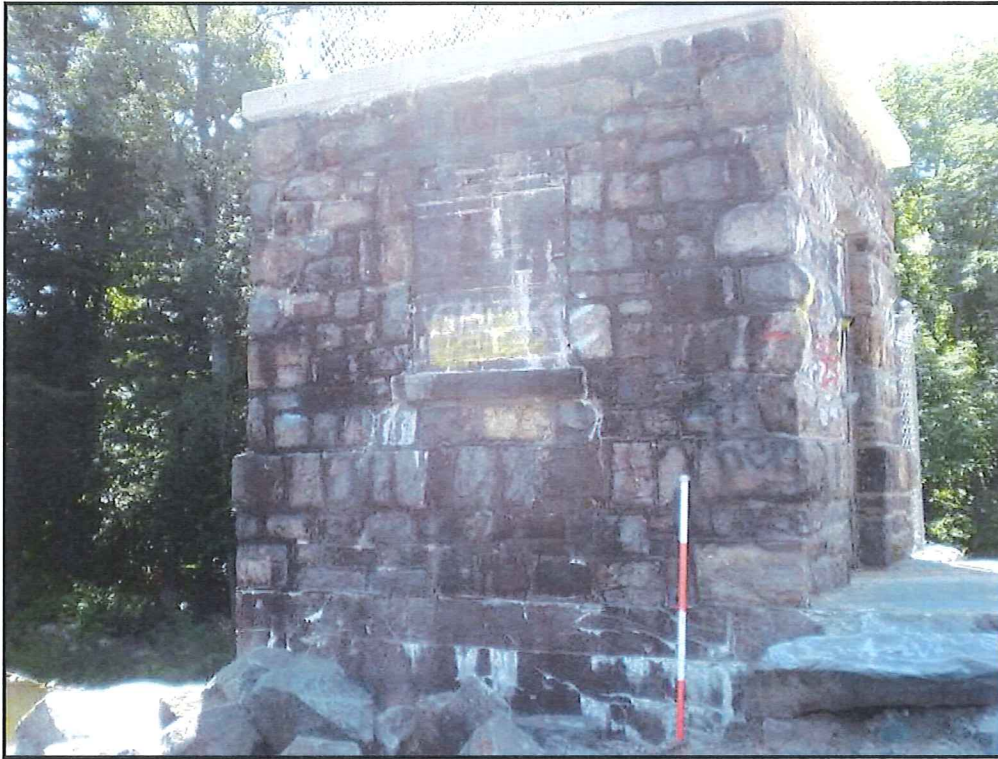
**Photo 29**

**View of upstream face of Valve House. Note hairline cracking with efflorescence throughout exposed portion of concrete valve chamber.**

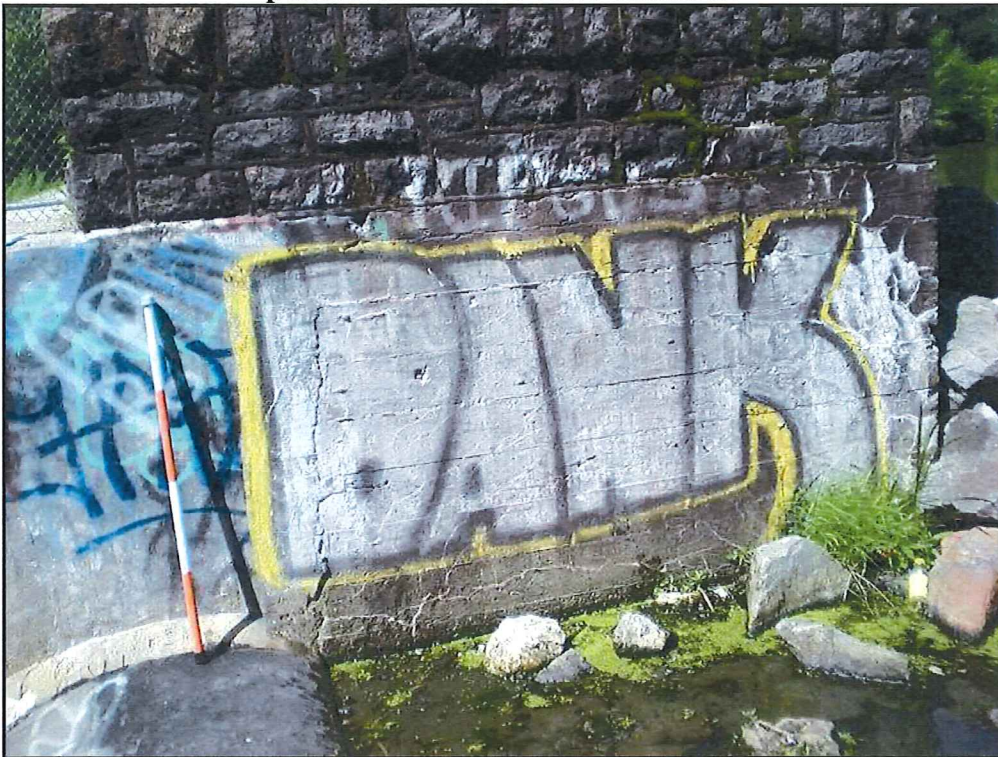
**Photo No. 30**

**View of left face of Valve House and exposed portions of the valve chamber. Note hairline cracking with efflorescence throughout exposed portion of concrete valve chamber.**

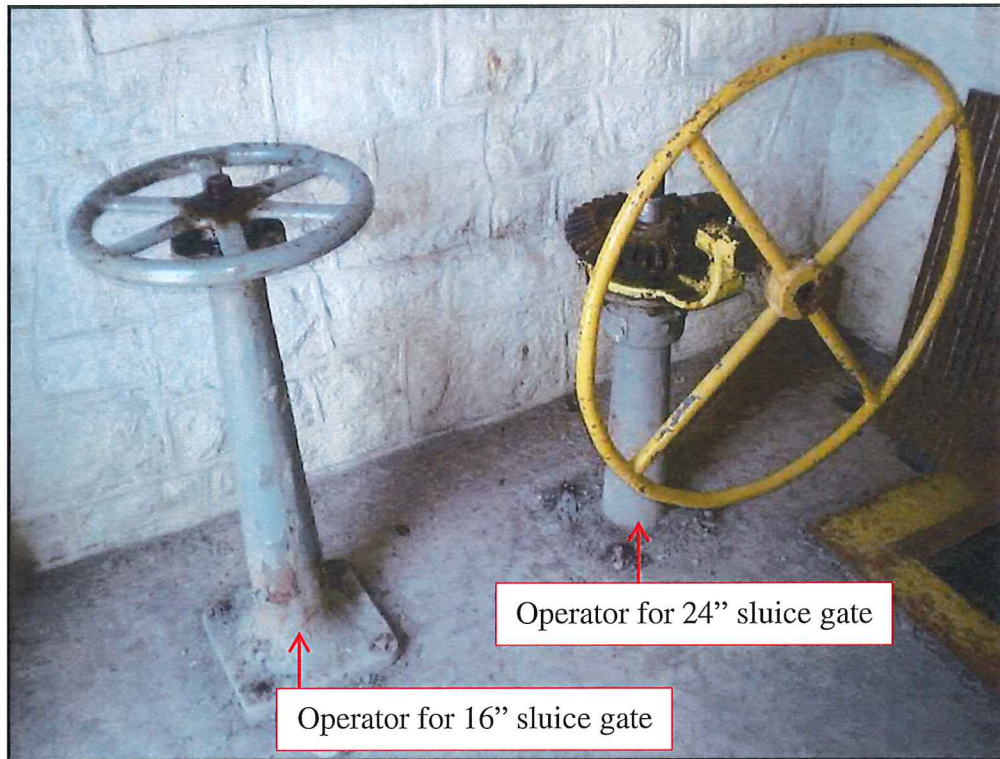
**Photo 31**

Item 59: Sluice gates were observed on the 16" and 24" CIPs entering and leaving the Valve House (four gates total) controlled by manually operated handwheels (refer to Photos 31, 32, 33 & 34). The upstream 16" and 24" sluice gates were operated at time of inspection. Downstream gates are inoperable with the 16" gate frozen in the closed position and the 24" gate frozen in the open position. Downstream gates are not required for the operation of the low level dewatering system. East Goshen Township reports that the downstream 16" CIP has been abandoned and plugged at an unknown location downstream of the dam. Valve House constructed of masonry with lockable door and observed to be in fair condition (refer to Photos 25, and 27 through 30). Hairline cracks with efflorescence observed on exposed exterior portions of the valve chamber (refer to Photos 28, 29 & 30). Dampness with efflorescence observed in the interior downstream left corner of the concrete valve chamber (refer to Photo 34). **Recommend** monitoring the condition of the concrete valve chamber for changes in condition which may warrant repairs.

**View of upstream interior of Valve House and operable sluice gate operators.**
