# 2016 ANNUAL INSPECTION REPORT

## MILLTOWN DAM

NDI ID No. PA-00218

DEP ID No. D15-146

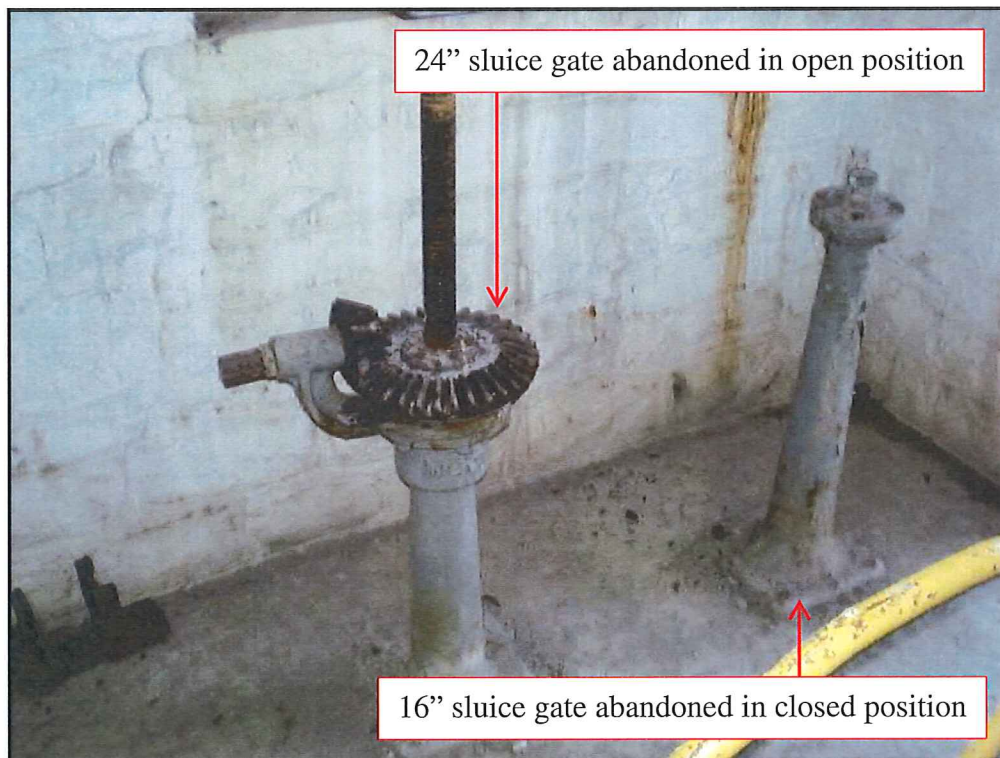
**Photo No. 32**

Item 59: Sluice gates were observed on the 16" and 24" CIPs entering and leaving the Valve House (four gates total) controlled by manually operated handwheels (refer to Photos 31, 32, 33 & 34). The upstream 16" and 24" sluice gates were operated at time of inspection. Downstream gates are inoperable with the 16" gate frozen in the closed position and the 24" gate frozen in the open position. Downstream gates are not required for the operation of the low level dewatering system. East Goshen Township reports that the downstream 16" CIP has been abandoned and plugged at an unknown location downstream of the dam. Valve House constructed of masonry with lockable door and observed to be in fair condition (refer to Photos 25, and 27 through 30). Hairline cracks with efflorescence observed on exposed exterior portions of the valve chamber (refer to Photos 28, 29 & 30). Dampness with efflorescence observed in the interior downstream left corner of the concrete valve chamber (refer to Photo 34). **Recommend** monitoring the condition of the concrete valve chamber for changes in condition which may warrant repairs.

**View of downstream interior of Valve House and in-operable sluice gate operators.**

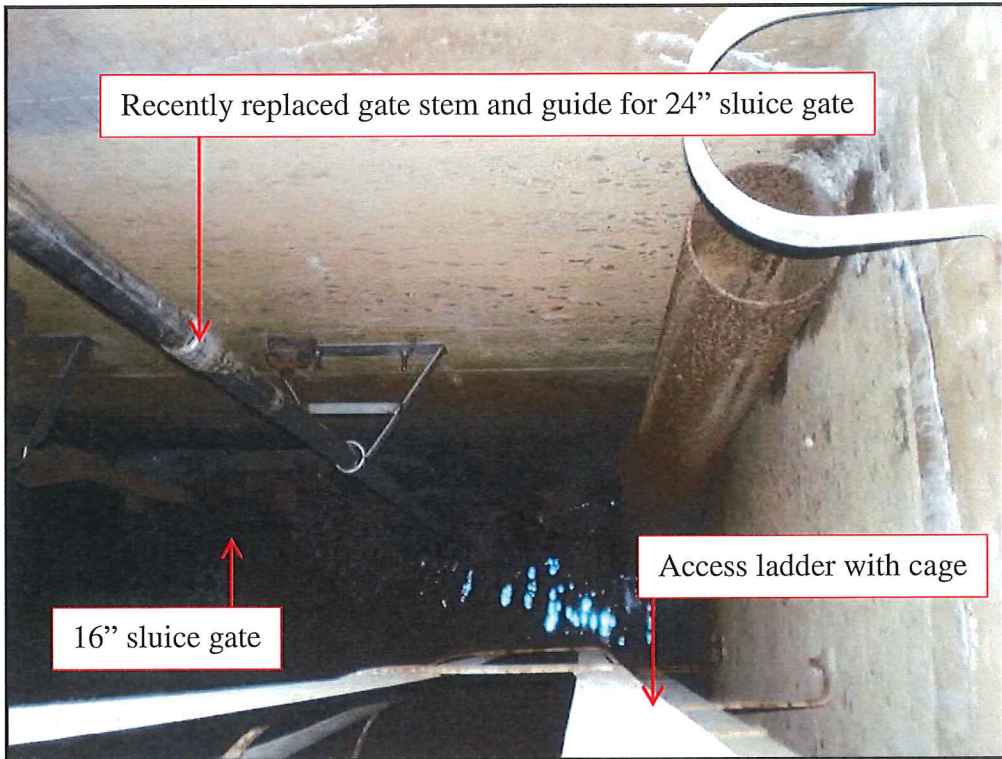
**Photo 33**  
**View of interior upstream wall of valve chamber.**

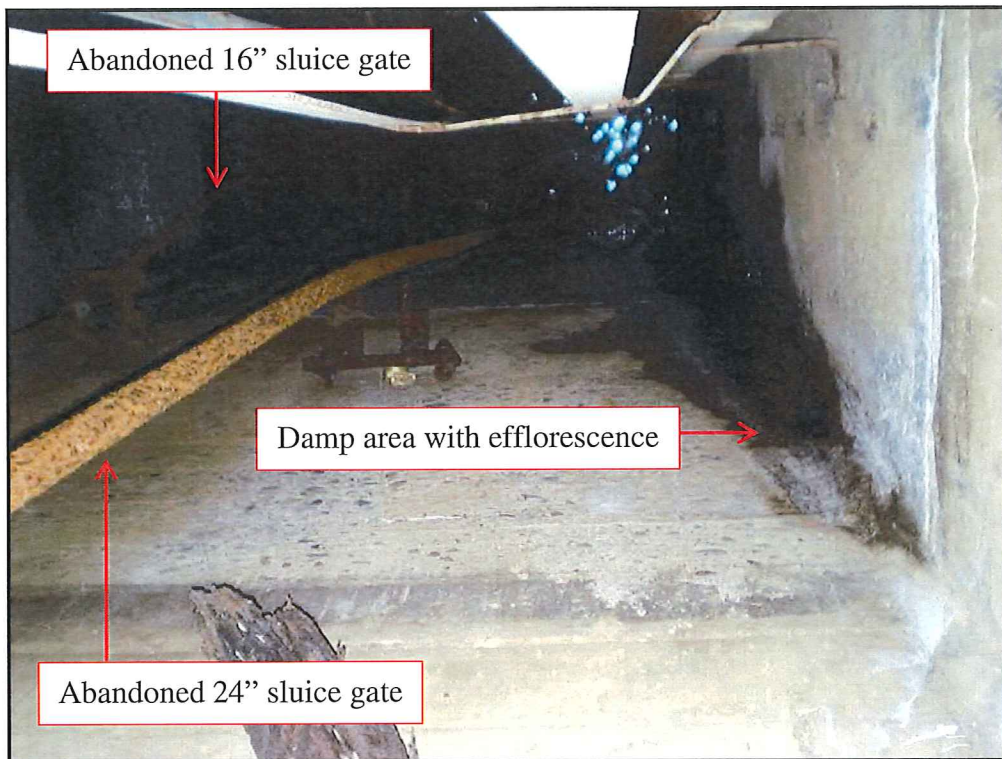
**Photo No. 34**  
**View of interior downstream wall of valve chamber.**

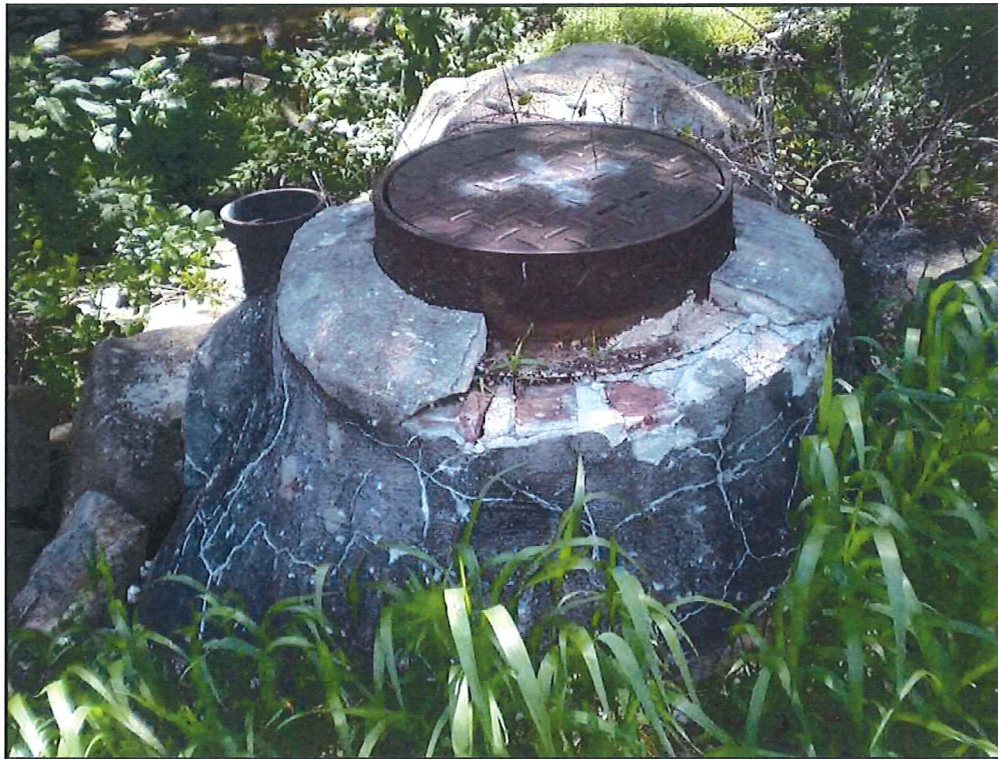
**Photo 35**

Item 65: Loss of mortar observed around frame and cover of valve manhole located immediately upstream of the discharge outlet of the 24" CIP low level dewatering system (refer to Photo 35). **Recommend** repairing mortar to keep manhole frame and cover operable and to prevent further deterioration of the structure.

**Valve manhole on 24" CIP low level dewatering pipe. Note loss of mortar around frame and cover.**

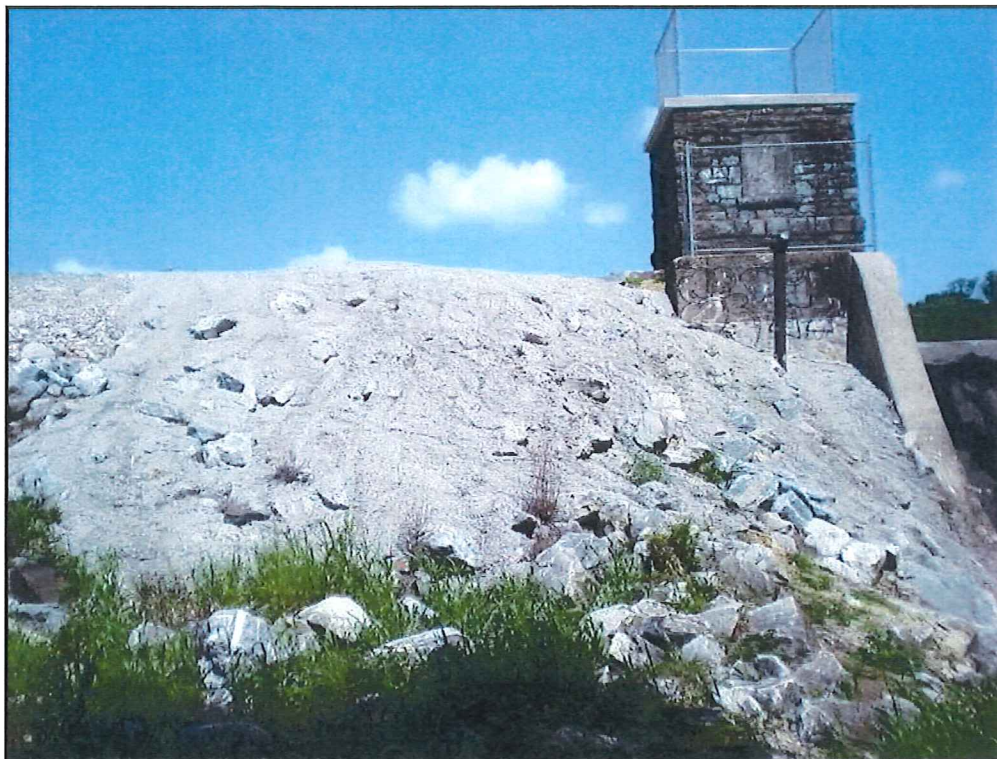
**Photo 37**

**Slush grouted riprap on downstream right embankment near Valve House.**
