**DAM INSPECTION CHECKLIST**  
**Department of Environmental Protection**  
**Bureau of Waterways Engineering**  
**Division of Dam Safety**

**NAME OF DAM:** Milltown Dam

**DEP DAM NO.:** 15-146

MILLTOWN DAM 2015 INSPECTION REPORT PHOTO LOG

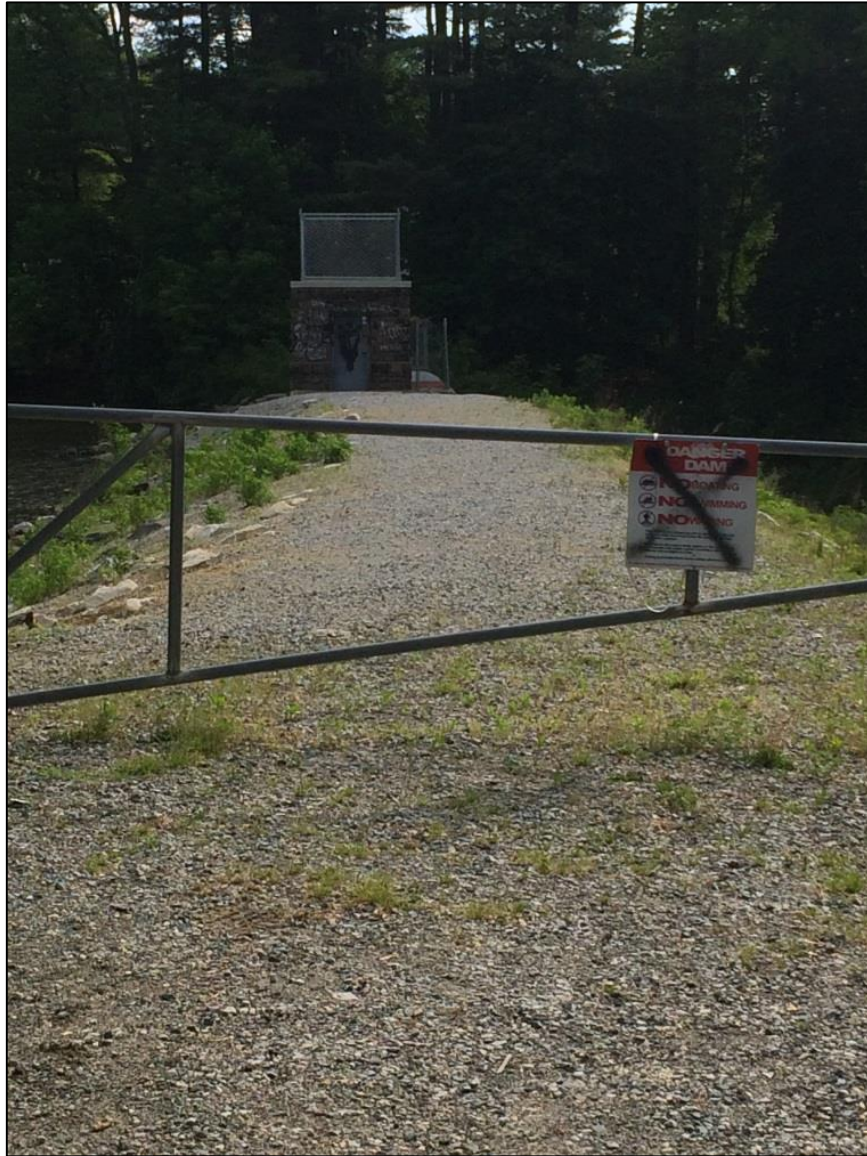
**P-1**

9			<input type="checkbox"/>	<input type="checkbox"/>	<input type="checkbox"/>
Additional Comments (Refer to item number if applicable): - Crest generally consists of flat gravel surface - See attached Photograph No. 1 for general view of crest - Item #6 – West side of spillway – good, very minor vegetation East side of spillway – remove vegetation					
<b>EMBANKMENT: UPSTREAM FACE</b>					
10	Slide, Slough, Scarp	Good – trace missing rip-rap	<input checked="" type="checkbox"/>	<input type="checkbox"/>	<input type="checkbox"/>
11	Slope Protection	Good	<input type="checkbox"/>	<input type="checkbox"/>	<input type="checkbox"/>
12	Sinkhole, Animal Burrow	None observed	<input type="checkbox"/>	<input type="checkbox"/>	<input type="checkbox"/>
13	Emb.-Abut. Contact	Good	<input type="checkbox"/>	<input type="checkbox"/>	<input type="checkbox"/>
14	Erosion	None observed	<input type="checkbox"/>	<input type="checkbox"/>	<input type="checkbox"/>

Photo 1. Dam crest looking northeast

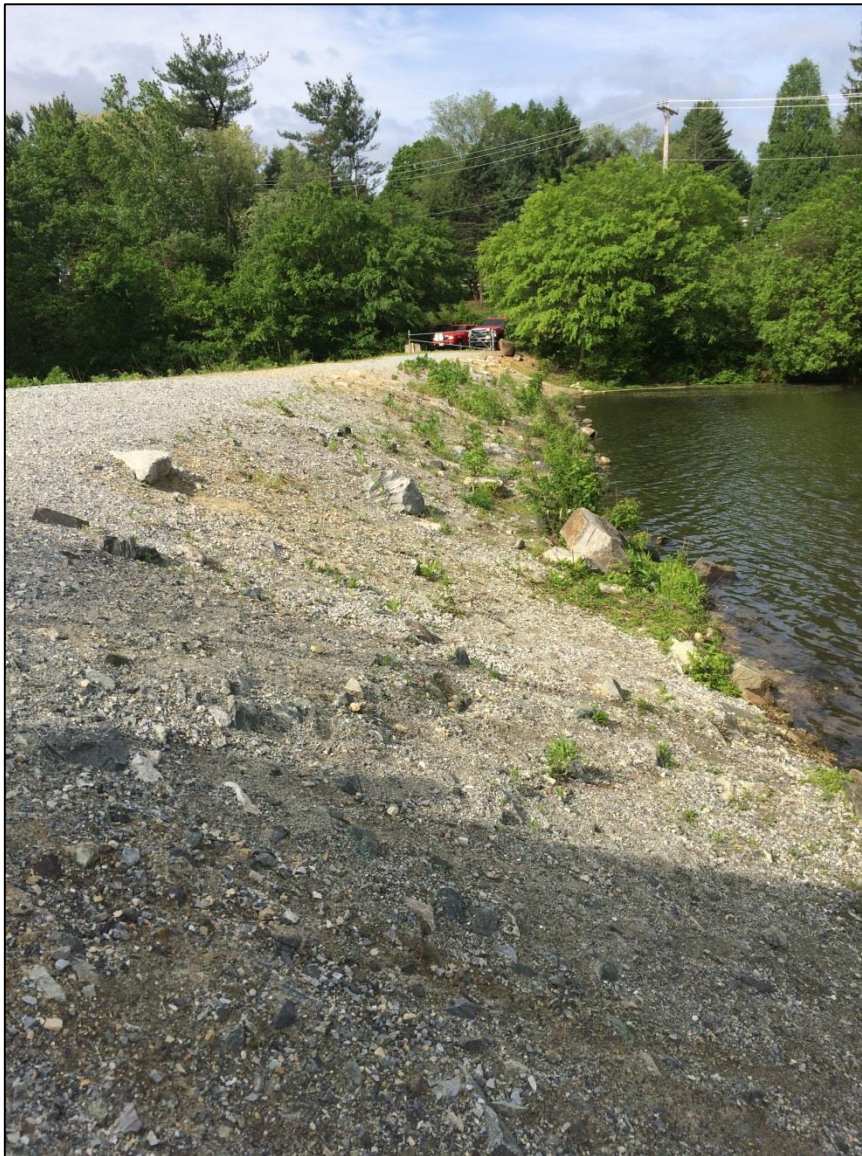
15	Vegetation Condition	Sparse vegetation	<input type="checkbox"/>	<input type="checkbox"/>	<input checked="" type="checkbox"/>
16			<input type="checkbox"/>	<input type="checkbox"/>	<input type="checkbox"/>
17			<input type="checkbox"/>	<input type="checkbox"/>	<input type="checkbox"/>
Additional Comments (Refer to item number if applicable): - Upstream face generally consists of rip-rap choked with PA DOT 2A Modified stone - See Photograph No. 2 for general condition of upstream face

Photo 2. Upstream face looking southwest.

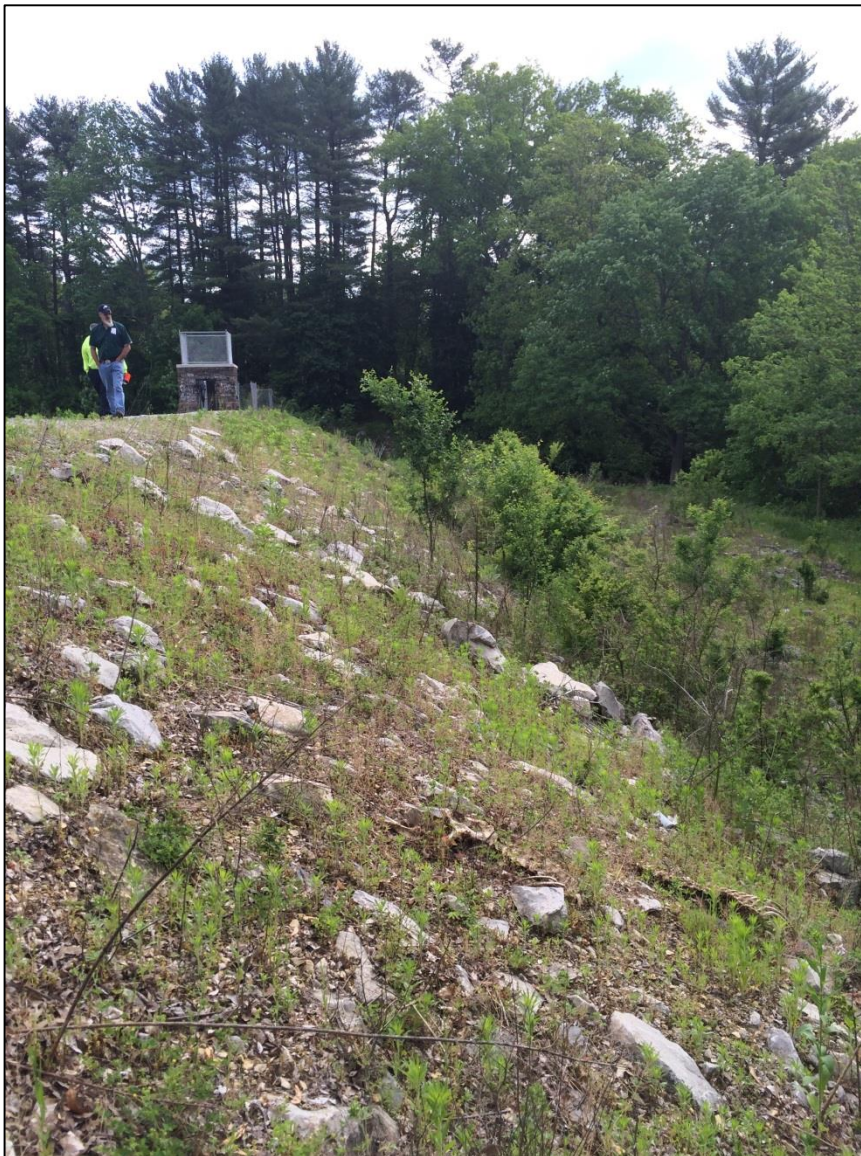
26			<input type="checkbox"/>	<input type="checkbox"/>	<input type="checkbox"/>
27			<input type="checkbox"/>	<input type="checkbox"/>	<input type="checkbox"/>
Additional Comments (Refer to item number if applicable): - See Photograph 3 for general condition of downstream face - Photograph 4 illustrates northeast end of downstream face where apparent mass concrete was placed within the past 2 years as per East Goshen					
<b>EMBANKMENT: INSTRUMENTATION</b>					
28	Piezometers/Observ. Wells	Not Present (NP)	<input type="checkbox"/>	<input type="checkbox"/>	<input type="checkbox"/>
29	Staff Gauge and Recorder	NP	<input type="checkbox"/>	<input type="checkbox"/>	<input type="checkbox"/>
30	Weirs	NP	<input type="checkbox"/>	<input type="checkbox"/>	<input type="checkbox"/>
31	Survey Monuments	NP	<input type="checkbox"/>	<input type="checkbox"/>	<input type="checkbox"/>
32	Drains	NP	<input type="checkbox"/>	<input type="checkbox"/>	<input type="checkbox"/>

Photo 3. Downstream face looking northeast

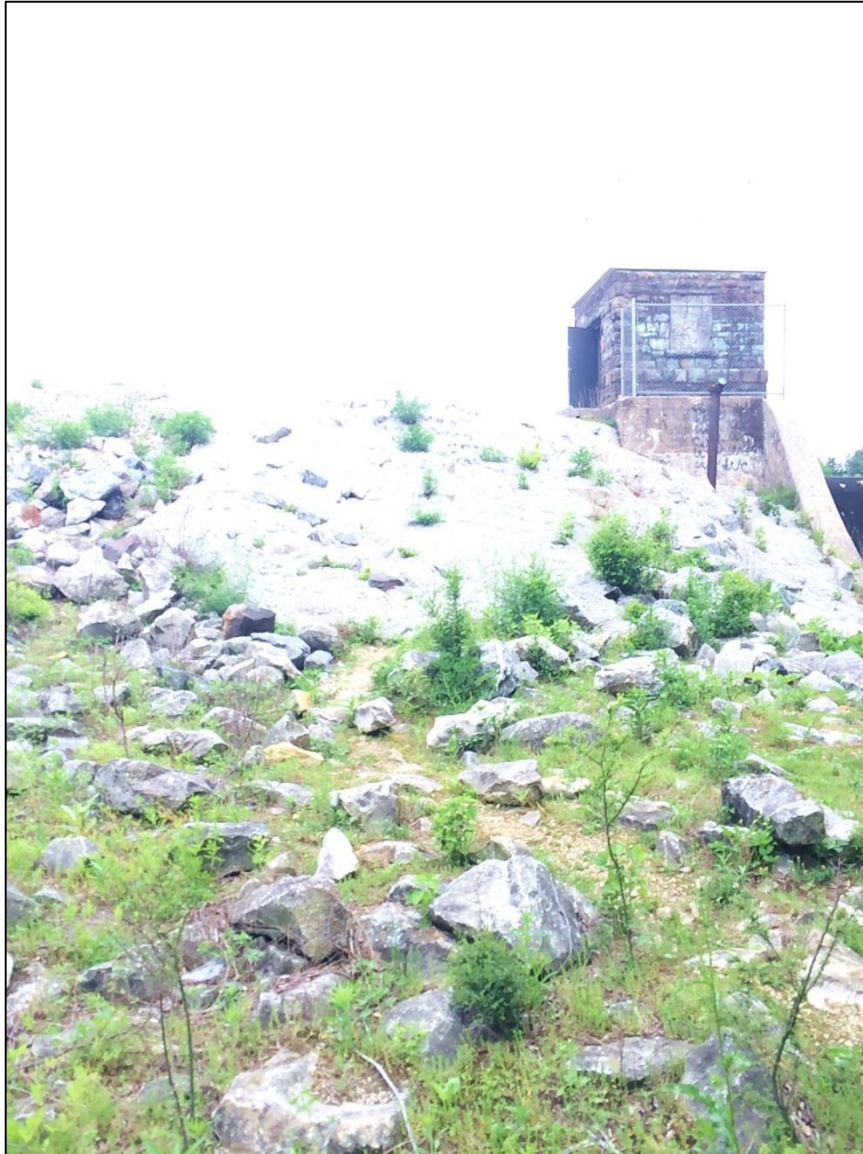
P-4

Photo 4. Downstream face at northeast end – Mass concrete

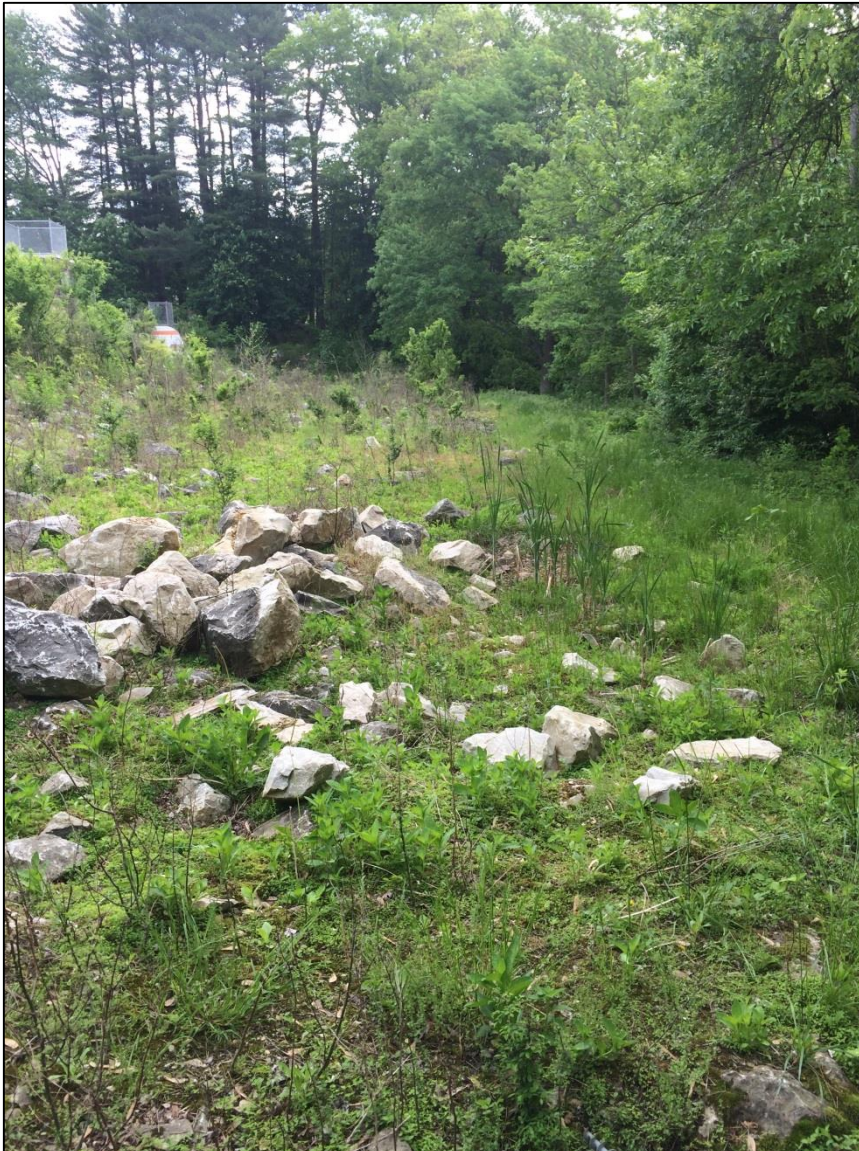
- Item 43 – area noted as being wet in August 2014 Yerkes inspection report was observed, but no standing water or wetness was observed during current site visit (see Photograph 5)
- Item 45 – access to dam is from small concrete stone surface “lot” off of Reservoir Rd
- Item 46 – access to crest of dam secured by locked gate with warning sign (see Photograph 1). Access to top of spillway protected by stone outlet structure on south west side and chain link fence on north east side.

Photo 5. Downstream 2104 wet area

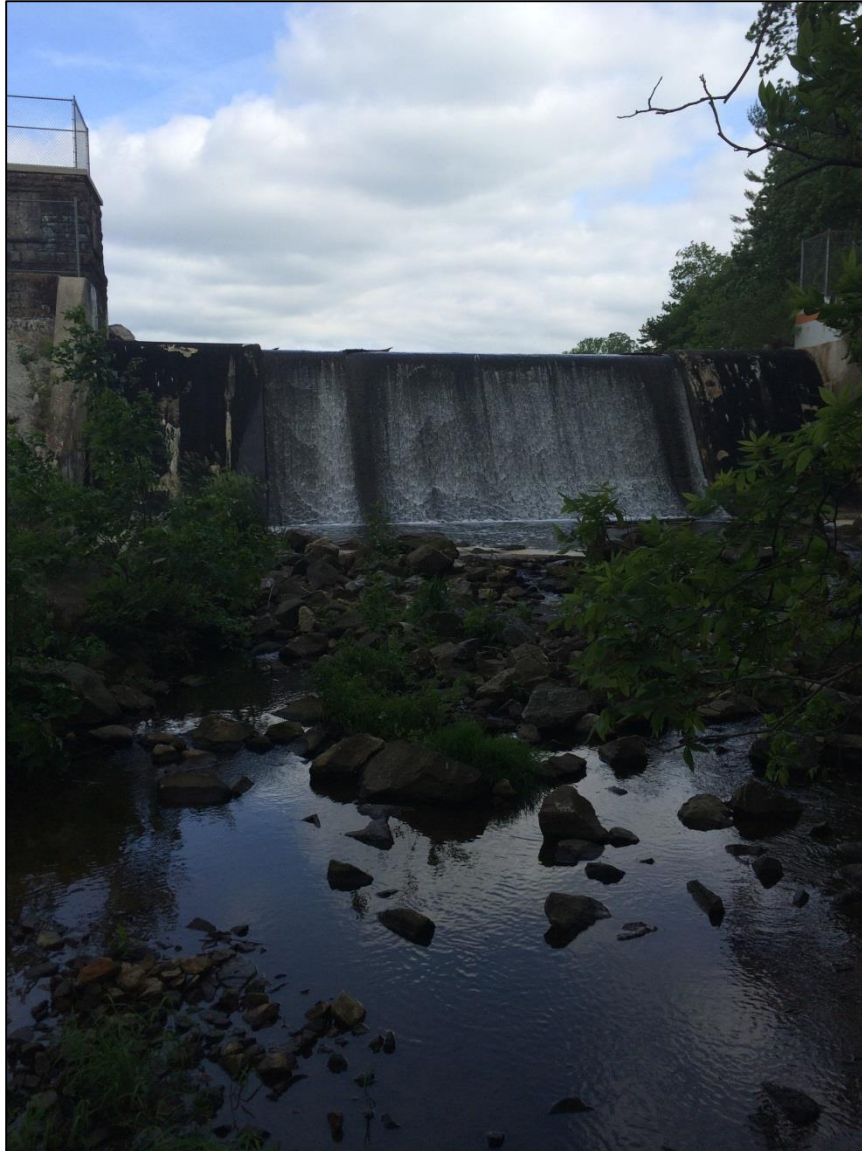
- Spillway is concrete (see Photograph 6)

ITEM	CONDITION	COMMENTS	MONITOR	INVESTIGATE	REPAIR
<b>SPILLWAYS: NON-ERODABLE CHANNEL</b>					
56	Sidewalls	Moderate – see Photograph Nos. 7 to 9 – see note below	<input type="checkbox"/>	<input type="checkbox"/>	<input checked="" type="checkbox"/>
57	Channel Floor	Moderate – see Photograph 7 – see note below	<input type="checkbox"/>	<input type="checkbox"/>	<input checked="" type="checkbox"/>
58	Unusual Movement	None observed	<input type="checkbox"/>	<input type="checkbox"/>	<input type="checkbox"/>
59	Approach Area	Good – no blockage observed – See Photograph 10	<input type="checkbox"/>	<input type="checkbox"/>	<input type="checkbox"/>
60	Weir or Control	Good – no blockage observed	<input type="checkbox"/>	<input type="checkbox"/>	<input type="checkbox"/>
61	Discharge Channel	Generally clear – no significant blockage – see Photograph Nos. 6 & 7	<input type="checkbox"/>	<input type="checkbox"/>	<input type="checkbox"/>

Photo 6. Spillway

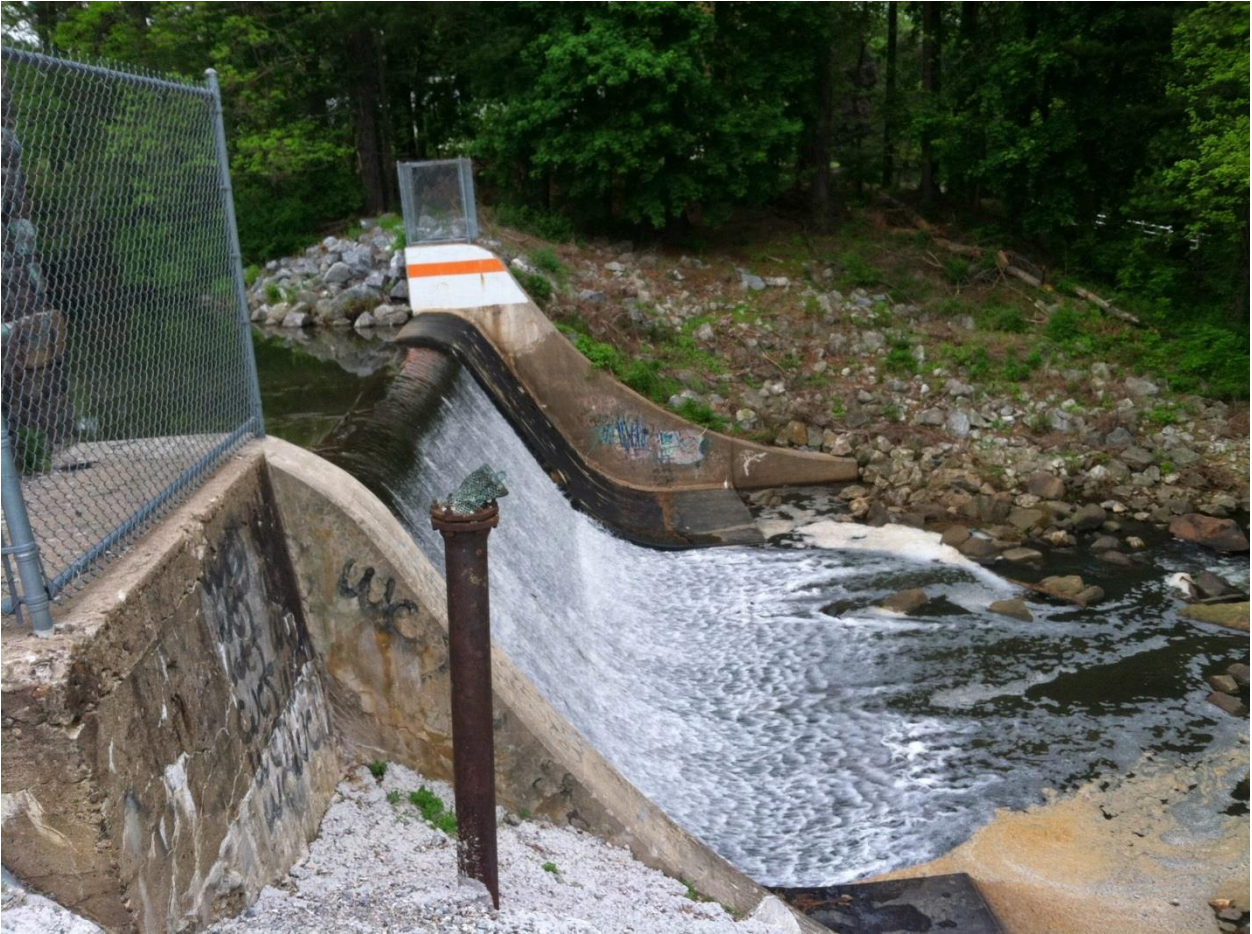
P-7

Photo 7. Spillway walls

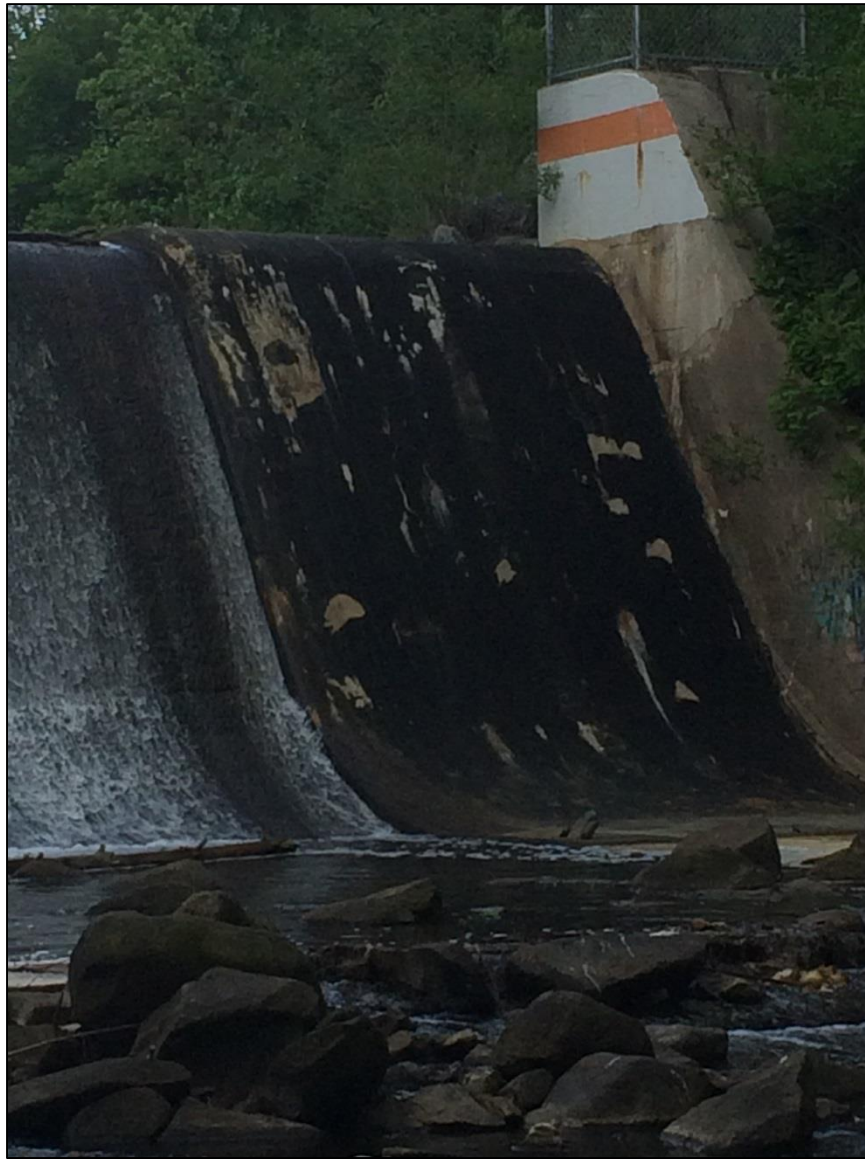
Photo 8. Northeast Spillway wall

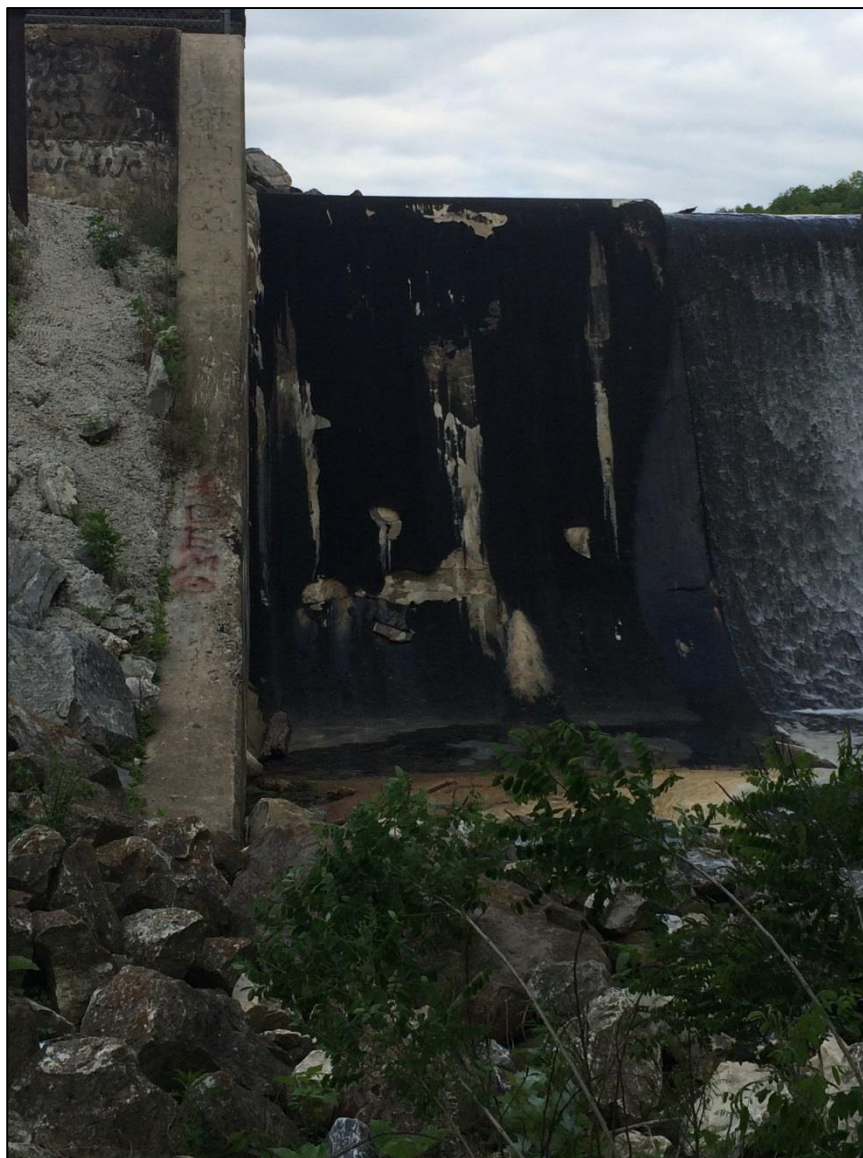
P-9

Photo 9. Southwest Spillway wall

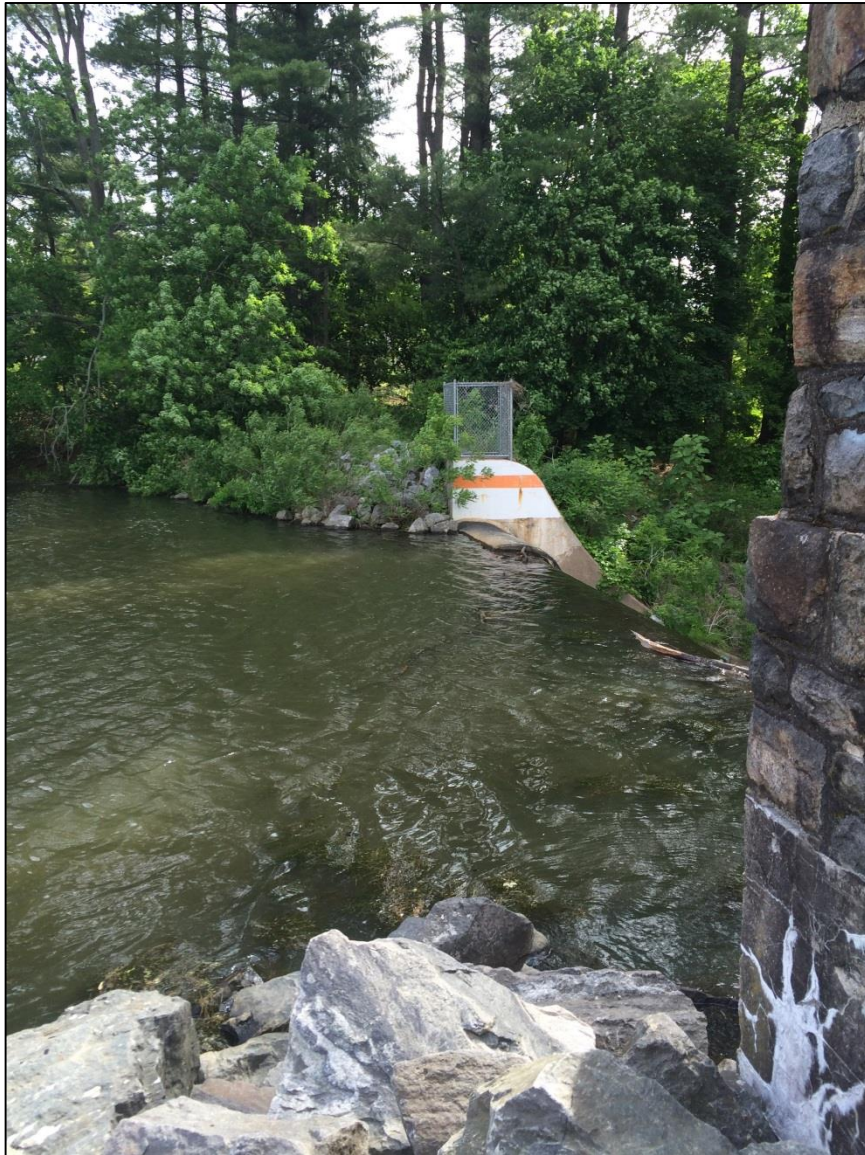
Photo 10. Spillway approach

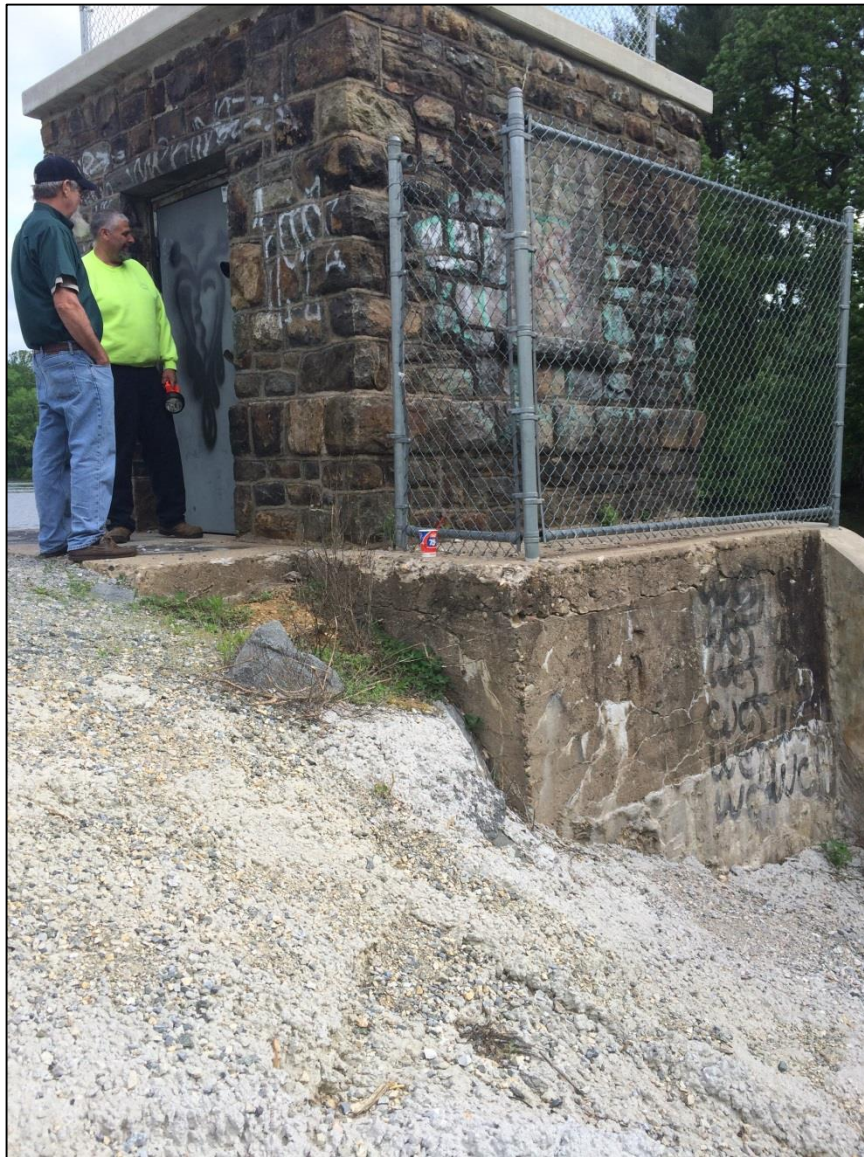
**P-11**

69			<input type="checkbox"/>	<input type="checkbox"/>	<input type="checkbox"/>
Additional Comments (Refer to item number if applicable): - Item Nos. 65 to 67 – this section refers to the inlet for the structure shown in Photograph 11. The intake for this structure was below the water surface at the time of our site visit and was not accessible.

Photo 11. Outlet Structure

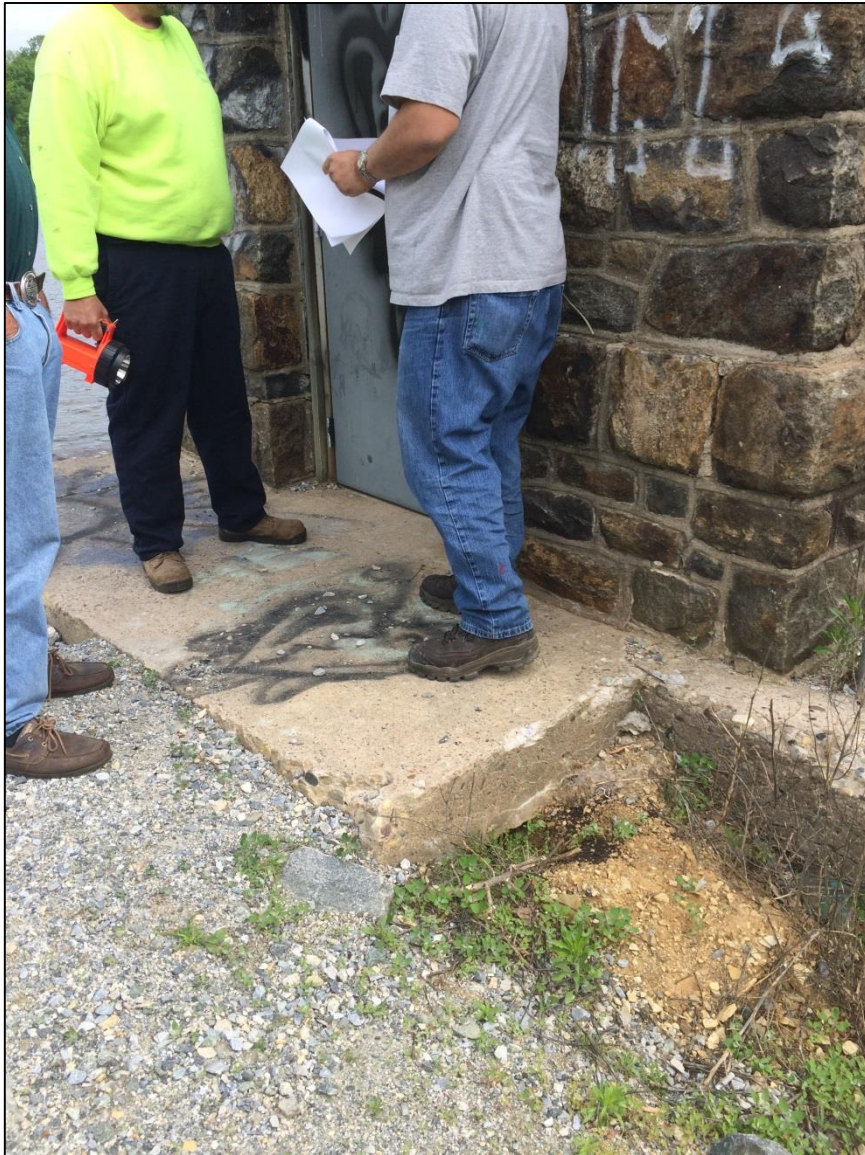
P-12

Photo 12. Outlet void facing downstream

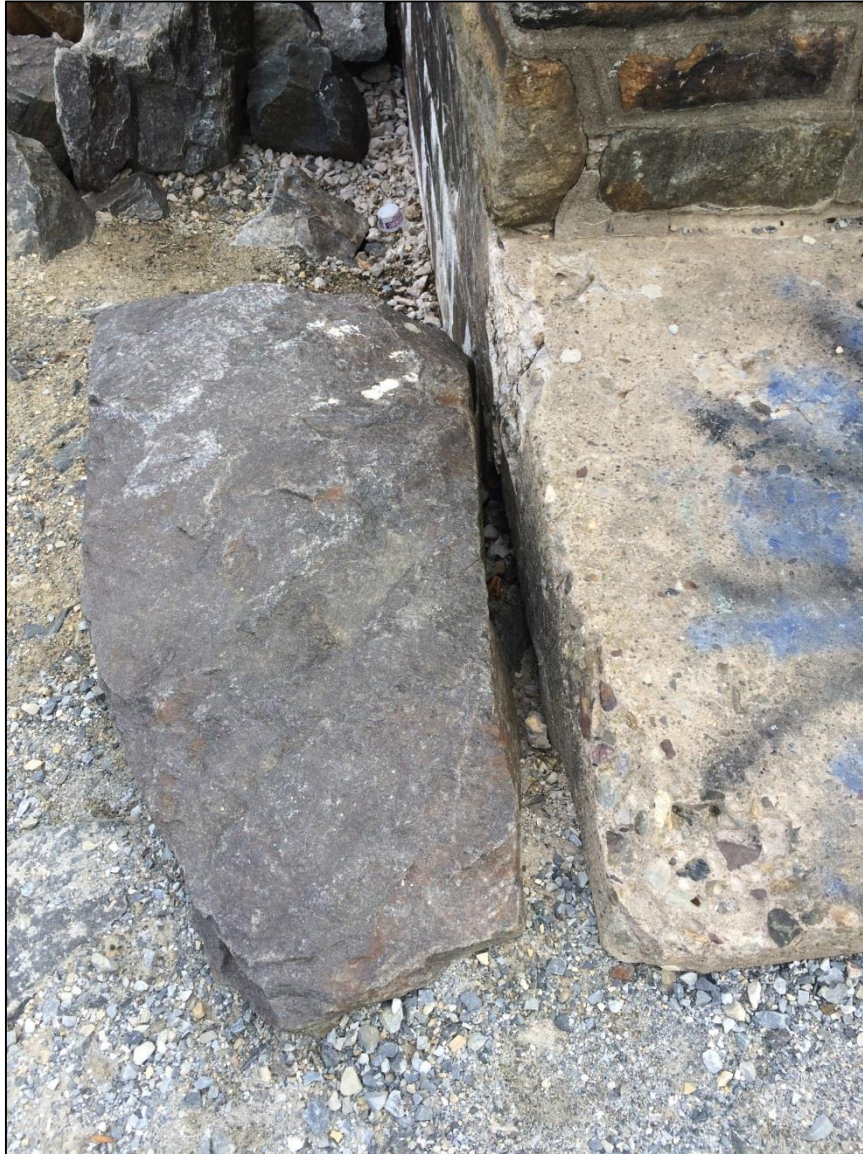
Photo 13. Outlet void facing upstream
