Re: Report on subsidence issue, East Goshen Township, Chester County, Penna.

Sasowsky Earth Science Consultants (SESC) has completed our desktop study of reported subsidence observed in East Goshen Twp., Chester County, Pennsylvania. This work was conducted based upon our agreement dated December 8, 2020. The letter report below describes our approach, findings and conclusions.

## **Depression Adjacent to Route 352 near Anne Drive/Bow Tree Drive East Goshen Township, Chester County**

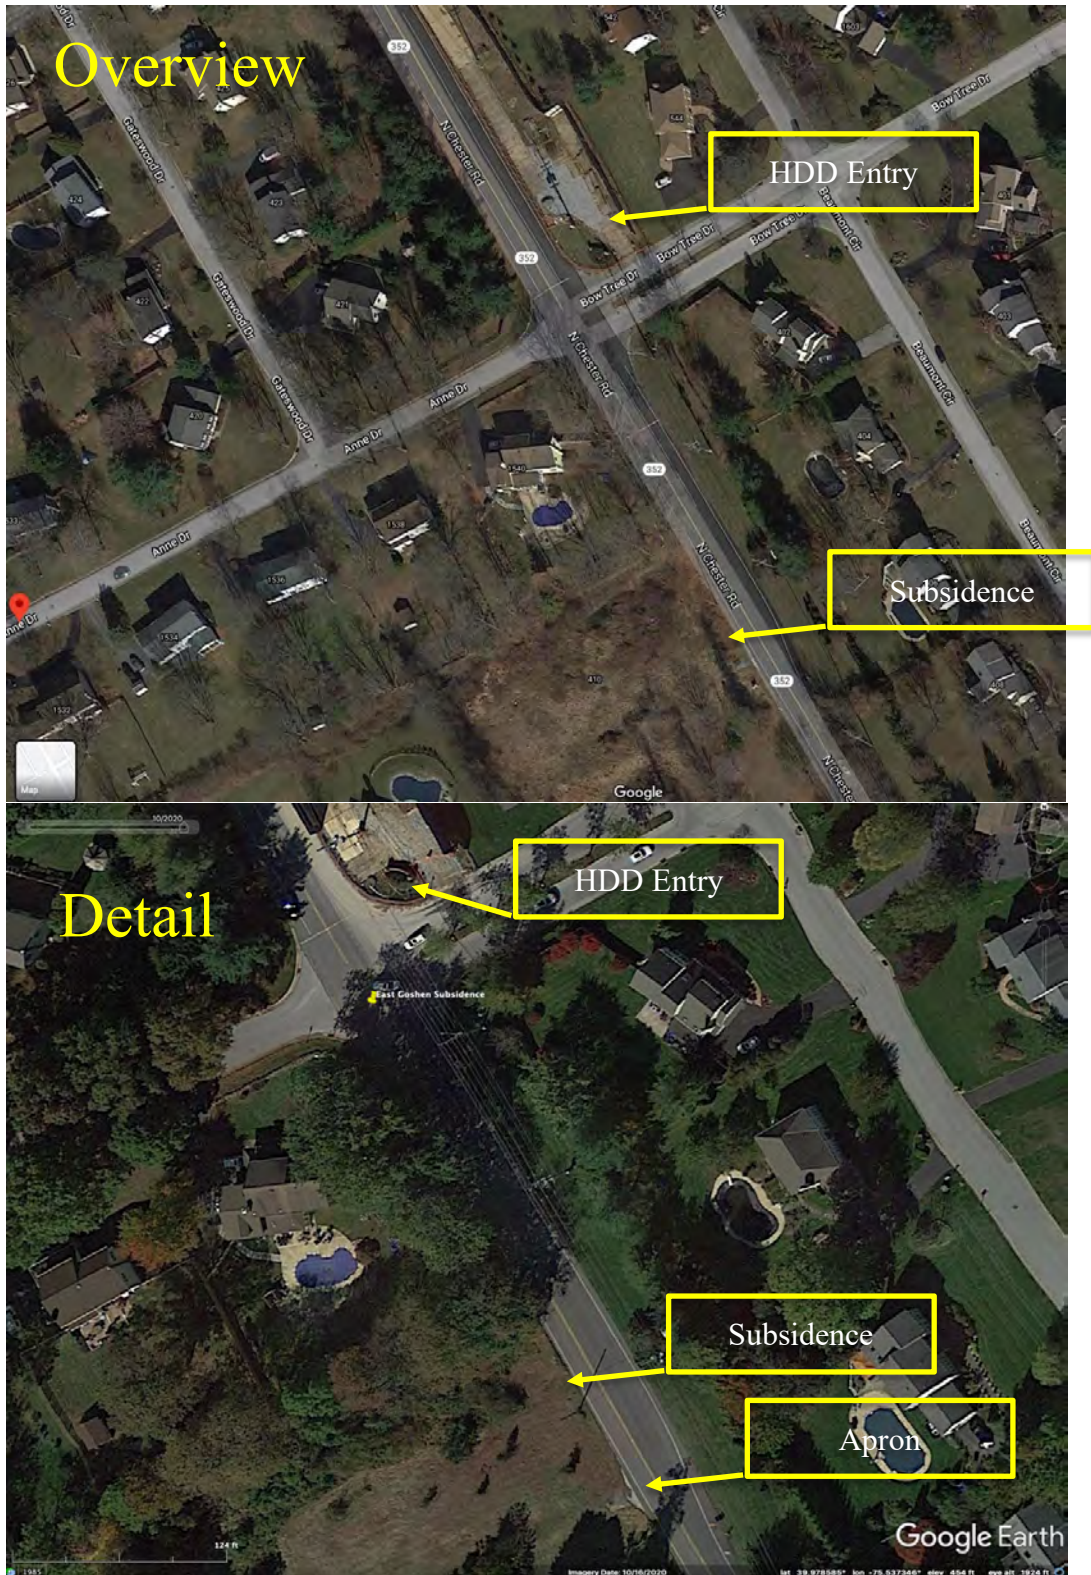
The area is currently mostly built out as low-density suburban development, with residential buildings, yards, etc. A major road, Route 352, Chester Road, runs generally NW-SE. Figure 1 shows salient features. The noted depression occurred on the SW side of Chester road, between the roadway and a lot which currently has no structures on it.

Figure 1: Aerial photographs of surroundings indicating major features (Google Earth, 2/2019, 10/2020). Apron is paved/stoned entry to former residence driveway.

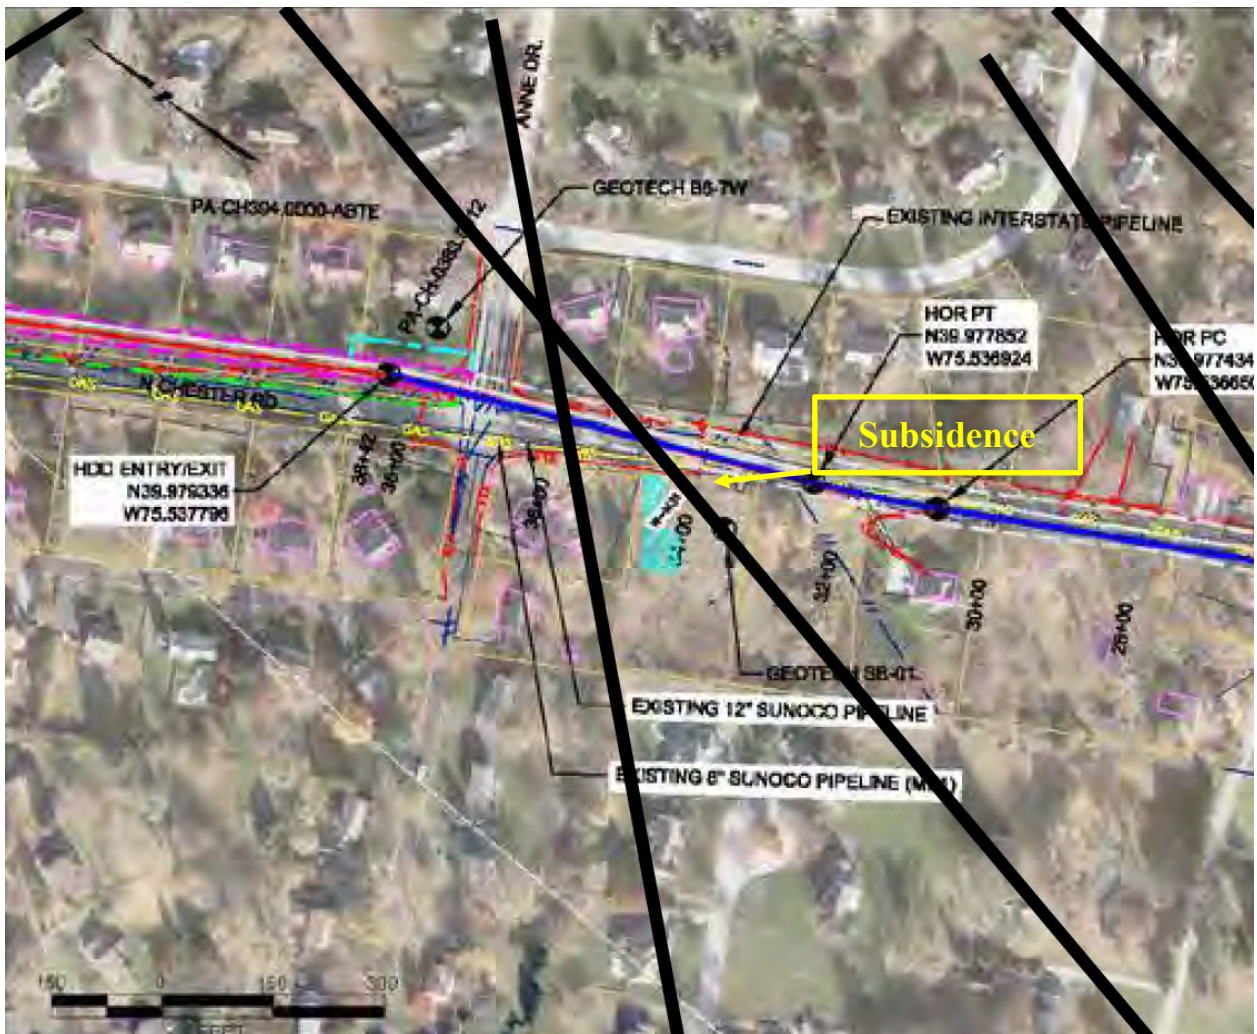
When subsidence is observed at any location, it is reasonable to consider if it is due to the presence of karst developed on soluble rocks such as limestone or marble. This is because sinkholes are a common feature in such settings. Eastern Pennsylvania does have significant karst areas, within which sinkholes are known as natural features and as safety hazards. However, this area in East Goshen Township does not lie within a known karst region, nor is it underlain by marble or limestone. Consequently, it is highly unlikely that karst is present, or is a concern, either with or without human activities such as HDD.

Figure 2: Enlargement of plan view showing fracture traces (black lines) from “Mariner East II HDD Hydrogeologic Reevaluation Report – HDD S3-0520 January 2018” prepared by GES (Groundwater & Environmental Services, Inc.) Approx. point of reported subsidence added.

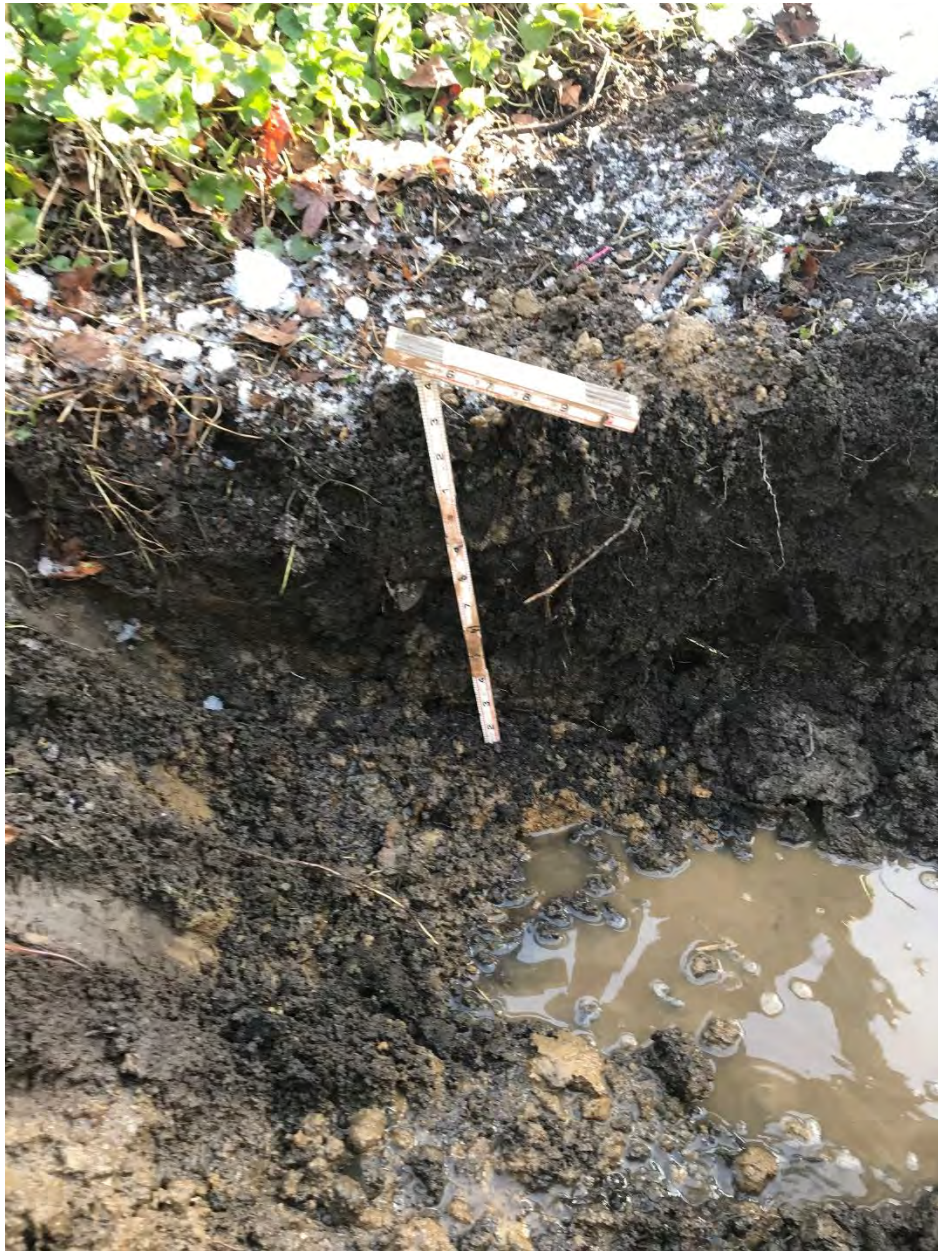
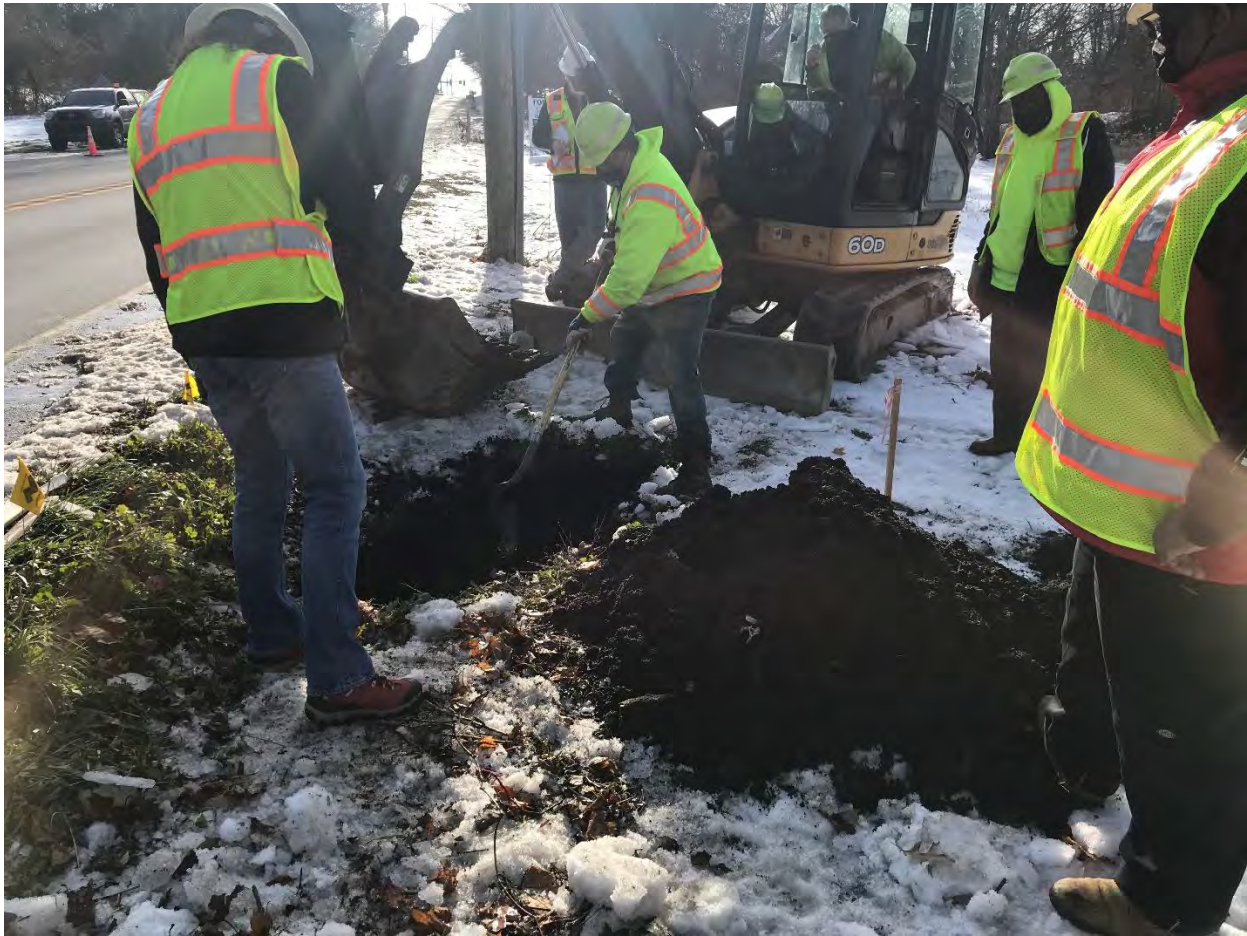
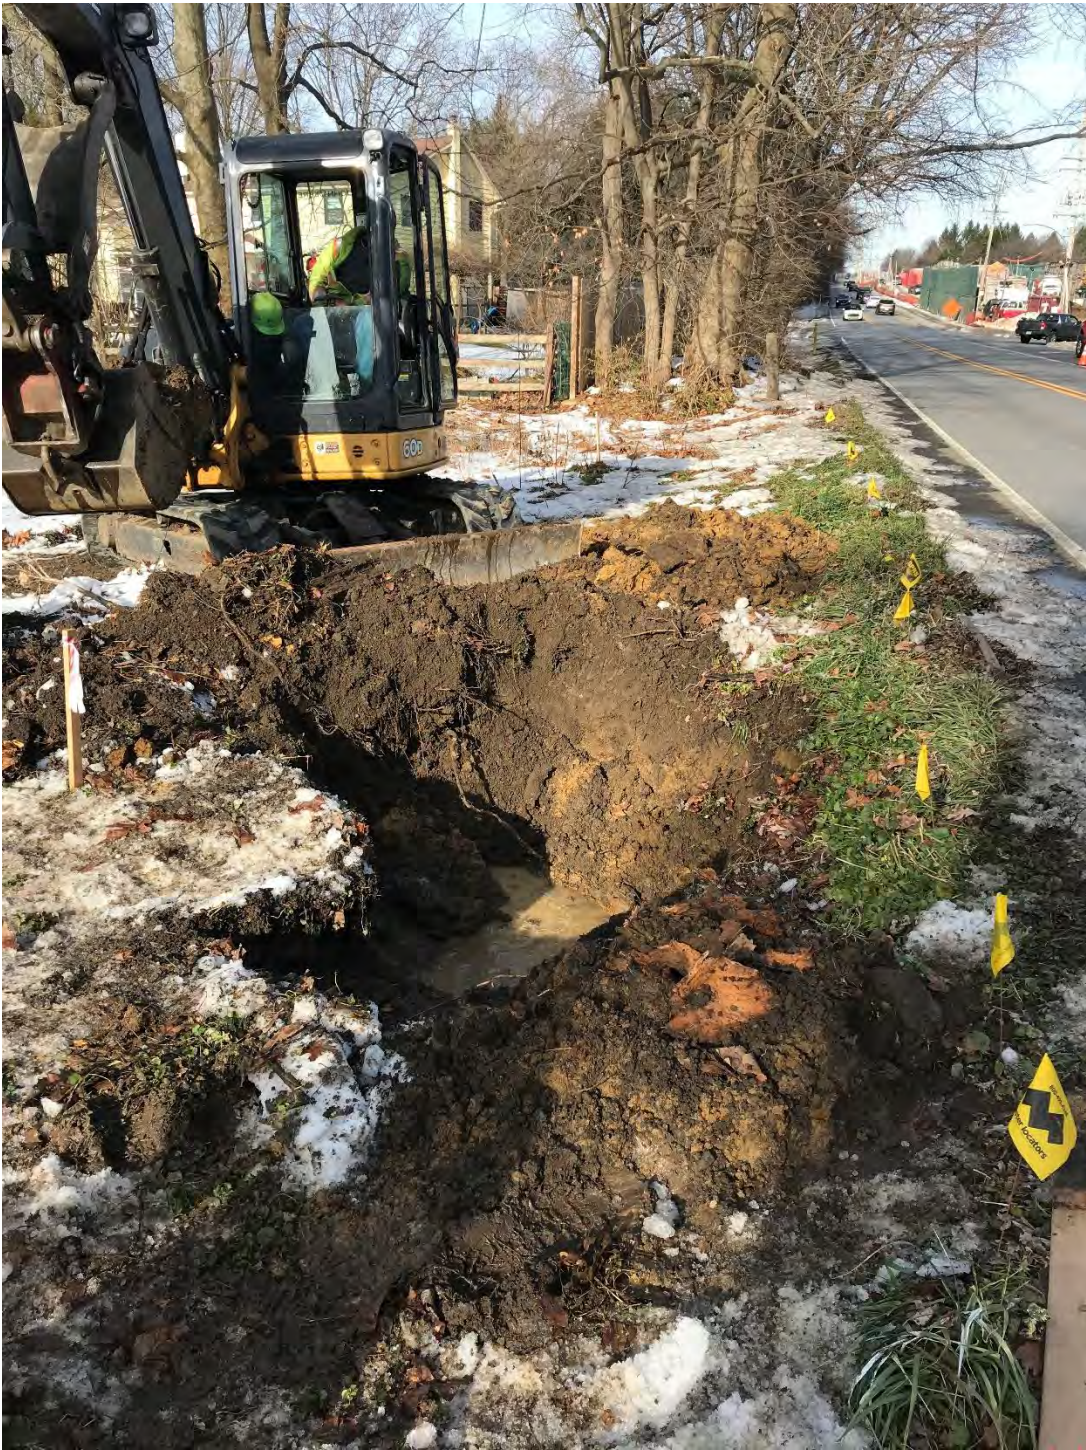
The subsidence adjacent to the southbound shoulder of Route 352 appears to be caused by the presence of silty clay at a depth of 2.3 feet below the road grade. This conclusion was reached based on careful excavation of a 7-foot-by-11-foot test pit (TP-1) roughly centered on the location of the depression. In addition to the silty clay, a tree stump was excavated from the test pit. Decay of the stump may also have contributed to the subsidence at this location. During the excavation, surface water was observed running along the top of the silty clay layer. Perched surface water can also potentially contribute to subsidence. Additionally, there was no evidence of subsidence or distress on the adjacent roadway.

The result of the investigation found that moving surface water and a decaying tree stump were likely the causes of the depression. In the department's professional view, the subsidence was not a risk to the safety and stability of the state roadway.

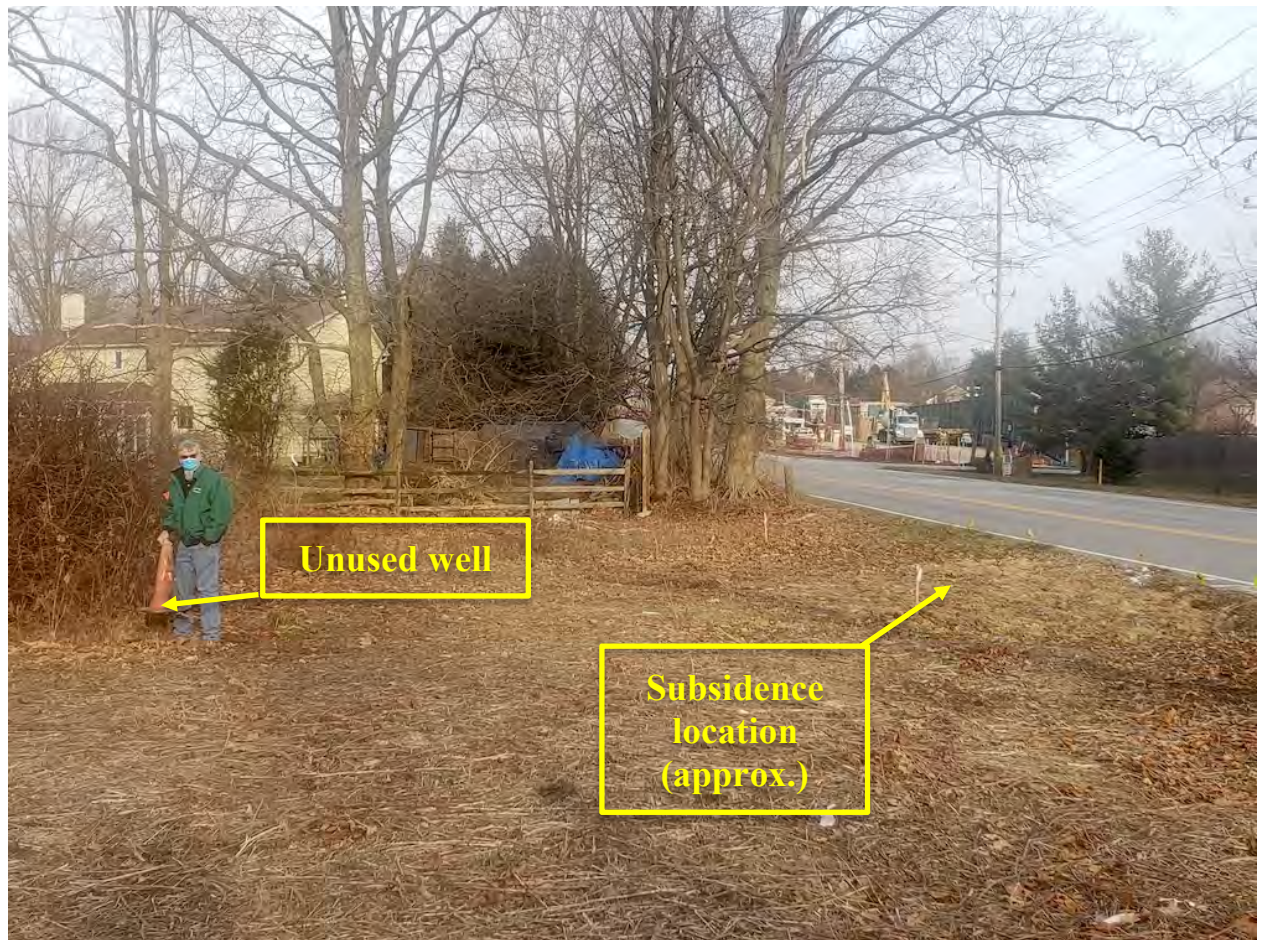
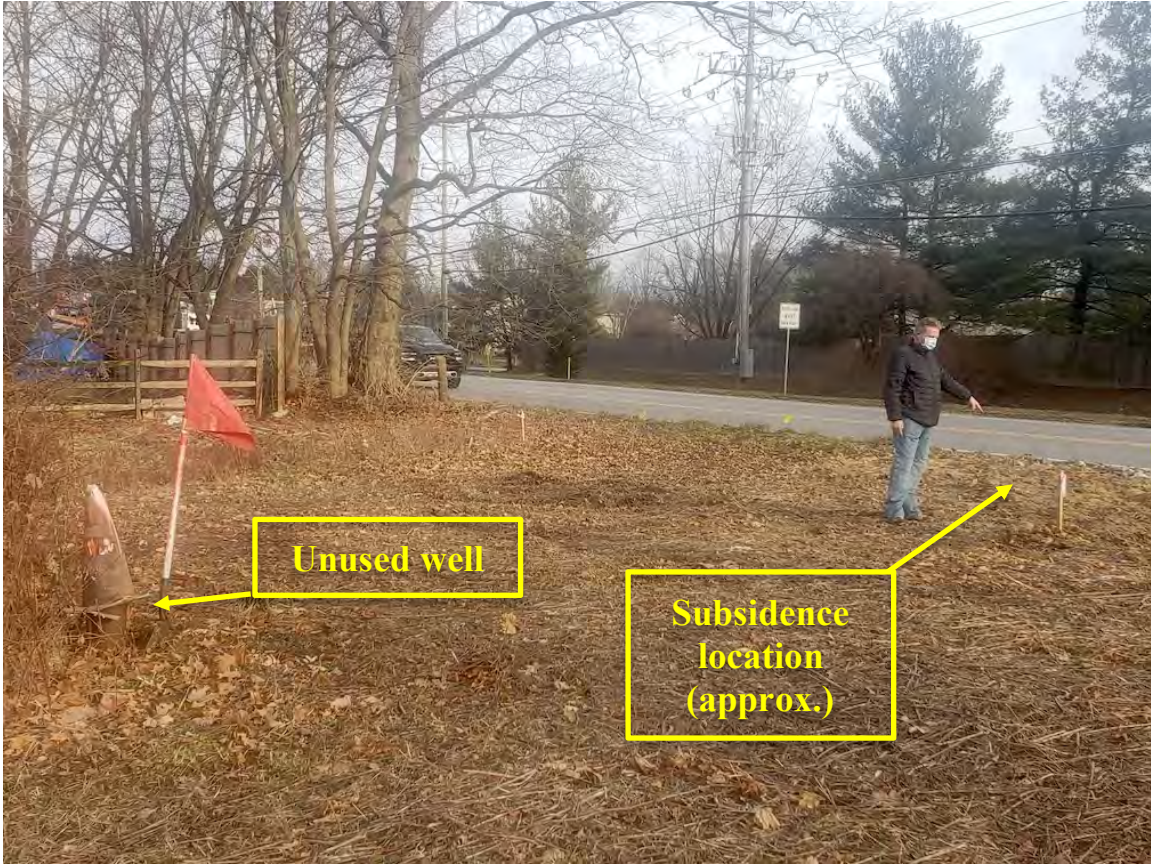
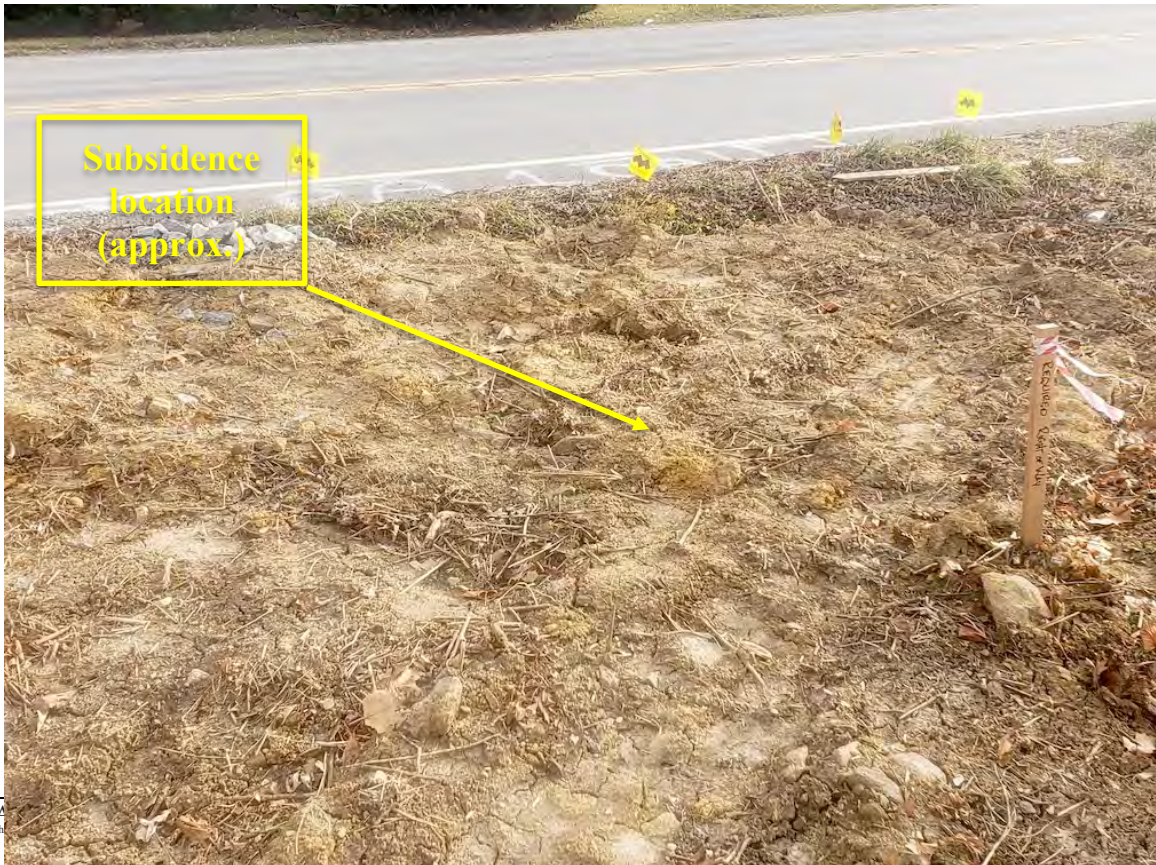
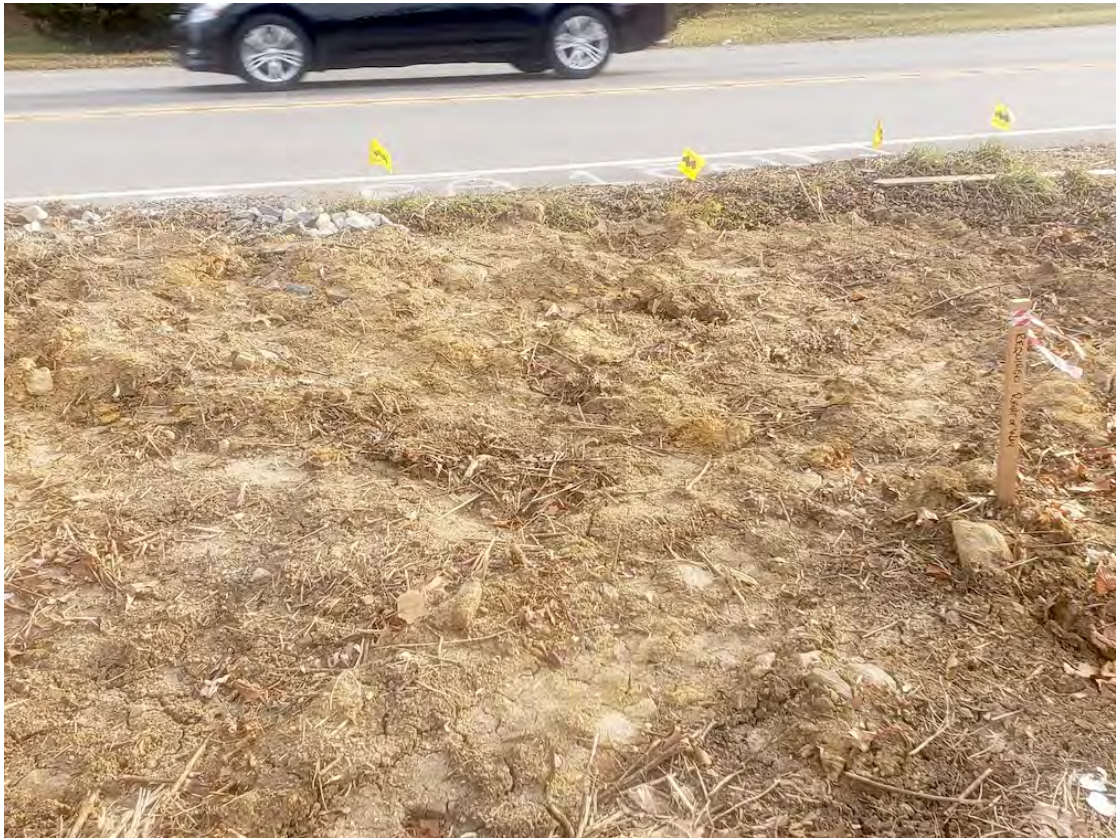
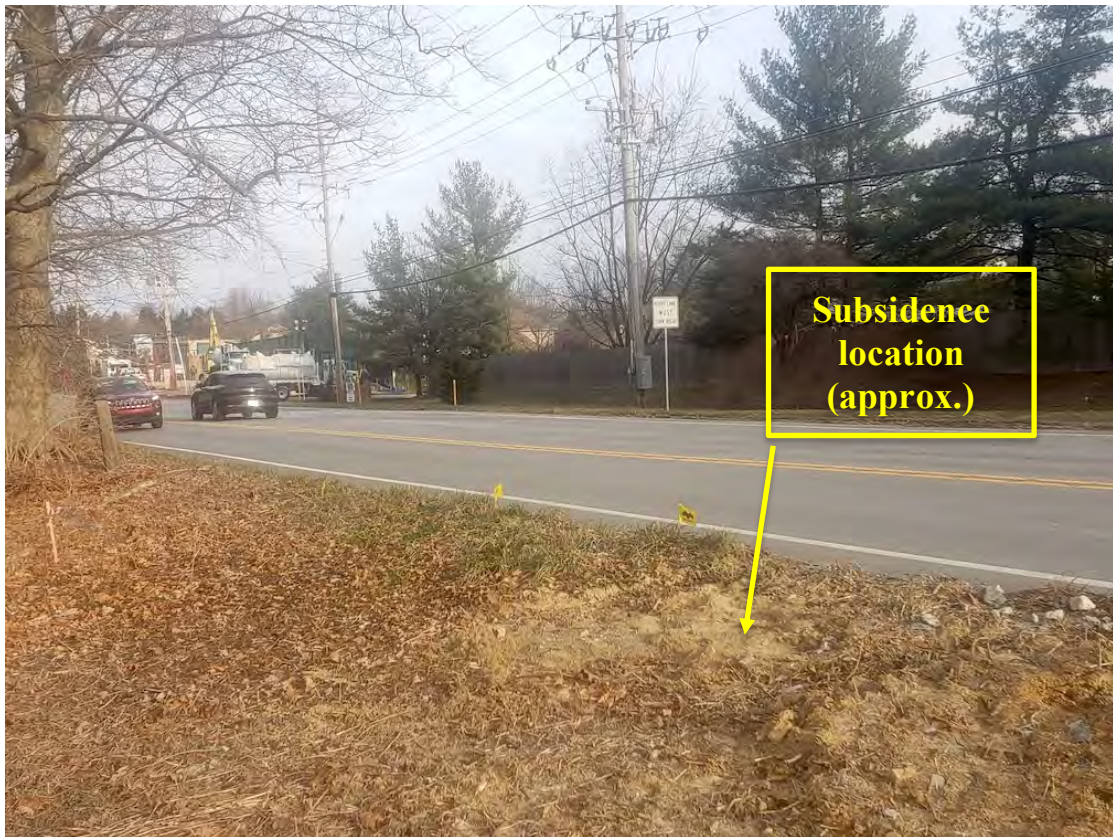
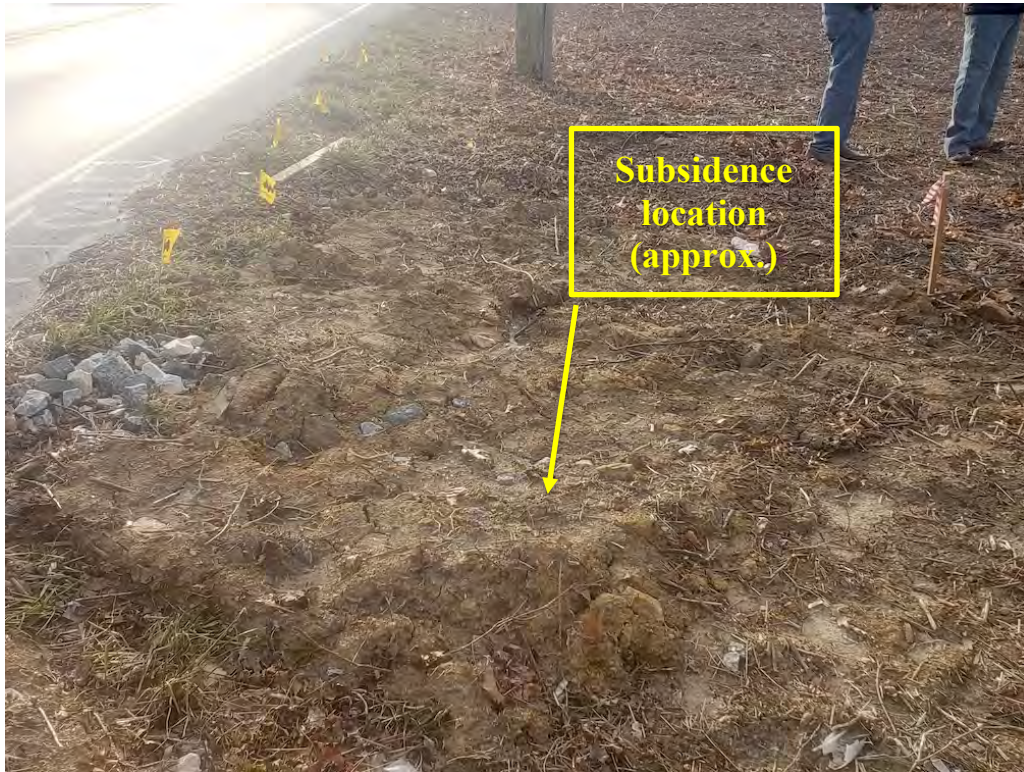
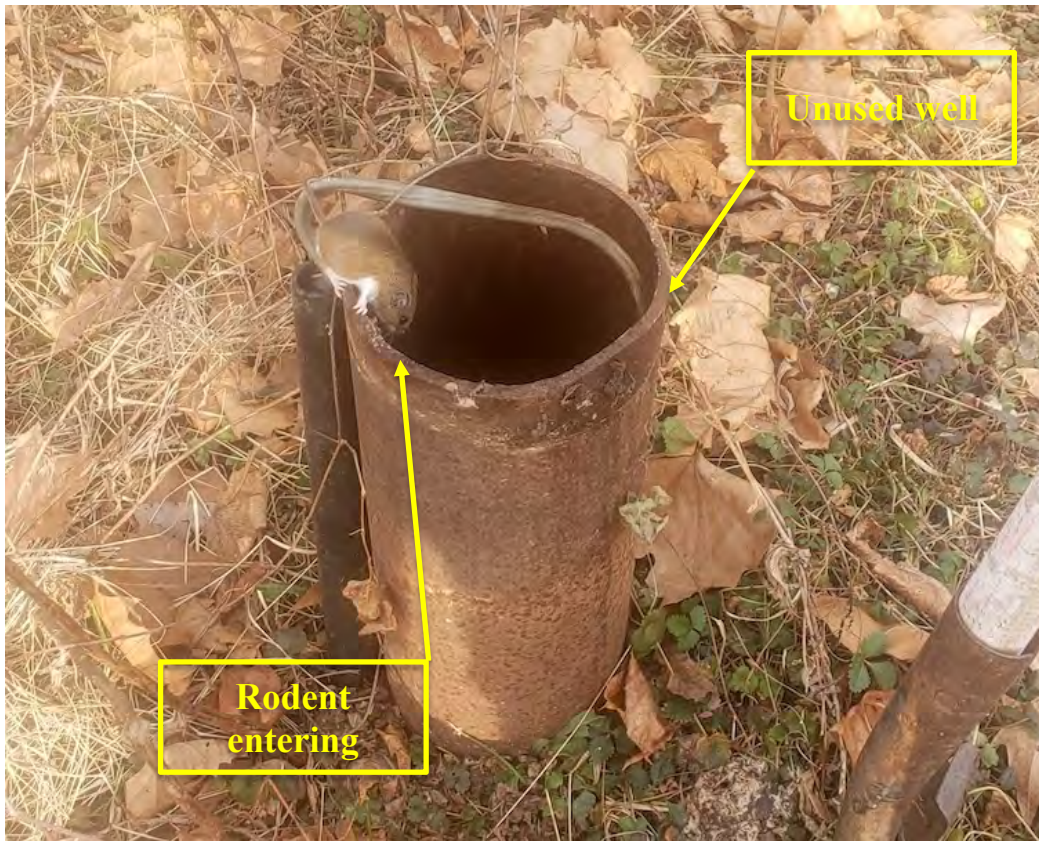
Attachment C (4 p)  
Site photographs taken January 28 by Christina Morley

Based upon ground disturbance (recent fill), they confirmed that the feature was located ~15 feet northwest of an existing utility pole, directly adjacent to the roadway. On this date there was no depression present, and no indication of active subsidence. A steel well casing, covered with a plastic traffic cone, was found ~20 feet to the west. It appears to be unused and was likely associated with the residence that had been present at the site in older aerial photographs. That residence was apparently removed circa 1990s. Township maps indicate that the former house on the property was constructed between 1883 and 1912.

2. That the unused water well be examined by a qualified professional to a) determine if it has structurally failed and might be receiving regolith from the region of the subsidence, and b) that it be properly repaired and capped, or that it be properly abandoned in order to protect against aquifer contamination and collapse.
