# Memorandum DRAFT

DATE: July 9, 2025

RE: East Goshen Municipal Authority  
Sequencing Batch Reactor (SBR) Tank #1

SUBJECT: Structural Assessment Memo

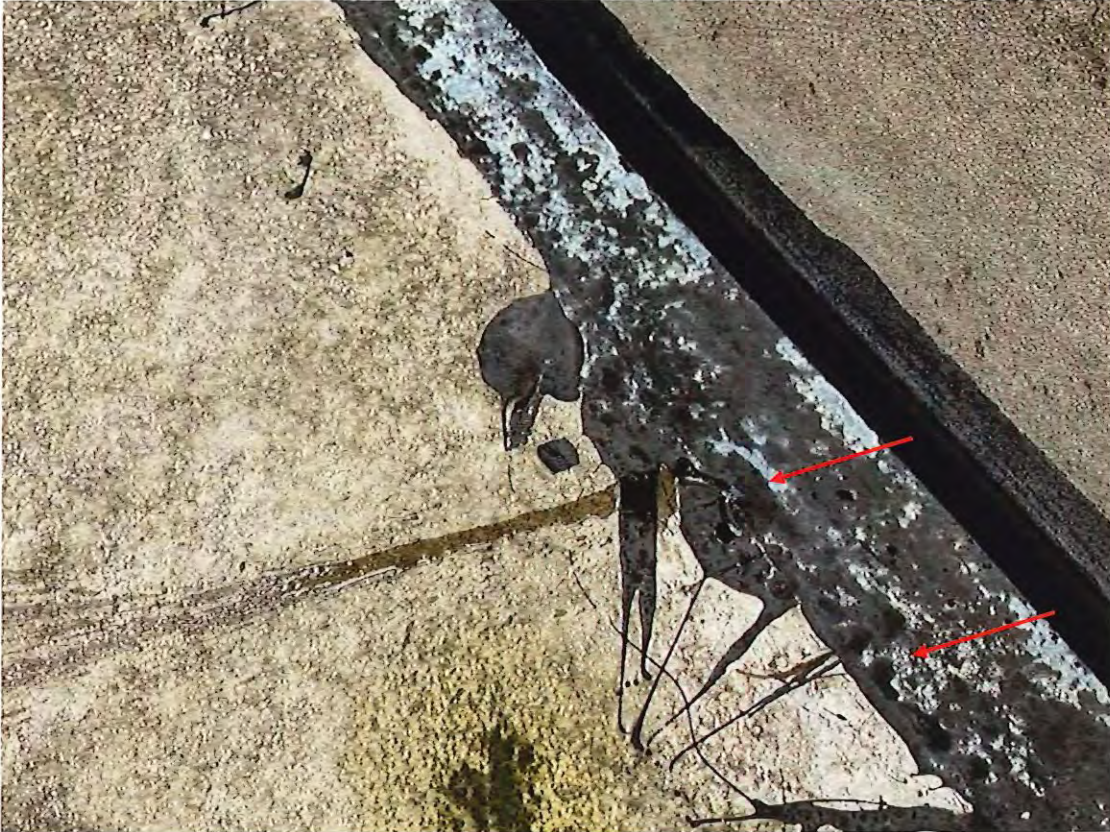
Photo #1A

1. At a few locations, blisters were observed in the CIM coating at the floor and wall surfaces, and when applied with pressure, were filled with air and/or fluid. The observed blisters in the coating are consistent with those described in the previous memo.

1. As noted in the 2021 Memo Report, the original CIM coating was removed and replaced in the same locations following the 2017 Report. As previously discussed, the cause of the blistering of the CIM 1000 coating is unclear, but factors contributing to the observed deficiencies include; moisture in the concrete, temperature conditions during application, improper installation/ surface preparation, and cracking of tank walls due to inadequate design of crack control reinforcement.

While Pennoni continues to recommend full removal of the existing coating and reinstallation with full coverage along all the floor and wall surfaces below the water line in order to maximize the life of the structure, localized repairs continue to appear to be an effective short term remediation. In lieu of full reapplication, Pennoni recommends the removal of the existing coating at locations where blisters are present, and application of a localized coating repairs. Pennoni also recommends that each tank is assessed more frequently for blisters in the CIM coating, as Tank #4 has never been assessed by Pennoni, and Tank #3 has only been assessed once.

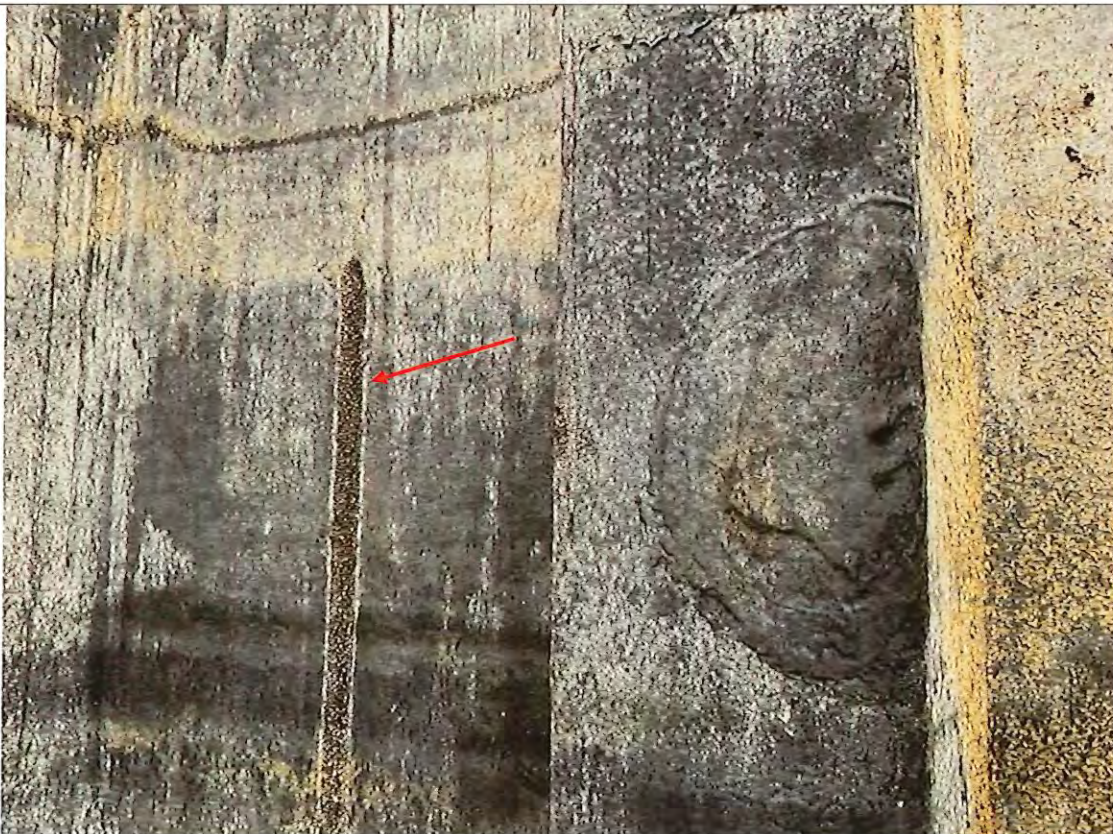
Photo #2A

2. Alligator cracking at vertical joints consistent to what was reported in both previous assessments was again observed.
3. Deterioration in the cementitious skim coating similar to what was reported in 2021 was observed throughout the coating.
4. No spalls were observed as previously documented. It appeared that repairs have been made.
5. The frequency and size of the previously observed horizontal hairline cracks in the exterior ribs of SBR Tank #1 appears to have remained the same.
6. The spall observed in the previous report at the exterior of SBR #4 was not observed due to overgrown vegetation.
7. No efflorescence was observed.
8. Joint sealant deterioration was observed in the exterior of the tanks in a similar state.

2. The discoloration and "alligator" cracking observed at the CIM coating appears to be the result of the coating's age and exposure to ultraviolet radiation, however, as noted in Pennoni's 2017 Report, there is no adverse effect to the function and performance of the membrane. If coatings are removed for reinstalment with full coverage, as recommended in item #1, Pennoni recommended replacement of joints prior to reapplication of the new coating.

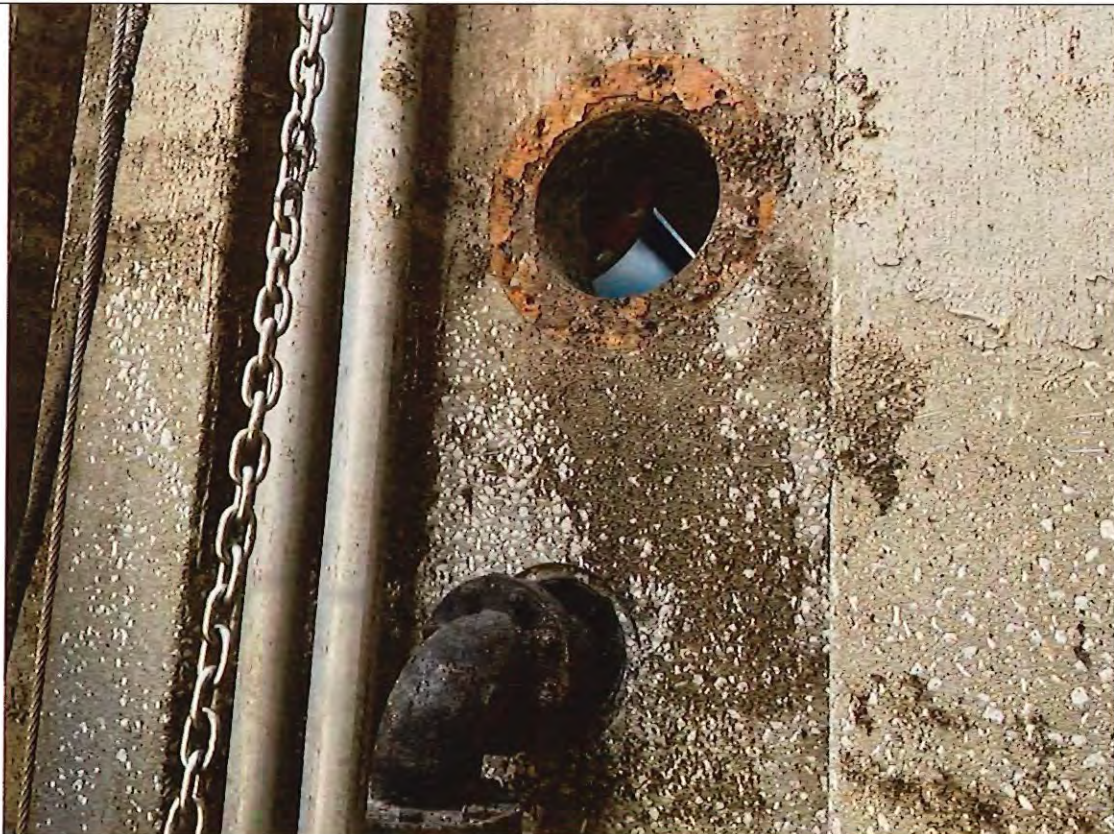
Photo #A.1

- A. Steel corrosion was once again observed at the iron pipe and mixing arm connections near the bottom of the tank.
- B. Deteriorated patches in the walking surface of the top of the tanks were still present as previously documented.

- A. The corrosion on the iron components at the base of SBR #1 is likely caused by the harsh wastewater environment, which accelerates rust formation due to high levels of dissolved oxygen and solids. Steel will readily react with oxygen to form iron oxide (i.e., rust). Normally this reaction is a slow process, particularly when the exposure conditions are controlled, such as the interior of a conditioned building that provides stable temperatures and low humidity. However, the wastewater environment increases the rate of corrosion, resulting in significant loss of cross-sectional area as the steel is converted into rust.

Therefore, it is recommended that the pipes and fittings be cleaned of all latent rust and evaluated for section loss by comparing the thickness of the remaining material against original condition. After the evaluation is completed, it can be determined if additional repairs or replacement (possibly with stainless steel or FRP components if available) is required, or if the pipes and fittings can be re-coated to maximize the lifespan and serviceability of the SBR tank.

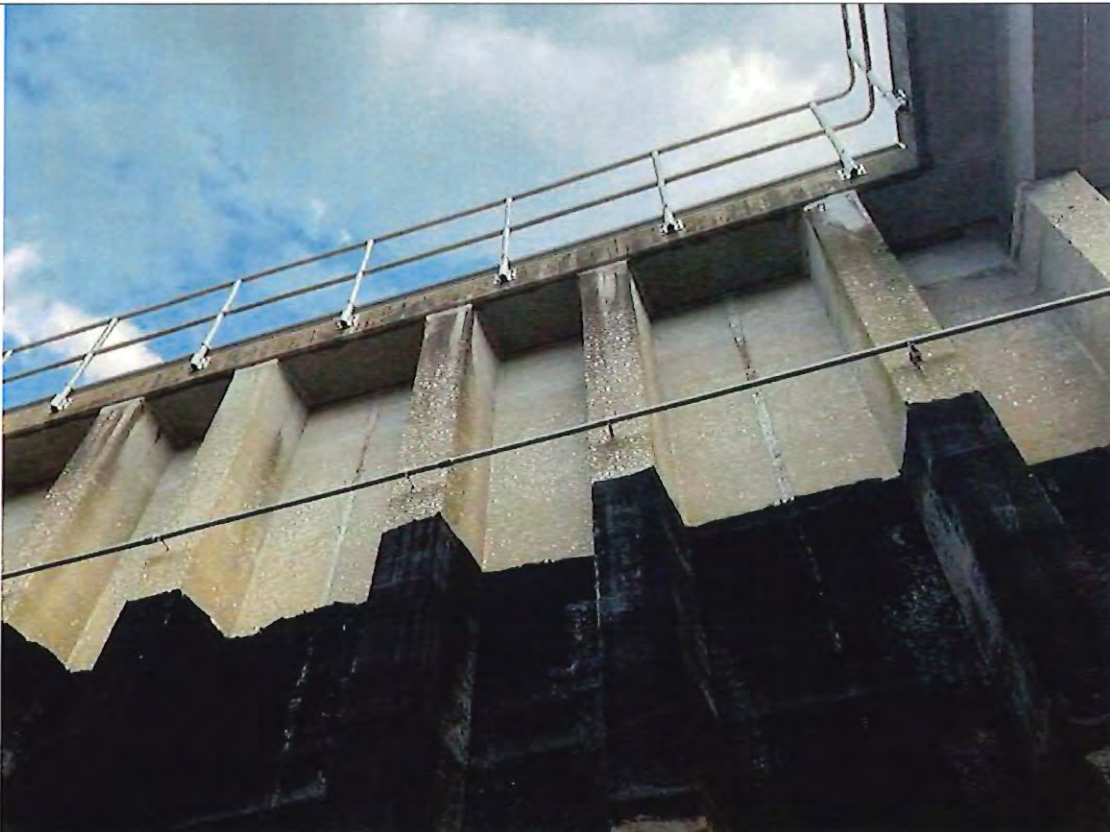
Photo #D.1

- C. No locations of orangish-brown colored deposits were observed.
- D. As previously observed, deterioration of the concrete was observed above the CIM coating. Exposed aggregate could be seen at these same locations.

- C. No action required.
- D. The deterioration observed in the concrete is more than likely due to an acid attack. When hydrogen sulfide is present, sulfuric acid can be formed when the hydrogen sulfide reacts with oxygen. This occurs near, and slightly above the water level in wastewater tanks. The deterioration of the concrete by acids, as previously mentioned is primarily the result of the reaction with calcium compounds that are leached away by the water in the tanks, which results in exposed surface aggregates that can be observed when the tank is drained. Pennoni recommends that when a new coating is applied, as recommended in item #1, the coating is placed above the water line around all walls of the structure.

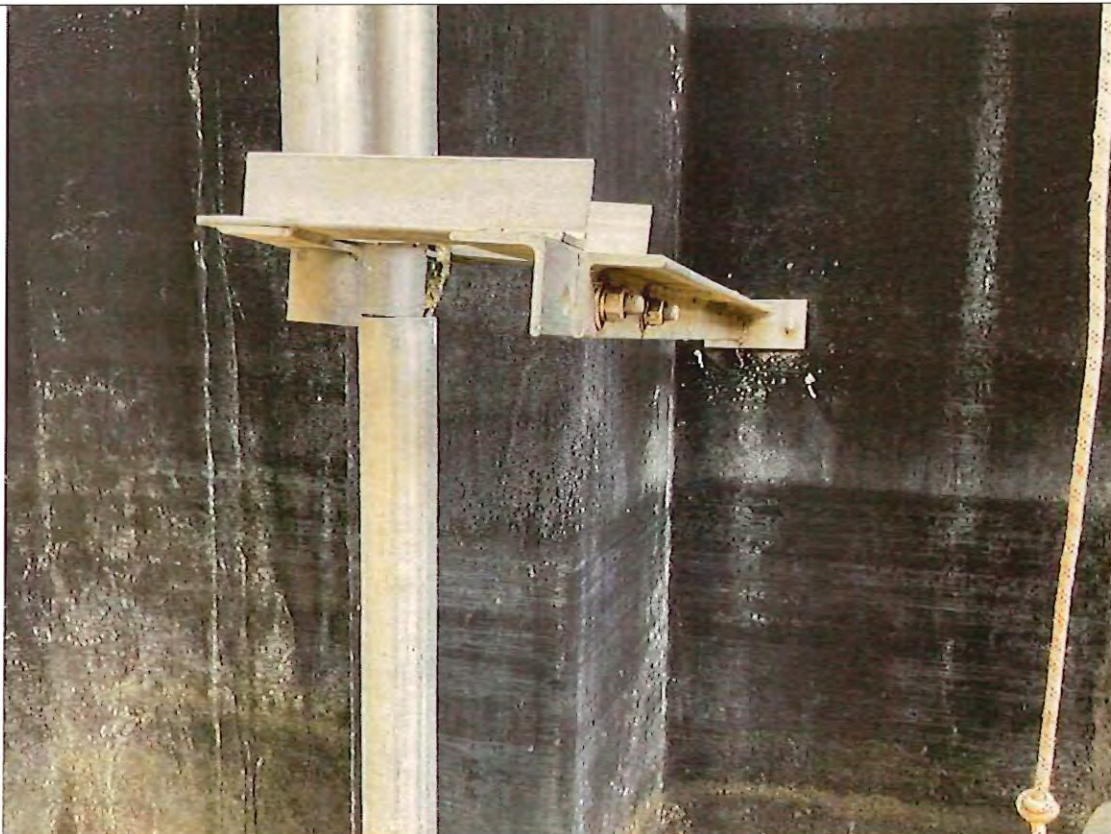
Photo #E.1

- E. The supports for the guide rails for the pump at the northeast corner of Tank #1 were observed deflected upward. Of the lower two guard rails, one was observed lodged against the bottom of the middle support, displaced from the support, while the other was observed missing altogether. At the top support, the horizontal components holding the upper rails in place were observed bent to a diagonal orientation.

- E. It is unclear if the observed damage is the result of normal use of the guide rails, or if the damage is due to a localized event. The guide rail supports should be removed and replaced with more robust supporting elements, and the guide rails reinstalled.

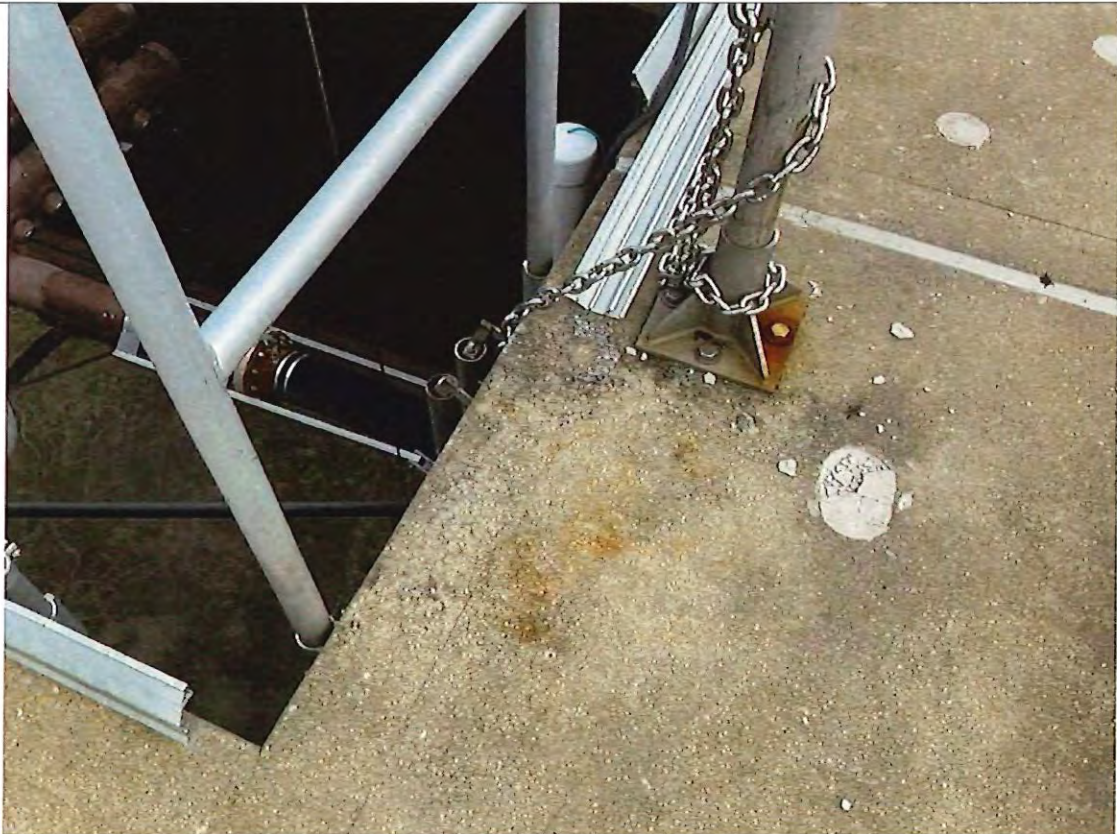
Photo #F

- F. At one location, the washer of an anchor bolt was observed with steel corrosion, leaving rust stains on surrounding material.

- F. It does not appear that the washer is stainless-steel as are the other steel elements at the connection, and therefore the observed corrosion is due to exposure to moisture and lack of adequate surface protection. The rusted washer should be removed and replaced with a stainless-steel washer.

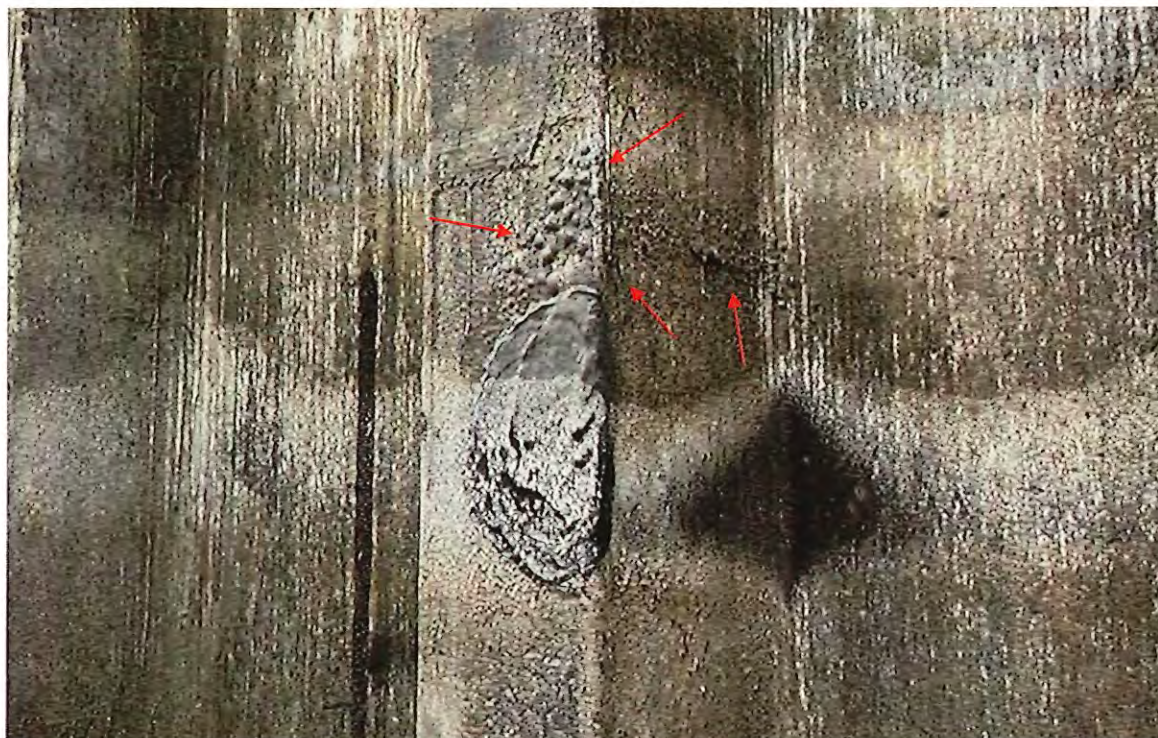
Photo #1:

1. Pennoni was informed that following the previous 2017 assessment, the existing CIM coating was removed and repaired, and a new coating was applied to the same areas as described in the previous report. At the areas where cores had been taken for material testing, it was also observed that the concrete had been repaired and covered with a thickened CIM patch. Unfortunately, a reoccurrence of the same deficient conditions, including fluid and air filled bubbles, were observed throughout the coating as described in the previous report (see **Photo 1**).

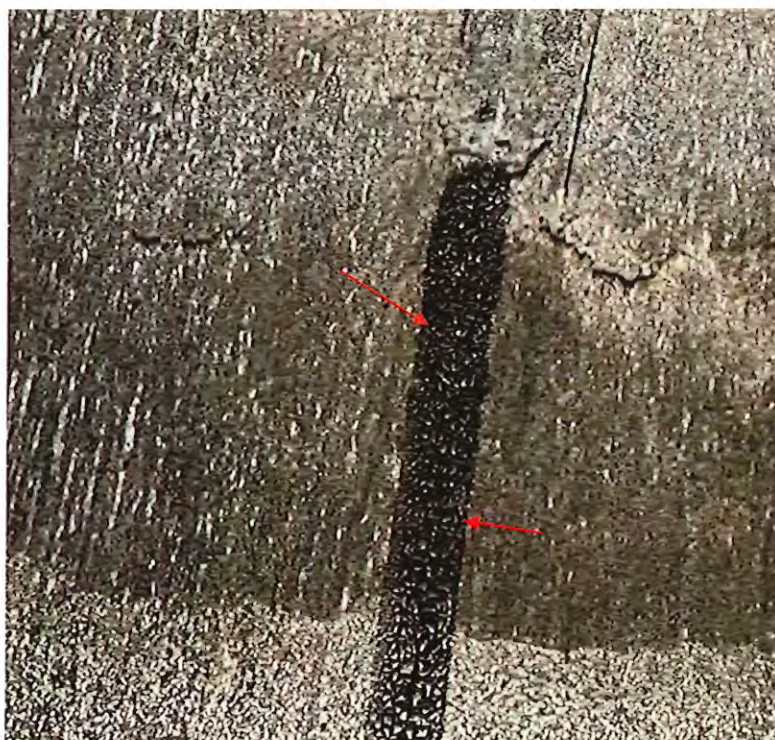
Photo #2:

2. Alligator cracking similar to what was reported in 2017 was observed (see **Photo 2**).
3. Deterioration in the cementitious skim coating similar to what was reported in 2017 was observed throughout the coating (see **Photo 3A & 3B**).

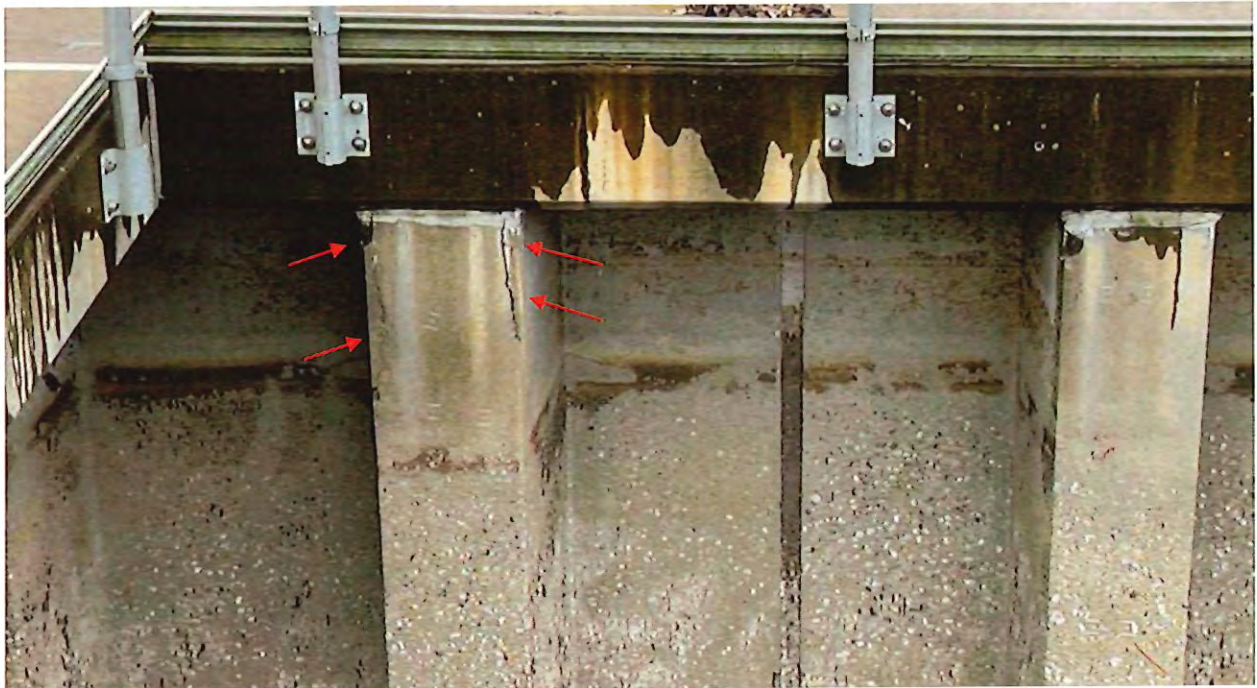
Photo #4:

4. The spalling discussed in the previous report was still present with several new spalls observed (see **Photo 4** and **Field Notes** for locations).

3. Based on the extent of deterioration of the existing coating it is recommended that the coating be removed, the surface properly prepared, and the new CIM 1000 coating be applied throughout all walls.
4. The localized spalling observed at the top of the ribs is most likely due to freeze thaw damage to the concrete. The spalls should be repaired to ensure the continued service life of the tank.
8. The sealant material appears to have reached the end of its service life and is in need of replacement.

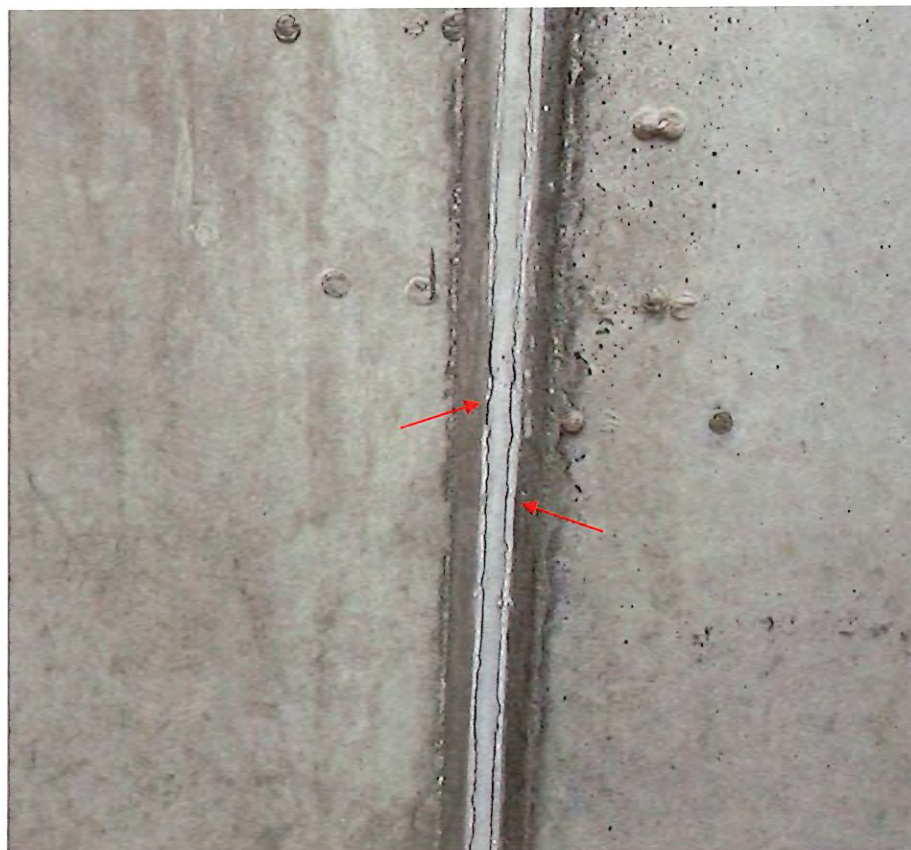
Photo #5:

5. The frequency and size of the previously observed horizontal hairline cracks appears to have remained the same.
6. The spall observed in the previous report at the exterior of SBR #4 was still present.
7. No efflorescence was observed, and it is unclear if the residue observed previously was intentionally cleaned off or dissipated on its own.
8. Joint sealant deterioration was observed in the exterior of the tanks (see **Photo 5**).

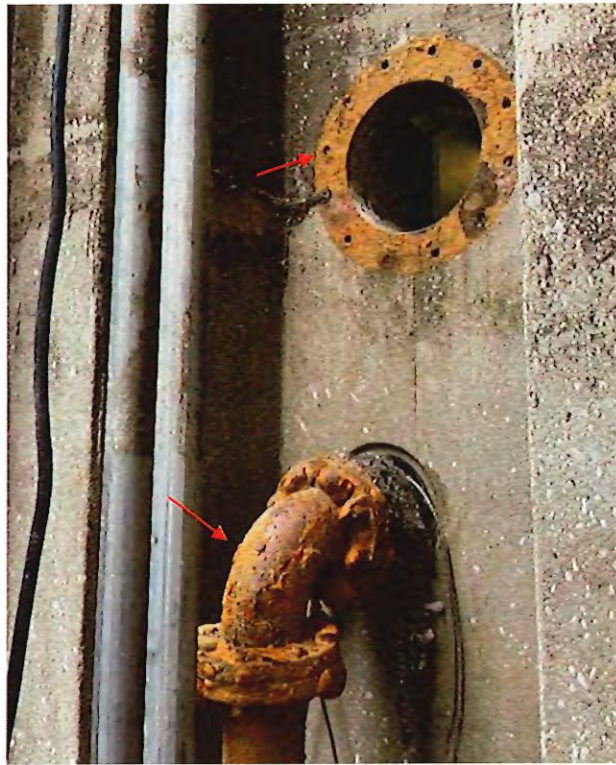
Photo #A:

- A. Corrosion was observed at the iron pipe and mixing arm connections near the bottom of the tank (see **Photo A**).
- B. Deteriorated patches in the walking surface of the top of the tanks were observed (see **Photo B**).
- C. Orangish-brown colored deposits were observed in an apparent intentional spacing. One of these locations were scratched off revealing no apparent steel corrosion beneath (see **Photo C1, C2, C3**).
- D. Deterioration of the concrete was observed above the CIM coating. Exposed aggregate could be seen at these same locations (**Photo D**)

- A. The corrosion exhibited by the iron pipe and mixing arm at the base of SBR #1 is more than likely due to the exposure to the aggressive environment of the wastewater, which includes high dissolved oxygen and solids. Steel will readily react with oxygen to form iron oxide (i.e., rust). Normally this reaction is a slow process, particularly when the exposure conditions are controlled, such as the interior of a conditioned building that provides stable temperatures and low humidity.

However, the wastewater environment increases the rate of corrosion, resulting in significant loss of cross-sectional area as the steel is converted into rust. Therefore, it is recommended that the pipes and fittings be cleaned of all latent rust and evaluated for section loss by comparing the thickness of the remaining material against original condition. After the evaluation is completed, it can be determined if additional repairs or replacement (possibly with stainless steel or FRP components if available) is required, or if the pipes and fittings can be re-coated to maximize the lifespan and serviceability of the SBR tank.

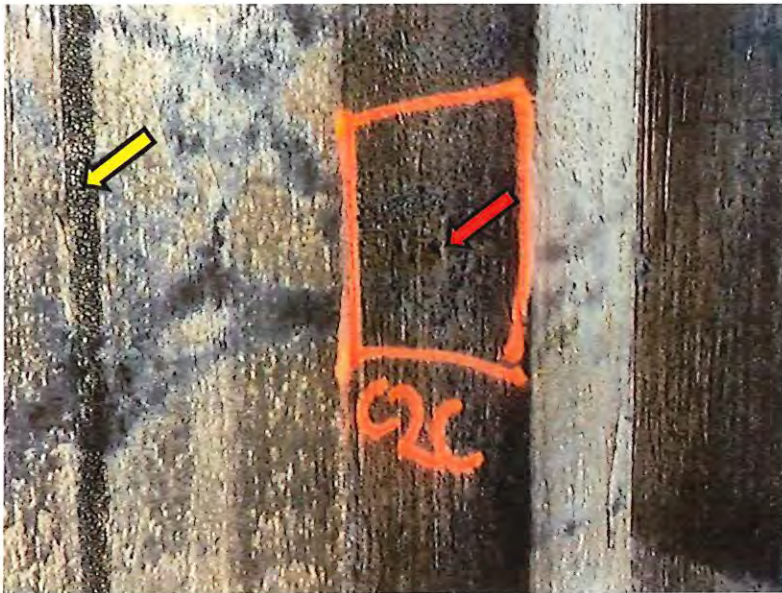
*Figure 1. Microcracking within the outer surface of the CIM 1000 coating (yellow arrow) and blistering (red arrow) of the coating is visible on the interior tank wall. This was the location where Core C2 was extracted. Image provided by Penmoni.*

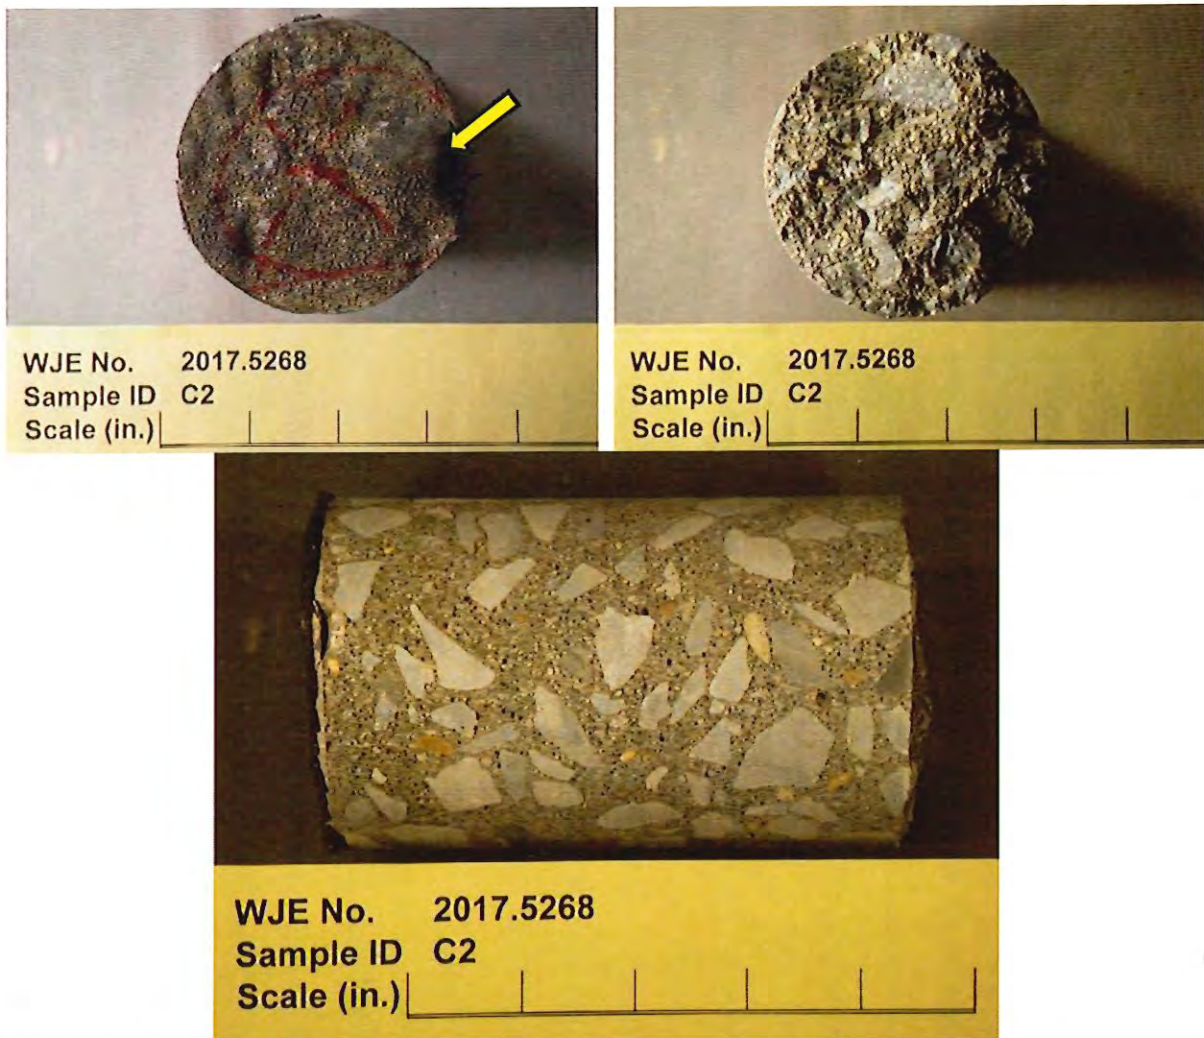
*Figure 3. The as-received appearance of the exterior coated surface (top left), the interior fracture surface (top right), and the side of Core C2 is pictured. A blister on the exterior surface of Core C2 is identified with an arrow.*

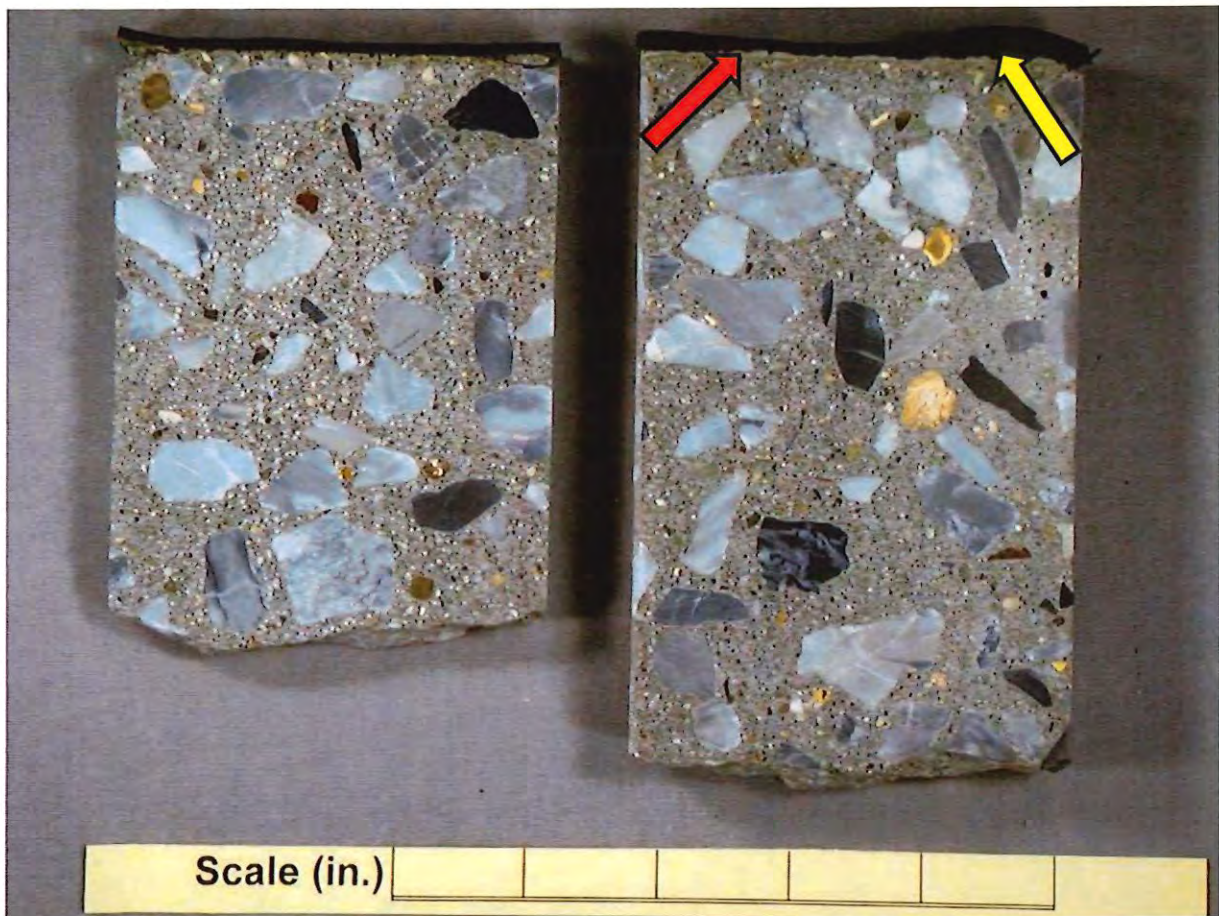
*Figure 4. The lapped surfaces of Core C1 (left) and Core C2 (right) are pictured. The cores represent compositionally similar concrete. A blister on the surface of Core C2 is identified with a yellow arrow. A skim coat (red arrow) is located between the CIM 1000 coating and the concrete in Core C2 and is not present in Core C1.*

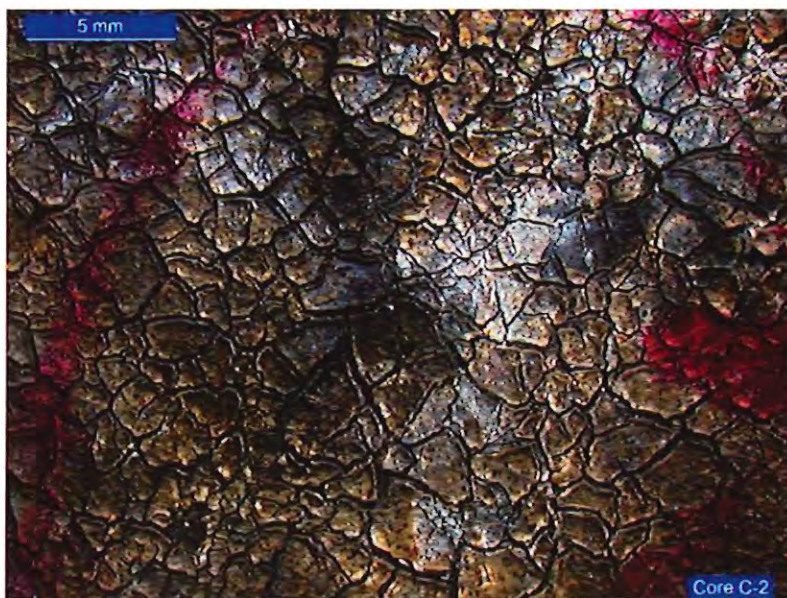
*Figure 7. The exterior surface of the coating exhibits an "alligator cracking" pattern, pictured for Core C2.*

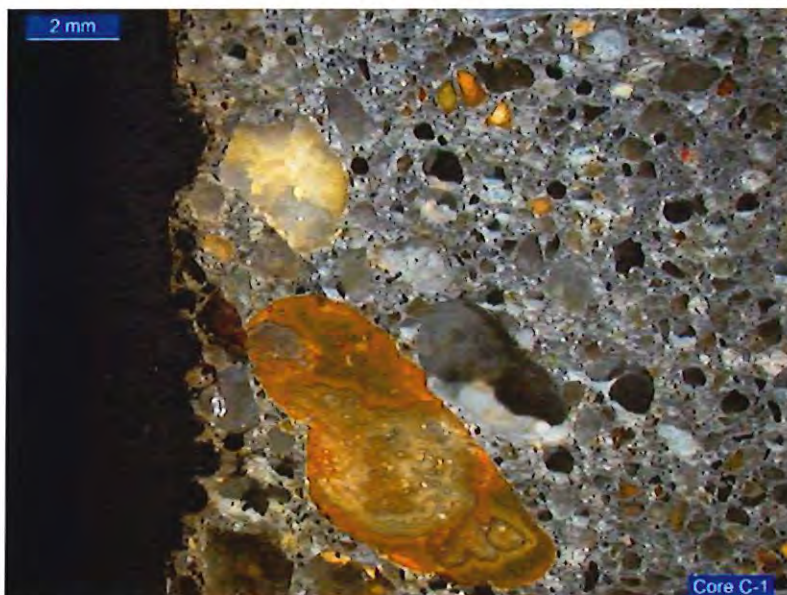
*Figure 8. In Core C1, the CIM 1000 coating was applied directly to the concrete tank wall, and no primer was detected. The concrete immediately in contact with the coating is tan in color compared to gray color in the body of the core.*

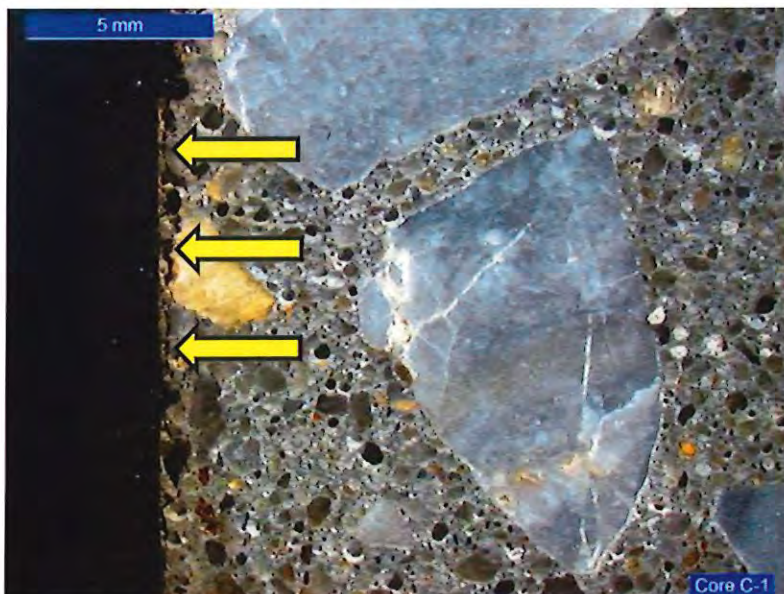
*Figure 10. The CIM 1000 coating is well bonded to each other and to the exterior surface of the concrete. A crack (arrows) is located immediately inboard of the coating-to-concrete surface in Core C1.*

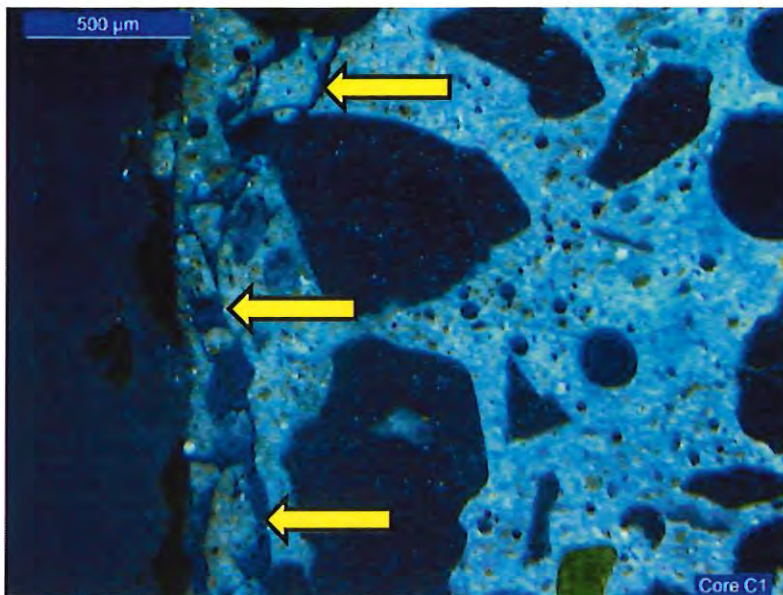
*Figure 11. Parallel cracks (arrows) are located at a depth of approximately 1/64 inch from the exterior surface of the concrete in Core C1. Image taken of the thin section using reflected light.*

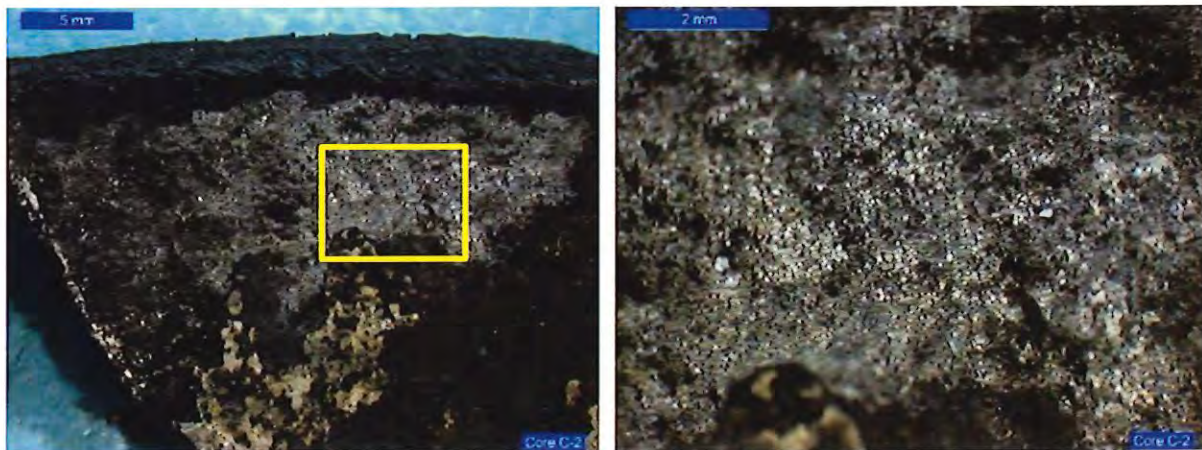
Figure 22. The inboard surface of the coating in Core C2 is pictured on the left after it had been peeled from the core. The area pictured represents the blister location. The boxed region is pictured at higher magnification on the right. White deposits are observed lining the coating at the blister location.

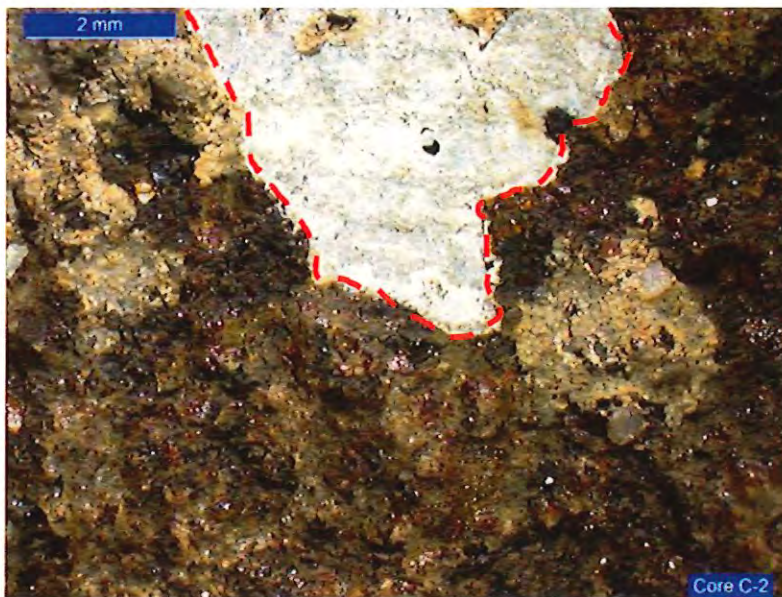
*Figure 24. Red-brown and dark brown discoloration is located along the exterior surface of the skim coat that had been in contact with the coating. The outlined region represents the exterior, formed surface of the concrete.*

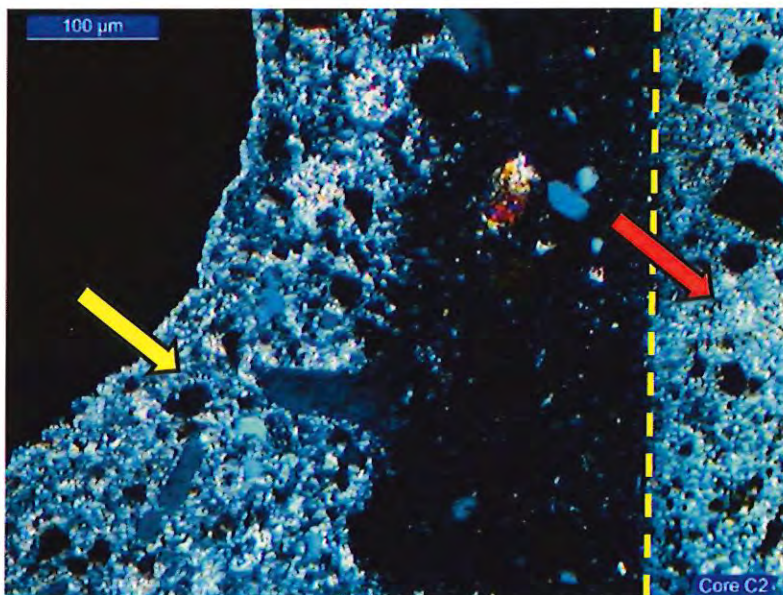
*Figure 29. The exterior portion of the skim coat (yellow arrow) and the exterior portion of the concrete substrate (red arrow) are carbonated, or brightly colored in the image, in Core C2. The skim coat is located to the left of the dashed line, and the concrete to the right of the dashed line.*
