Milltown Dam (DEP ID No. D15-146) Dam Assessment and Alternatives Analysis

MILLTOWN DAM DAM ASSESSMENT AND ALTERNATIVES ANALYSIS

FINAL REPORT

MARCH 2016

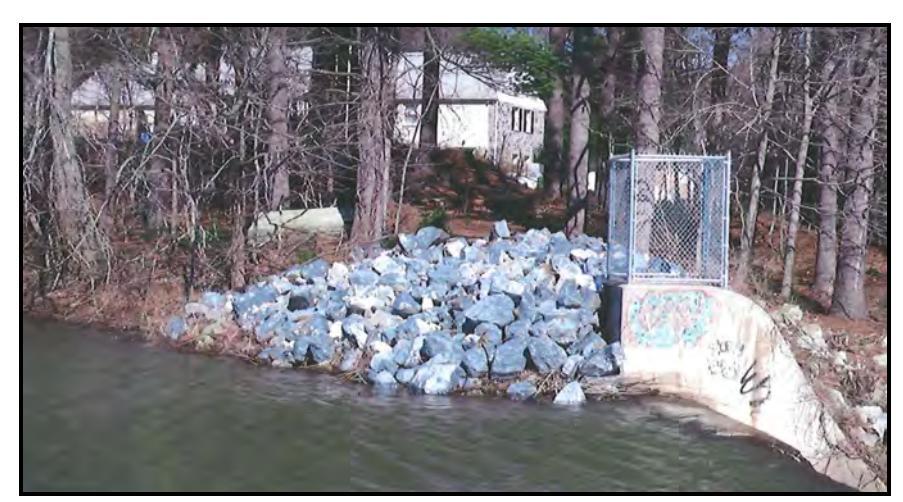
Figure 2-5 Left embankment raised 18-inches by adding riprap.

As mentioned in Section Two of this report, in 2008 the left embankment crest was raised 18-inches by adding riprap. If impervious material was not used to construct the crest, the top 18-inches of the left embankment is relatively pervious and would allow flow to pass through the riprap and over the downstream face of the left embankment prior to the reservoir reaching the top of dam elevation. This condition could lead to saturation and erosion and possible failure of the left embankment. If the impervious core of the left embankment is not present in the top 18-inches of the riprap, it is recommended that Township extend the core wall to the crest of the dam as part of any embankment rehabilitation project.

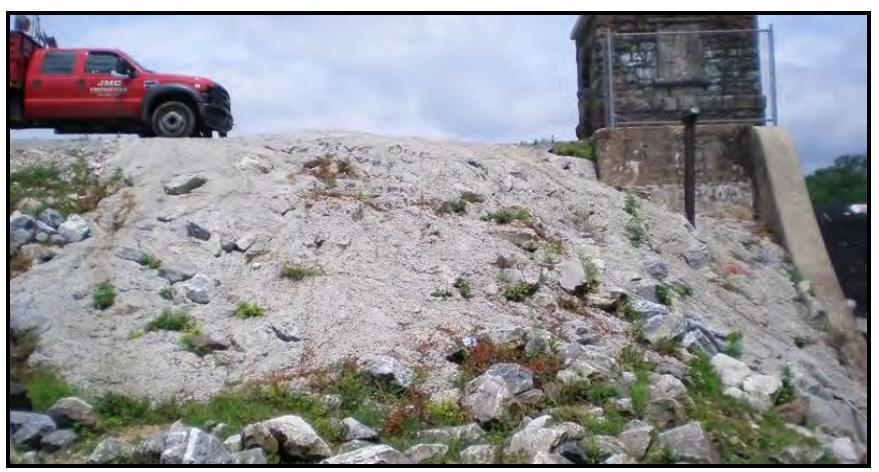
• 2012 Riprap located on the downstream right embankment immediately below the valve house was slush grouted with concrete to stabilize the riprap (refer to Figure 2-6).

Figure 2-6 Area of slush grouted riprap (photograph taken on June 19, 2015).

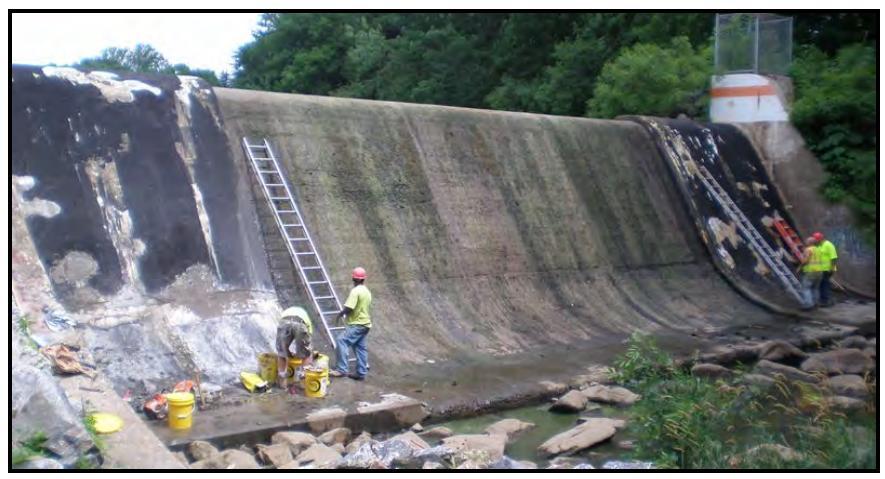
Figure 2-7

- 2013 Replaced roof on valve house.
- 2013-Present Surface concrete repairs on spillway. Areas of the spillway outside of the low flow notch were coated with a liquid applied urethane (CIM 1000). Areas of the initial coating failed (refer to Figure 2-7) and the coating was reapplied/repaired in the fall of 2015.

Failing areas of black urethane coating on downstream face of spillway. Ongoing repair work observed on June 19, 2015.

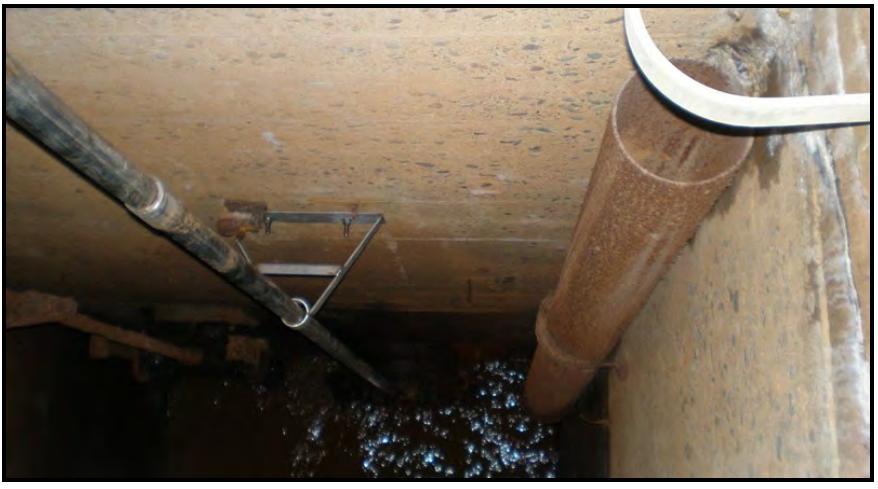
- 2015 Valve stem and guides on the upstream 24-inch sluice gate were replaced. Connection between valve stem and gate failed during operation of the gate during the Annual Inspection performed on August 4, 2015. Township reports that the connection was repaired and that the 24-inch sluice gate is operable.

Figure 2-8 Replacement of 24-inch gate stem and guides visible in center of photograph. (Photograph taken on August 4, 2015).

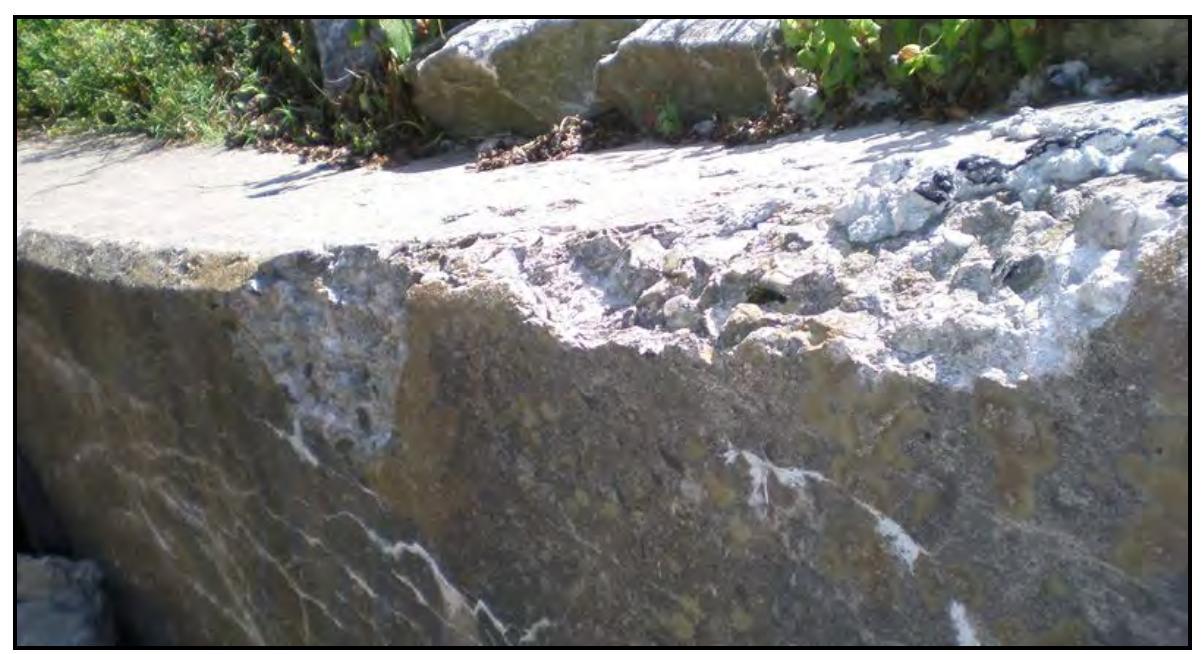
observed on the vertical faces of the left and right training walls and concrete spalls were observed on the downstream right training wall (refer to Figure 4-5). Exposed aggregate was observed throughout the low flow notch (refer to Figure 4-6). It is recommended that the concrete spalls be repaired.

Figure 4-5 Spalls and hairline cracking on right spillway training wall. (Photograph taken on August 4, 2015)

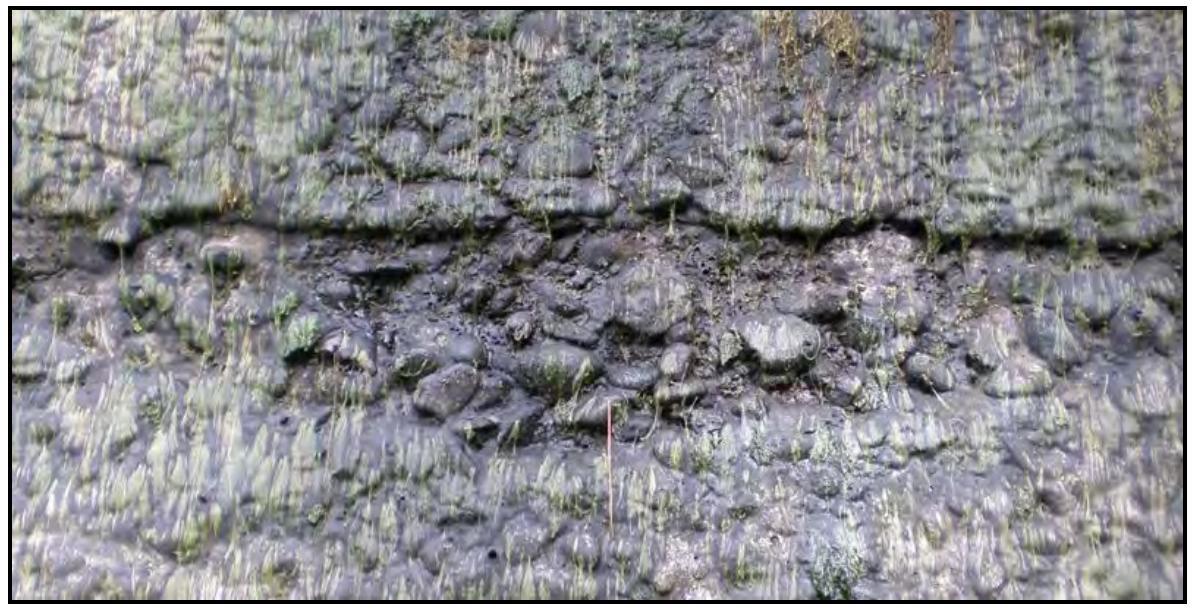
Figure 4-6 Exposed aggregate on downstream face of spillway. (Photograph taken on June 19, 2015)

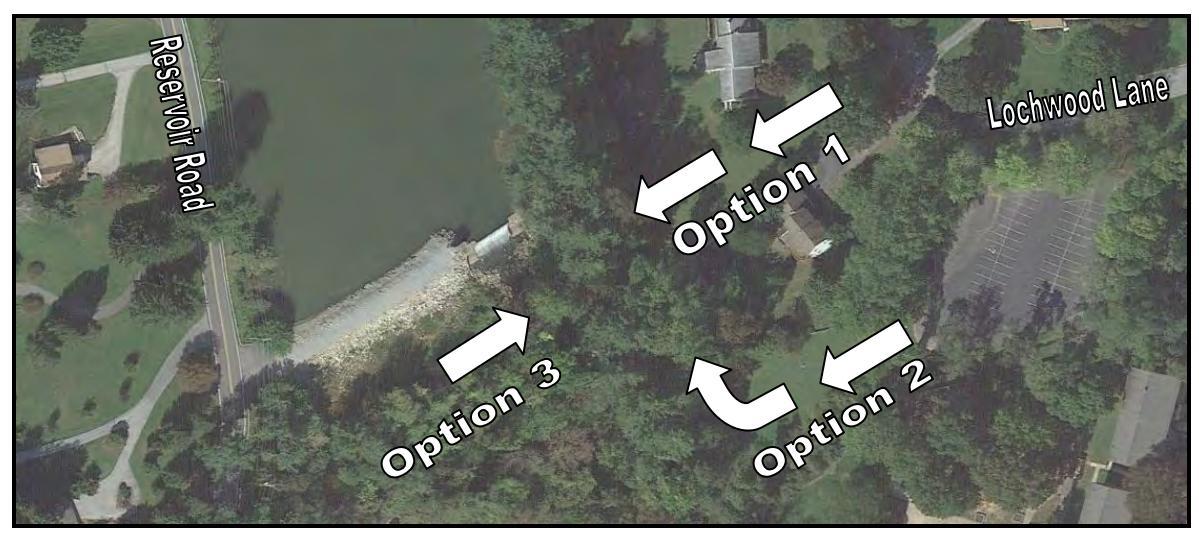
Figure 4-10 Potential site access routes to left embankment.

It is recommended that the Township establish access to the left embankment for maintenance and emergency purposes. Potential access routes are shown on Figure 4-10. Access could be provided by establishing an easement with one or more homeowners along Lochwood Road (Option 1 on Figure 4-10) or by using the parking lot and grassed field associated with the public pool located just downstream of the dam (Option 2 on Figure 4-10). Both of these options would require removal of trees in order to gain access to the dam. Installation of a ford crossing within East Branch Chester Creek is also an option for providing access to the downstream left embankment (Option 3 on Figure 4-10). Most of the conveyance capacity alternatives identified in Section Seven can incorporate a ford crossing of East Branch Chester Creek.

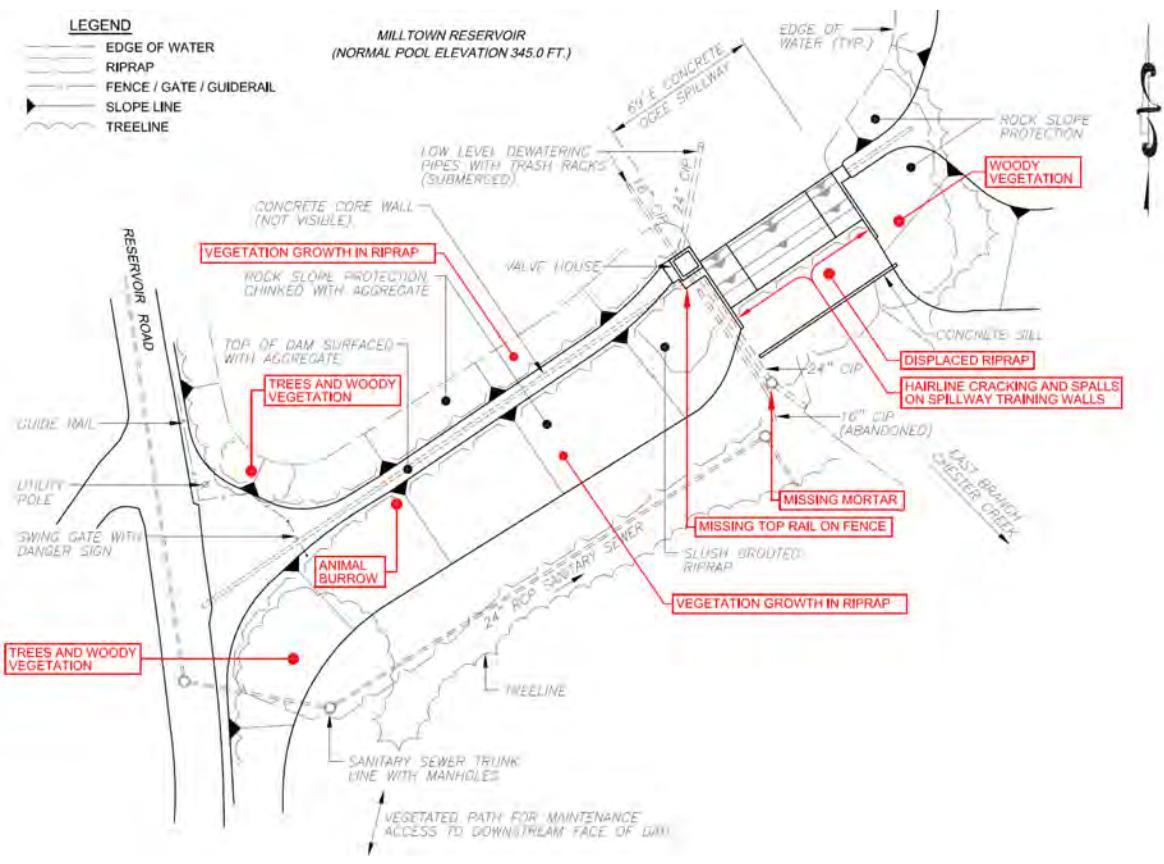
Figure 6-1 Noted deficiencies from 2015 Annual Inspection Report

In August of 2014, the Township rejected bids associated with the replacement of the sluice gates within the valve house with the intent that this maintenance would be deferred until a determination is made regarding whether-or-not the Township would maintain, decommission or otherwise modify the dam. Three bids were received which ranged in price from \$70,620 to \$113,400. Should the Township choose to maintain the dam, the sluice gate replacement project should be considered as deferred maintenance.
