Subject: **Drawdown Permit and Eastern Redbelly Turtle Capture & Relocation Work Plan**Hazard Classification Reduction of Milltown Dam (DEP ID No. D15-146)
East Goshen Township, Chester County, Pennsylvania

East Goshen Township (Township) owns and operates Milltown Dam (DEP ID No. D15-146) as a recreational facility. The dam is currently classified as a High Hazard (C-1) structure and the Spillway Design Flood (SDF) is currently established as the 1/2 Probable Maximum Flood (PMF). Constructed in 1923-1924, the structure no longer complies with current dam safety regulations, the most significant of which is inadequate spillway capacity. In order to address dam safety concerns, the Township is proposing to reduce the hazard classification of Milltown Dam which will reduce the SDF from the ½ PMF to the 100-year storm. This will be accomplished by lowering the existing spillway and right embankment which in turn will eliminate the permanent pool and reduce the storage volume impounded by this structure, reducing the potential for downstream consequences in the unlikely event of a dam failure and uncontrolled release of water. In preparation for the embankment lowering project which i

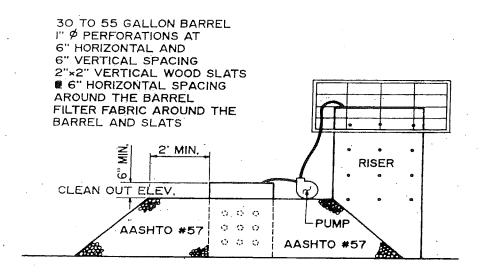
FIGURE 1

Sediment Storage Dewatering Device

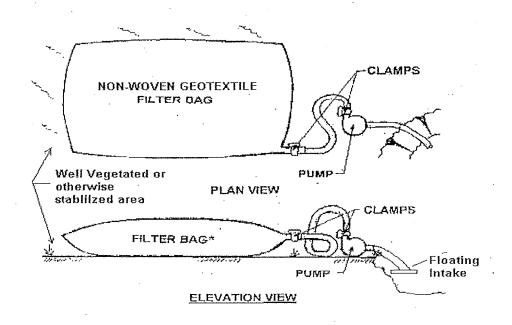
FIGURE 2
Pumped Water Filter Bag Details

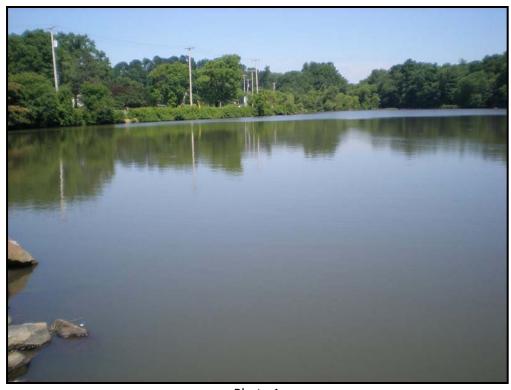
Photo 1
Standing at the principal spillway looking upstream at Milltown Reservoir.
(Reservoir Road located along left side of photo)

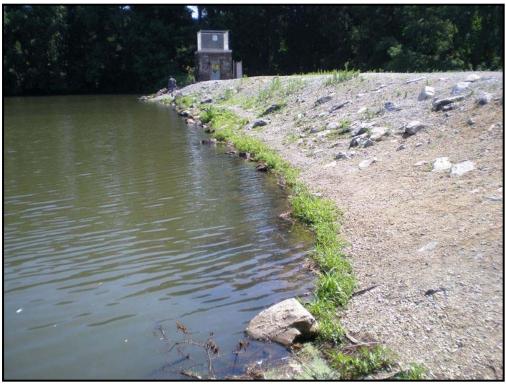
Photo 2
View of upstream slope of Milltown Dam right embankment.

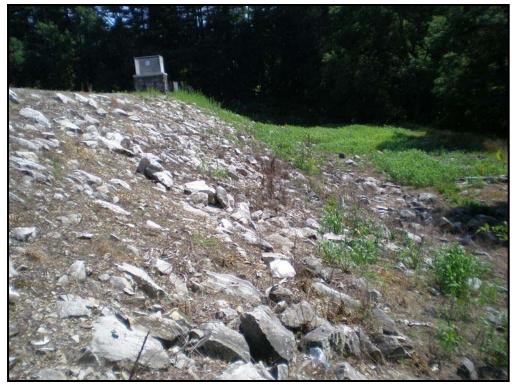
Photo 3 View of downstream slope of Milltown Dam right embankment.

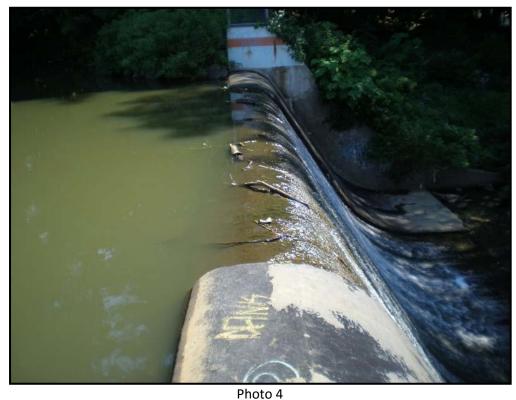
View of ogee spillway crest with low flow notch.
(Standing with back to valve house looking towards left abutment)

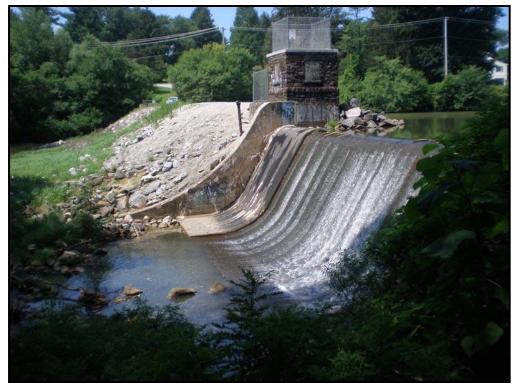
Photo 5

View from left embankment looking at Valve House and downstream face of concrete spillway.

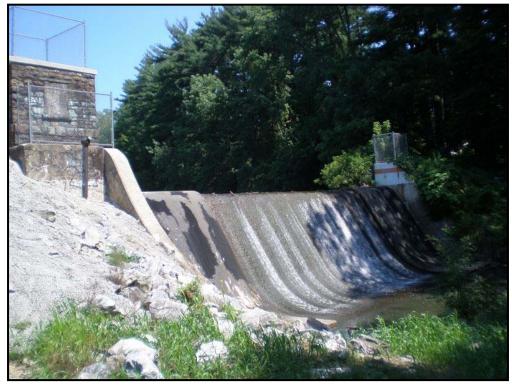
Photo 6

Standing below right embankment looking at downstream face of concrete spillway.

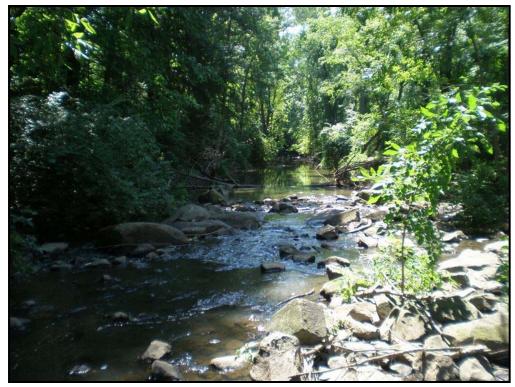
Photo 7
Standing below spillway looking downstream at receiving channel.
(East Branch Chester Creek)

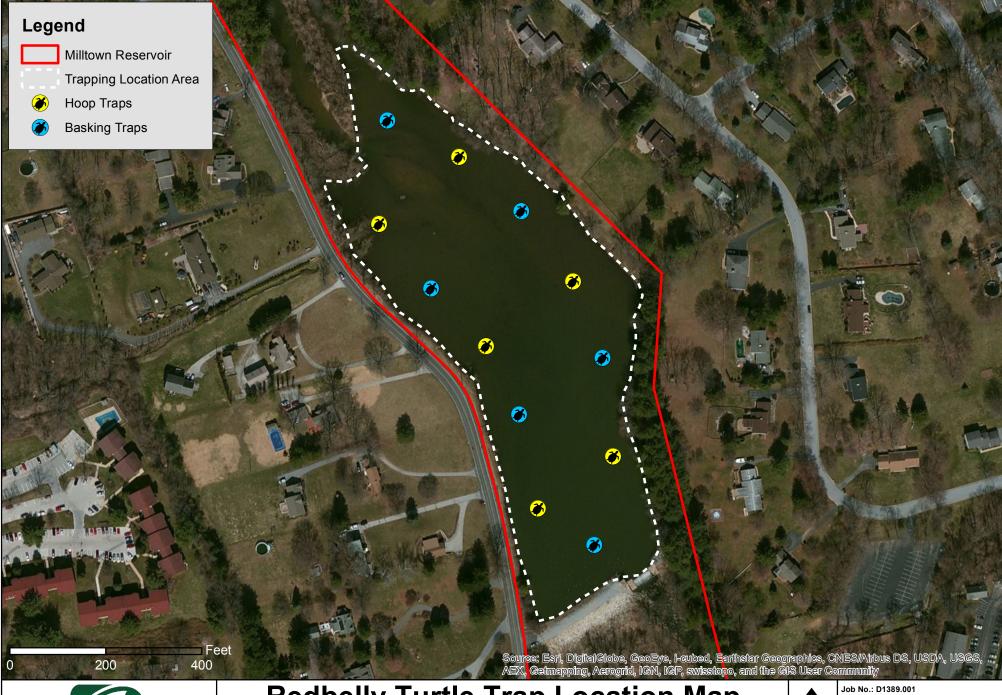
Figure 5

Redbelly Turtle Trap Location Map

Based on professional experience monitoring redbelly turtle populations associated with drawdowns of water features, it has been documented that redbelly turtles will vacate the area once the water level is lowered. In an effort to accommodate this movement of turtles, trapping will be conducted in addition to standard removal from the lake itself during the drawdown process. Two (2) types of traps will be used to capture turtles before and during the complete drawdown of the lake. Please refer to *Figure 5: Redbelly Turtle Trap Location Map* for a depiction of trap types and locations.

Six (6) basking traps approved by the PAFBC will be used in areas of the lake with suitable sun exposure that served as good basking areas. Turtles are attracted to the floating substrate, and when they climb atop to bask, the weight of the turtle triggers hinges that cause the turtle to fall within a confined aquatic cage, and turtles have access to open air.

Six (6) floating hoop traps will be placed within the water, which based on experience has been successful in capturing a wide variety of species and a high number of individual turtles. The hoop traps contain multiple mesh compartments, and once entered, a turtle may not escape
