RE: Geophysical Survey
Sunoco Pipeline, LP Pipeline Project
S3-0460 Greenhill Road GPR Survey at Wilson Drive
East Goshen Township, Chester County, PA
RETTEW Project No. 096303003

EXECUTIVE SUMMARY

RE: Geophysical Survey
Sunoco Pipeline, LP Pipeline Project
250-Foot Section of Boot Road Centered on 460 HDD Saw-cut Location
East Goshen Township, Chester County, PA
RETTEW Project No. 096303003

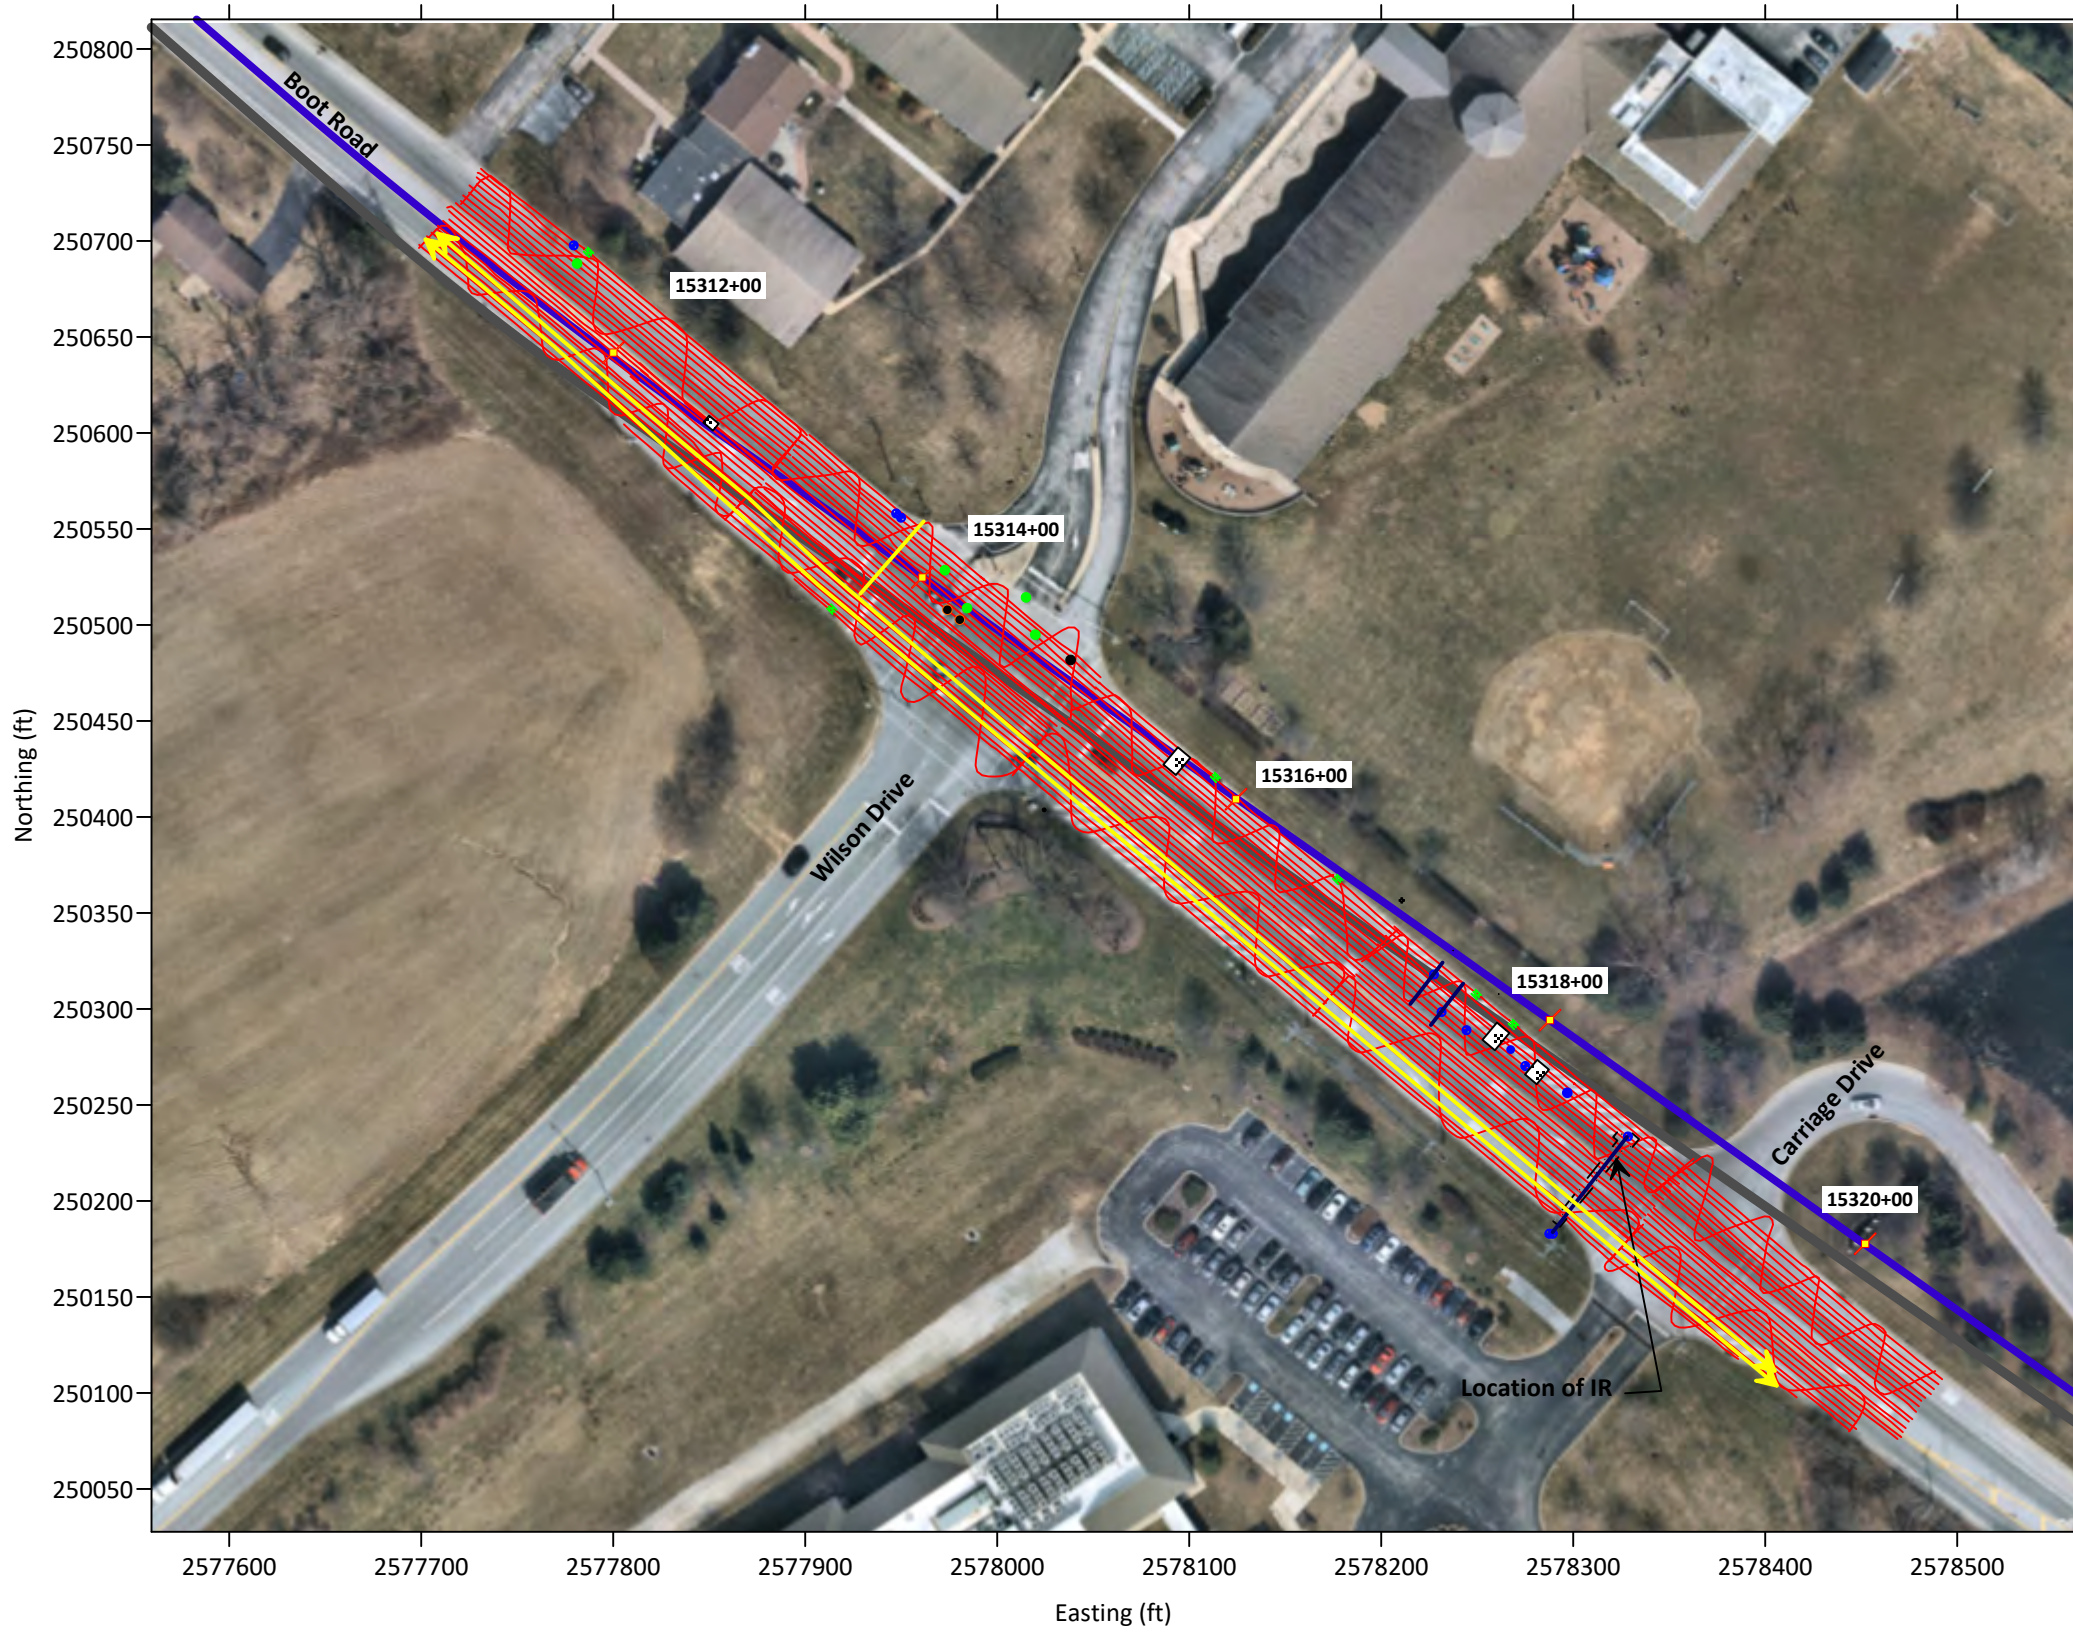
Figure 2: Data Coverage Map

GPR scanning was performed along survey profiles spaced approximately 2 feet apart, as well as several additional diagonal transects (see **Figure 2**, red lines). The GPR data were integrated in real time with a Topcon Hiper Lite Plus DGPS GNSS system. The profiles were recorded for post-processing with both Radan by GSSI and GPR-Slice by Geophysical Archaeometry Laboratory, Inc. GPR-Slice was used to filter the individual profiles before combining them into a three-dimensional model of the subsurface. Seven horizontal slices were then extracted between 0 and 6 feet below grade. **Figure 3** shows three of the seven horizontal slices and a composite of the seven slices combined. The shades of red represent the relative amplitude of the GPR signal increasing from white (minimum) to red (maximum).

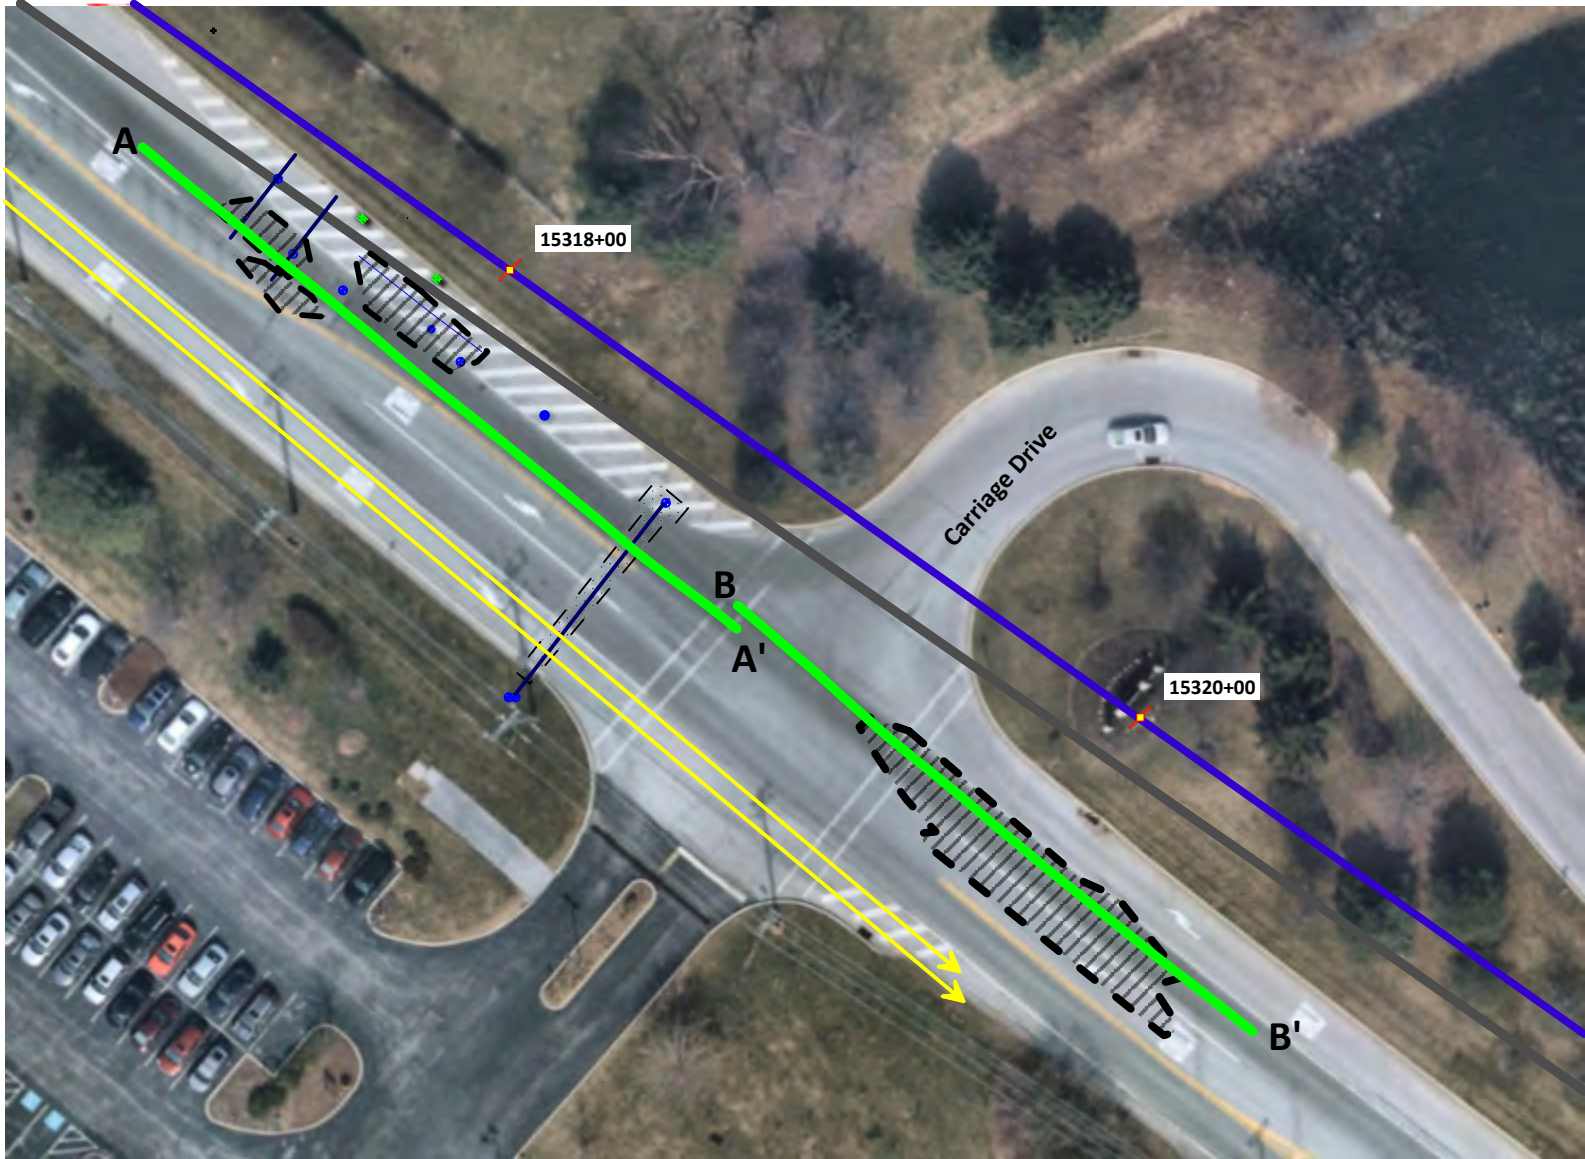
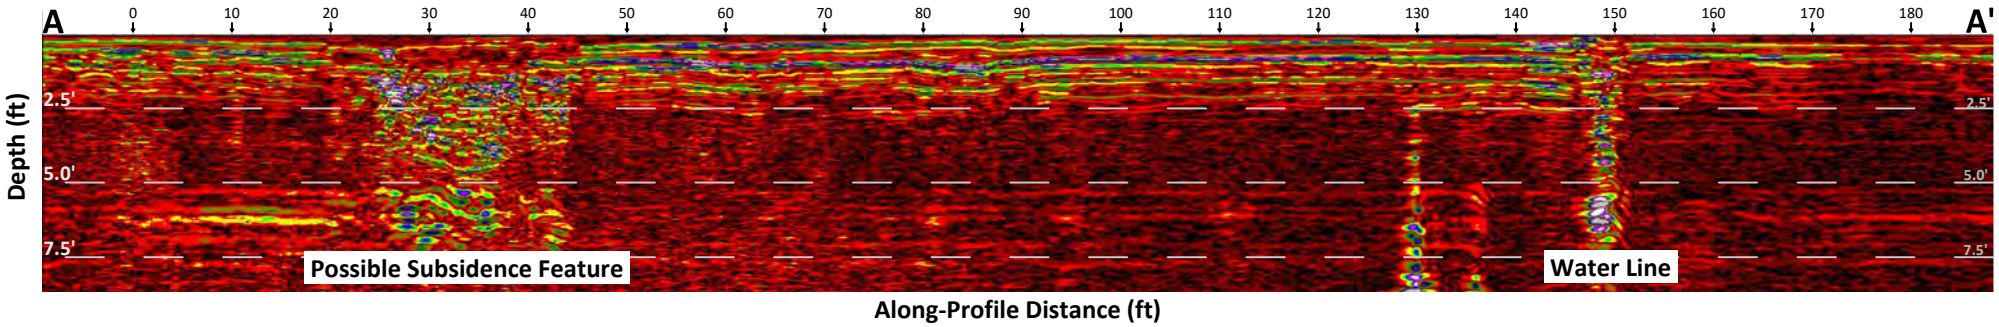
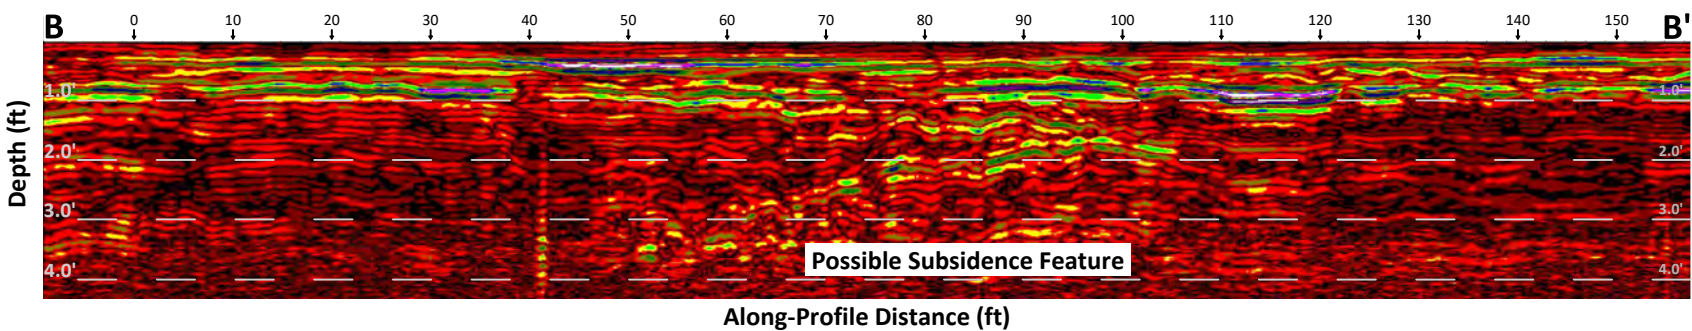
Figure 4: Data Summary Map

Figure 4 summarizes the results of the GPR survey with an annotated slice and two vertical GPR cross-sectional profiles showing samples of the anomalous features identified in the 3D model. The vertical profile colors represent relative amplitude of the GPR signal. Shades of light blue to white indicate the highest amplitude signal, while black and red represent the lowest amplitudes. **Appendices I through V** include every other GPR profile performed in a southwest direction across the survey area. The profiles are a fusion of the data from both antenna frequencies (300 and 800 MHz) into a single cross section.

Three adjacent anomalous areas are located beneath the west-bound lane (near 15318+00), between several suspected water lines and multiple water valves (hatched in **Figure 4**). These areas show high-amplitude GPR reflectors, including downward-dipping reflectors possibly consistent with settlement of utility trench backfill materials. The two westernmost areas were identified in the June 2019

GPR survey by RETTEW. The third is coincident with a known backfilled excavation area. This GPR reflection pattern is characteristic of settlement or subsidence, as opposed to most of the GPR reflectors across the site that are associated directly with utility lines or disturbed soils around and above the buried utilities. The three anomalous areas (near 15318+00) are located between water lines and water valves and therefore may be related to settlement of the water line trench materials or associated with other past events not related to the recent IR. A larger area of high-amplitude reflectors (near 15320+00) was observed in the eastbound lane, southeast of the Carriage Drive intersection (**Figure 4**). These GPR reflectors also show characteristics of settlement or subsidence, but do not appear to be associated with observed underground utility lines. These reflectors may be related to pre-road construction or pre-road land use and do not appear to have had an impact the current roadway condition. None of the anomalies display reverberation of the type commonly associated with air-filled voids. No subsurface voids were identified by GPR in the survey area.

The GPR results show multiple high-amplitude reflectors across the survey area. Most of the reflections are associated with the numerous underground utility lines beneath the survey area, as well as related metallic surface features such as valve and utility hole covers and storm drains. Utility lines appear as hyperbolas or “chevrons” where the GPR profile crosses them at a high angle, and as continuous reflections when the profile runs parallel and close to the trace. On **Figure 2**, water lines (blue) are shown only where they were clearly visible on the GPR records. Metallic surface features produce reflections that “ring” all the way down through the record. These are actually multiple returns of the transmitted pulse as it bounces back and forth in the air between the antenna and the metal target (see **Figure 4** and **Appendices**). The labels on the GPR features in **Figure 4** and the **Appendices** are interpretive, not definitive. None of the identified anomalies resemble the expected reflection pattern for voids beneath the roadway.

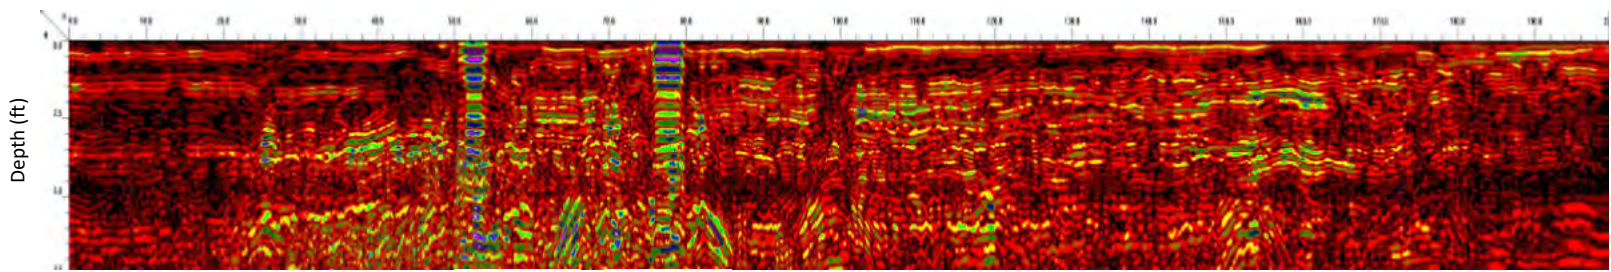
File 030 P_611
Utility Hole or Valve Cover? Utility Hole or Valve Cover?
Possible Subsidence Feature

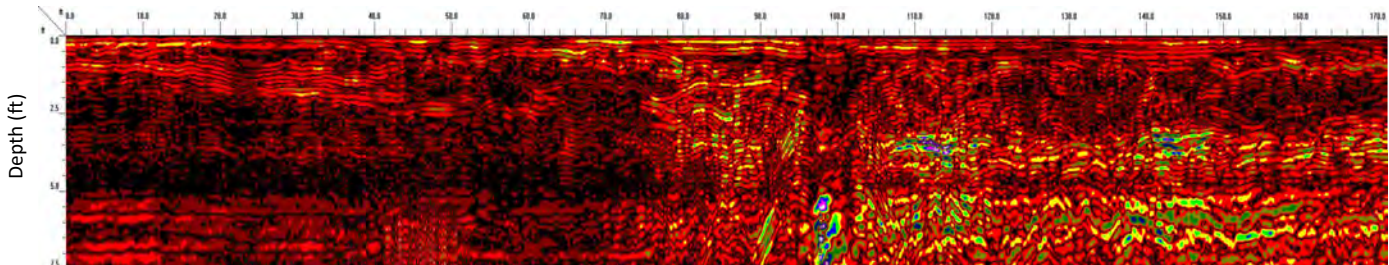
File 040 P_611

Possible Subsidence Feature

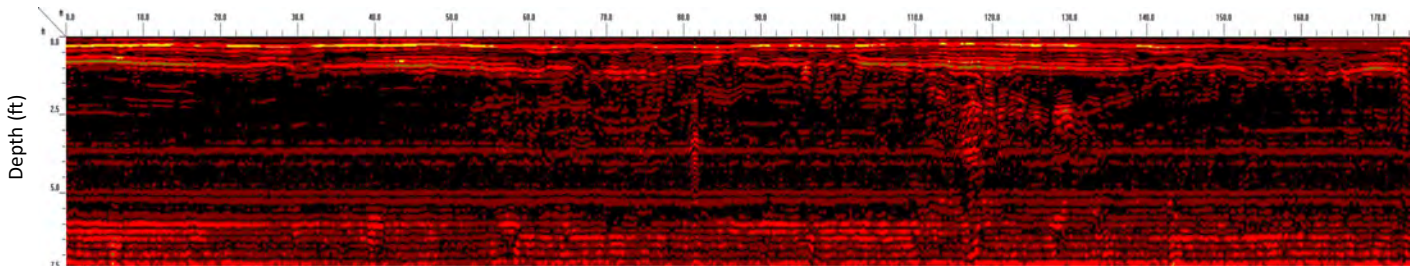
File 081 P_611

Possible Subsidence Feature

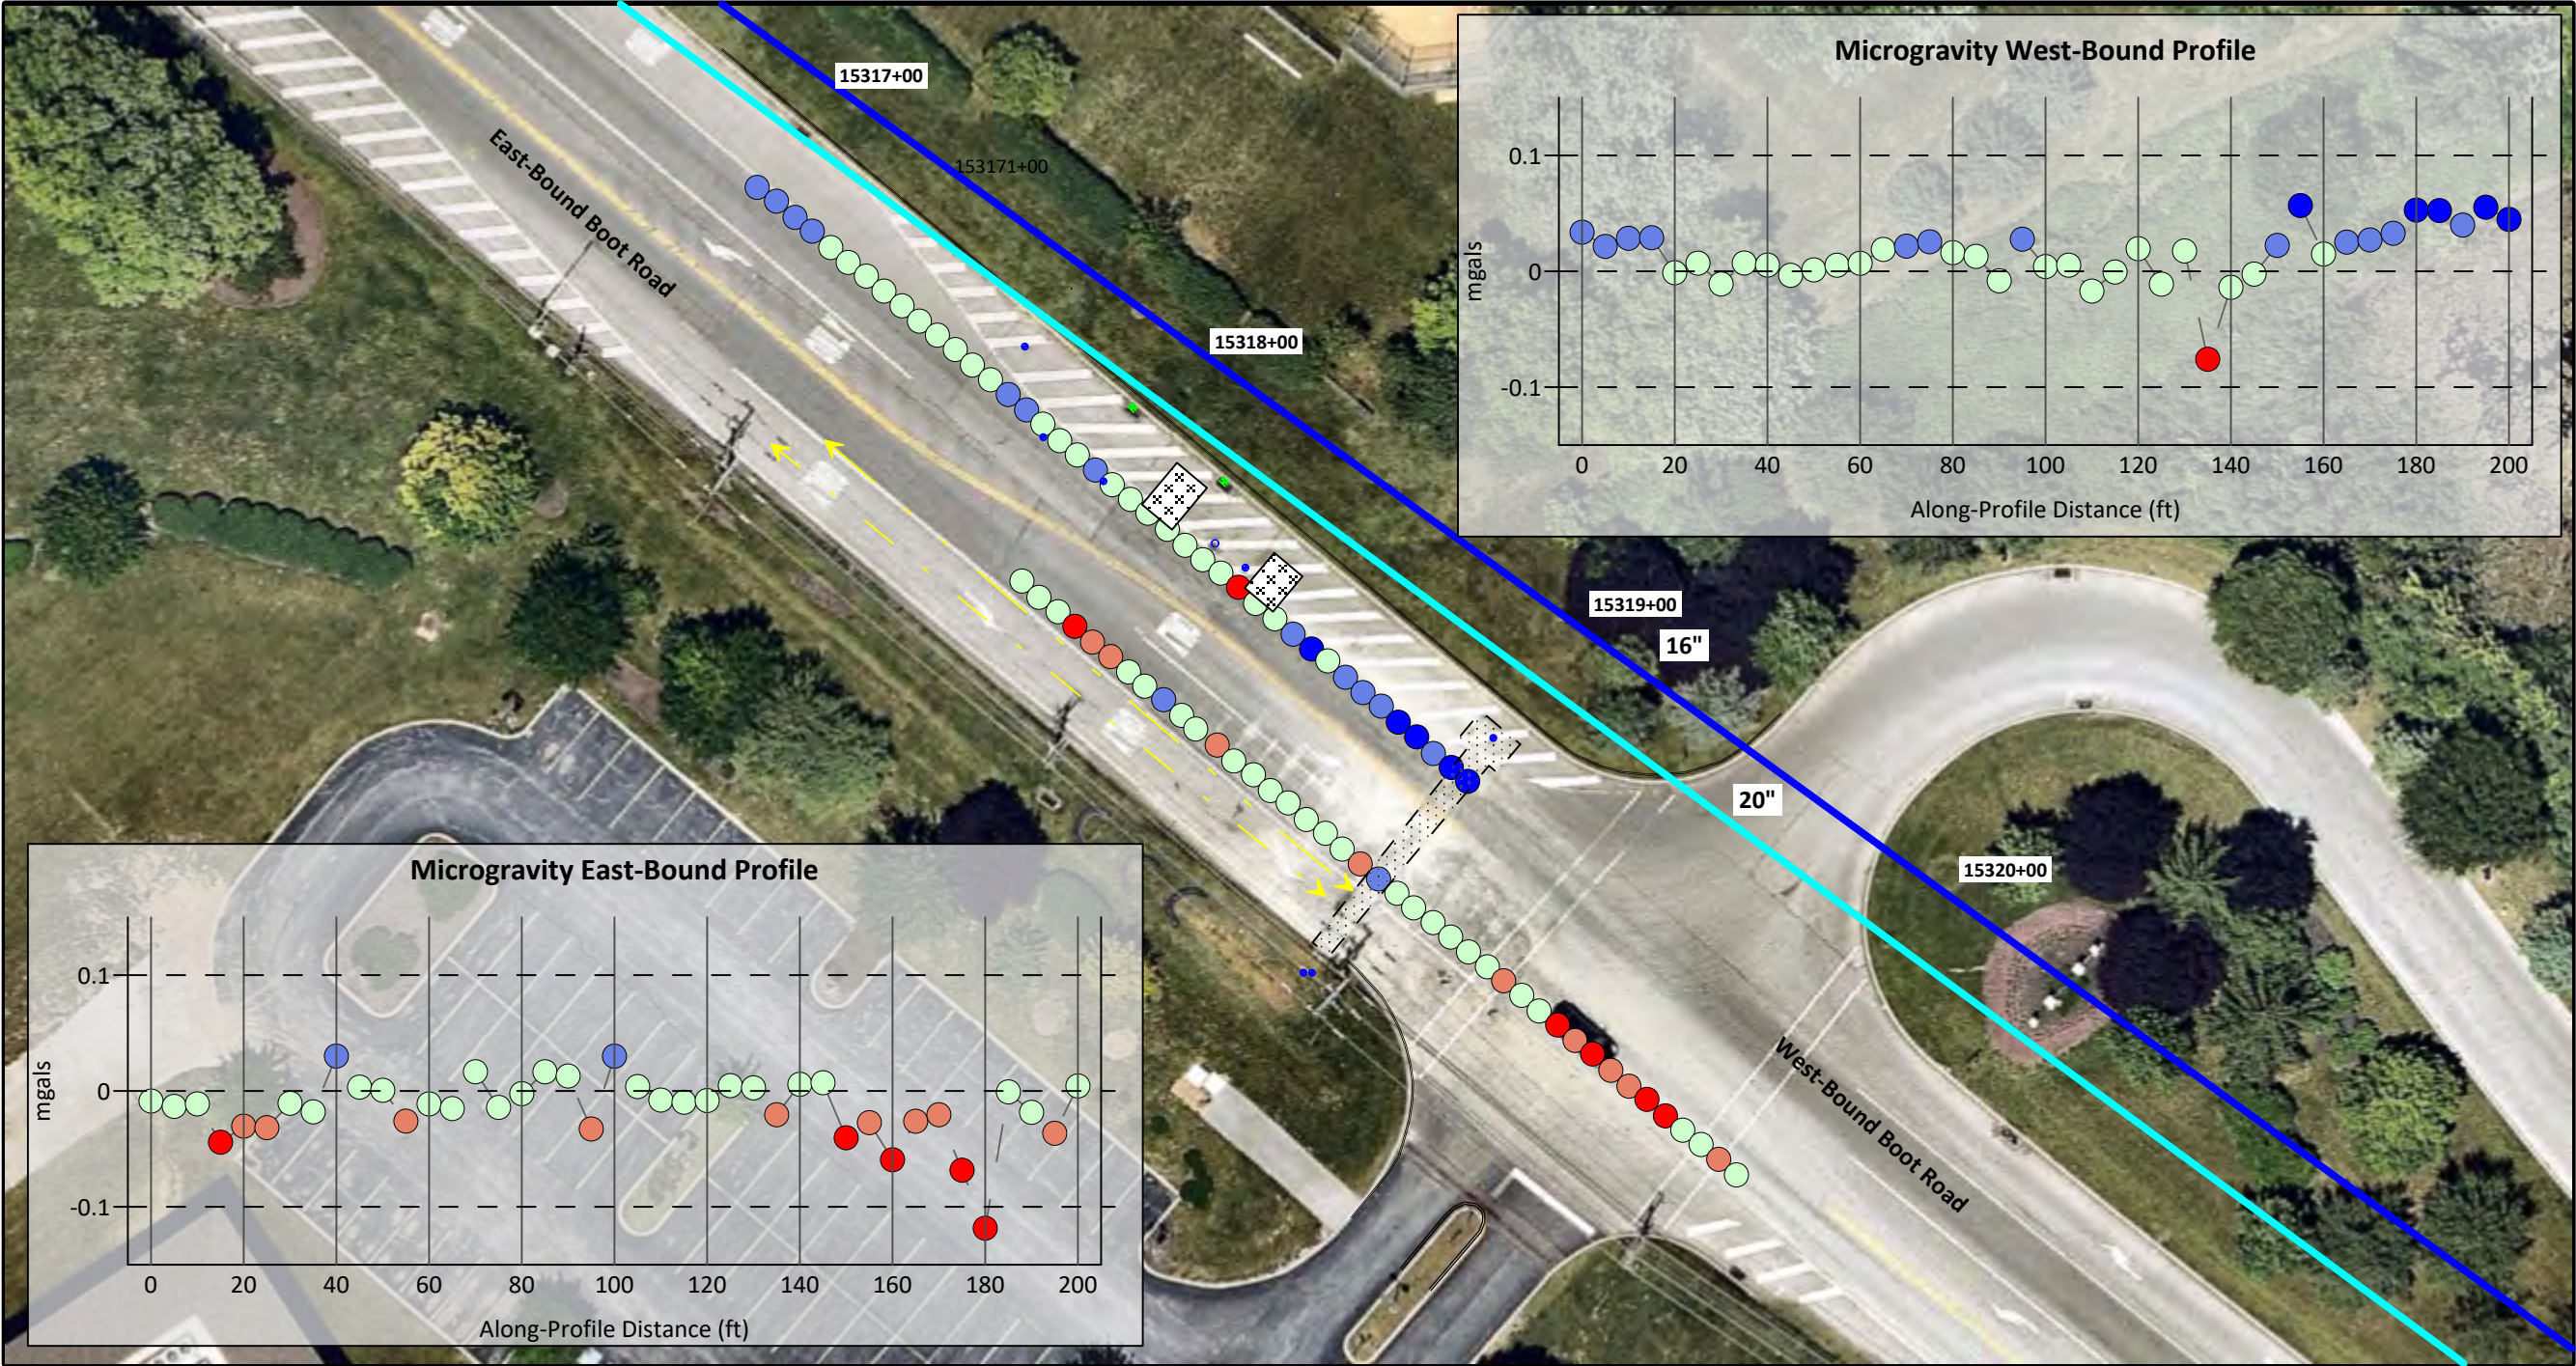
Figure 3: Residual Microgravity Results

The resulting residual microgravity data are shown on **Figure 3**. The values depict the general plan-view shallow mass distribution beneath the survey area. Lower values (red) represent local mass deficiencies (air- or clay-filled voids or deeper soils), and higher values (blue) represent local mass excesses (bedrock highs or float blocks).

The microgravity data are depicted on **Figure 3** as colored dots representing the relative density of the subsurface, with blue for high-density, green for “site normal,” and red for locally low-density areas. The microgravity results delineated several low-density areas beneath the survey grid. Low density (red) represents low-density soils or possible “missing” rock and soils, while blue represents intact bedrock or float material, or compacted soils. A minor low-density reading was detected around the location of the IR; however, it is very laterally restricted, indicating that it is not extensive.

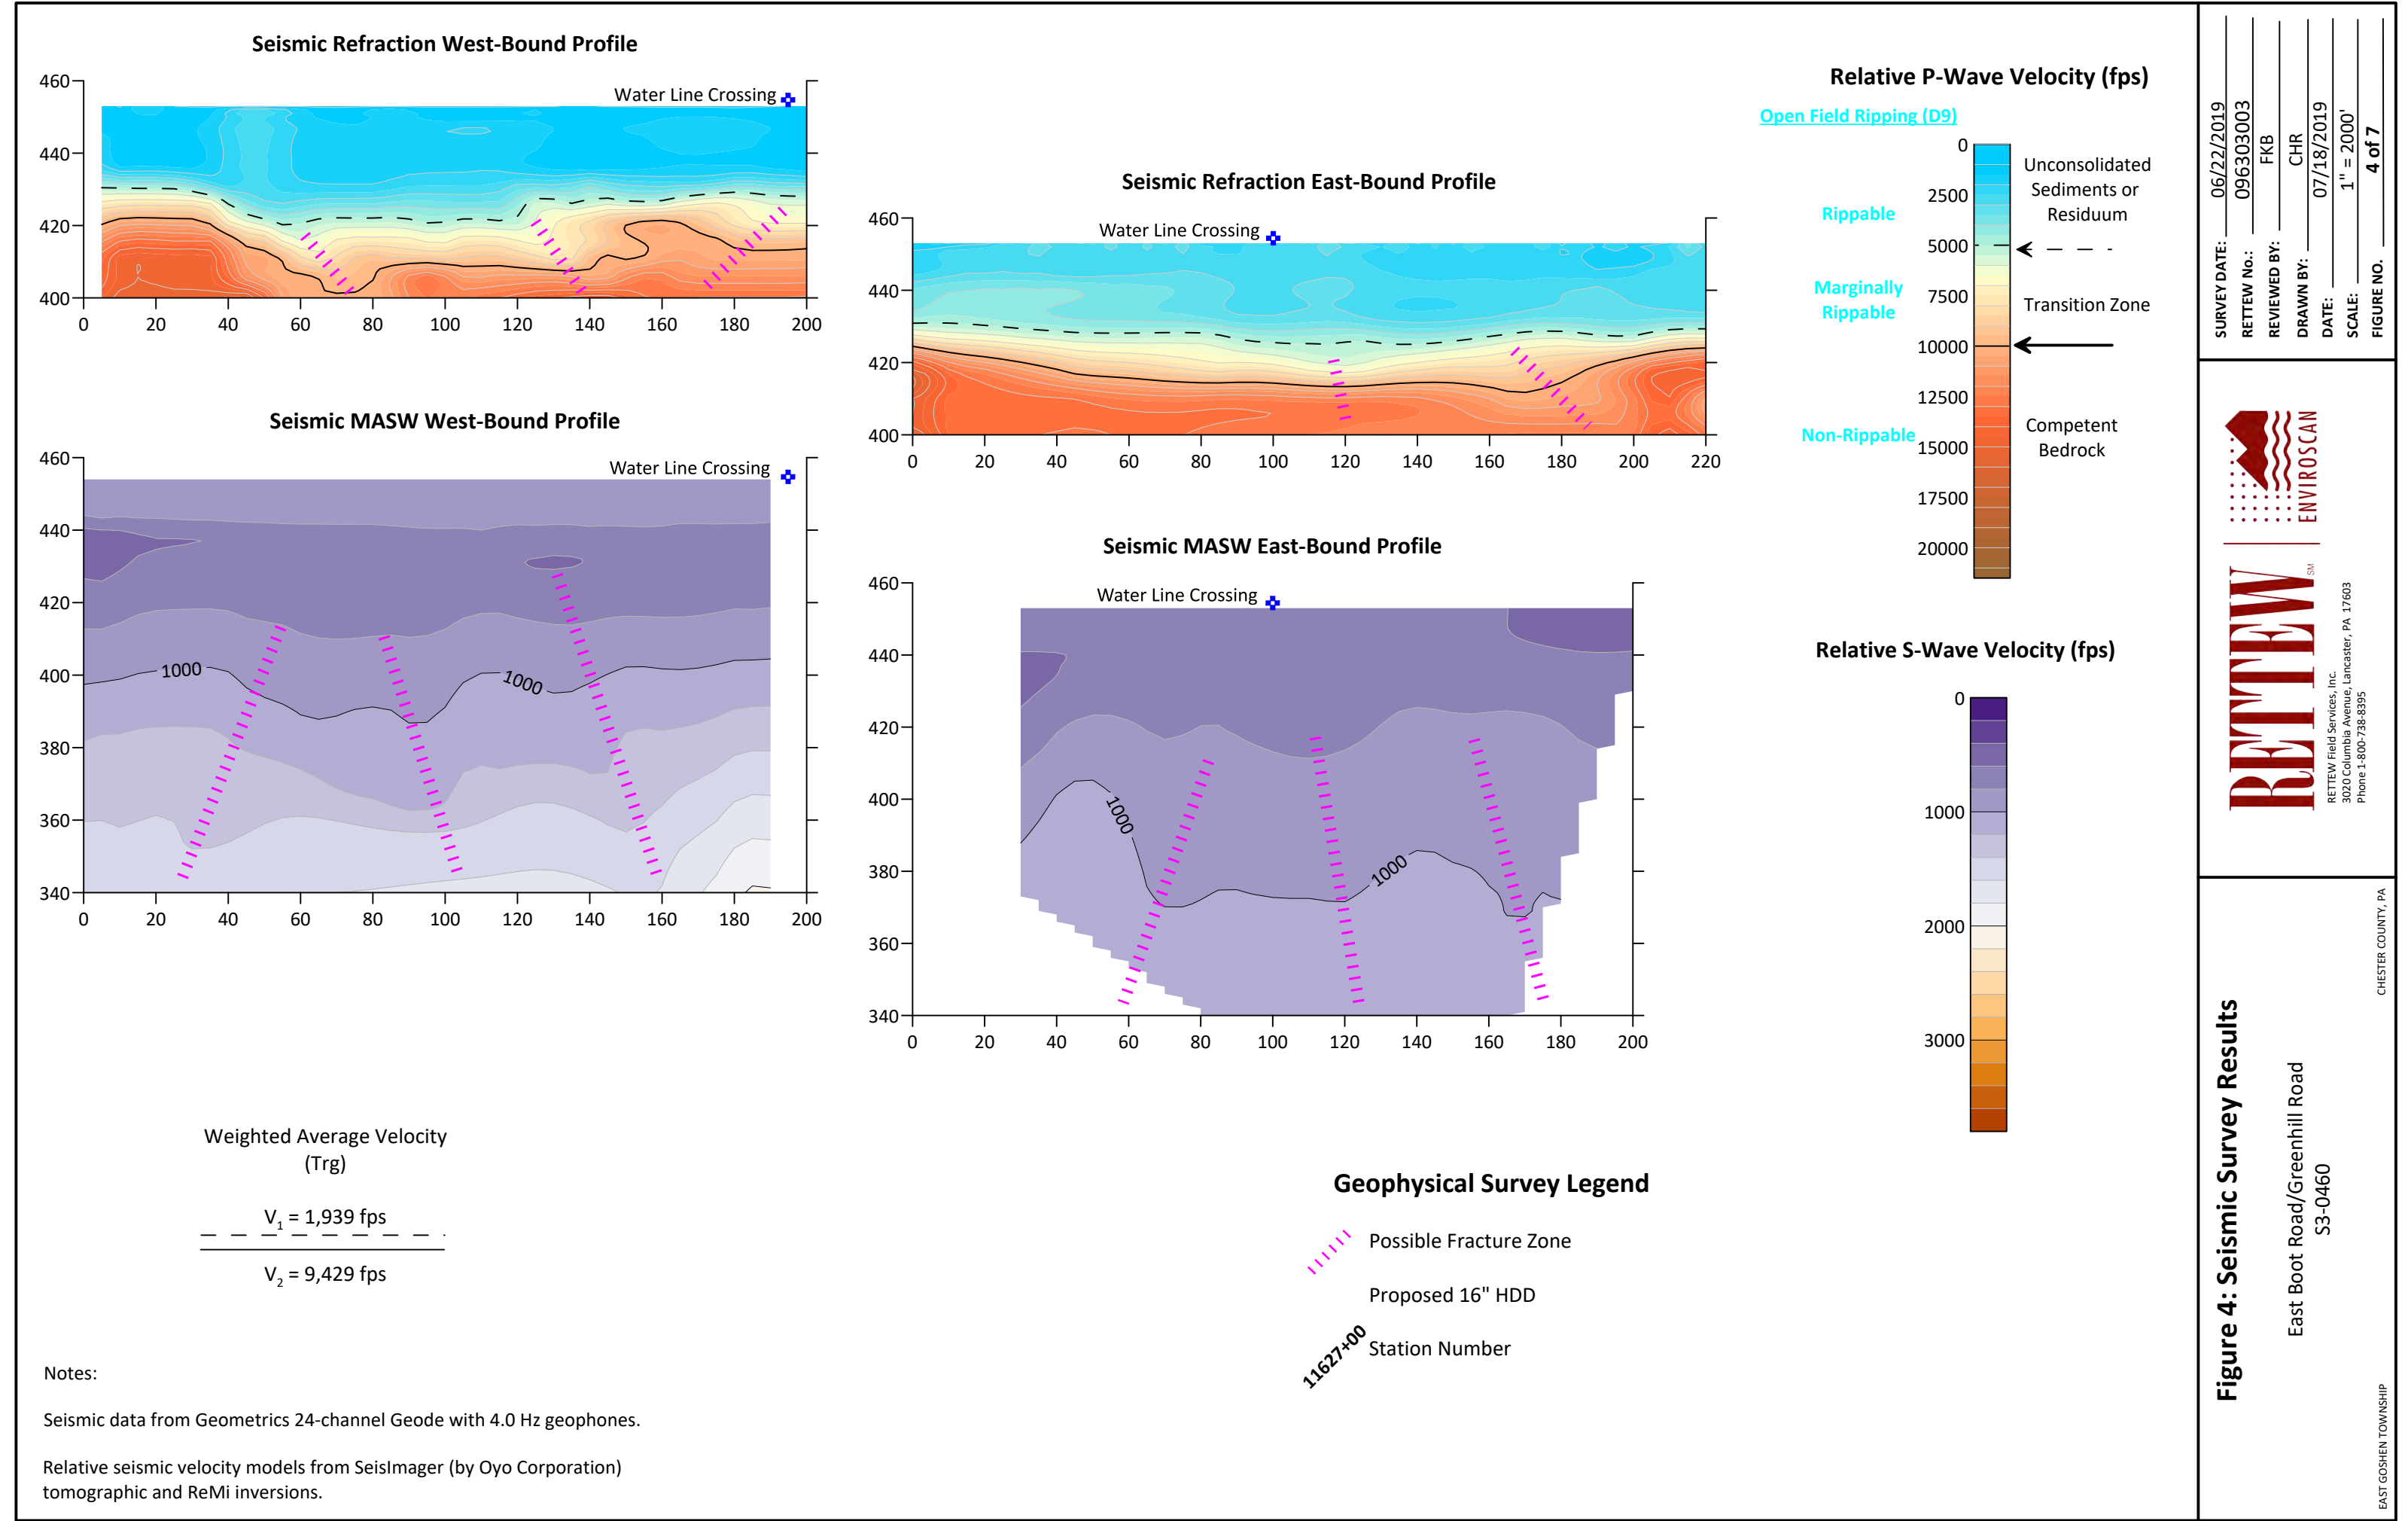
The seismic refraction data are presented as cross-sectional profiles on **Figure 4** and indicate a general two-layer stratigraphy consisting of residual soil mantle over bedrock. The uppermost layer has average P-wave velocities generally less than 5,000 feet per second (fps) with a thickness of approximately 25-35 feet. This is consistent with the residual clay soil mantle or deeply weathered bedrock (shaded blue to yellow). The deepest layers have velocities over 10,000 fps (shaded orange to brown) consistent with competent crystalline bedrock (Carmichael, R. S., 1989). The area between roughly the 5,000 and 10,000 fps contours represents a suspected weathered bedrock zone or saprolite transitioning from soil to bedrock.

The seismic refraction results show several locations where the competent bedrock surface is depressed, possibly indicative of deeper weathering along fractures. The suspected fracture zones are highlighted in magenta on the seismic profiles.

The MASW seismic cross sections are presented on **Figure 4**, lower profiles. The MASW velocity models show velocity changes within the bedrock layer across the profiles that are relatively consistent with the seismic refraction. Velocity lows below the bedrock surface could indicate fractures; these zones are highlighted on the cross sections.

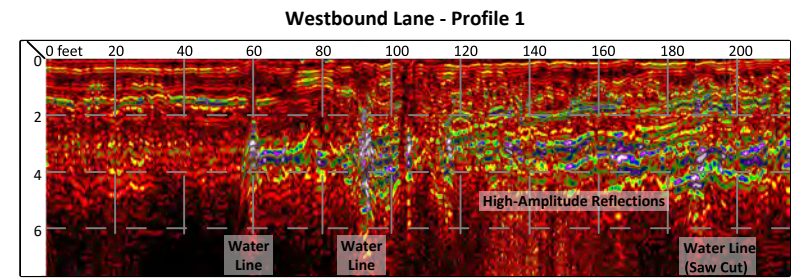
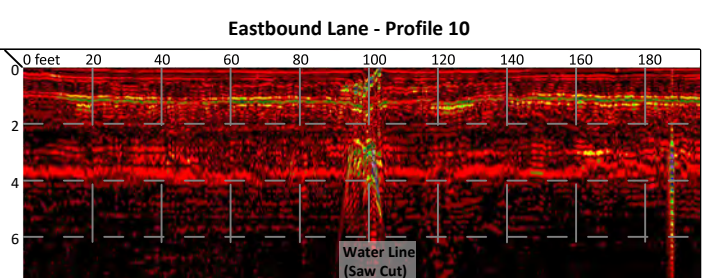
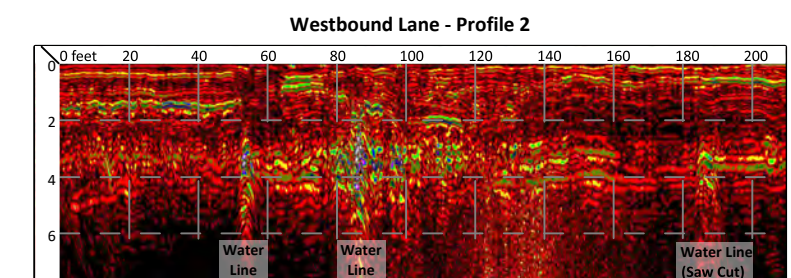
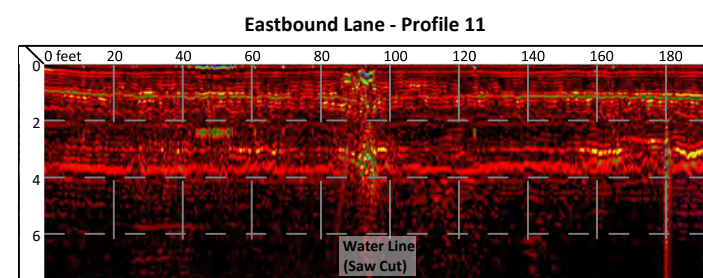
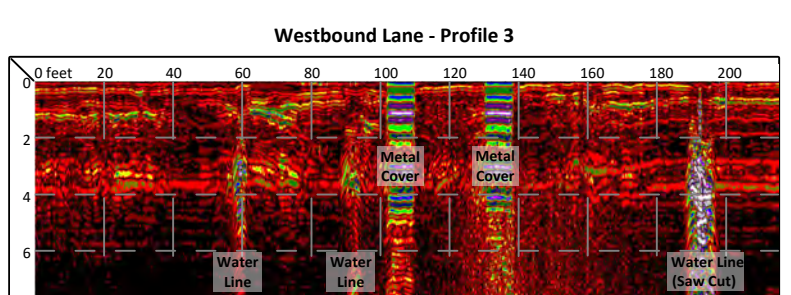
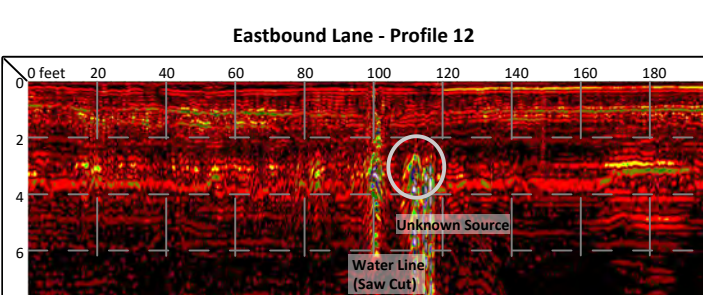
Figure 5: GPR Profiles

The GPR results show multiple high-amplitude reflectors across the survey area. Most of the reflections are associated with the numerous underground utility lines beneath the survey area. An area beneath the west-bound lane, between two suspected water lines, shows high-amplitude reflectors, including downward-dipping reflectors. This reflection pattern (circled on Profiles 7, 8 and 9, in **Figure 5**) is characteristic of settlement or subsidence. These anomalies are between two water lines. A smaller area of high-amplitude reflectors observed in the eastbound lane along Profile 12 is also adjacent to a water

line in the saw-cut area (**Figure 5**). These results suggest that there has been some settlement of the water line trench materials, and possibly infiltration of the trench materials by outside material; i.e. water from precipitation or the lines themselves, or possibly drilling fluids.

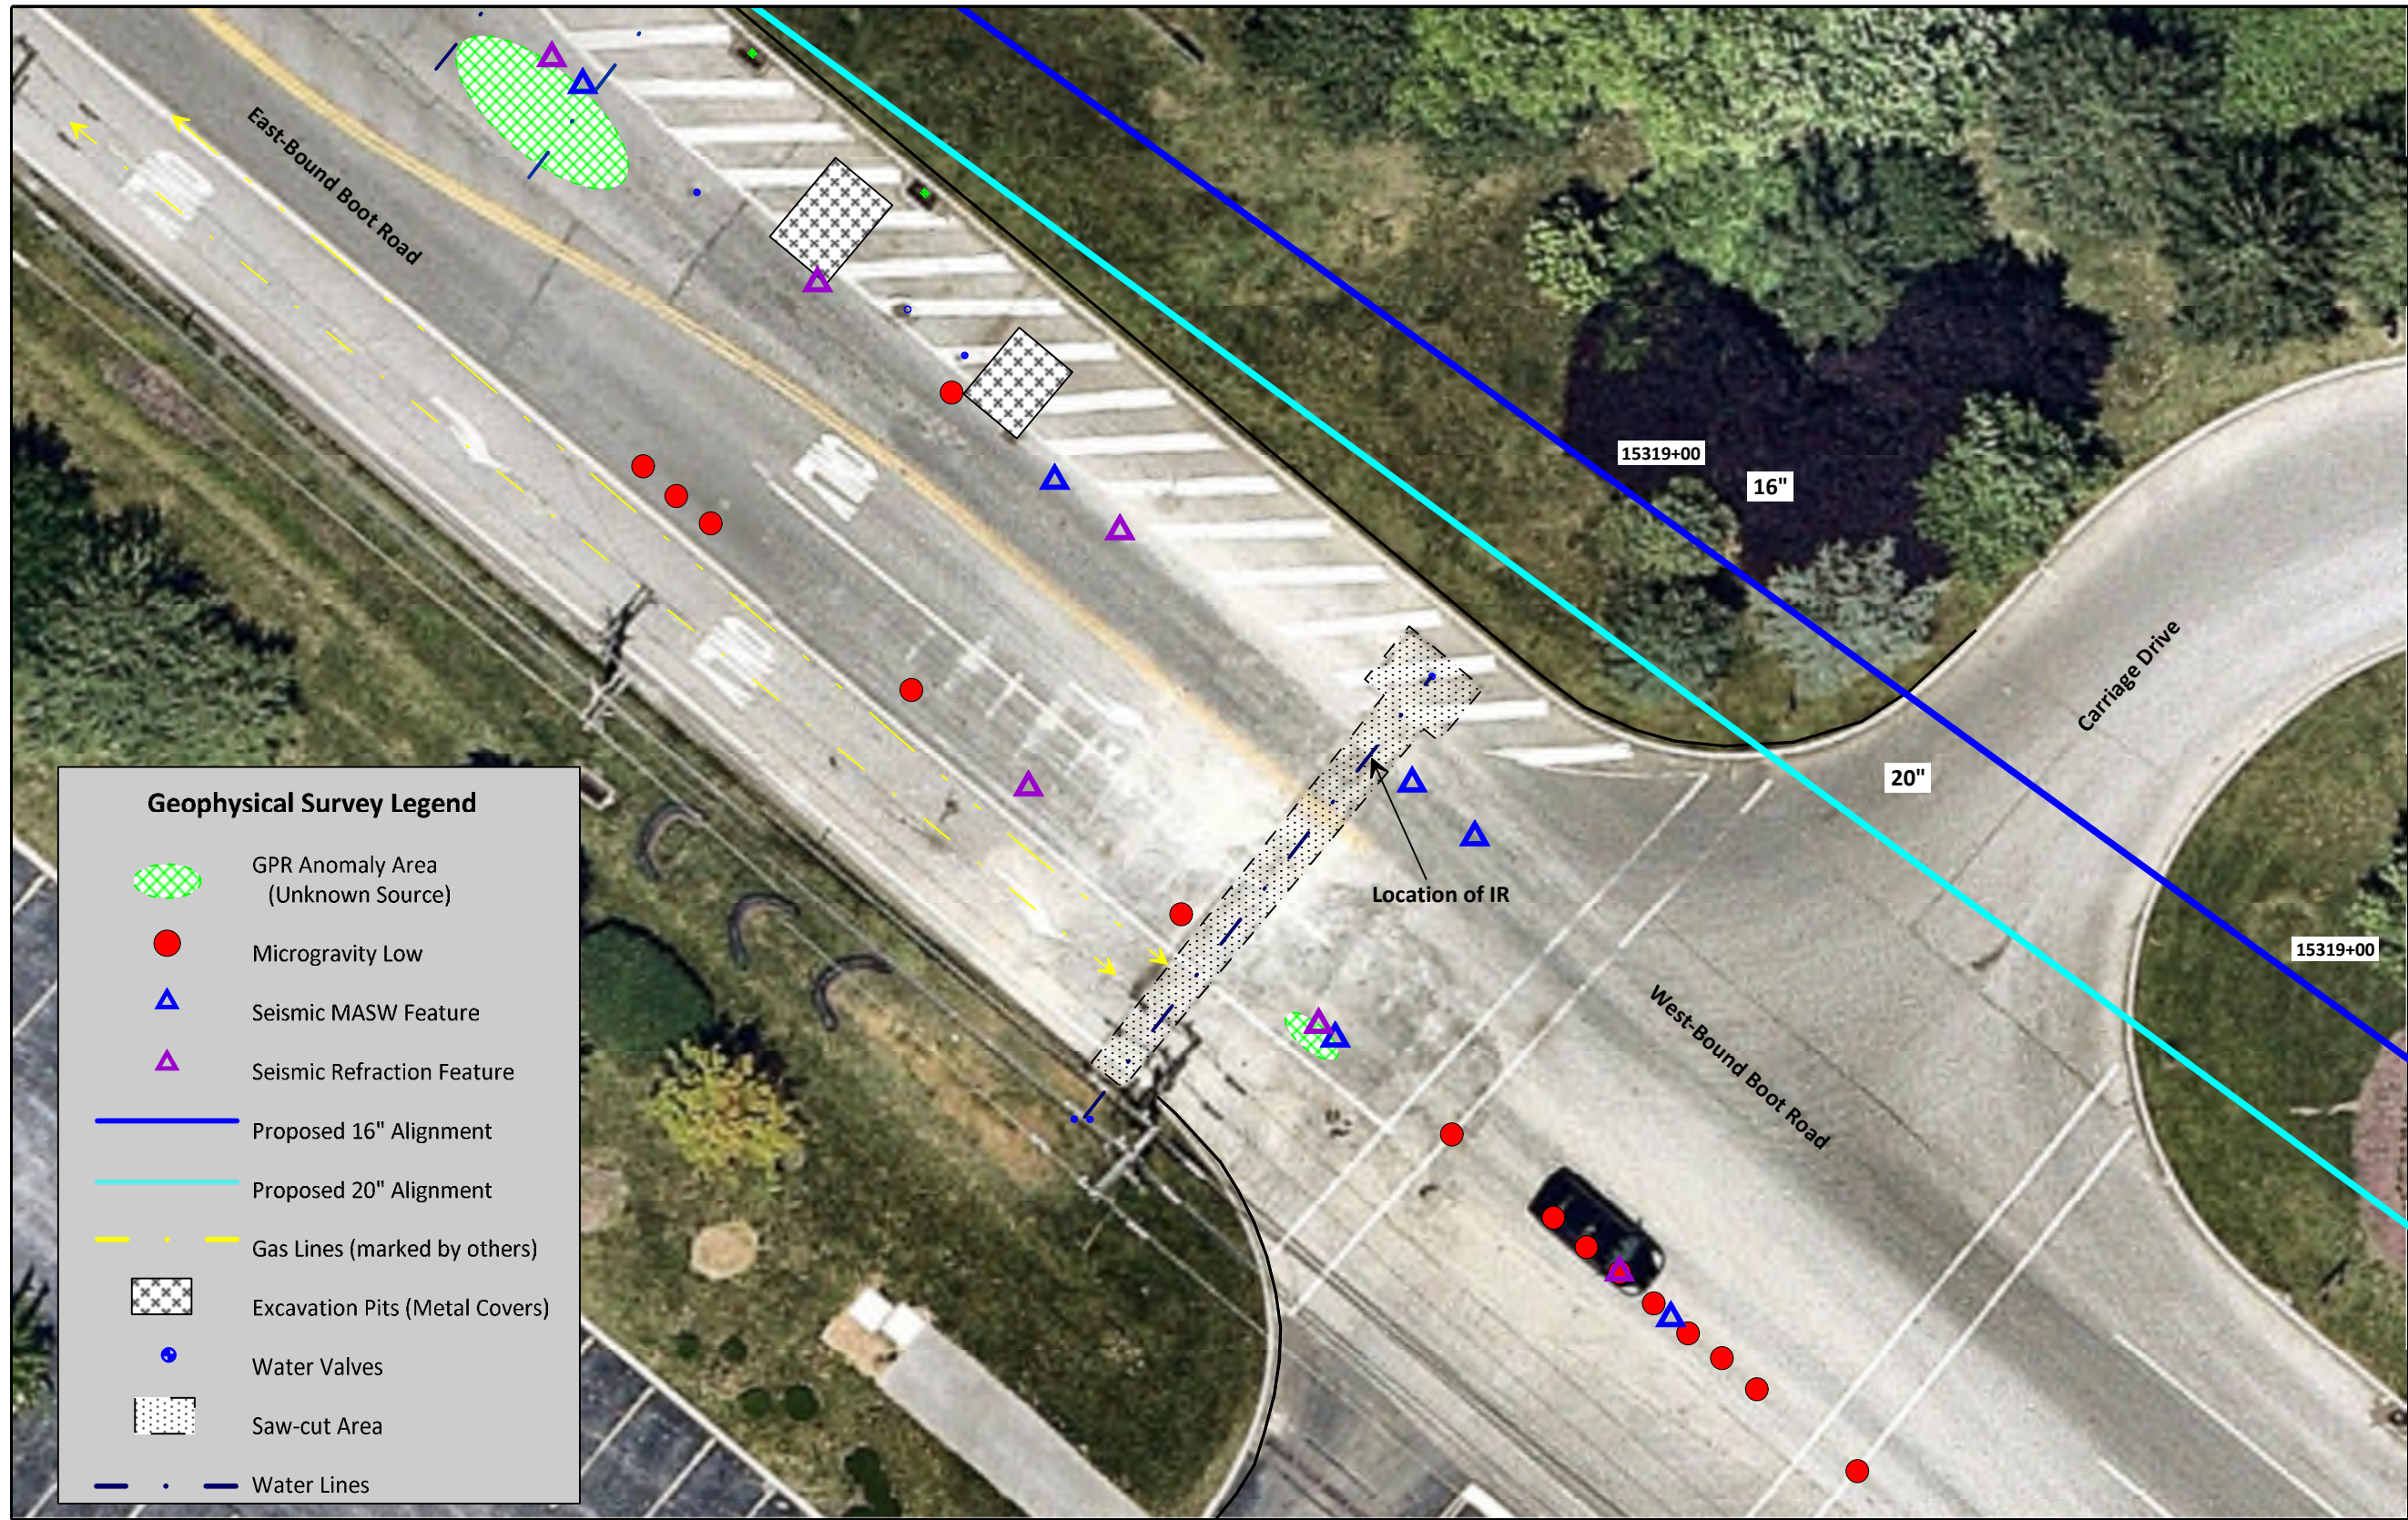
Figure 7: Geophysical Survey Summary

The geophysical techniques display anomalies indicative of potential fracture zones within the underlying bedrock. **Figure 7** summarizes the geophysical survey results in plan view. The GPR survey indicated two significant anomalous zones, both above seismic anomalous zones and underground utilities, that may be associated with saturated soils (possibly from the nearby utilities). These two areas do not show significant microgravity lows, and neither the microgravity nor GPR data show open voids along the asphalt cut.

Although RETTEW sees no evidence the IR caused any subsurface impacts or subsidence, there are identified anomalies beneath the roadway which may be related to leaks in existing water lines. For safety considerations these anomalies warrant further investigation. RETTEW recommends Sunoco investigate the two GPR anomalous areas identified on **Figures 5, 6, and 7** by drilling or test pitting to further characterize these anomalous conditions to ensure the anomalies are not resulting from drilling activities.
