RE: Geophysical Survey
Sunoco Pipeline, LP Pipeline Project
S3-0460 Greenhill Road GPR Survey at Wilson Drive
East Goshen Township, Chester County, PA
RETTEW Project No. 096303003

EXECUTIVE SUMMARY

RE: Geophysical Survey
Sunoco Pipeline, LP Pipeline Project
250-Foot Section of Boot Road Centered on 460 HDD Saw-cut Location
East Goshen Township, Chester County, PA
RETTEW Project No. 096303003

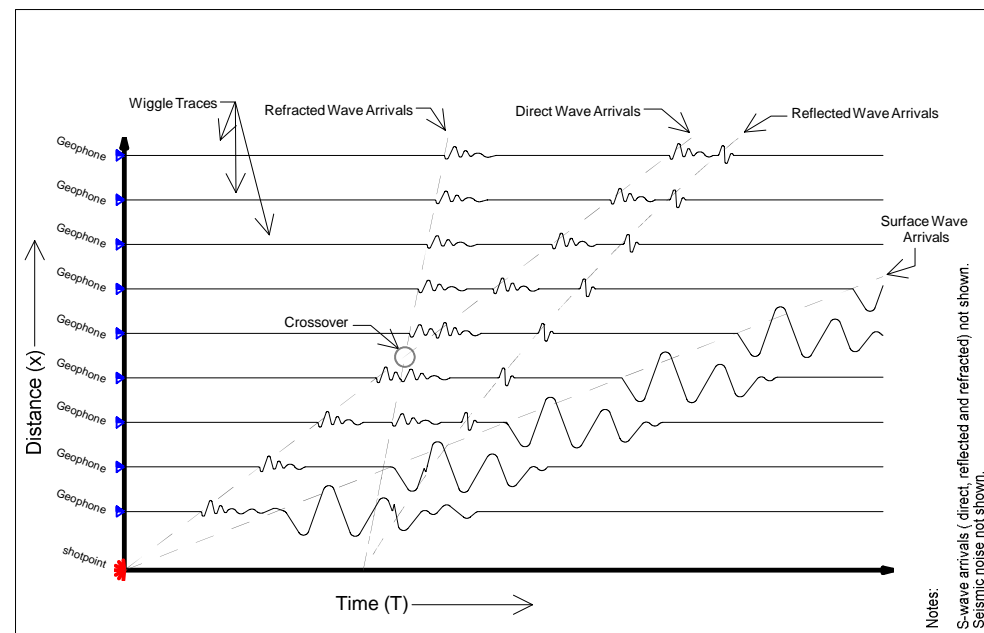
Figure SR-4

As depicted in the time-distance (T-X) curve in Figure SR-4, the layered earth structure can be determined by analyzing the seismographic wiggle traces. At distances close to the seismic source, the first wiggle or ground motion (the first arrival after the shot) is due to passage of the direct wave travelling at the velocity of the upper layer. Reflected waves arrive later since they have by definition traveled a greater distance at the same velocity (additional later wiggles are caused by passage of the more slowly travelling S and surface waves). Beyond a distance dictated by the critical angle, the first arrival of seismic energy represents the head wave of the critically refracted ray. These refracted rays also by definition travel a greater distance than the direct wave. However, along part of their path, they have traveled at the higher velocity of the underlying more consolidated layer. At greater distances from the shot point, where the path length in the higher velocity layer becomes significant, the head wave arrivals actually race past the direct wave and become the first arrival (see labeled crossover in **Figure SR-4**). By extension, it can be shown that if a third layer with even greater velocity lies at greater depth, the head wave from this layer will become the first arrival at a sufficient distance from the shot point.

Idealized
Seismic Record
and T- X Graph
