Depression Adjacent to Route 352 near Anne Drive/Bow Tree Drive East Goshen Township, Chester County

The Pennsylvania Department of Transportation performed excavation of a depression on the west side of Route 352 just south of the intersection of Anne Drive/Bow Tree Drive in East Goshen Township, Chester County, on Wednesday, December 23, 2020.

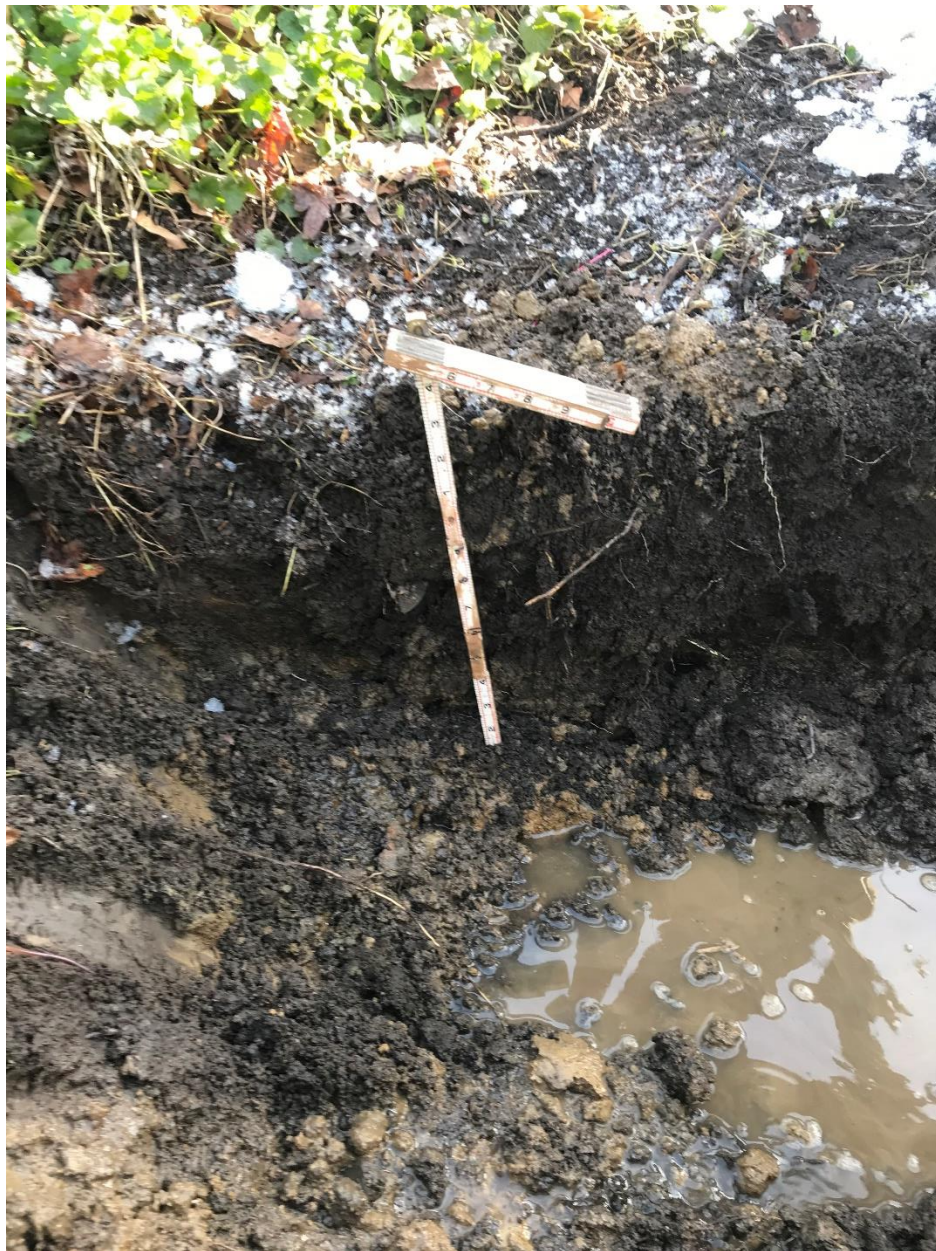
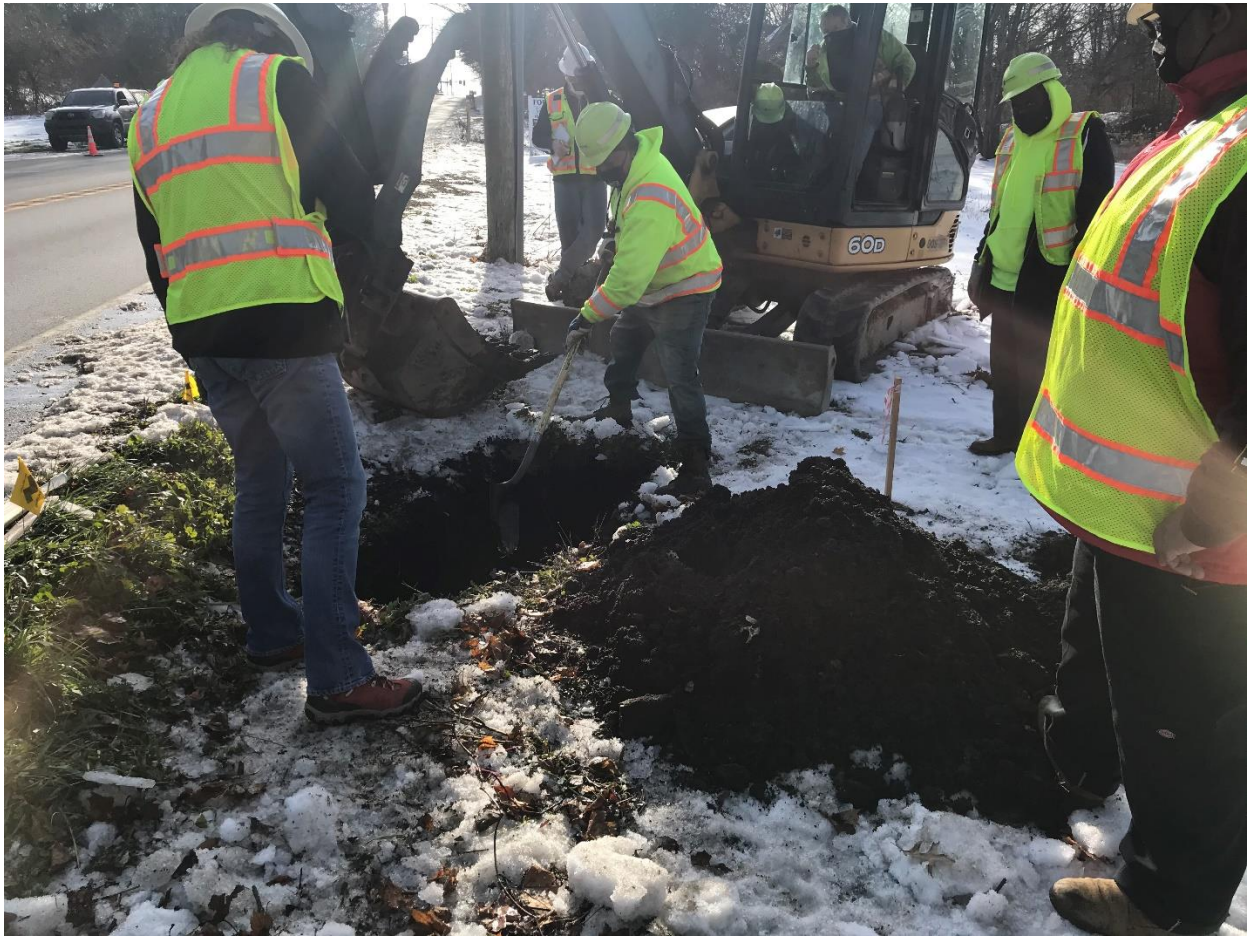
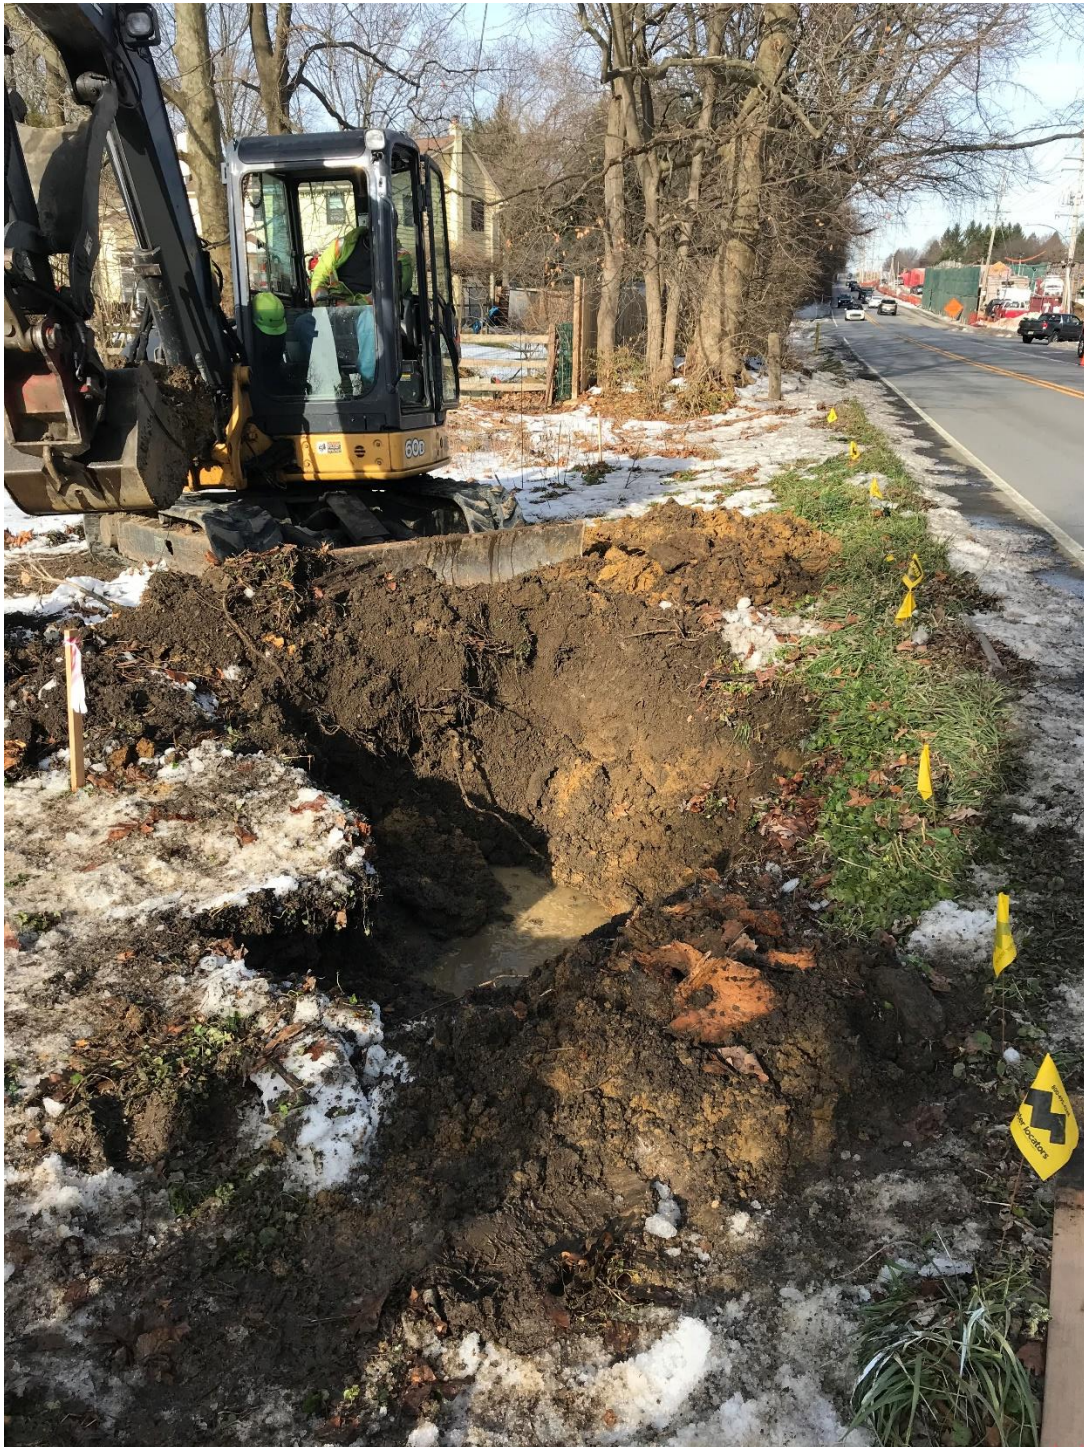
The subsidence adjacent to the southbound shoulder of Route 352 appears to be caused by the presence of silty clay at a depth of 2.3 feet below the road grade. This conclusion was reached based on careful excavation of a 7-foot-by-11-foot test pit (TP-1) roughly centered on the location of the depression. In addition to the silty clay, a tree stump was excavated from the test pit. Decay of the stump may also have contributed to the subsidence at this location. During the excavation, surface water was observed running along the top of the silty clay layer. Perched surface water can also potentially contribute to subsidence. Additionally, there was no evidence of subsidence or distress on the adjacent roadway.

The result of the investigation found that moving surface water and a decaying tree stump were likely the causes of the depression. In the department's professional view, the subsidence was not a risk to the safety and stability of the state roadway.

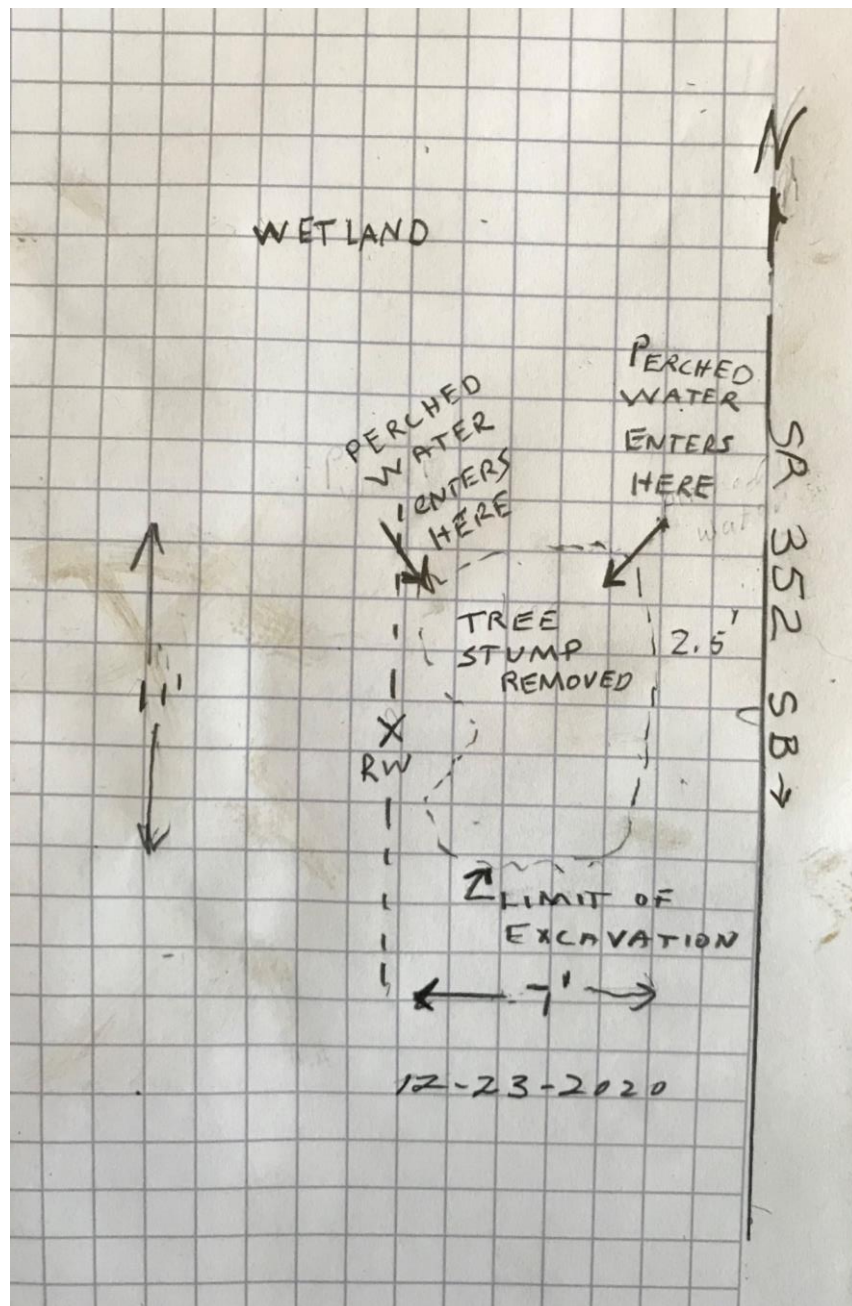
Test Pit No: **TP-.1**

DEPTH (ft.)	GRAPHIC	MATERIAL DESCRIPTION	ASTHOSUS	DEPTH (ft.)	BAG SAMPLE NUMBER	POCKET PEN. (lbf.)	TORVANE (lbf.)
0		START 1' below ROAD GRADE		0			
1.3		SILT, dark brown, topsoil, wet		1.3			
2.7		SURFACE, PERCHED water on top of SILT, clay layer		2			
		SILT, light brown, some clay, moist + tree stump		3			
		Same		4			
		2.7' BOTTOM OF TEST PIT		5			
		Ease of Excavation = easy with moderate casting due to water seeping in		6			
				7			
				8			
				9			
10				10

WATER level of monitoring well = 7.0'
 29' from edge of hole
 BOTTOM OF HOLE = 3.3' 3-60
 FROM GRADE
