AGENDA EAST GOSHEN TOWNSHIP CONSERVANCY BOARD MEETING

Re: 301 Reservoir Road/Timbermill Conditional Use Application

Reference: Tree Review

PCSM PLAN NOTES & DETAILS SHEET No.1 PRELIMINARY SUBDIVISION AND LAND DEVELOPMENT PLANS TIMBERMILL, LLC

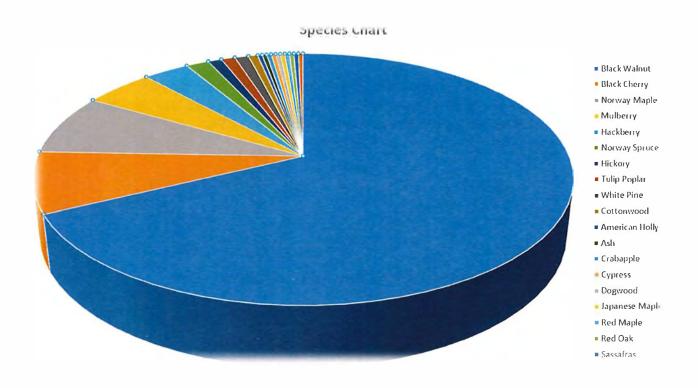
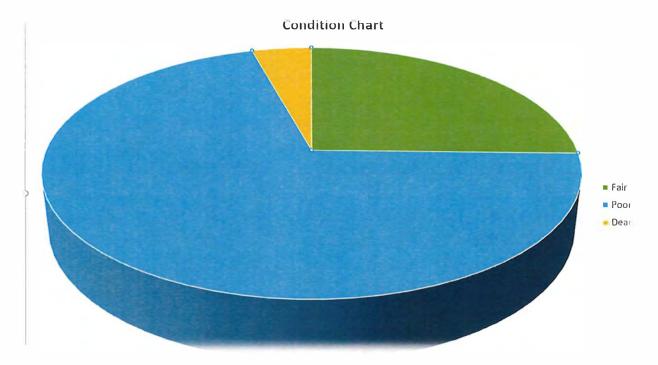
Summary Chart

We performed an inventory of all trees 6" or greater in DBH to determine the stand dynamics, condition and defects. A total of 307 trees were reviewed. As seen with the below summary charts, that the site has a very excessive monoculture of 67.8 Black walnut and a poor condition factor of 74.5%. Tools utilized.

Sp	ecies Detail:	14/4/4/4	%:	Total Trees:		
	Black Walnut	208	67.8%	All Species	307	
	Black Cherry	24	7.8%		2.9.2.2.4.00	
	Norway Maple	24	7.8%	Condition of Trees:		
115 (115	Mulberry	15	4.9%	Fair	78	25.4%
	Hackberry	10	3.3%	Poor	216	70.4%
1993 N. 149	Norway Spruce	5	1.6%	Dead	13	4.2%
	Hickory	3	1.0%			
	Tulip Poplar	3	1.0%	Defects Observed:		
	White Pine	3	1.0%	Dead	13	4.2%
	Cottonwood	2	0.7%	Emerald Ash Borer	1	0.3%
	American Holly	1	0.3%	Invasive	23	7.5%
Tract-	Ash	1	0.3%	Structural	192	62.5%
nng menghan pengangan kanalagan salah	Crabapple	1	0.3%	None	78	25.4%
	Cypress	1	0.3%			
	Dogwood	1	0.3%	Total Inches:	SAN STATE	
	Japanese Maple	1	0.3%	Fair	1,310	
	Red Maple	1	0.3%	Poor	2,973	
	Red Oak	1	0.3%	Dead	141	3-18.63 3 7 P-9/4-
	Sassafras	1	0.3%			
1,54,714,547	Sycamore	1	0.3%	Compensation:	A MITT	
				Yes	78	25.4%
	Specimen Trees	10		No	229	74.6%
