Milltown Dam (DEP ID No. D15-146) Dam Assessment and Alternatives Analysis

MILLTOWN DAM DAM ASSESSMENT AND ALTERNATIVES ANALYSIS

FINAL REPORT

MARCH 2016

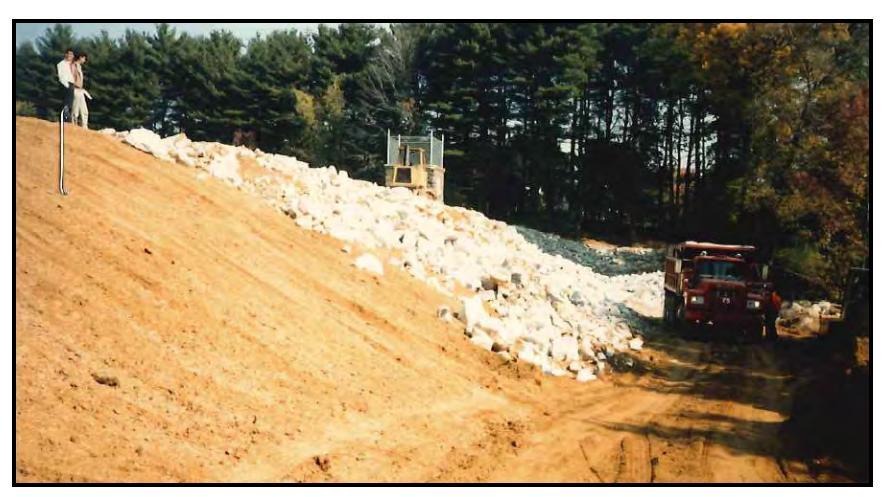
Figure 2-1 Installation of riprap slope protection on the downstream right embankment. (Photograph taken on October 26, 1986)

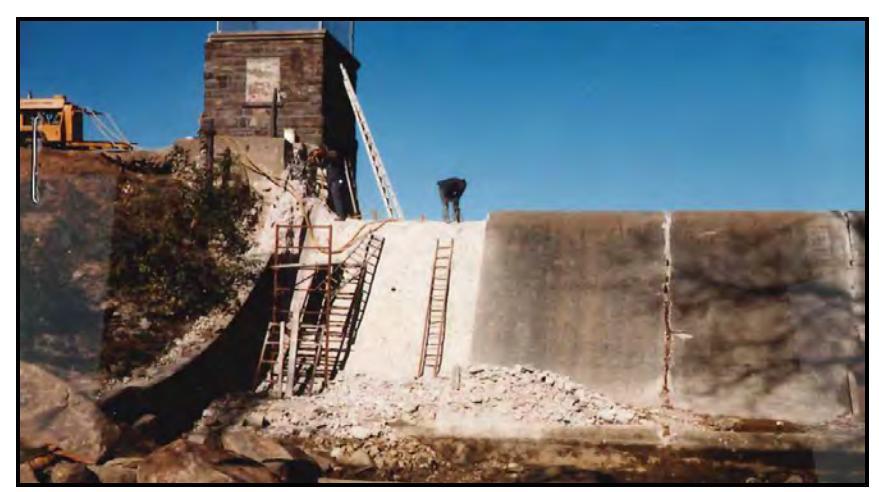
Figure 2-2 Extent of spillway demolition/reconstruction at right spillway abutment (Photograph taken on October 29, 1985)

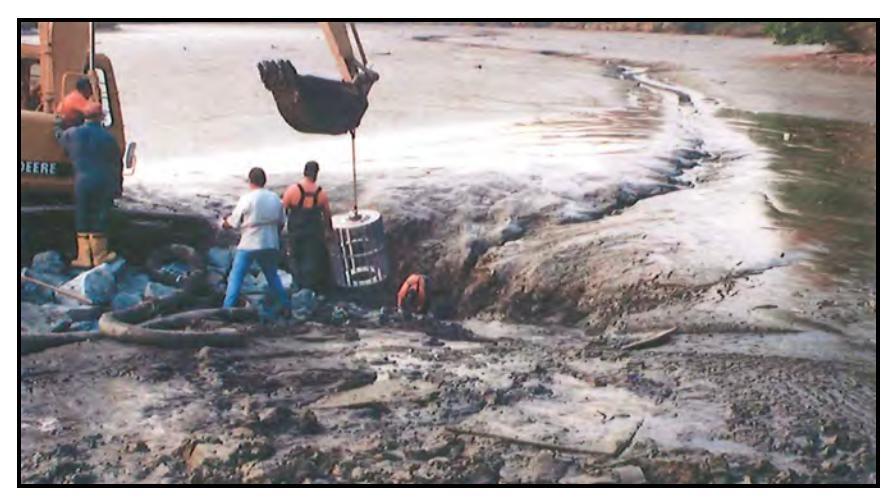
• 1997 Trash racks were added at the upstream entrances of the 16-inchdiameter and 24-inch-diameter CIPs which draw water from the reservoir into the valve chamber (refer to Figure 2-3). A letter from Yerkes Associates to DEP dated March 15, 2000, indicates that both CIPs were inspected and cleaned free of debris and one valve was rebuilt at the same time the trash racks were installed.

Figure 2-3 Installation of trash rack(s). Note sediment deposition in bottom of reservoir.

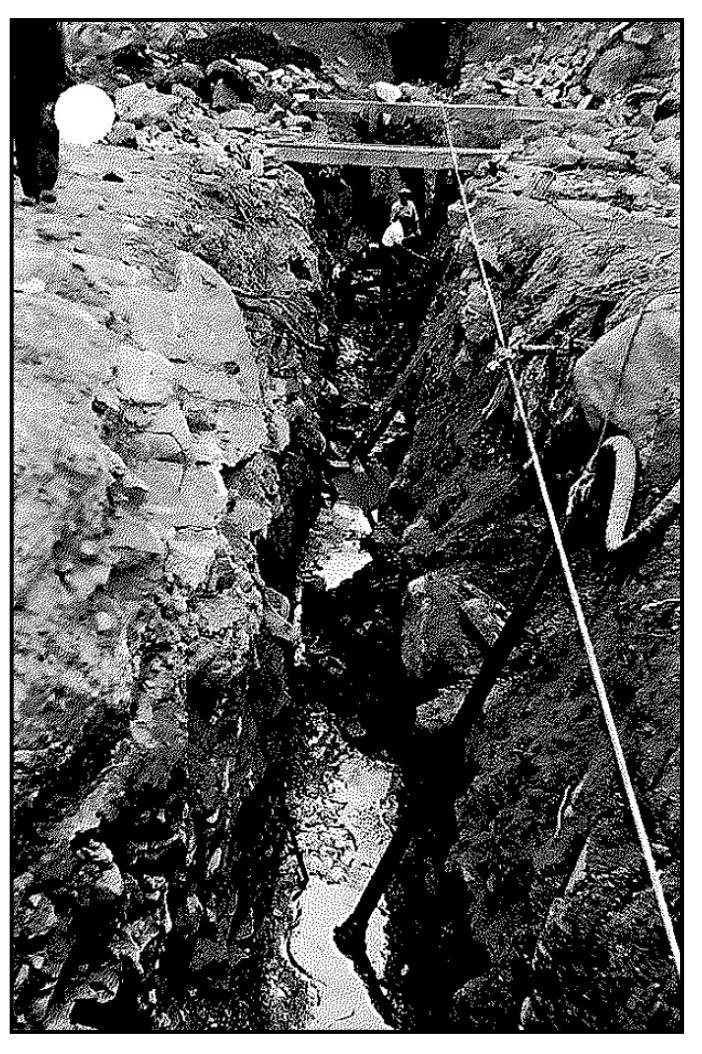
Figure 4-1 Excavation for Concrete Core Wall (Photograph taken on July 17, 1923)

"...composed of one (1) part Portland Cement, and six (6) parts of fine and coarse aggregate; each measured separately and accurately by volume." An inspection performed during the construction of the dam on July 17, 1923 indicates that the overburden consists of large boulders and loose seamy stone with excavations for the core wall reaching 15-feet in depth. Observed bedrock was classified as very hard gneissic rock with tight seams. Figure 4-1 shows a section of the core wall excavation as observed during the July 17, 1923 inspection. Perspective is given to the depth of the core wall excavation by the two workers standing within the trench in the top center of the photograph.

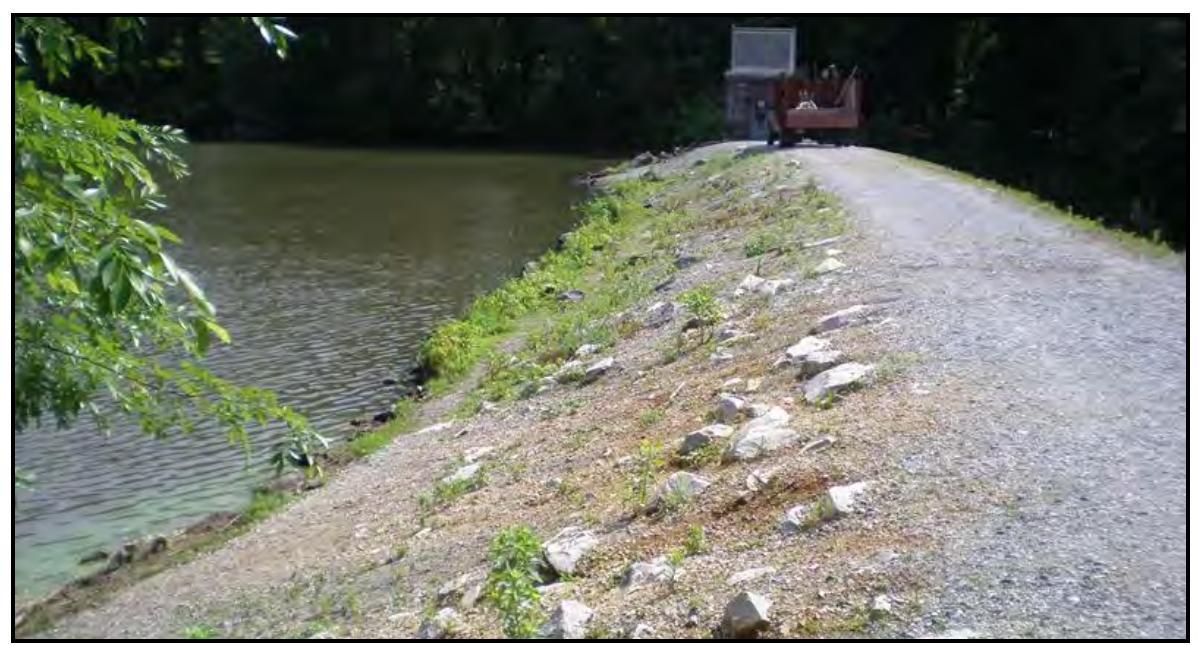
In 1985, the upstream embankment located above normal pool and the downstream embankment were covered with riprap consisting of 24-inch to 30-inch diameter quarry rock chinked with #3 stone. A six-inch layer of 2B stone was placed under the riprap as a bedding layer. A construction inspection performed by PADEP on October 26, 1986 reported that the installed rock appeared to be smaller than the specified size and that the aggregate bedding had been changed from 2B material to 2RC material. Based on photographs taken during the inspection, it is questioned if the aggregate bedding material was placed beneath the riprap on the downstream embankment slope (refer to Figure 2-1). Figure 4-2 provides a typical view of the upstream right embankment. Note that the surface of the riprap has been chinked with aggregate to create a relatively smooth surface.

Figure 4-2 View of upstream right embankment (photograph taken on June 19, 2015).

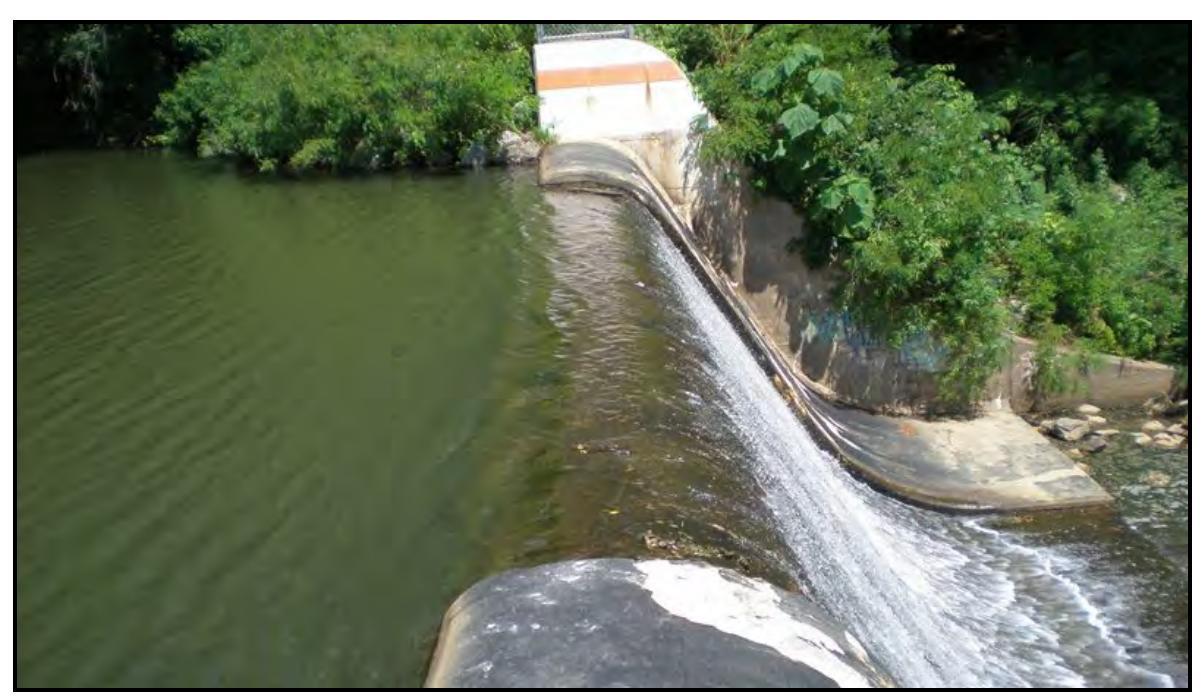
The original 1921 design calculations for Milltown Dam are unavailable. Information contained within the 1981 Phase I Inspection Report indicates that the storage capacity of the reservoir (at top of dam) is 114 acre-feet and that the spillway capacity with the pool at the top of dam elevation is approximately $2,060\pm$ cfs. Due to observed low areas along the crest of the dam, the Phase I Inspection found the top of dam to be 4.1-feet above the low flow notch in the spillway. Based on the design top of dam elevation (5.3 feet above the low flow notch in the spillway), the Phase I Inspection Report calculated the spillway capacity to be $3,080\pm$ cfs. According to current USGS stream statistics published for this site, the 100-year flood discharge is estimated to be approximately 3,500 cfs. The current spillway capacity is therefore less than the 100-year flood. Figure 4-3 shows the condition of the spillway crest as observed on August 4, 2015.

The spillway flow capacity calculated within the Phase I Inspection Report is based on a weir coefficient of 3.88 for the ogee-shaped crest. This weir coefficient appears reasonable for the original design; however, sediment buildup at the entrance of the spillway can reduce the approach depth of the flow and decrease the efficiency of the spillway. The as-built approach depth to the spillway was approximately 15.5 feet. The current approach depth is approximately 5 feet. The impact of the reduced approach depth was analyzed using procedures in *Design of Small Dams* and found to be negligible. The currently estimated discharge capacity of the spillway is therefore reasonable.

Figure 4-3 View of spillway crest. (Note 6-inch deep low flow notch)

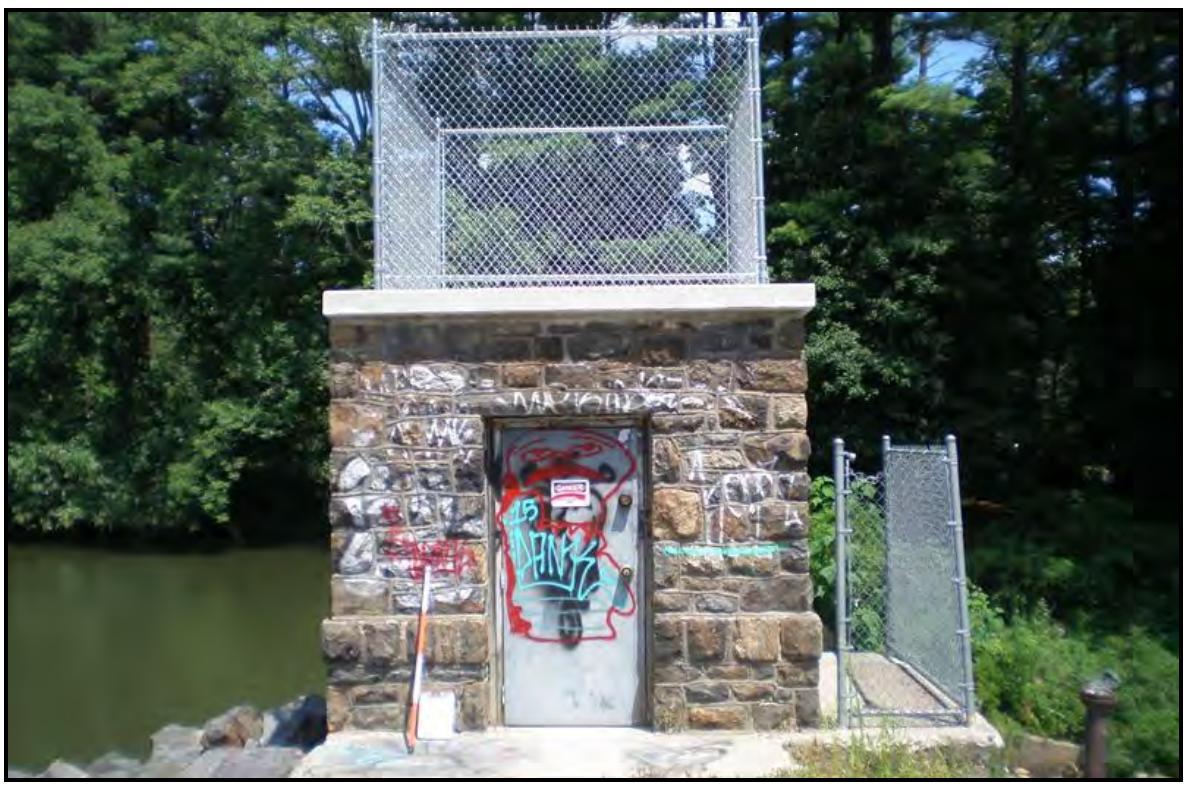
The valve house is a stone masonry structure situated over a concrete valve chamber (refer to Figure 4-4). A lockable door provides access to the interior of the valve house. The door locks are protected with steel shrouds to prevent vandalism which is reported by the Township to be a recurring problem. The original windows have been bricked shut to prevent/deter vandalism. The roof on the valve house was replaced in 2013 and contains an access hatch to facilitate future gate repairs/replacements. A chain-link fence prevents unauthorized access to the roof. The stone masonry valve house appears to be in fair condition.

Figure 4-4 View of Valve House situated at the right spillway training wall.

The exterior portions of the concrete valve chamber which are exposed contain hairline cracks with efflorescence deposits. The valve chamber walls vary in thickness with the left and right walls being the thinnest at 16-inches. The interior of the valve chamber was inspected from the floor of the valve house through an access port on the floor. A damp area was observed near the normal pool elevation in the downstream left corner of the valve chamber.

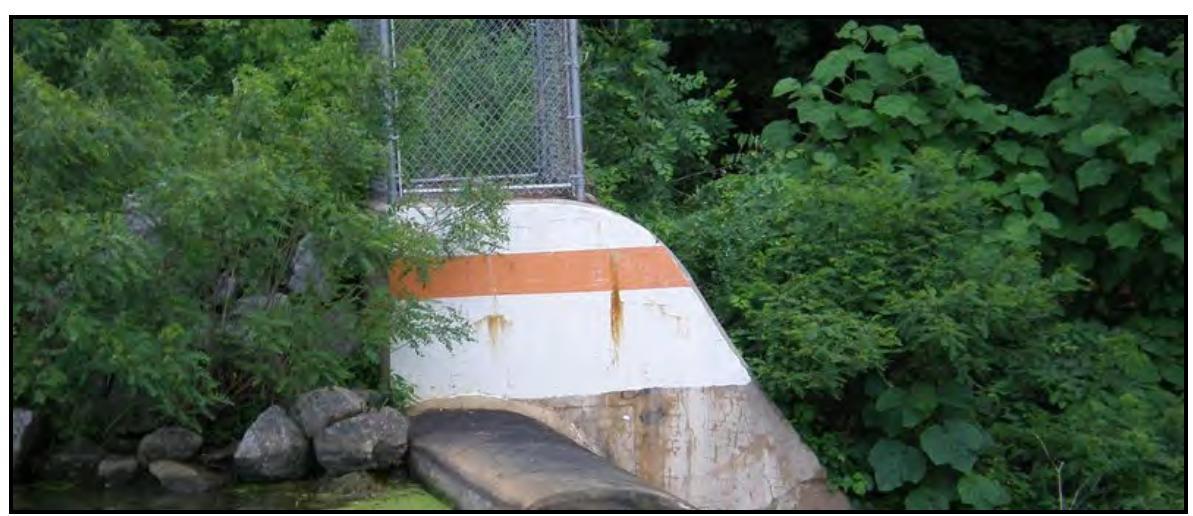
Horizontal paint markings are present on the left spillway training wall. These markings correspond to the Emergency Action Plan (EAP) event trigger levels (refer to Figure 4-7). No additional instrumentation is present at Milltown Dam.

- *Staff Gage.* Although the painted markings on the spillway are innovative and provide an excellent visual indication of the water level, the flow approaching the spillway and discharging over the crest of the spillway would have considerable velocity which results in the flow depth contracting vertically. Therefore the horizontal paint marking on the left spillway wall may not provide an accurate reservoir level reading. If a new staff gage is installed, it should be easily readable from the Reservoir Road pull-off area at the right abutment of the dam.

Figure 4-7 EAP event trigger levels marked on left spillway training wall.

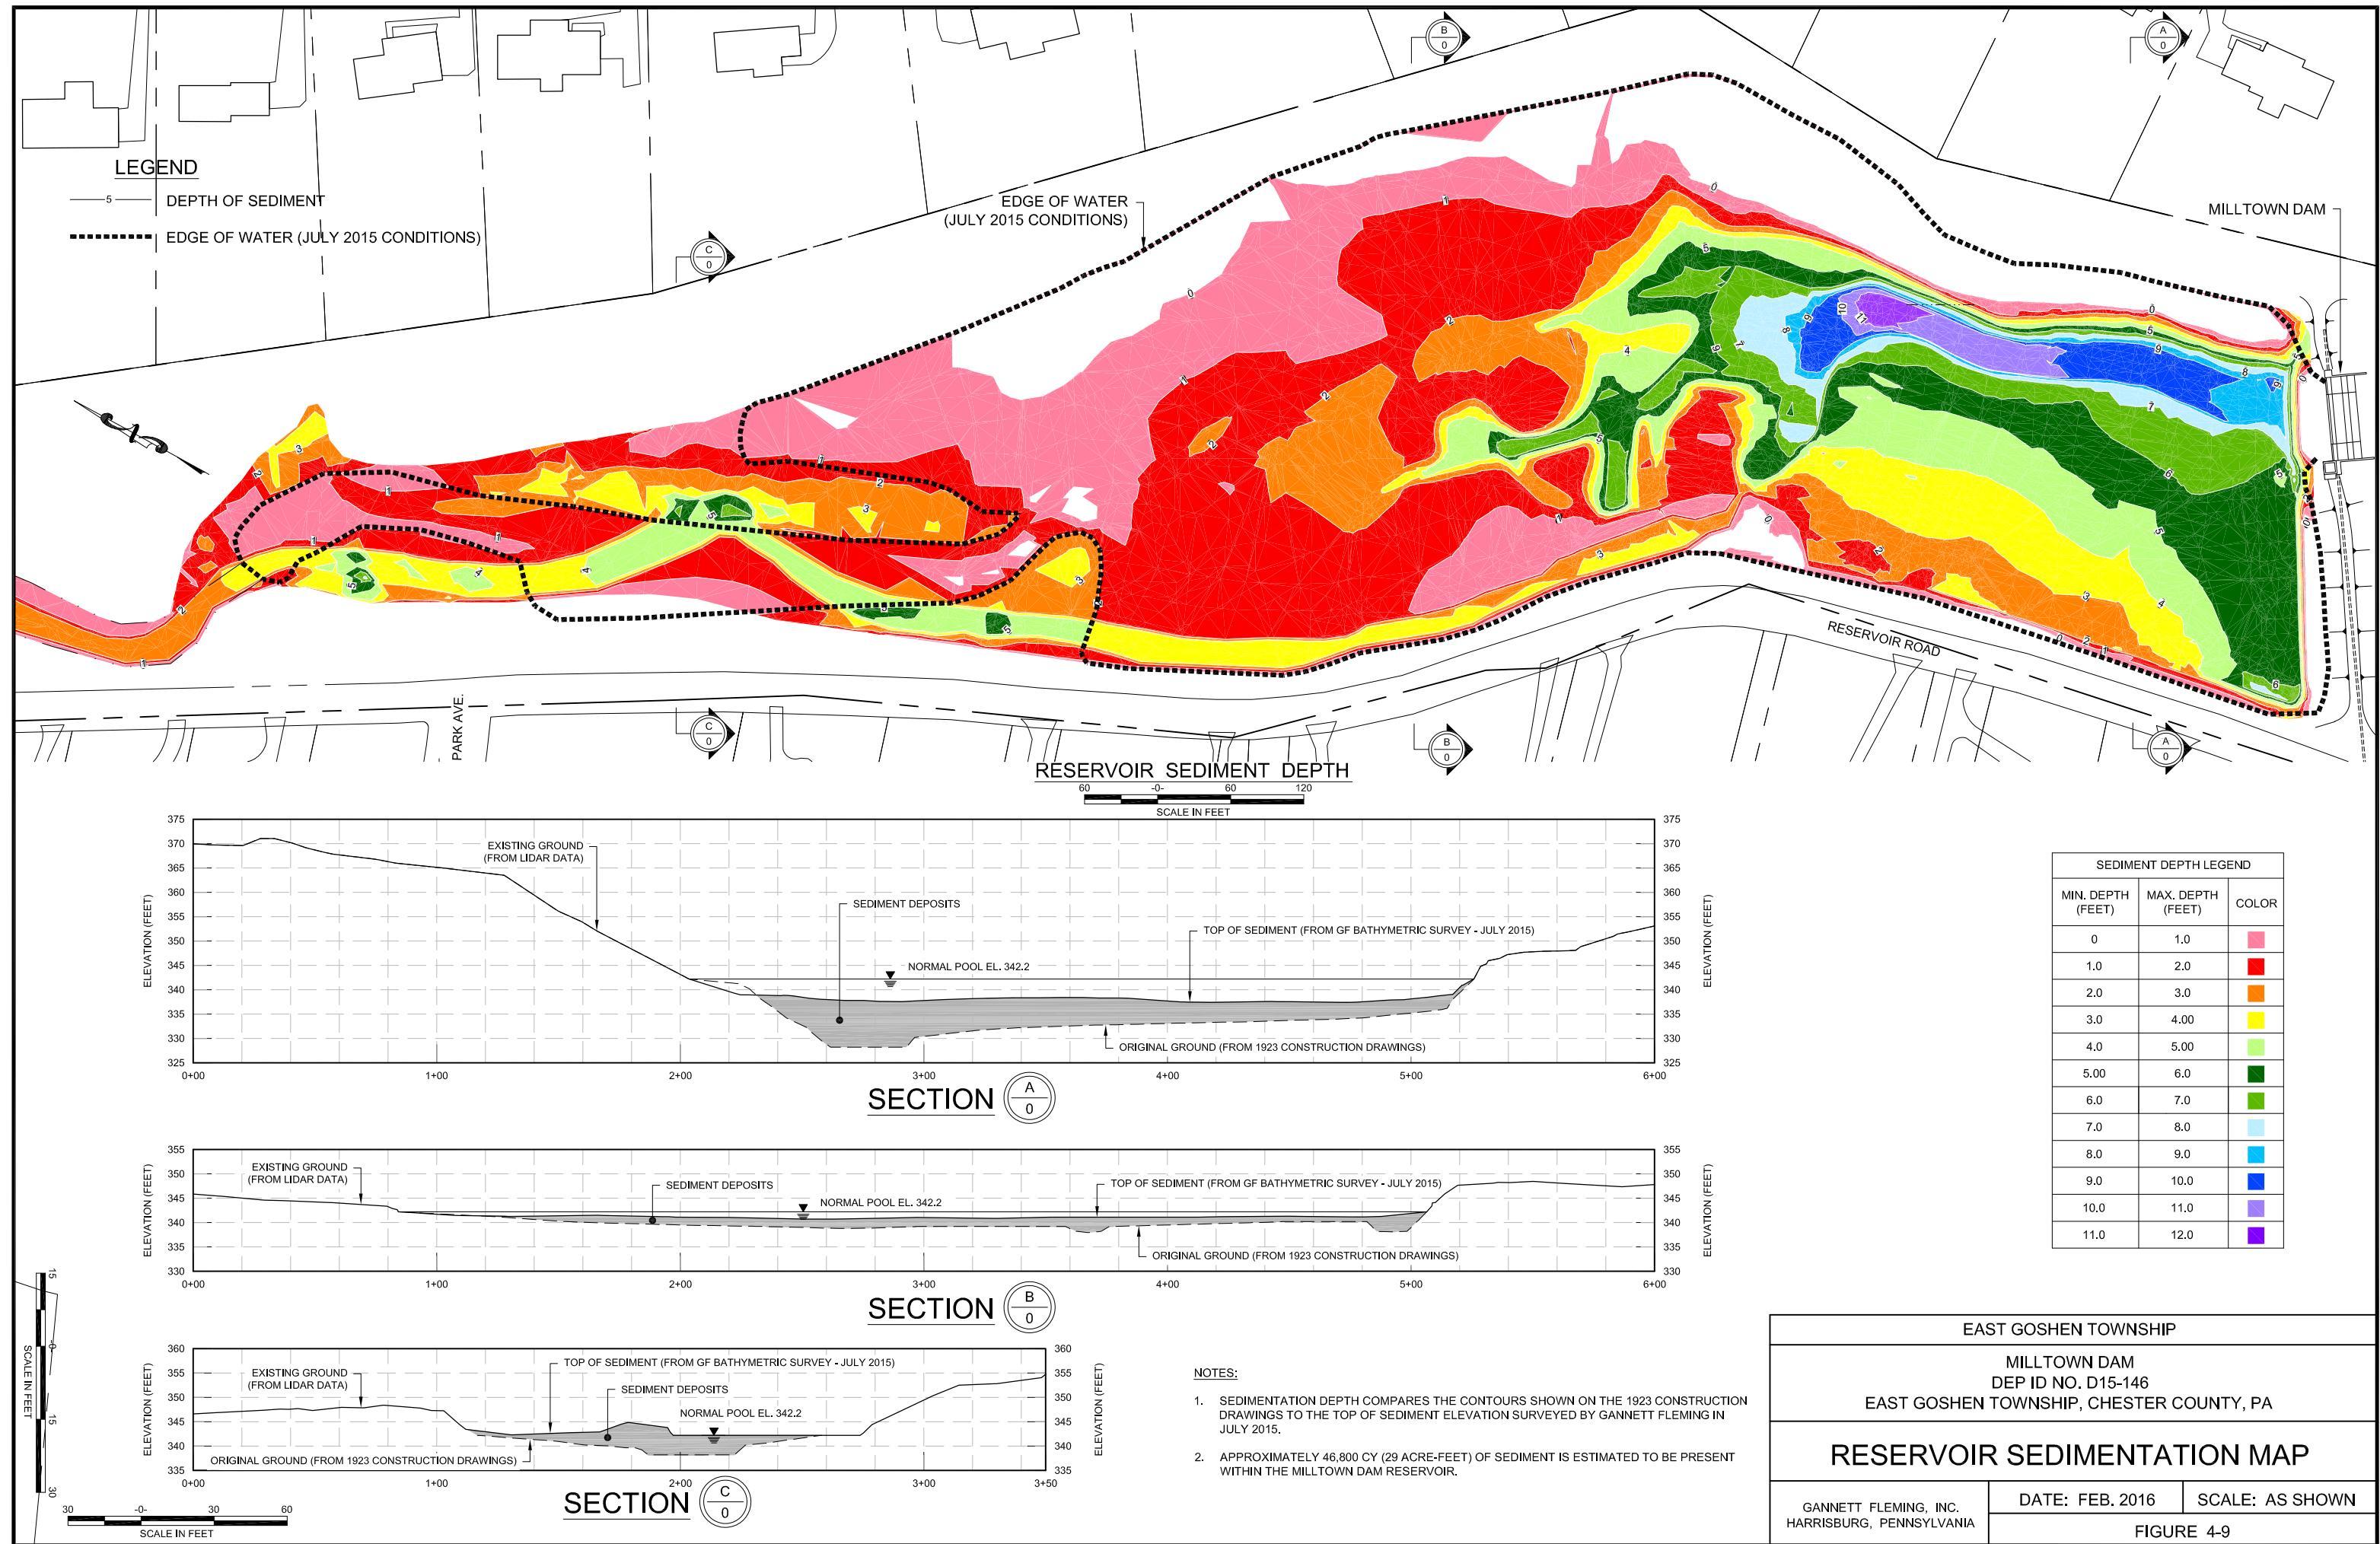
The Milltown Dam reservoir has a history of chronic sediment deposition. Reports from the water company indicate that in 1961, the reservoir was so heavily silted that a bypass water line was needed to pass flows around the reservoir, indicating that the raw water intakes at the dam site were no longer usable for water supply purposes. Photographs taken in 1997, during the installation of the trash racks on the low level intake pipes, clearly show sediment buildup in the lower end of the reservoir (refer to Figure 2-3). Consequently, it appears that the majority of the sedimentation within the reservoir occurred between 1923 and 1961 when the watershed was being converted from farmland to residential type development. As such, it is difficult to estimate the current rate of sedimentation. With the majority of the watershed in a stabilized residential condition, the most likely source of sedimentation is expected to be from stream bank erosion. The trap efficiency of the reservoir is also decreasing with time causing more suspended sediments to pass through the reservoir and be transported over the spillway and downstream of the dam. Gannett Fleming performed a bathymetric survey of the reservoir in July 2015. Topography above normal pool was supplemented with County Lidar data. The 2015 bathymetric survey confirms the presence of significant sediment deposits throughout the reservoir. Figure 4-9 compares the top of sediment surveyed in 2015 against the original contours shown on the 1923 construction drawings and depicts the depth of sediment within the reservoir. Approximately 46,800 cubic yards (29 acre-feet) of sediment is estimated to be deposited in the Milltown Dam reservoir. Figure 4-8 compares the storage volume of Milltown Dam at normal pool as depicted on the 1923 construction drawings to the bathymetric survey performed by Gannett Fleming in 2015. According to this information, approximately 63 percent of the reservoir storage has been displaced with sediment.

Using County LiDAR data, the current surface area of reservoir is estimated to be $10\pm$ acres at normal pool and 27+ acres at top of dam which extends upstream of East Strasburg Road. The reservoir storage volume is calculated to be approximately 17 acrefeet at normal pool and 104 acre-feet at the top of dam elevation.

Reservoir sedimentation at Milltown Dam is expected to continue. Over time, the upstream end of the lake would continue to infill with sediment and become overgrown with wetland vegetation. Eventually, if no action is taken to dredge the reservoir, an equilibrium would be reached where the reservoir area would consist of a stream channel through the reservoir with shallow wetlands within the channel overbank areas. Should the Township choose to maintain the dam, it is recommended that the Township plan for a future dredging project.

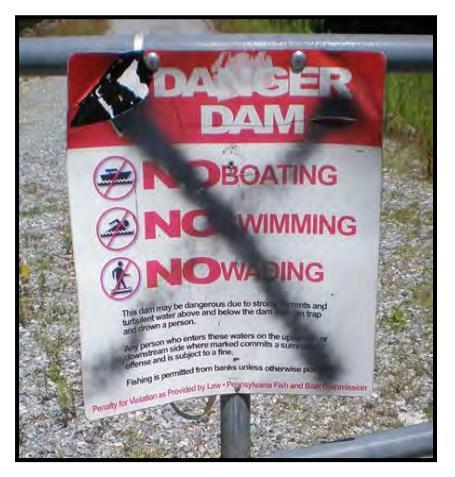
The Township currently operates Milltown Dam as a recreational facility. The dam is located in a highly urbanized setting and pedestrian access to the dam and reservoir is allowed. The Township reports that vandalism is a recurring concern. Vehicular access to the crest of the dam is prohibited by a swing gate along Reservoir Road at the right abutment. This gate has a warning sign indicating that no boating, swimming and/or wading is allowed (refer to Figure 2-4). Graffiti was observed on the warning sign at the time of the August 4, 2015 visual inspection (refer to Figure 4-11). Chain-link fence is installed at the top of the left and right spillway

Figure 4-11 Warning sign on swing gate.

- Replacing the existing warning sign located at the right abutment of the dam so that it is legible. The warning sign should be displayed at a location which is clearly visible to the public before they enter the property.
- Adding a second warning sign at the left abutment to warn pedestrians who approach the dam from the east.
- Adding fencing or handrail along the top of the spillway walls to reduce the risk of falling into the spillway.
- The existing parking area off of Reservoir Road has limited site distance to the south which presents a safety hazard to the traveling public as vehicles enter and leave this parking area. Consider adding additional parking to the north.

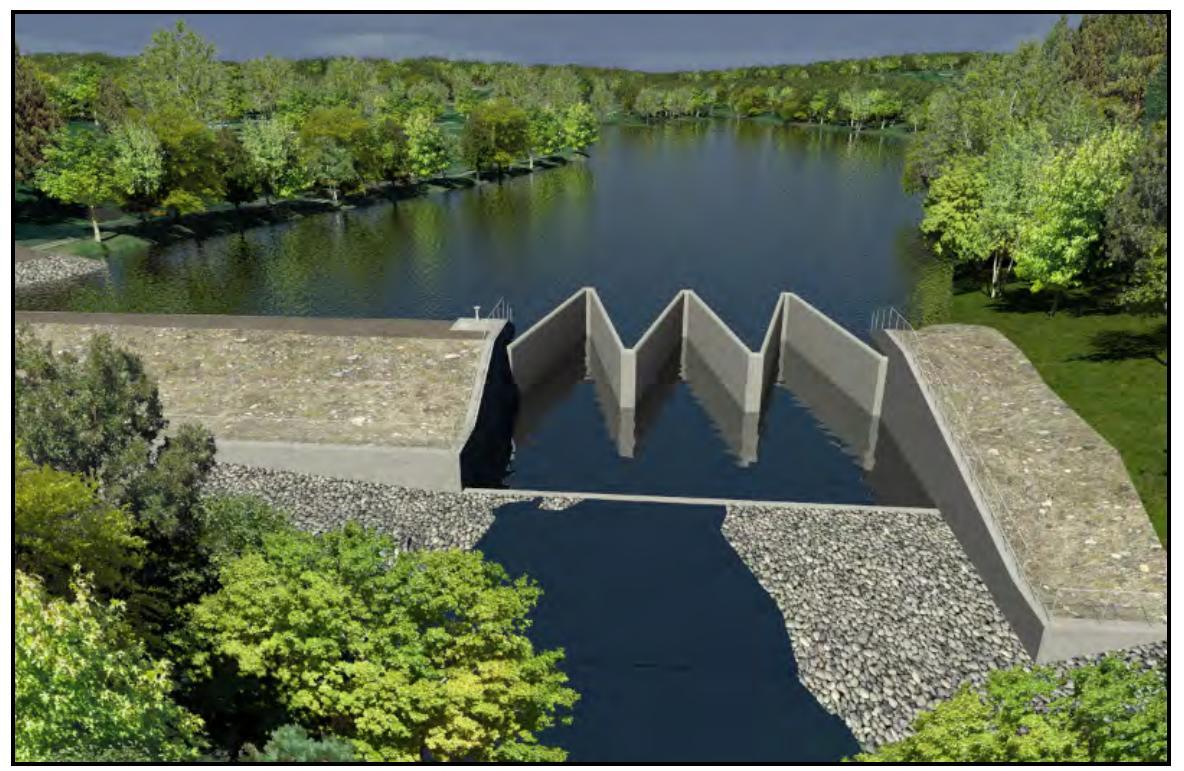
Figure 7-12 Alternative 5 – Spillway Improvements

The spillway would be widened to from 69- to 100-feet in order to accommodate a three cycle labyrinth spillway. The reservoir area immediately upstream of the spillway would be excavated to accept the labyrinth spillway section and prevent the submergence of the control section during the SDF. It is critical that this area remain free of sediment in order to maintain the approach depth and performance of the spillway. As such, the Township would need to implement a monitoring and dredging program to keep this area free of sediment. New spillway retaining walls would be required which would approach 28-feet in height. It is anticipated that the floor of the spillway channel would be protected with a reinforced concrete slab which would extend downstream and serve as a stilling basin. Beyond this point, the spillway discharge channel would be transitioned to match the geometry of East Branch Chester Creek.

The proposed improvements associated with Alternative 5 also include reconstruction of the valve vault and the low level dewatering system. It is anticipated that these features would be incorporated into the right spillway training wall.

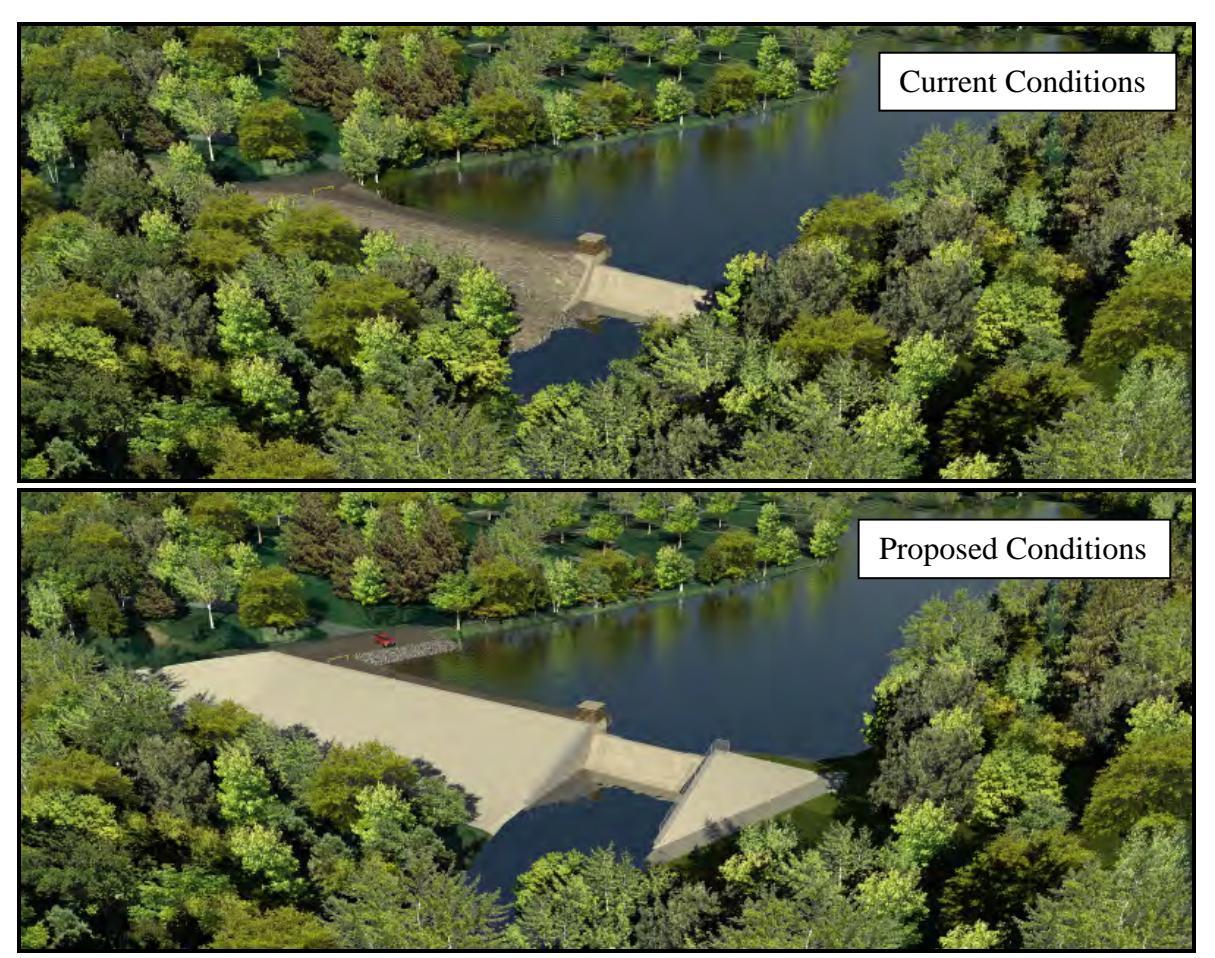
Figure 7-13 Alternative 6 - ACB Embankment Overtopping Protection

Based on the anticipated overtopping depth (approximately 4 feet), the use of articulated concrete blocks are considered to approach their upper performance limits for this application. PADEP generally does not approve of the use of ACBs for embankment overtopping depths greater than 4-feet due to limited laboratory test results under these high-head conditions.

Alternative 6 converts the entire crest of the dam into an auxiliary spillway with a 280foot \pm length. The overtopping protection includes grading the downstream embankment slope to 3H:1V and installing a geotextile, aggregate drainage layer and geogrid to prepare the ACB foundation. The ACB mats are laid on the prepared surface with each adjoining mat connected to each other by the use of laced steel cable connections. This results in a continuous mat of concrete blocks over the armored embankment. The sides and downstream edges of the ACB coverage are toed down into a trench that is either rock-lined or armored with A-jacks. The downstream limit of the ACB system is set at a location where the erosive velocity of the flow over the embankment no longer threatens the integrity of the embankment. For the purpose of this study, a run-out length of 30feet was assumed beyond the downstream toe of the embankment. Figure 7-14 provides photographs of a typical ACB embankment armoring project.

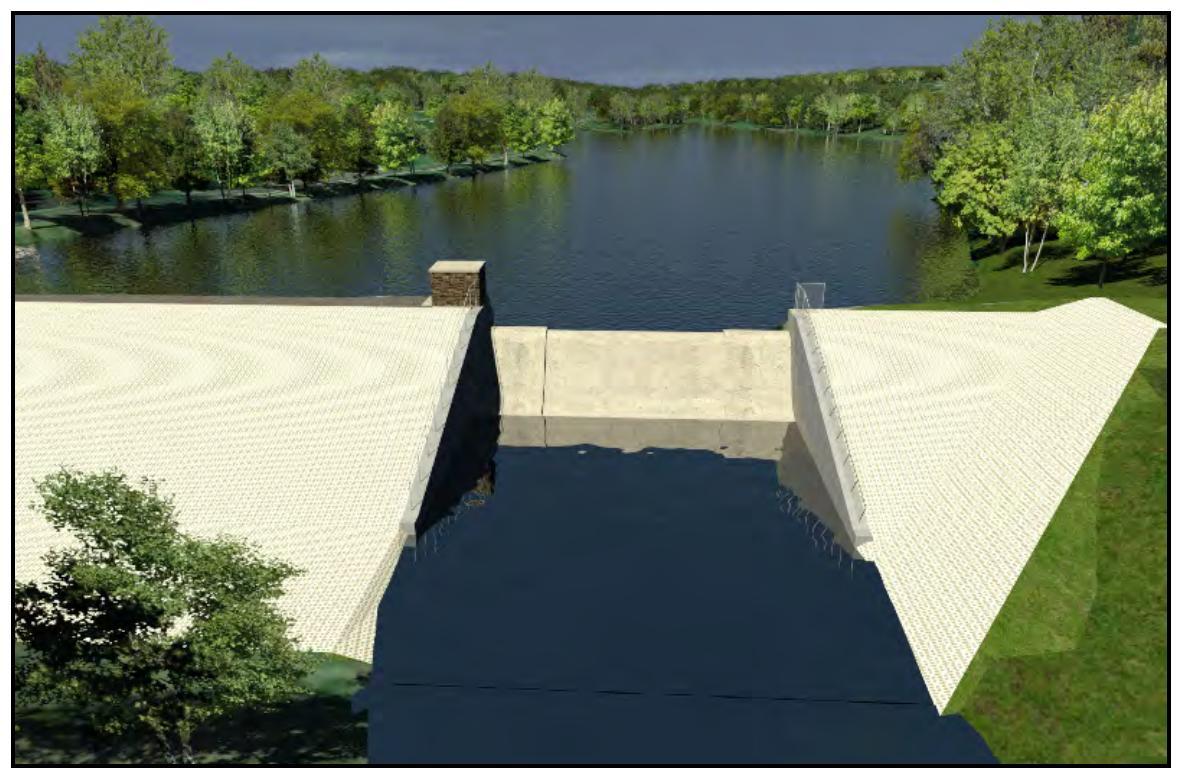
Figure 7-15 Alternative 6 – Spillway Improvements

Figure 7-13 compares the current site conditions to the proposed Alternative 6 conditions. Figure 7-15 provides an enlarged view of the proposed spillway modifications, which for this option, only involves the raising and extension of the downstream left and right training walls which are needed to accommodate the flattened downstream embankment slopes. Refer to Sheet Nos. E6-1 and E6-2 in Appendix E for plan and cross sections of the proposed Alternative 6 improvements.

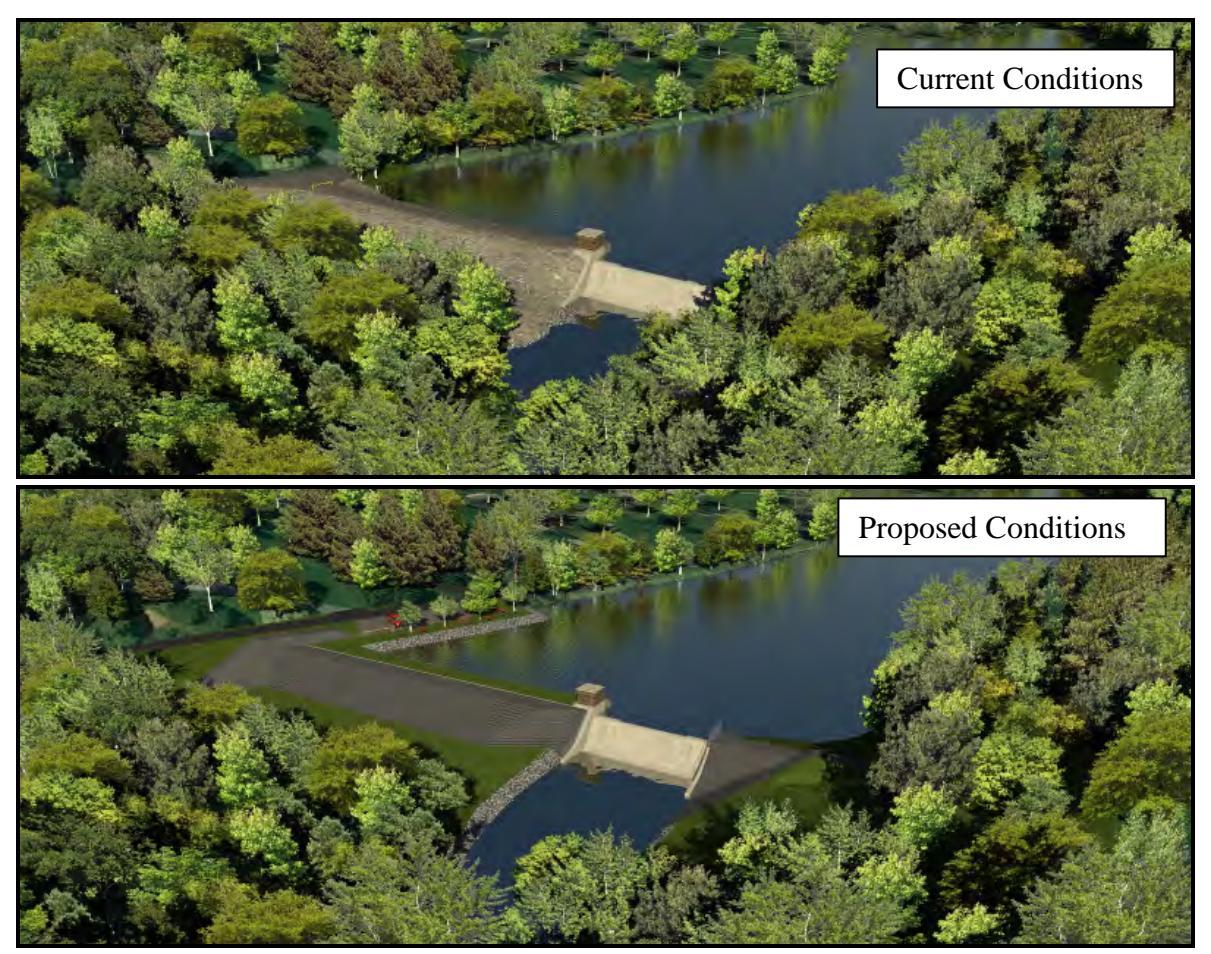
Figure 7-16 Alternative 7 - RCC Embankment Overtopping Protection

Alternative 7 converts the entire dam into an auxiliary spillway with a 270-foot length. The overtopping protection starts by excavating the downstream toe of the dam down to bedrock (refer to Figure 7-17). The RCC would be founded on bedrock and placed in horizontal lifts (typically one-foot in thickness) to form a stepped face over the entire downstream embankment. A drainage layer is proposed under the RCC to reduce any uplift pressure.

Similar to Alternative 6, the interaction of Milltown Dam and Reservoir Road introduces additional hydraulic concerns. Water flowing over/along Reservoir Road can potentially breach the dam at the right abutment. To address this concern, it is proposed that the top of dam be lowered to the top of the concrete cutoff wall (a 1.8-foot lowering of the top of dam to El. 345.7) in conjunction with raising Reservoir Road by approximately one foot in the vicinity of the right abutment to prevent extreme flood flows from discharging down Reservoir Road and bypassing the RCC overtopping system. This would force the SDF to pass over the RCC slope protection.

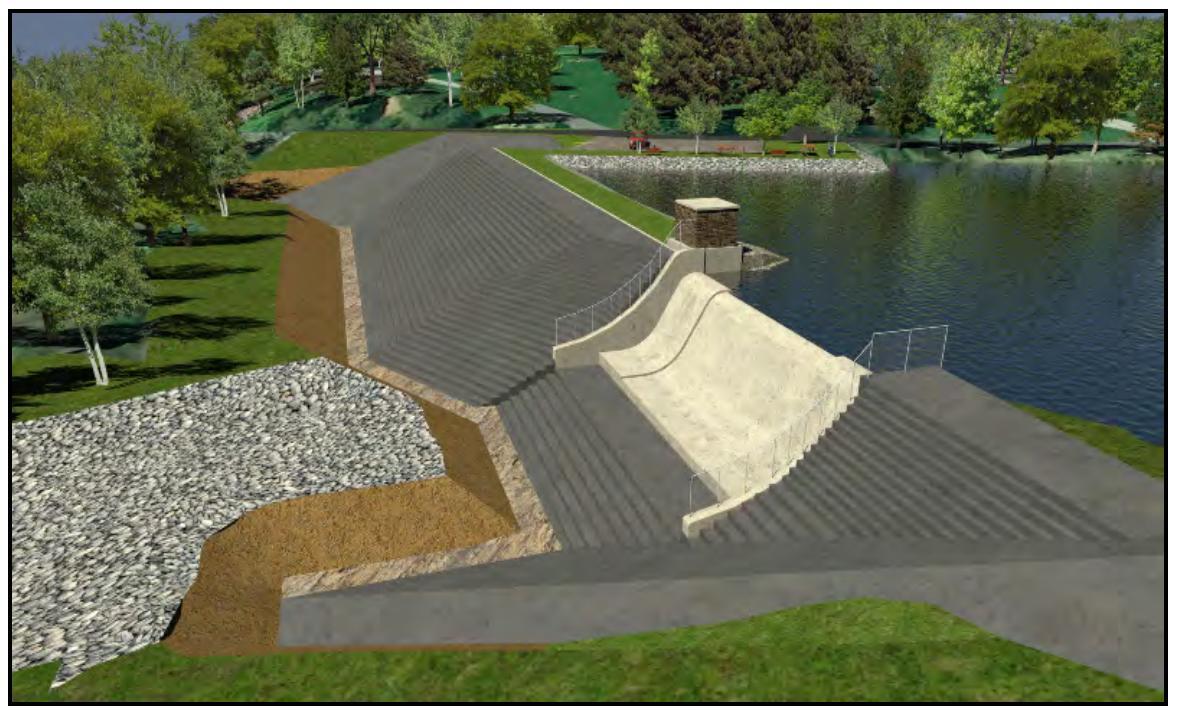
Figure 7-17 Alternative 7 - RCC Placement – Temporary Excavation to Bedrock

- Strip downstream face of the embankment, install drainage layers and armor with RCC.
- Extend RCC to bedrock at downstream toe of the embankment in order to provide a condition that would adequately protect the dam embankment during an overtopping event. Figure 7-17 shows the full height of the RCC placement extending from bedrock to the top of dam. Figure 7-18 shows the final RCC configuration after the excavation needed to found the RCC on bedrock has been backfilled.

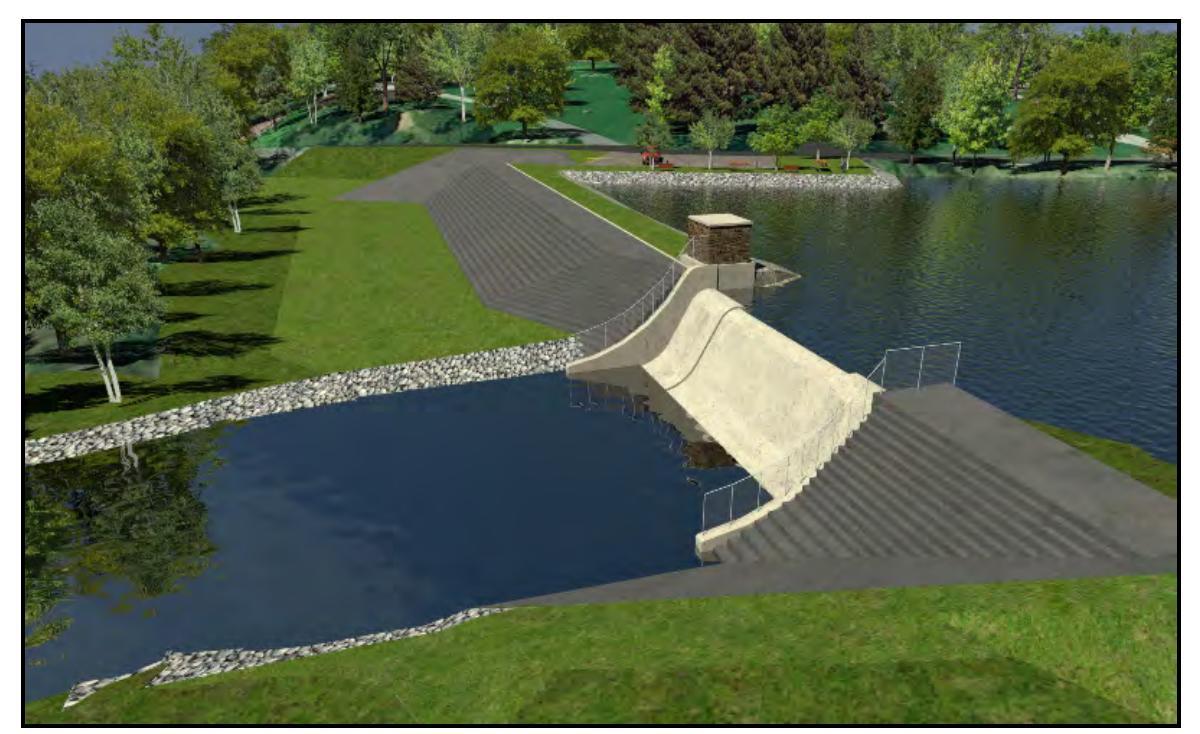
Figure 7-18 Alternative 7 - RCC Placement – Final Conditions

The proposed improvements associated with Alternative 7 do not impact the existing spillway. However, RCC would be placed within the downstream stilling basin to provide scour protection and buttress the end sill of the existing spillway in order to encapsulate the erodible material beneath the existing spillway.

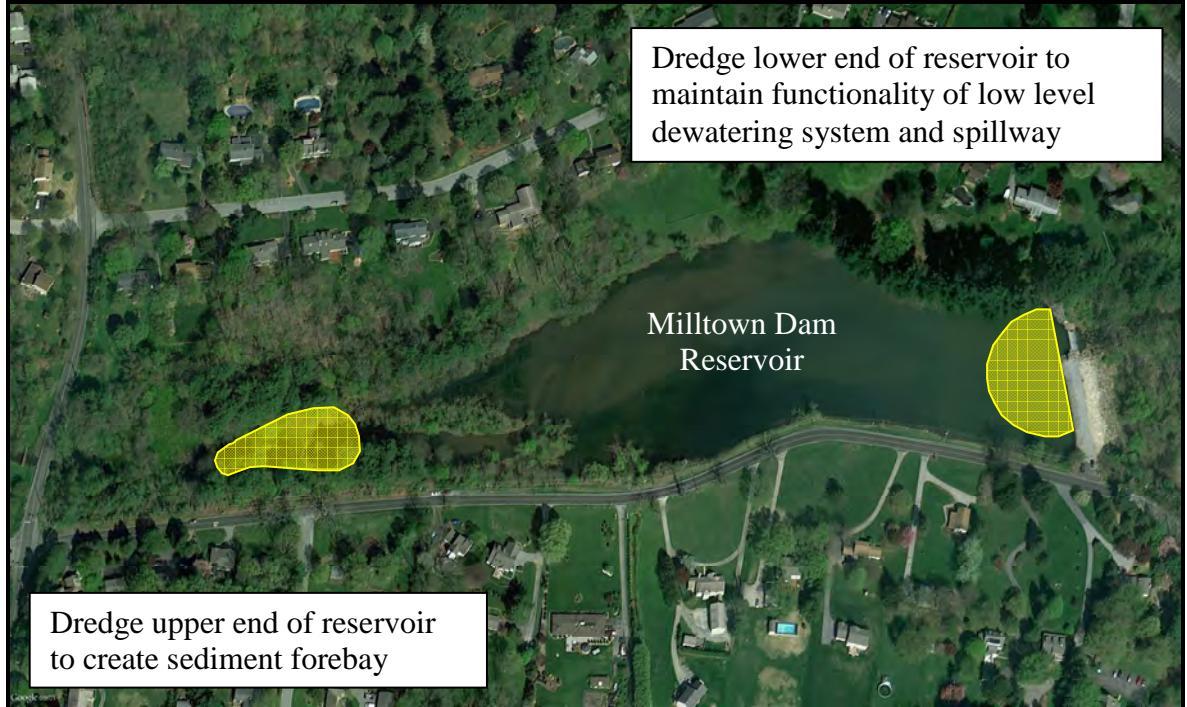
Figure 8-4 Partial Dredging Locations for Milltown Dam Reservoir

Consideration may be given to excavating the sediment deposits within the upper end of the reservoir to create a sediment forebay. The intent of the sediment forebay is to trap the incoming sediment deposits to reduce the amount of sediment deposition in the downstream portion of the reservoir. It is recommended that vehicular access be provided to the forebay to facilitate routine cleanings in the future. A conceptual plan showing the locations for the partial dredging concept is provided in Figure 8-4.

The extent of dredging can be tailored to accommodate the Township's budget. However, for the purpose of establishing a cost associated with the dredging shown in Figure 8-4, the following assumptions are made.

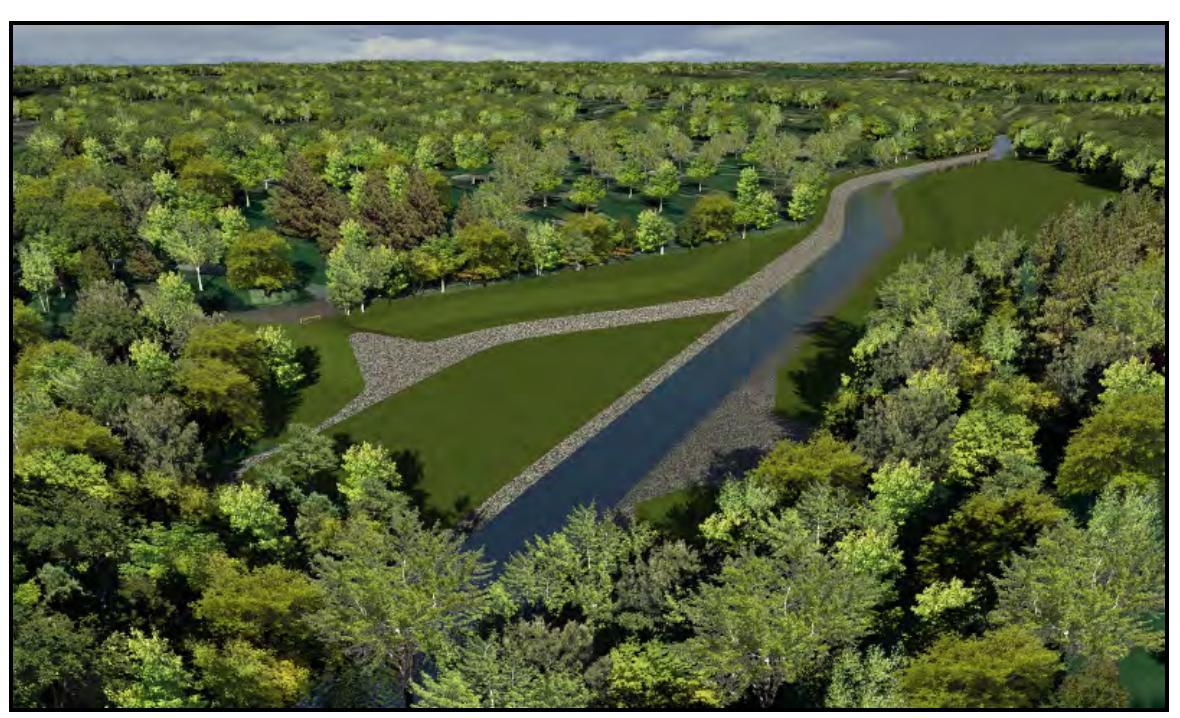
A variation of this option is to construct a pilot channel through the reservoir that mimics the original stream bed alignment and grade, leaving the sediment in the left and right overbank areas in place. This option is portrayed on Sheets F1-1 and F1-2 in Appendix F and in Figure 9-1.

Figure 9-1 Dam Decommissioning Alternative
The vertical alignment of the pilot channel is established by connecting the existing elevation downstream of the dam with a uniform slope to the historic streambed elevation at the upstream end of the reservoir near the culvert under East Strasburg Road. The horizontal alignment of the pilot channel also attempts to mimic the original stream bed as shown on the 1923 construction drawings with the upper and middle reaches of the pilot channel aligned against the western shoreline and the lower reaches of the pilot channel aligned against the eastern shoreline. The material excavated from the breach and through the reservoir can be spoiled within the reservoir on both sides of the pilot channel. Based on the volume of excavation, it is anticipated that the majority of the remaining reservoir would be required for spoiling activities, assuming that the material is spoiled no higher than the top of dam elevation. Spoiling activities may impact adjacent properties depending on how the spoil pile is configured.
