Milltown Dam (DEP ID No. D15-146) Dam Assessment and Alternatives Analysis

MILLTOWN DAM DAM ASSESSMENT AND ALTERNATIVES ANALYSIS

FINAL REPORT

MARCH 2016

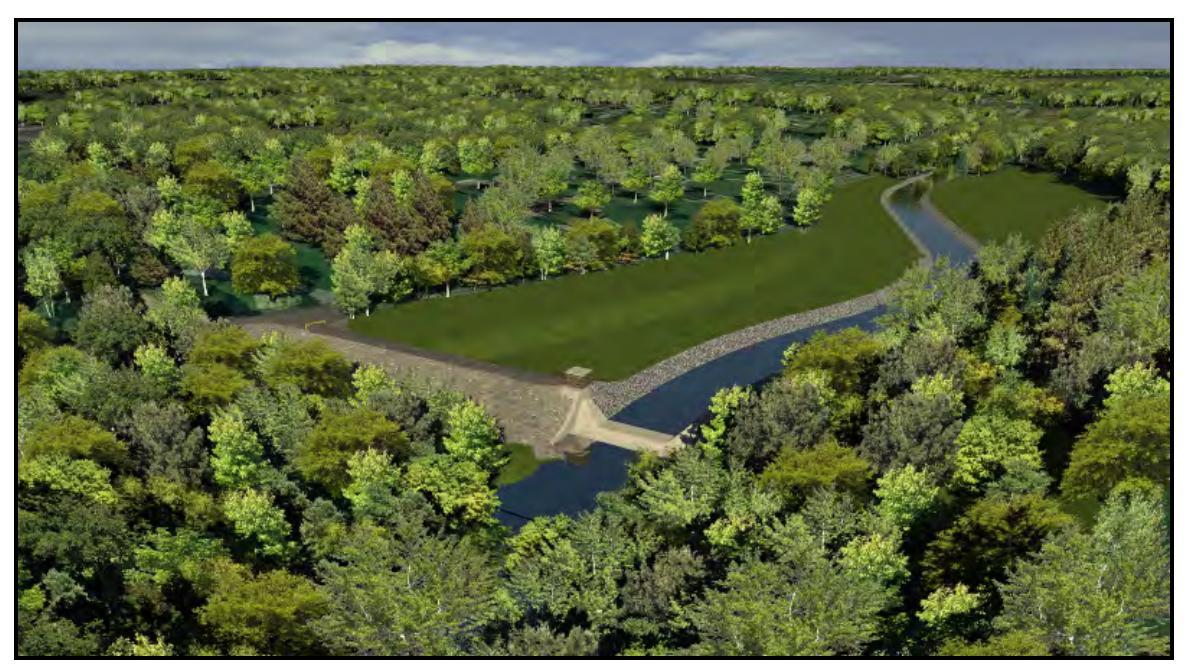
Figure 9-2 Partial Breach Alternative

One option (Alternative 9) would be to lower the existing spillway crest to elevation 331.5 (refer to Sheets F2-1 and F2-2 in Appendix F) and raise the top of dam by approximately one foot to elevation 348.5 to pass the SDF through the spillway without overtopping the dam (assuming that the dam retains its C-1 High Hazard classification). A shallow pilot channel (approximately five feet at its maximum depth) could be excavated through the sediment layer to channelize and direct flows through the lowered spillway. This option allows the majority of the sediment deposits to be left in place and essentially converts the reservoir into a dry pond, only filling during larger storm events. Additional structural investigations would be needed to determine if the integrity of the existing concrete spillway can be maintained with the center of the spillway lowered to elevation 331.5. For this option, the Township would continue to own and operate Milltown Dam as a regulated structure and the Township can expect to incur the annual operation and maintenance costs as identified in Section Six.

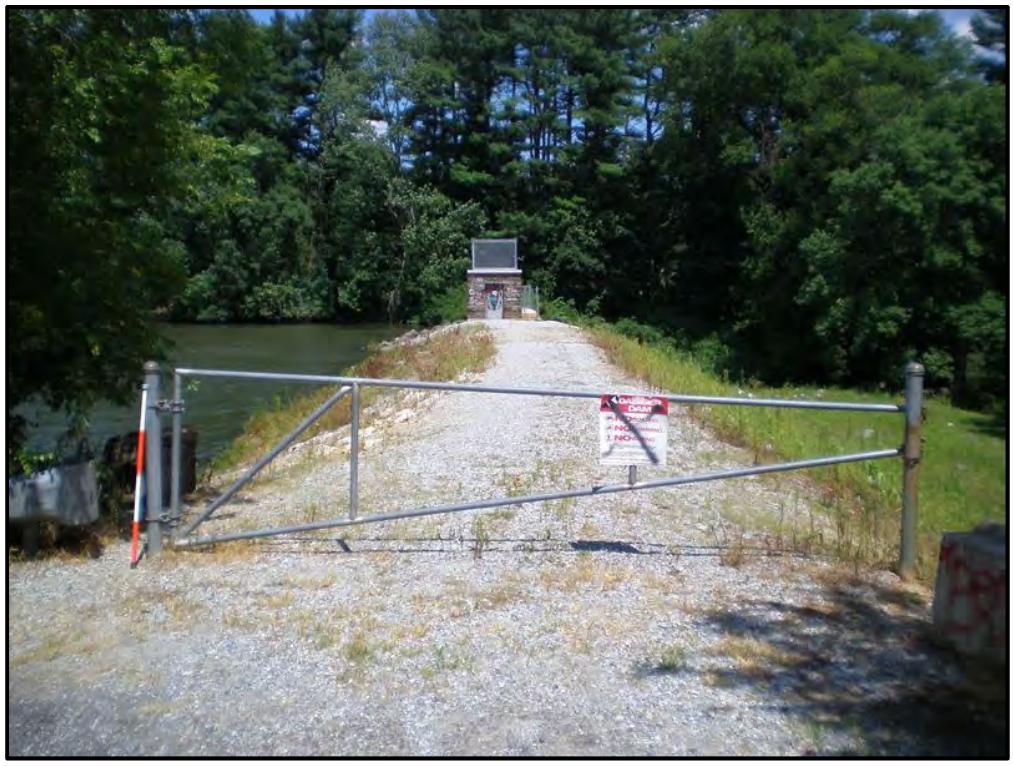
Photo C-1 Standing on Reservoir Road looking across top of dam towards left abutment.

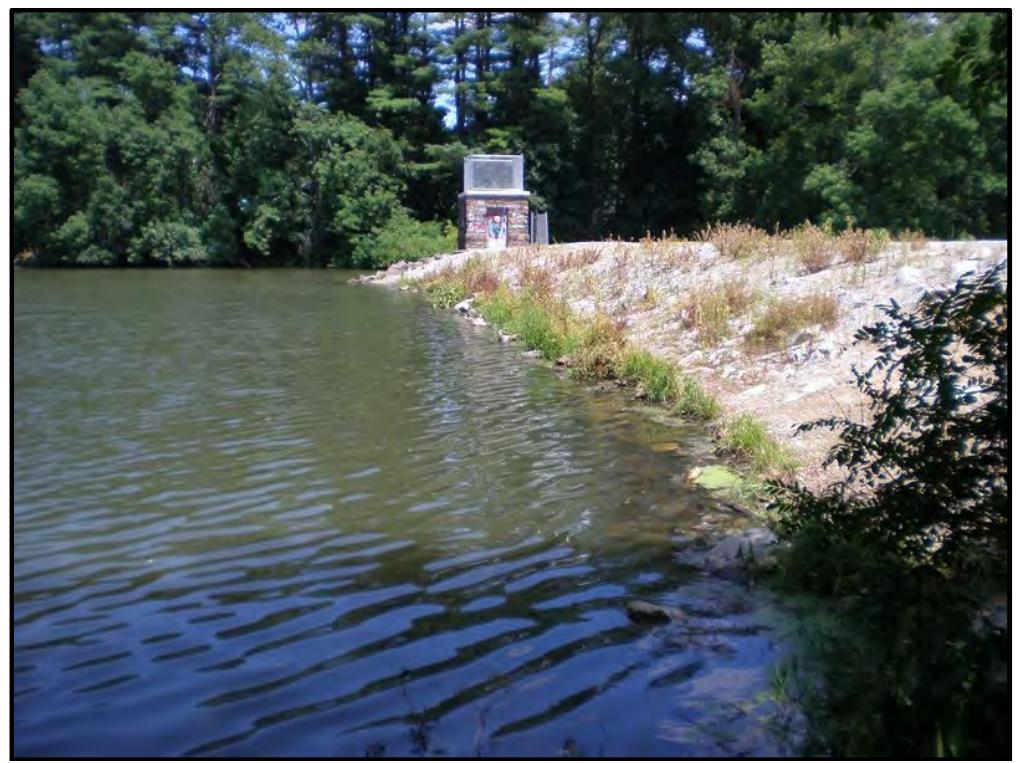
Photo C-2 Looking across upstream face of dam towards left abutment.

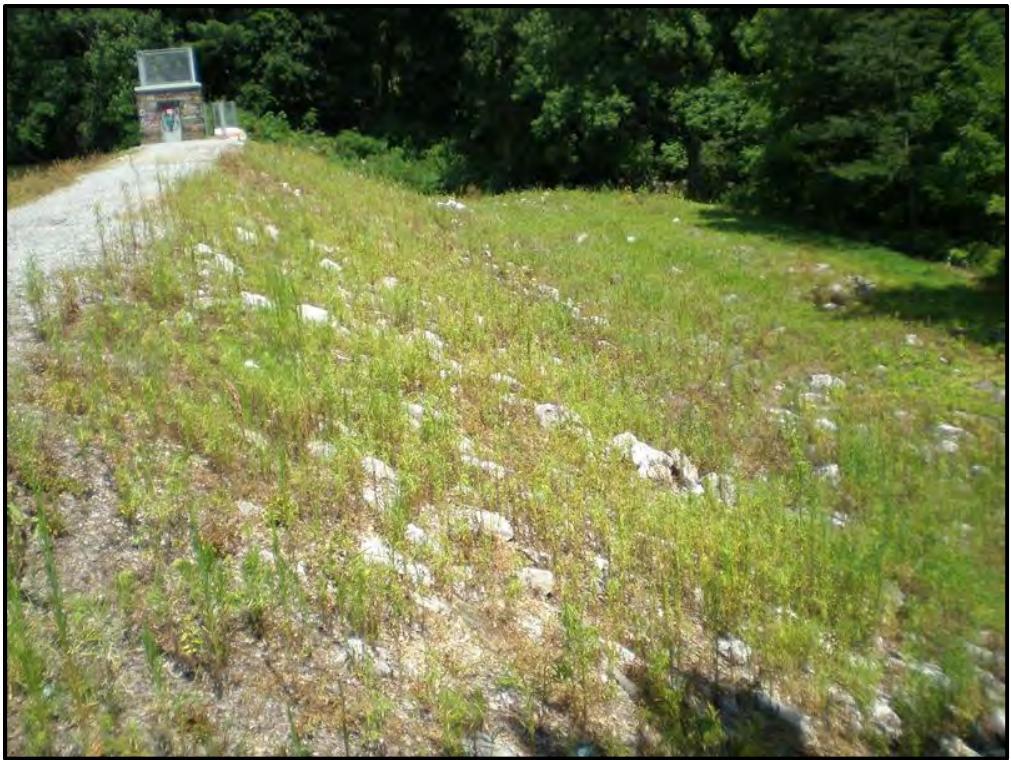
Photo C-3 Looking across downstream face of dam towards left abutment.

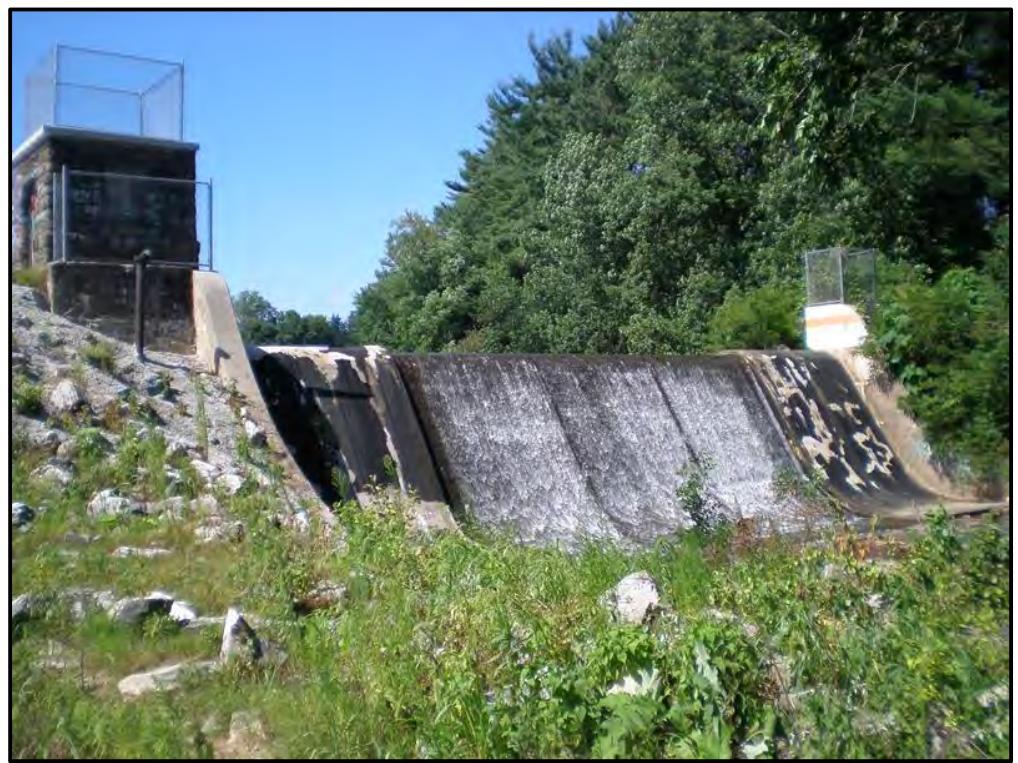
Photo C-4 Looking upstream at downstream face of principal spillway.

The 2015 annual inspection identified dislodged and missing riprap within the stilling basin located immediately downstream of the principal spillway. The dislodged riprap has been moved downstream by high spillway flows. It is recommended that the scour protection be replaced or alternate methods implemented to prevent scour and undermining of the principal spillway. For the purpose of establishing a cost of this repair, it is assumed that the missing riprap will be refreshed by moving riprap found within the stream back into the stilling basin. For the purpose of this cost estimate, it is assumed that this work will be performed by a Contractor and not by Township forces. Assume work can be completed within one week which includes mobilization, developing site access, performing instream work activities, site cleanup/stabilization and demobilization activities.

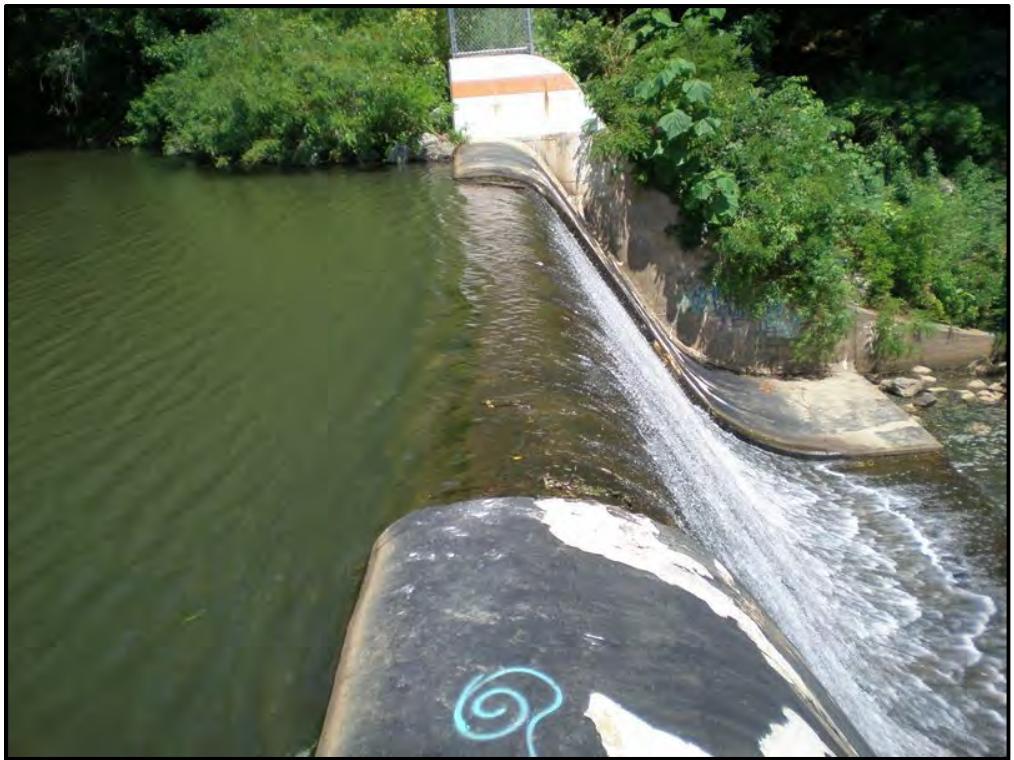
Photo C-5 Looking across the Principal Spillway crest towards left abutment.

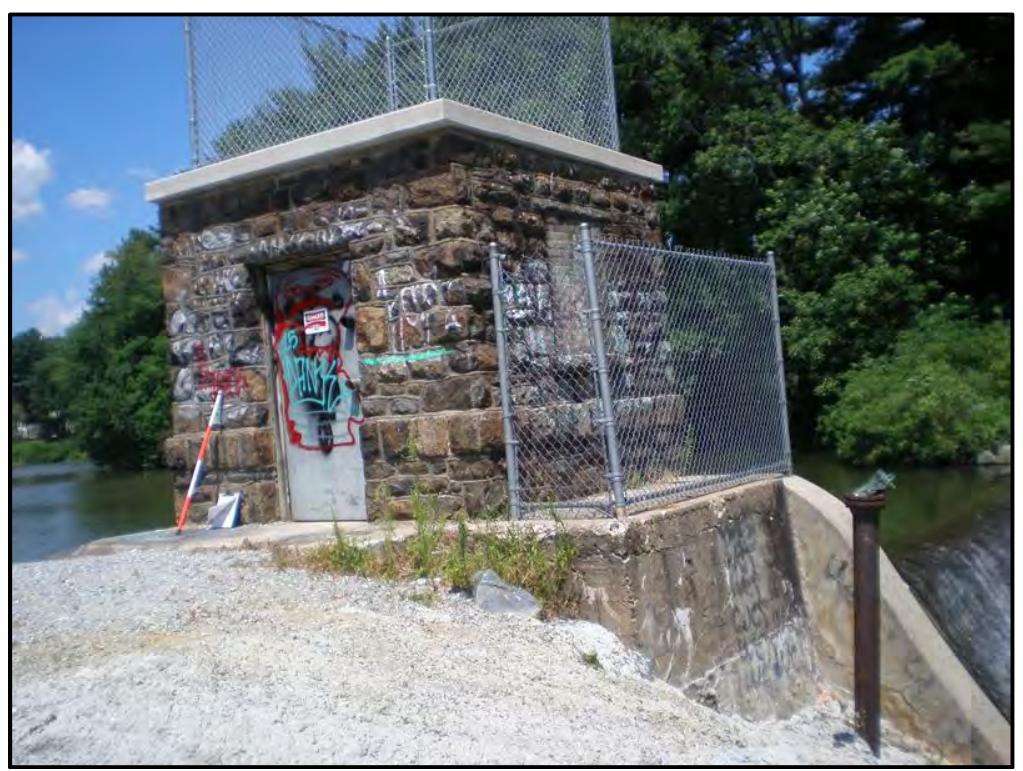
Photo C-6 View of Valve House.

The 2015 annual inspection identified a damaged/missing top support rail on the chain link fence immediately adjacent to the Valve House. Assume that this can be repaired by Township maintenance personnel. Assume work can be completed within two hours using a two man crew.

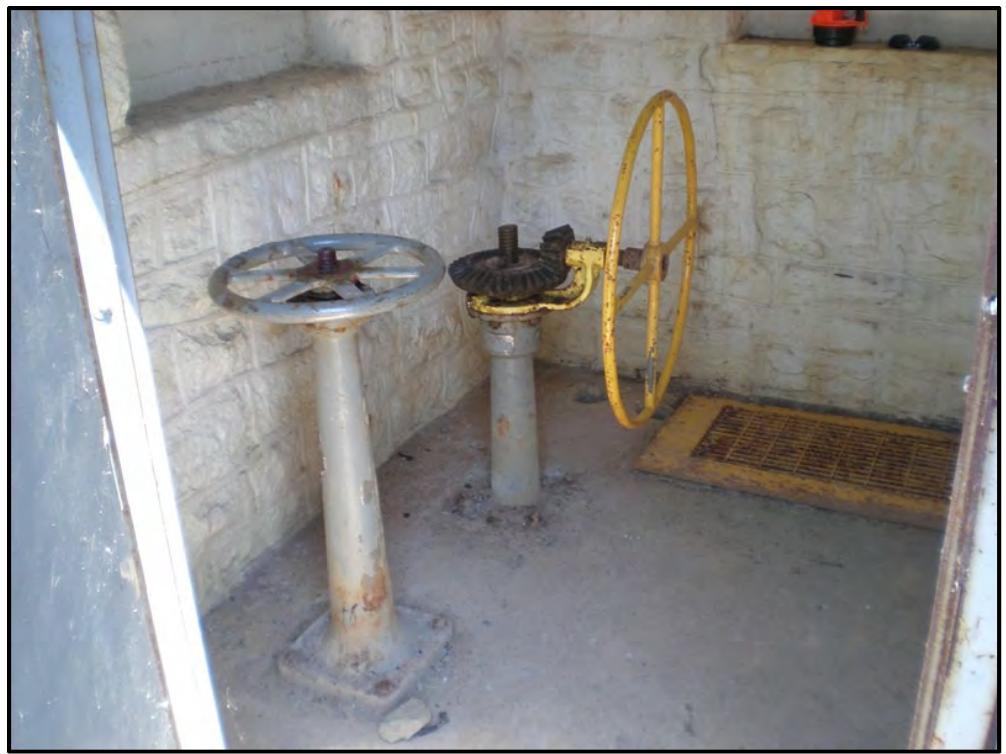
Photo C-7 View of interior of Valve House and upstream gate operators.

The Township has identified a need to replace the two upstream sluice gates located within the Valve Chamber. The Township received bids for this work in 2014 which ranged between \$70,620 and \$113,400. For the purpose of this study, it is assumed that the replacement of the two sluice gates will be required should the Township choose to maintain the dam. Based on the historic bid prices from 2014, assume a cost of \$90,000 for this work activity (average of high and low bids).

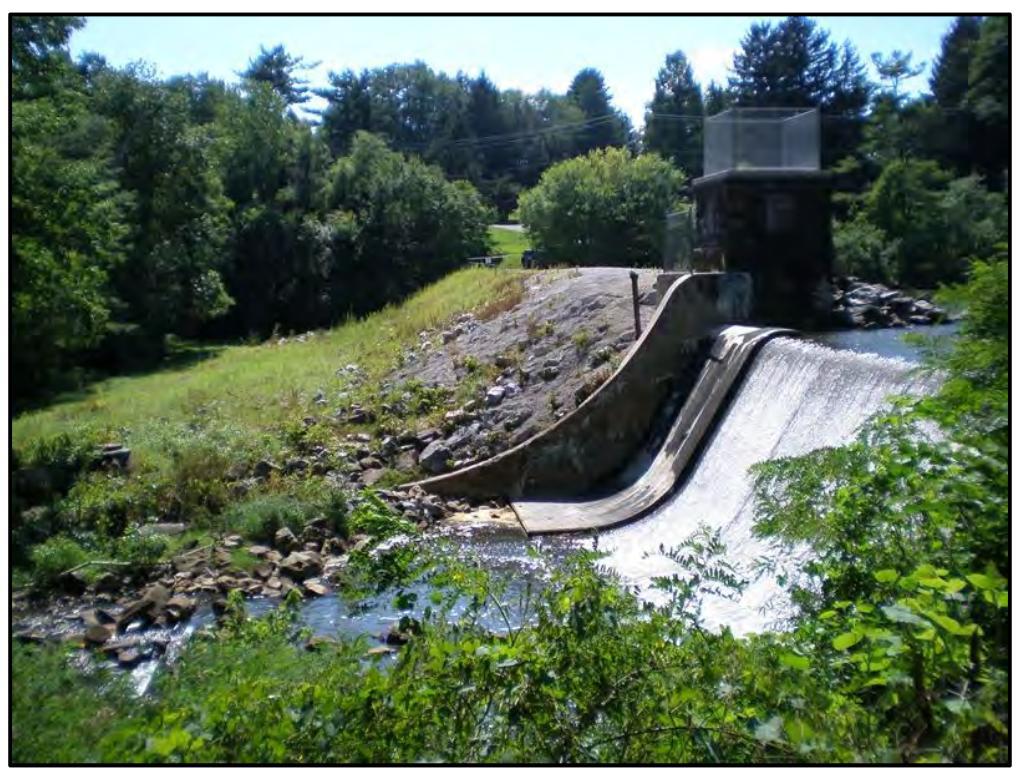
Photo C-8 Looking across downstream face of dam towards right abutment.

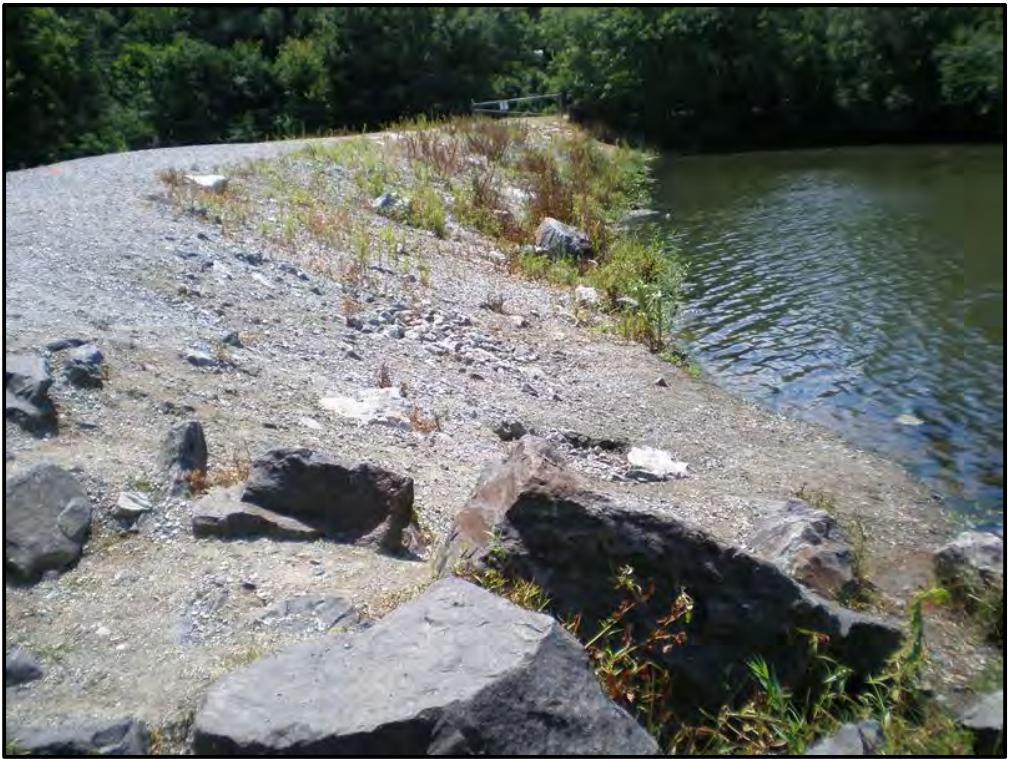
Photo C-9 Looking across upstream face of dam towards right abutment.

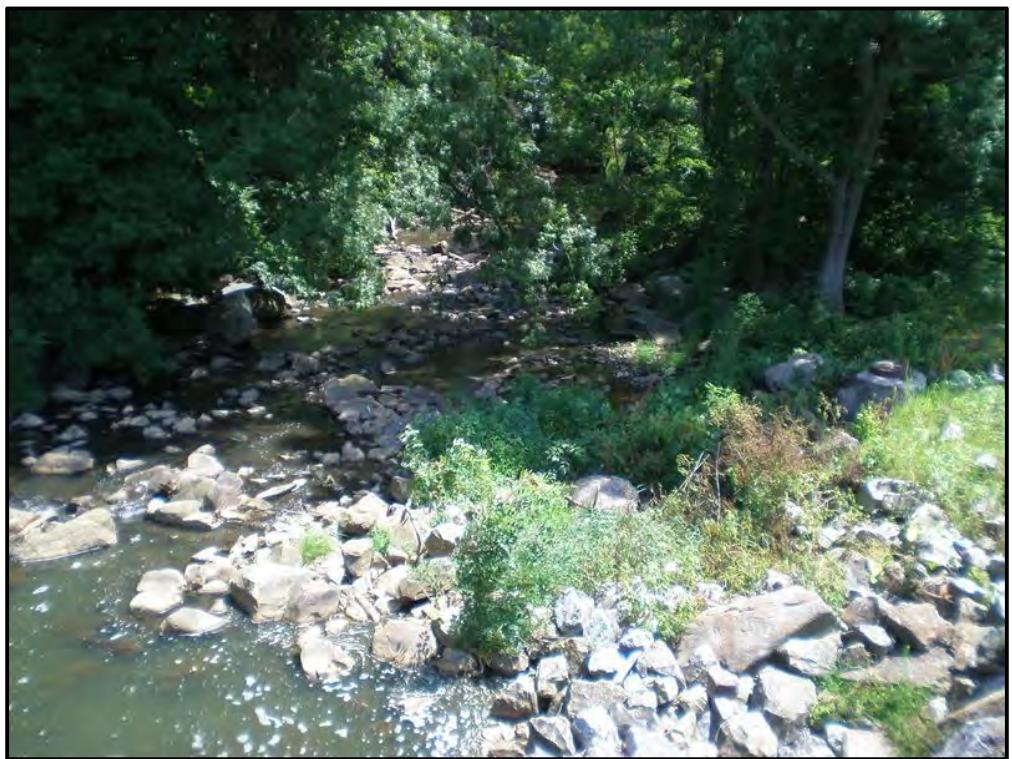
Photo C-10 Looking downstream at receiving channel (i.e., East Branch Chester Creek).
