Re: Report on subsidence issue, East Goshen Township, Chester County, Penna.

Sasowsky Earth Science Consultants (SESC) has completed our desktop study of reported subsidence observed in East Goshen Twp., Chester County, Pennsylvania. This work was conducted based upon our agreement dated December 8, 2020. The letter report below describes our approach, findings and conclusions.

## **Depression Adjacent to Route 352 near Anne Drive/Bow Tree Drive East Goshen Township, Chester County**

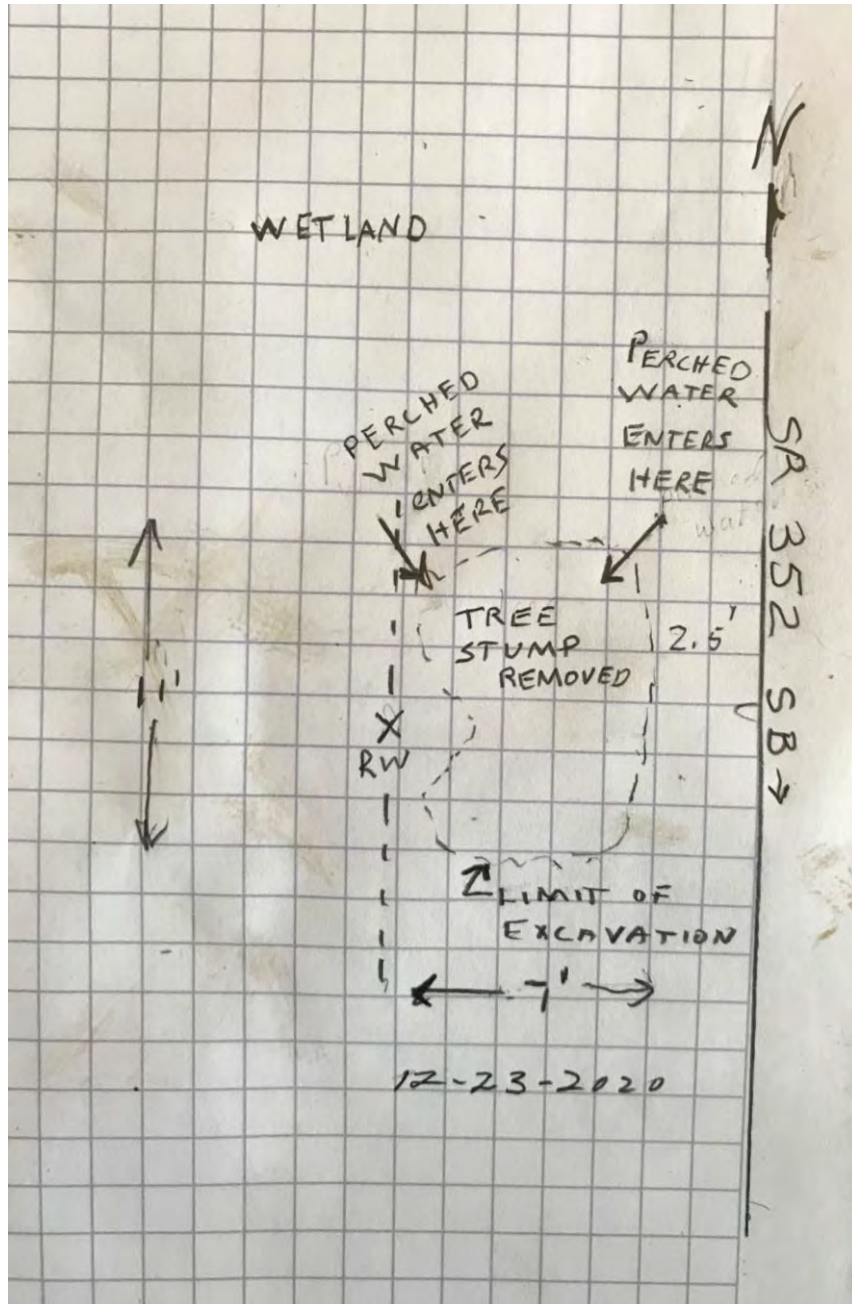
PENNDOT TEST PIT LOG - PENNDOT GINT 12-18-2013 PM 6:07 - 12/19/13 13:47 - SUBBUREAU OF CONSTRUCTION & MATERIALS/PROJECTS/FILE TO PRINT BLANK FORMS - FULL ROCK LEGEND - FULL SOIL LEGEND - 12-19-2013 GPJ

The subsidence adjacent to the southbound shoulder of Route 352 appears to be caused by the presence of silty clay at a depth of 2.3 feet below the road grade. This conclusion was reached based on careful excavation of a 7-foot-by-11-foot test pit (TP-1) roughly centered on the location of the depression. In addition to the silty clay, a tree stump was excavated from the test pit. Decay of the stump may also have contributed to the subsidence at this location. During the excavation, surface water was observed running along the top of the silty clay layer. Perched surface water can also potentially contribute to subsidence. Additionally, there was no evidence of subsidence or distress on the adjacent roadway.

BOTTOM OF HOLE = 3.3' 3-60  
 FROM GRADE

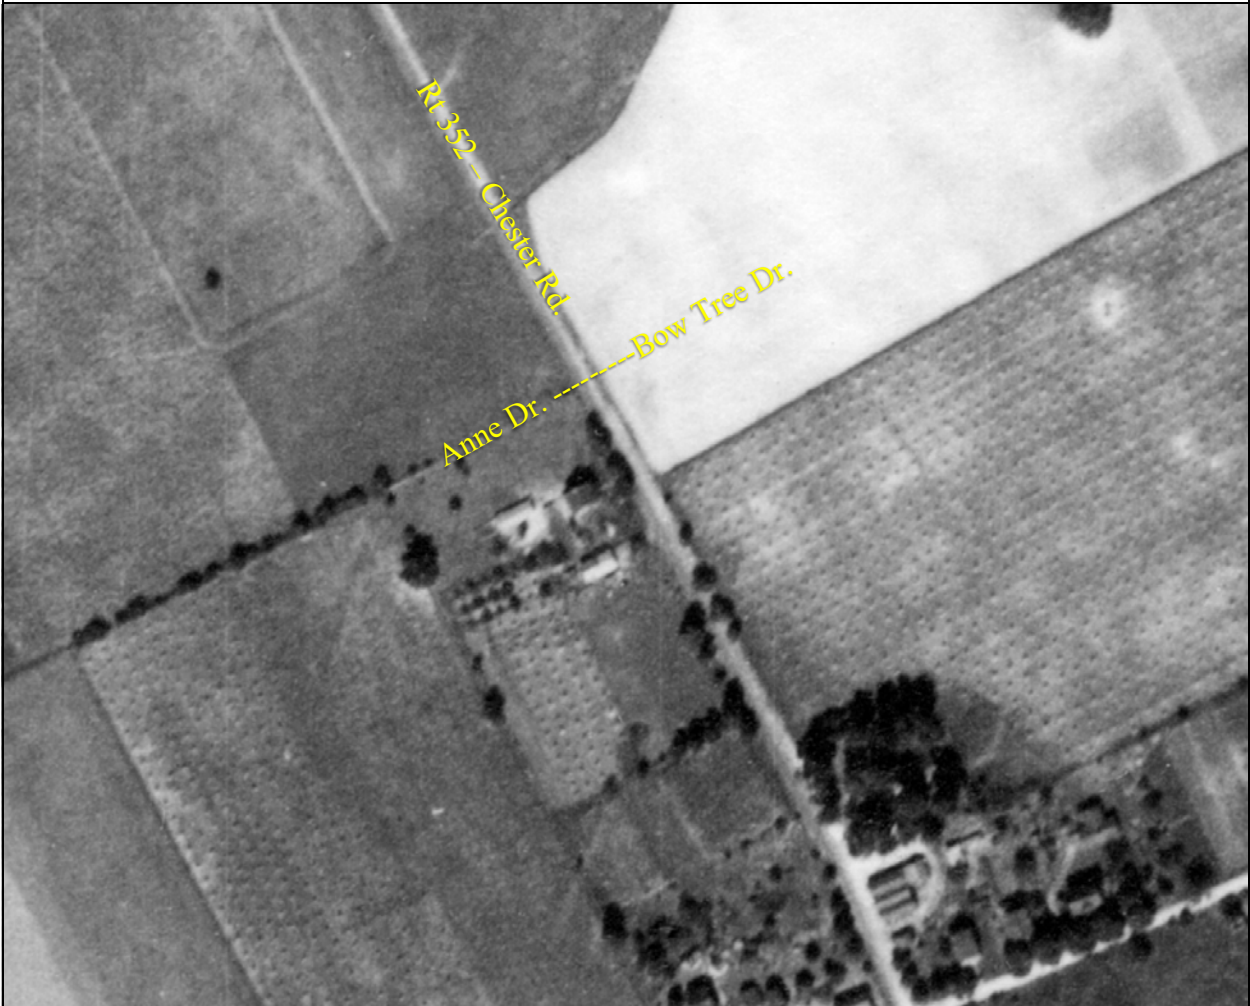
The photos show 3 items of interest. First, a residence, as well as several outbuildings, were present on the lot in various configurations from the earliest photo 1937 to 1992. In 1999 the structure is absent based on Google Earth photo. What remains observable is a paved/stoned apron leading from Chester Road on to the lot. Second, for much of the time period covered, there were trees of substantial size growing along the roadway including in the area of the depression. Finally, there is not apparent subsidence at the location historically.
