# Memorandum DRAFT

DATE: July 9, 2025

RE: East Goshen Municipal Authority  
Sequencing Batch Reactor (SBR) Tank #1

SUBJECT: Structural Assessment Memo

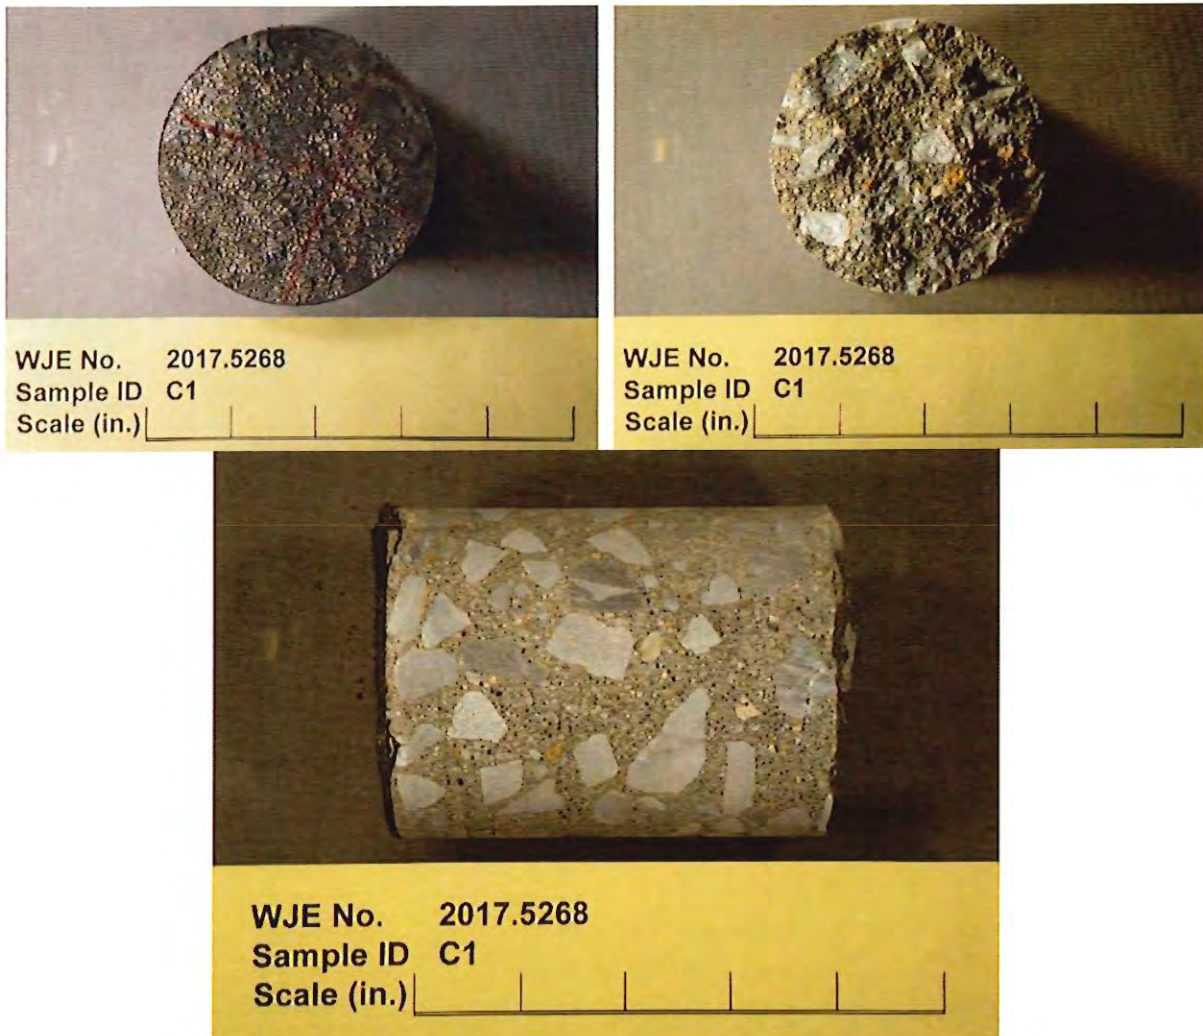
Two concrete cores 3-1/4 inches in diameter were received from Pennoni on August 25, 2017, for our studies. The cores had been extracted horizontally through adjacent vertical interior walls of SBR Tank #1 at WP-32. They were not full depth, and had fractured at a depth of 4-1/2 and 5-1/2 inches, respectively, within the concrete wall. The exterior surface of both cores contains a black coating membrane reported to be the CIM 1000 coating. For this report, the exterior surface of the cores represents the interior formed tank walls on which the coating was applied. The interior surface of the cores represents the fracture surface within the tank wall. No reinforcement was intersected by either core. The as-received appearance of the samples is presented in Figures 2 and 3.

*Figure 2. The as-received appearance of the exterior coated surface (top left), the interior fracture surface (top right), and the side of Core C1 is pictured.*

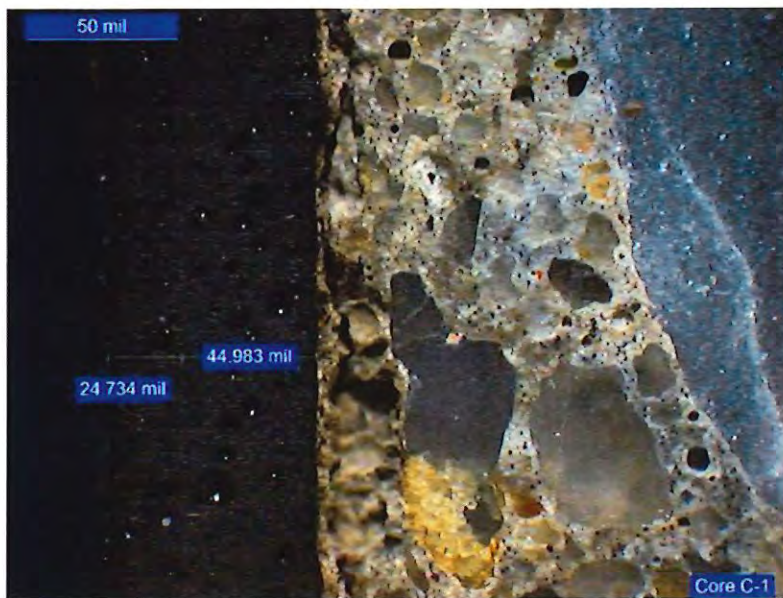
The exterior surfaces of Cores C1 and C2 were covered with a black coating material presumed to be CIM 1000. The material was elastic when probed with a steel needle. Two applications (Figure 5), and possibly three in some areas (Figure 6), of the coating were detected on the exterior surface of both cores. The average dry film thickness (DFT) for the coating layers on both cores is provided in Table 1. The exterior surface of the coating on the cores was discolored and cracked in an “alligator crack” pattern (Figure 7). No pinholes were detected within the exterior surface of the coating. Beyond the distress visible on the exterior surface of the coating, no degradation of the coating was detected within the cross-sectional surfaces of the cores. Spherical air voids were detected within the body of the CIM 1000 layers.

*Figure 5. Two applications of the coating were detected on the exterior surface of both cores, pictured for Core C1. At this location, the first application of the coating is measured to be 44.983 mils DFT, and the second application is 24.734 mils DFT.*

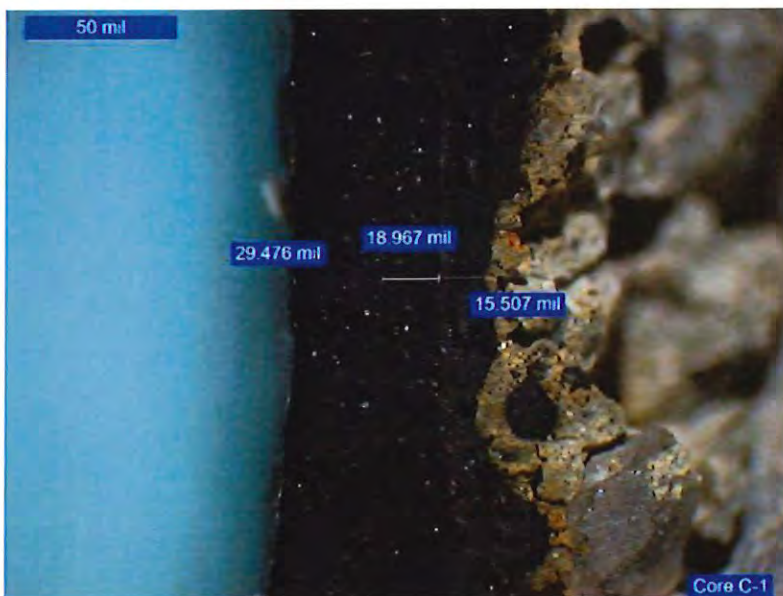
*Figure 6. At the location pictured for Core C1 (also observed in an area in Core C2), there appear to be three applications of the CIM 1000 coating. The first application was measured to be 15.507 mils DFT, second application to be 18.967 mils DFT, and the third application to be 29.476 mils DFT.*

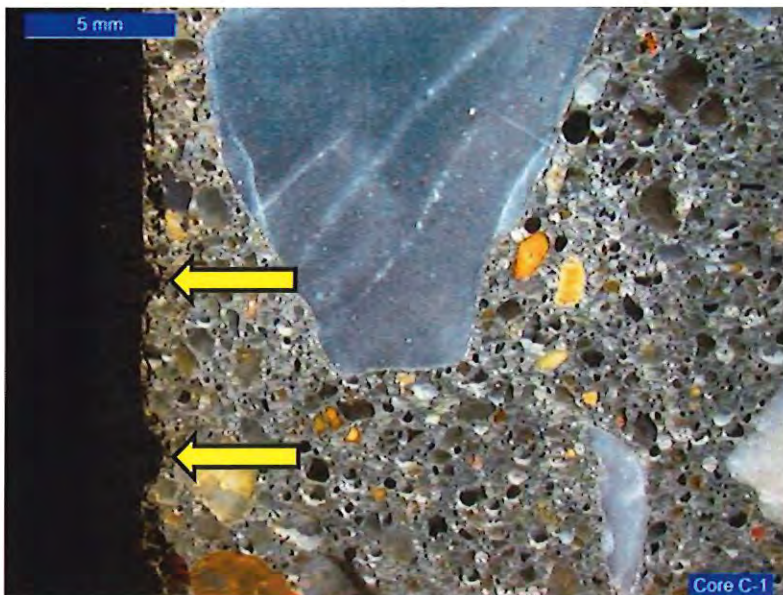
*Figure 8. In Core C1, the CIM 1000 coating was applied directly to the concrete tank wall, and no primer was detected. The concrete immediately in contact with the coating is tan in color compared to gray color in the body of the core.*

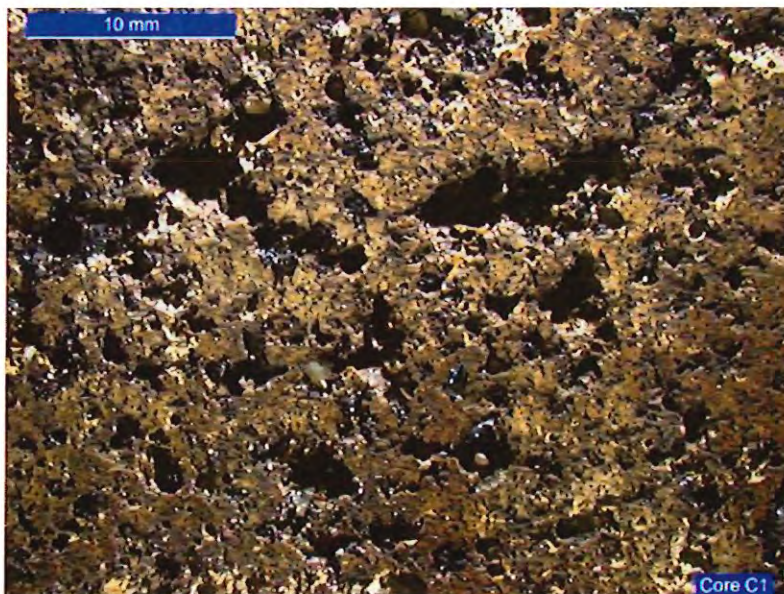
*Figure 11. Parallel cracks (arrows) are located at a depth of approximately 1/64 inch from the exterior surface of the concrete in Core C1. Image taken of the thin section using reflected light.*

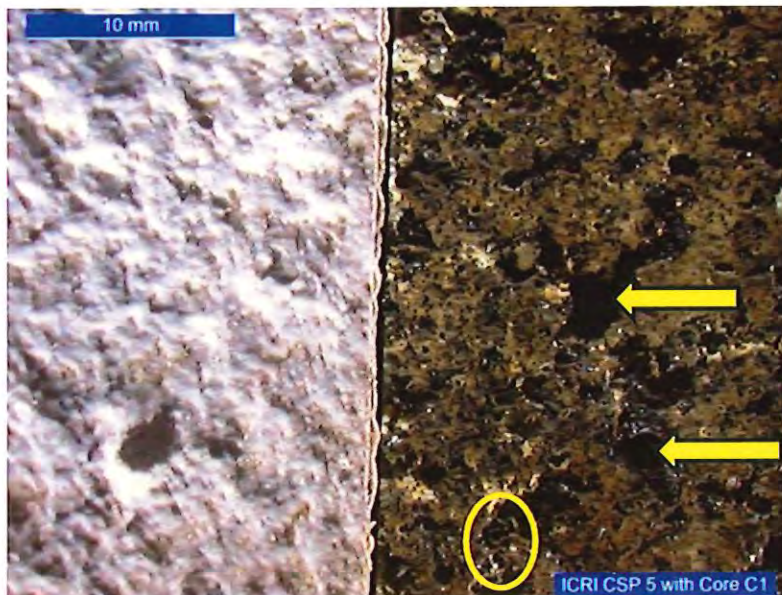
Despite these cracks, the coating appeared to be well adhered, as it was peeled (with difficulty) from the surface of the concrete in the laboratory and did not separate along the cracks within the concrete. When the exterior surface of the concrete was exposed by removal of the coating, the concrete was smooth and contained several bugholes that had been infilled with coating (Figure 12).

*Figure 12. The CIM 1000 coating was peeled from the concrete surface in the laboratory. The exterior surface of the concrete after coating removal is pictured. Several depressions are pictured on the exterior surface that became partially to fully infilled with coating.*

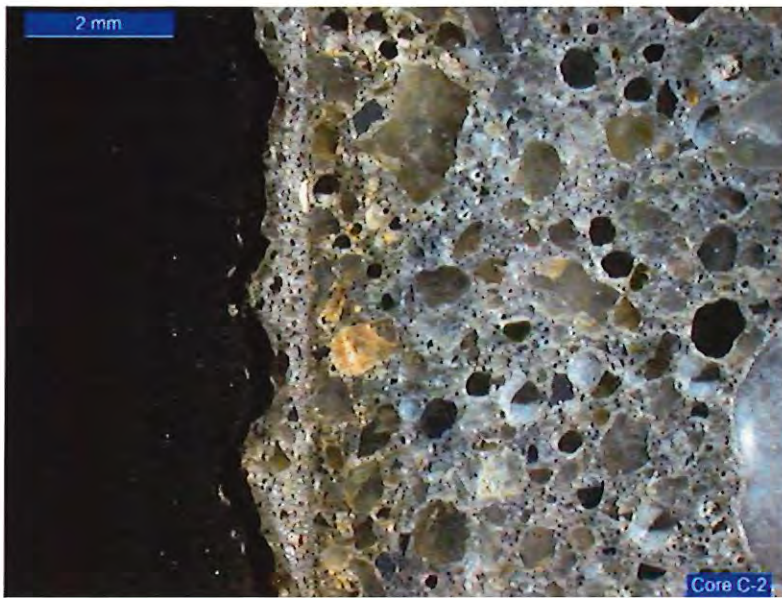
*Figure 19. The CIM 1000 coating has adhesively separated (arrows) from the exterior surface of the skim coat in Core C2.*

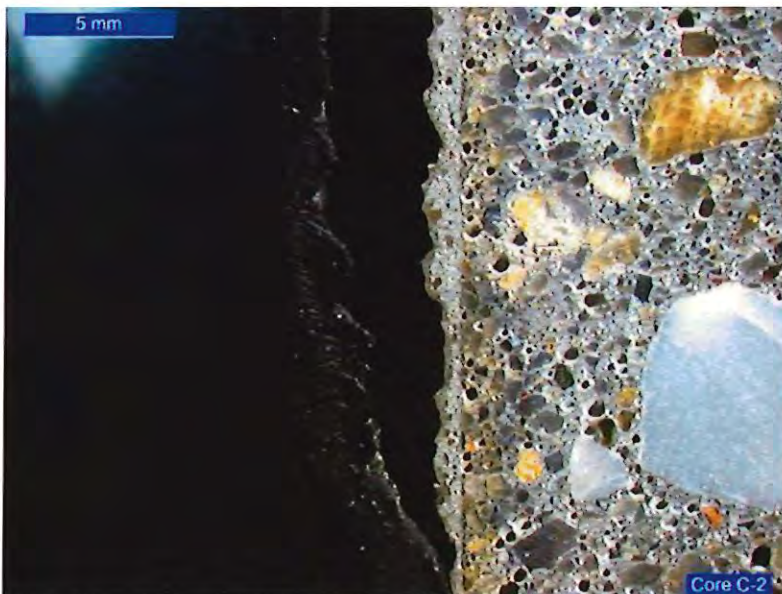
*Figure 20. The irregular exterior profile of the skim coat is reflected on the debonded surface of the coating. This feature indicates the coating had been in contact with the skim coat prior to separation.*

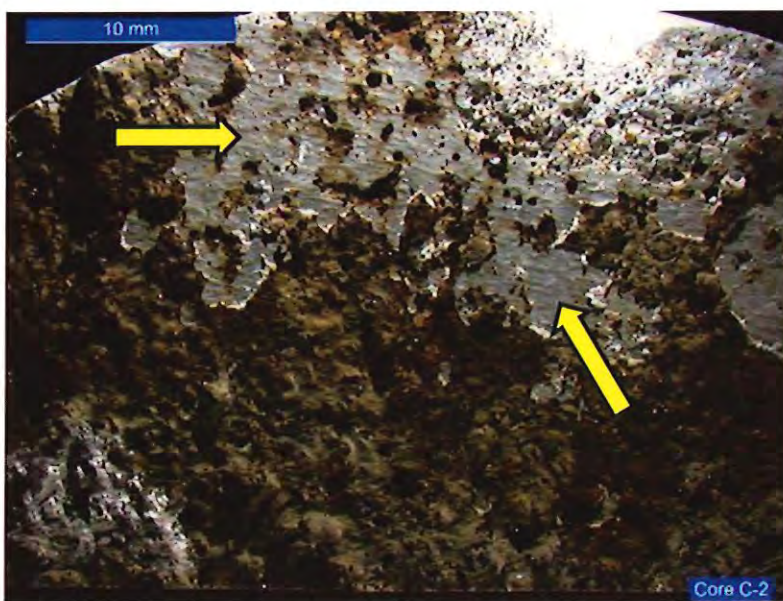
When the CIM 1000 coating was peeled from the core in the laboratory, white deposits were detected lining the surfaces of the coating and skim coat at the blistered locations (Figure 22). These deposits had optical properties consistent with carbonated secondary deposits, indicating that this region had been exposed to moisture migration after initial installation. Despite the separation detected on the lapped surfaces between the coating and the skim coat, the adhered portion of the coating was difficult to remove from the skim coat surface in the laboratory. The coating primarily peeled (adhesively) from the exterior surface of the skim coat, although some areas of the coating remained bonded to the skim coat, and the skim coat separated (adhesively) from the exterior concrete surface (Figure 23). The exterior surface of the skim coat that was in contact with the coating was discolored red-brown to dark brown in color (Figure 24). No discoloration was detected on the skim coat at the blistered location.

Figure 22. The inboard surface of the coating in Core C2 is pictured on the left after it had been peeled from the core. The area pictured represents the blister location. The boxed region is pictured at higher magnification on the right. White deposits are observed lining the coating at the blister location.
