**Subject: Dam Related Engineering Services for East Goshen Township
Hershey Mill Dam (DEP ID No. D15-125)
Construction Cost Estimate for Dam Rehabilitation**

In accordance with Service Authorization No. 9, as approved by East Goshen Township (Township) on February 22, 2017, we are pleased to provide the Township with an independent engineer's estimate of probable construction costs for the Hershey's Mill Dam rehabilitation design as depicted on the drawings prepared by Edward B. Walsh & Associates, Inc., dated April 10, 2012, last revised on June 11, 2014 and which was approved by DEP Dam Safety for construction on July 15, 2014. The following letter report defines our scope of services, identifies the assumptions used within the analysis, and summarizes our findings.

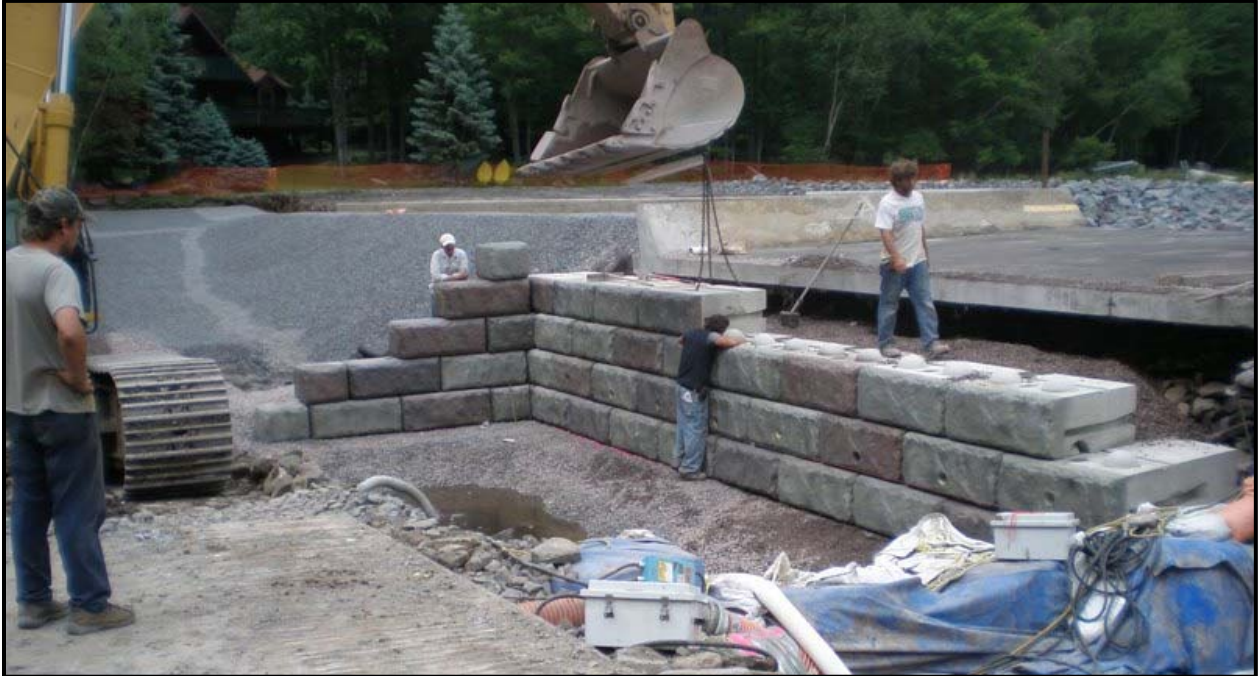
Exhibit 2
Example of Large Block Retaining Wall Used for a Spillway Structure
(Wall Under Construction)

Use of Alternate Construction Material for the Auxiliary Spillway Retaining Wall: The auxiliary spillway design calls for a concrete foundation slab, vertical concrete walls and a concrete slab across the crest of the spillway and the spillway excavation is to be backfilled with on-site soils blended with cement. It appears that the design could be simplified by using a large block retaining wall system which would reduce the volume of concrete required and reduce the construction duration. Many of these retaining wall systems can be provided with an exposed face that looks like hand laid stone, eliminating the cost associated with placing a stone façade on the downstream face of the retaining wall. Exhibits 2 and 3 provide an example of a large block retaining wall used to form the downstream face of an 80-foot long, 10-foot high principal spillway. This example is very similar to the situation at Hershey's Mill Dam which proposes an auxiliary spillway that is approximately 60-feet wide and 15-feet high.

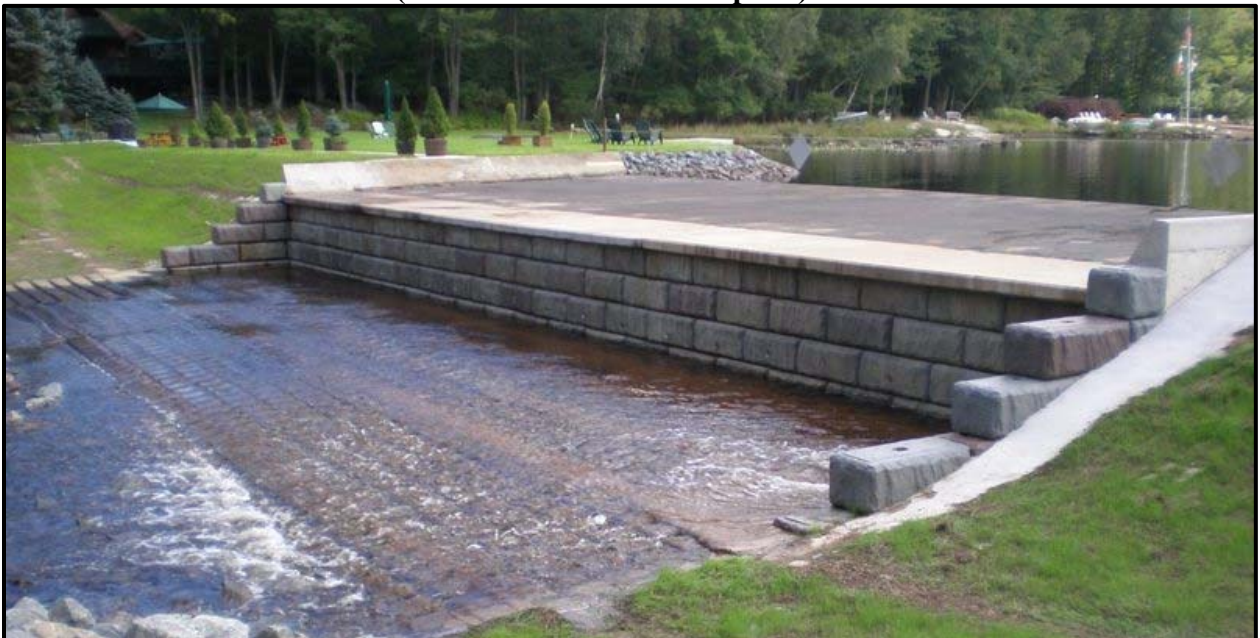
Exhibit 3
Example of Large Block Retaining Wall used for a Spillway Structure
(Wall Construction Complete)

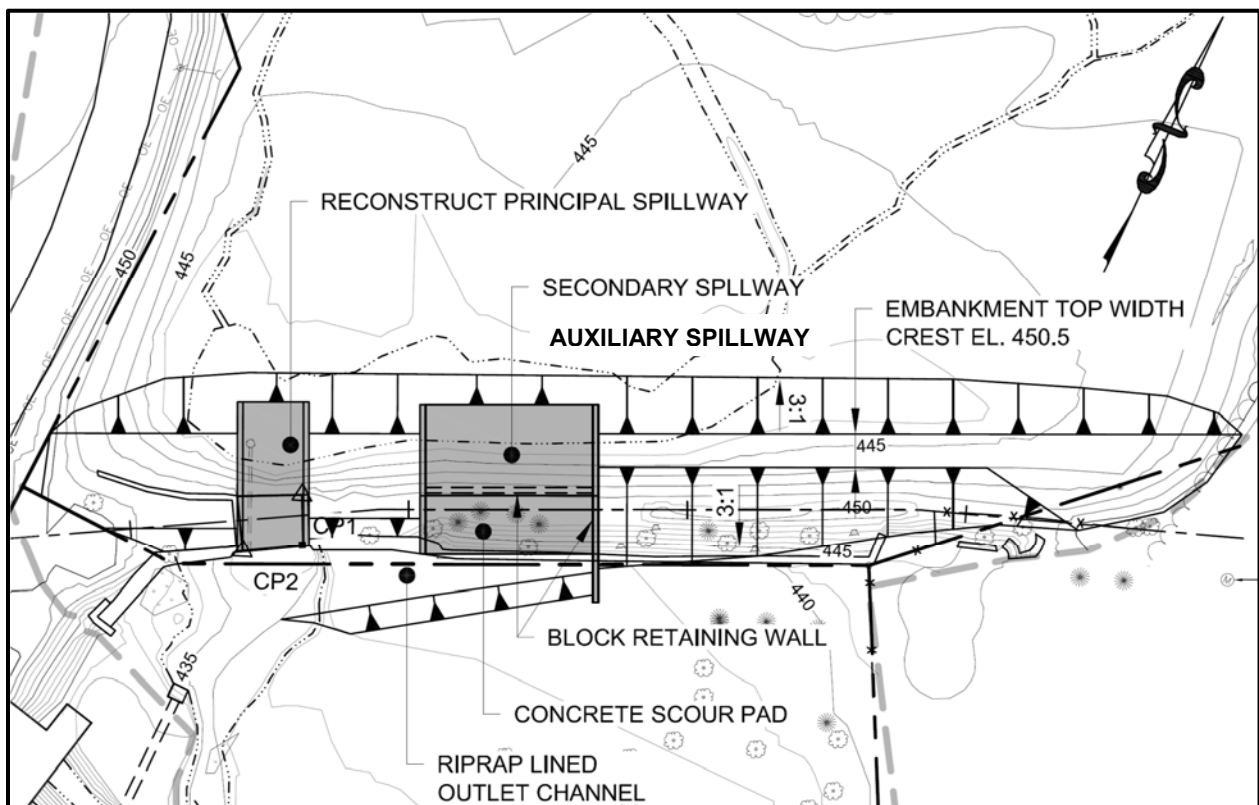
Exhibit 4
Plan View of Hershey's Mill Dam Rehabilitation (Modified)

Elimination of the Sheet Pile Support Wall: The installation of the sheet pile support wall creates a discontinuity within the earth embankment and introduces a penetration and potential seepage path through the embankment. As a cost savings and seepage reduction measure, it is recommended that the sheet pile support wall be eliminated by moving the location of the new auxiliary spillway to the left a sufficient distance such that the excavation needed to construct the foundation of this structure will not undermine the existing principal spillway. It is anticipated that the auxiliary spillway would need to be moved approximately 40 feet to the left to provide adequate separation to allow the sheet pile support wall to be eliminated (refer to Exhibit 4 for a plan view showing the relocation of the auxiliary spillway to the left).

The recommendations described above are conceptualized in Exhibits 4, 5 and 6 which provide a plan view, typical cross section through the left embankment and a typical cross section through the auxiliary spillway, respectively. The construction cost for the dam reconstruction as depicted on Exhibits 4, 5, and 6 is estimated to be between \$720,000 and \$860,000. Engineering costs to support and permit the dam rehabilitation design may be in the range of \$75,000 to \$150,000.

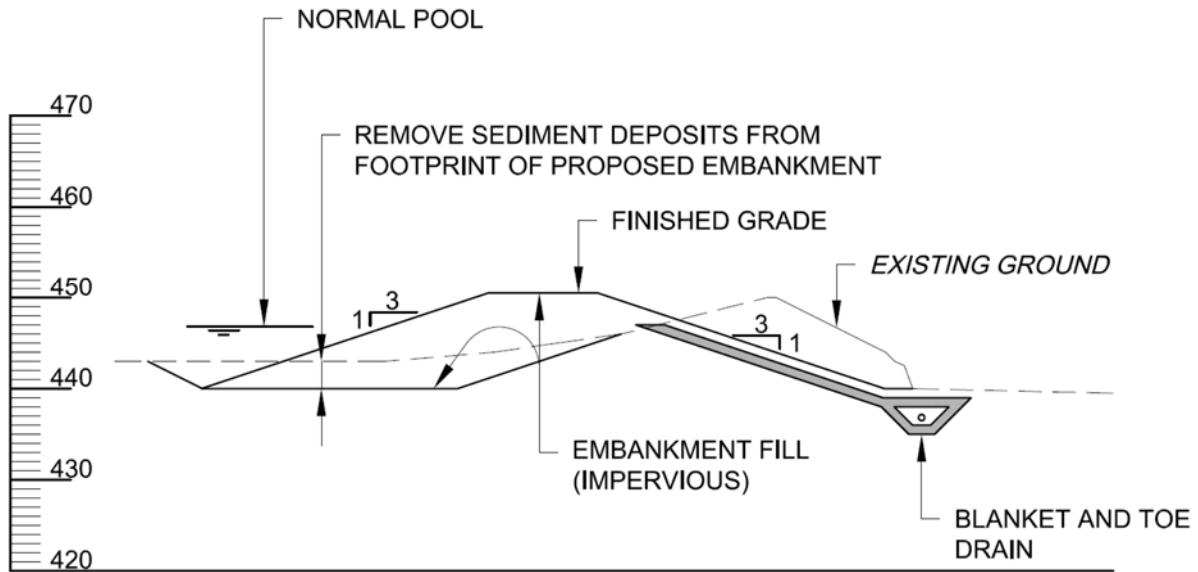
Exhibit 5
Typical Cross Section through Left Embankment

Downstream Embankment Slopes: The downstream left embankment contains steep slopes and a deteriorating hand-laid stone wall. In order to improve embankment stability, it is recommended that the slope of the downstream left embankment be reduced to 3H:1V or flatter. Shifting the embankment to the south and using slopes steeper than 3H:1V would reduce embankment earthwork costs and would be acceptable if supported by a geotechnical stability analysis.

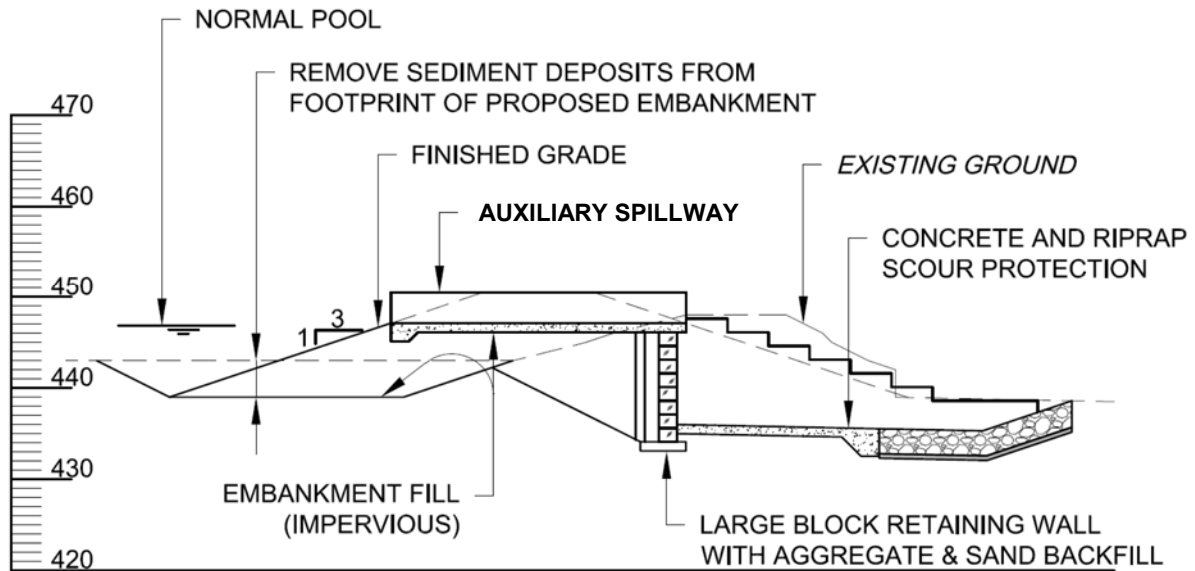
Exhibit 6
Typical Cross Section through Auxiliary Spillway

auxiliary spillway is important. If the spillway is founded on erodible overburden material, which appears to be the case, the auxiliary spillway design should include a seepage analysis and would likely require a seepage cutoff wall and filtered drain system to control seepage under the structure and prevent a piping failure. If the auxiliary spillway structure is founded on bedrock, foundation treatment would include additional excavation and effort to clean and inspect the foundation rock, and place backfill concrete to the desired foundation grade. Should the Township choose to rehabilitate Hershey's Mill Dam, it is recommended that a geotechnical subsurface exploration program be implemented to verify the existing site conditions and support the design of the proposed improvements.
