**EAST GOSHEN TOWNSHIP  
CHESTER COUNTY, PENNSYLVANIA  
MILLTOWN DAM (DEP ID NO. D15-146)**

**EAST GOSHEN TOWNSHIP  
BOARD OF SUPERVISORS MEETING  
MARCH 22, 2016**

# **AGENDA**

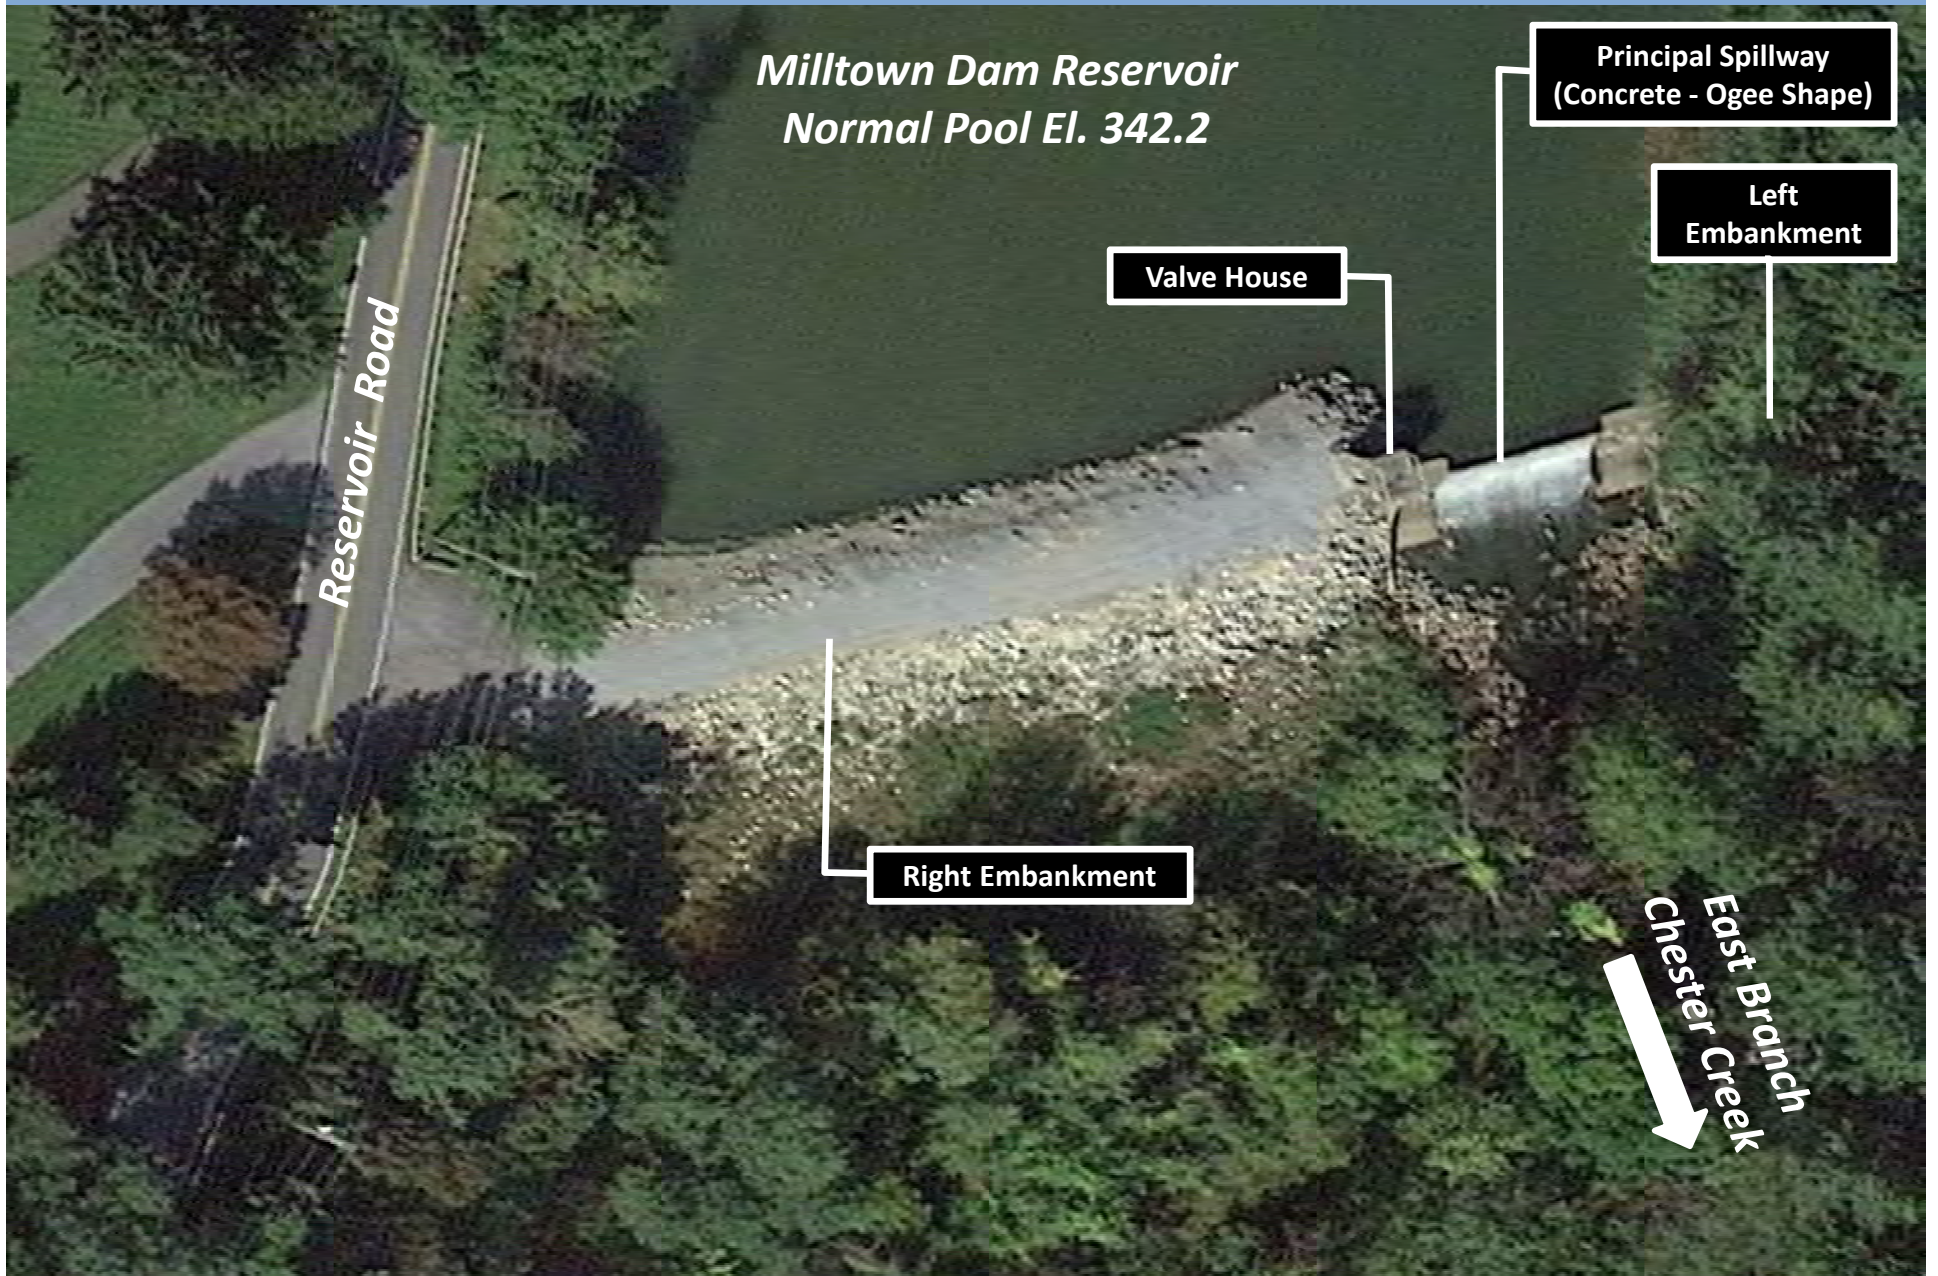
# MILLTOWN DAM

*Milltown Dam Reservoir*  
*Normal Pool El. 342.2*

Valve House

Principal Spillway  
(Concrete - Ogee Shape)

Left  
Embankment

Right Embankment

East Branch  
Chester Creek

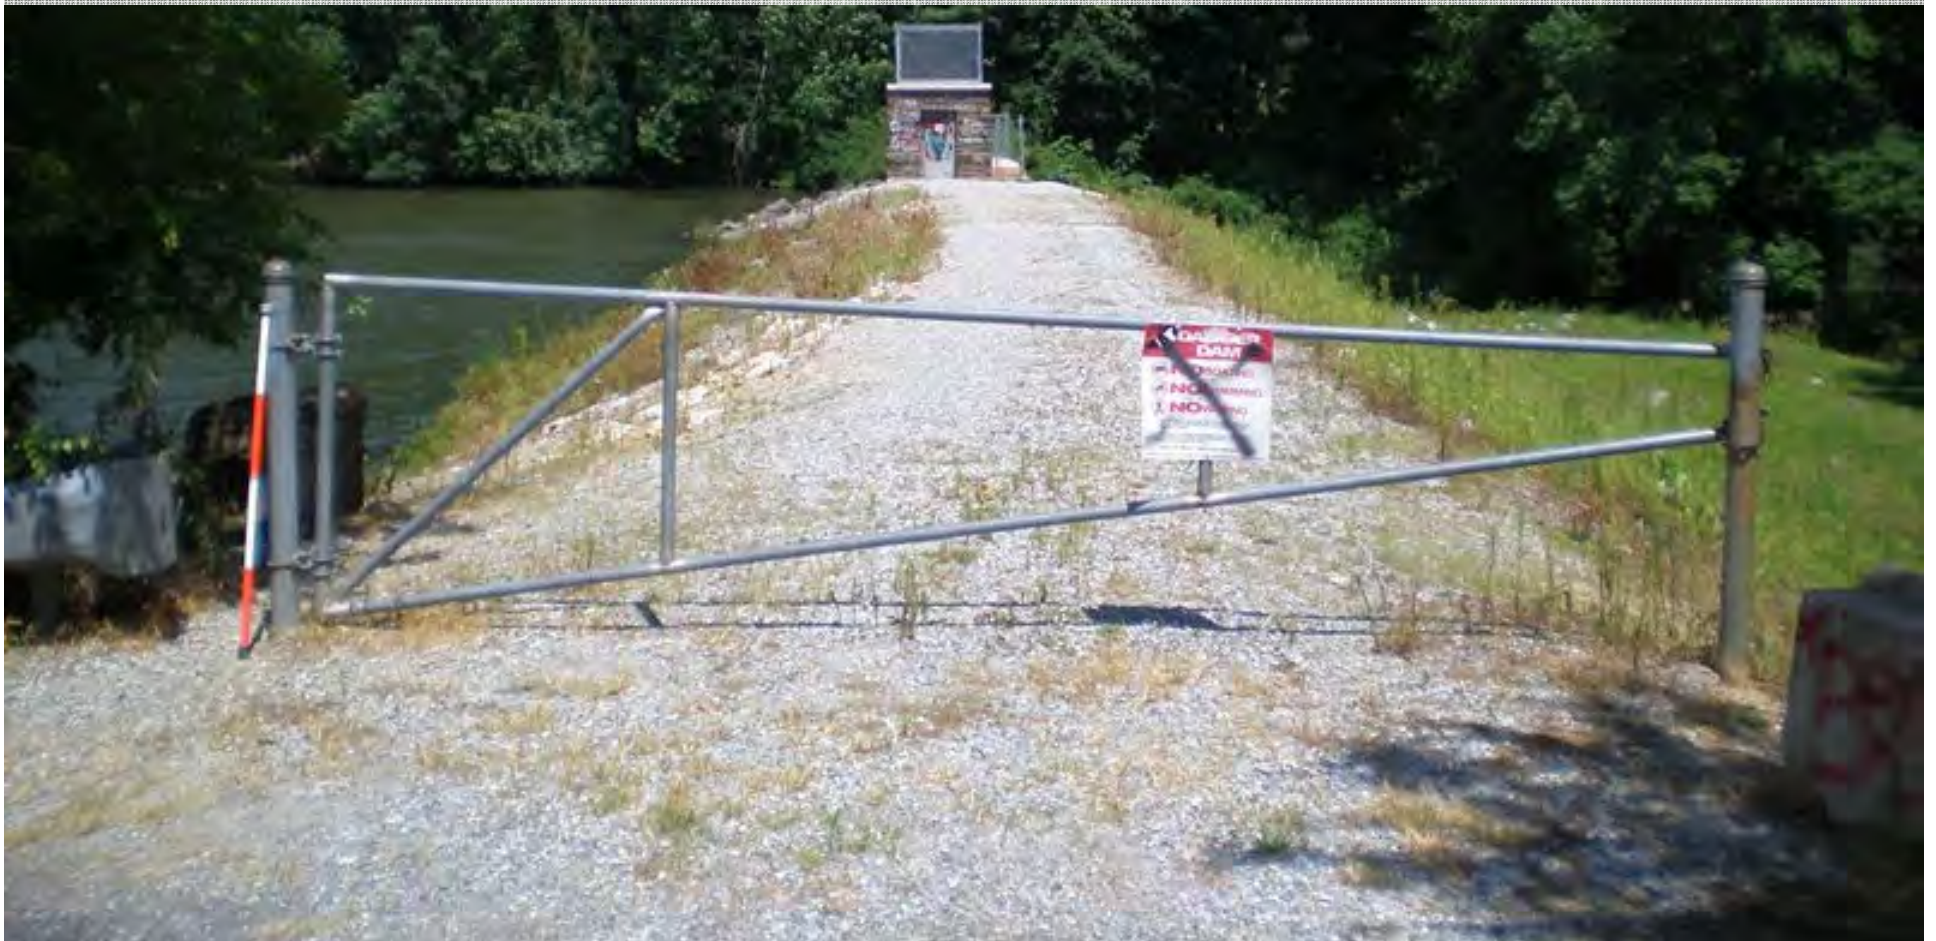
## Earth Embankment

350'± in Length (Total Length of Dam)

20'± in Height at Maximum Section

Concrete Core Wall Along Entire Length of Dam

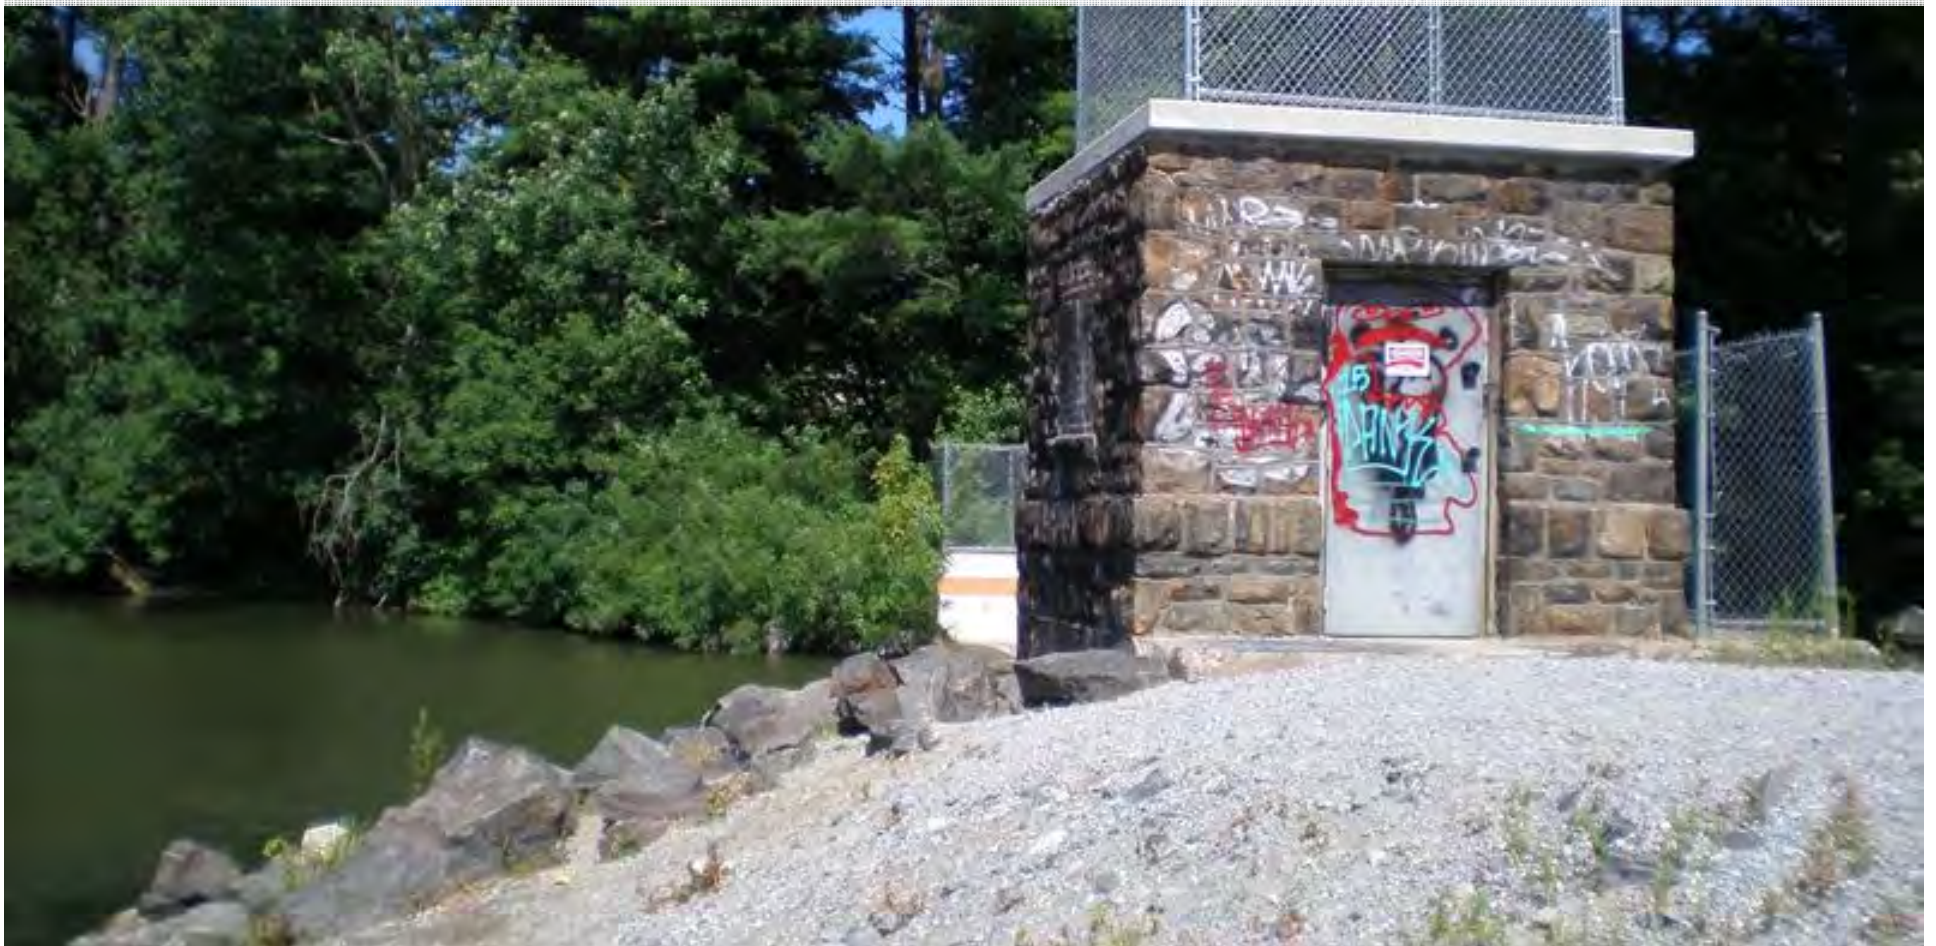
## Low Level Dewatering System

Valve House situated over a Valve Chamber

24-Inch Discharge Pipe to East Branch Chester Creek

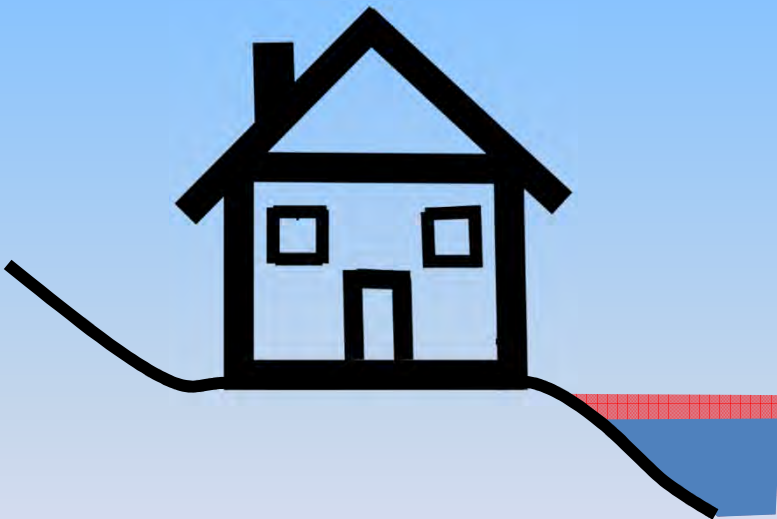
No Additional Hazard

**Incremental depth of flooding**

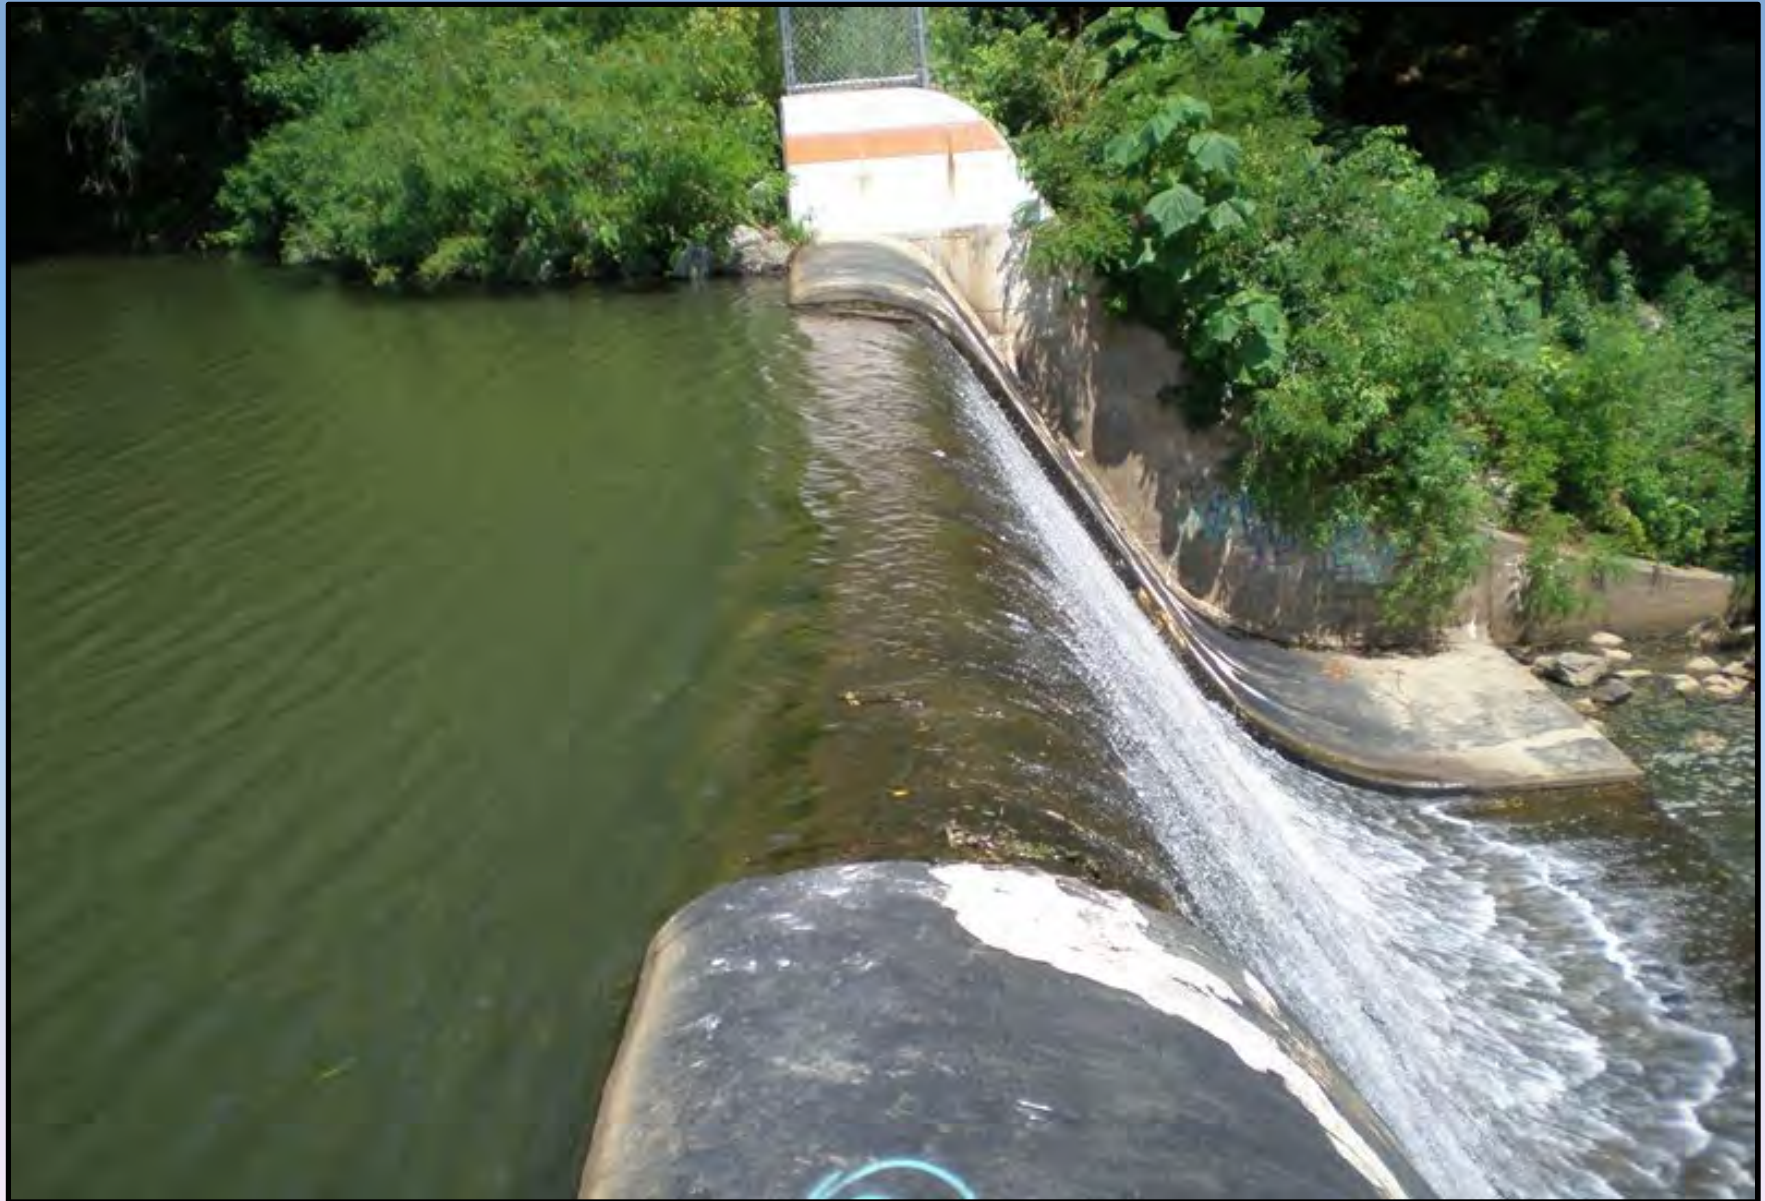
# PRINCIPAL SPILLWAY AND LOW FLOW NOTCH

Photograph Taken on August 4, 2015

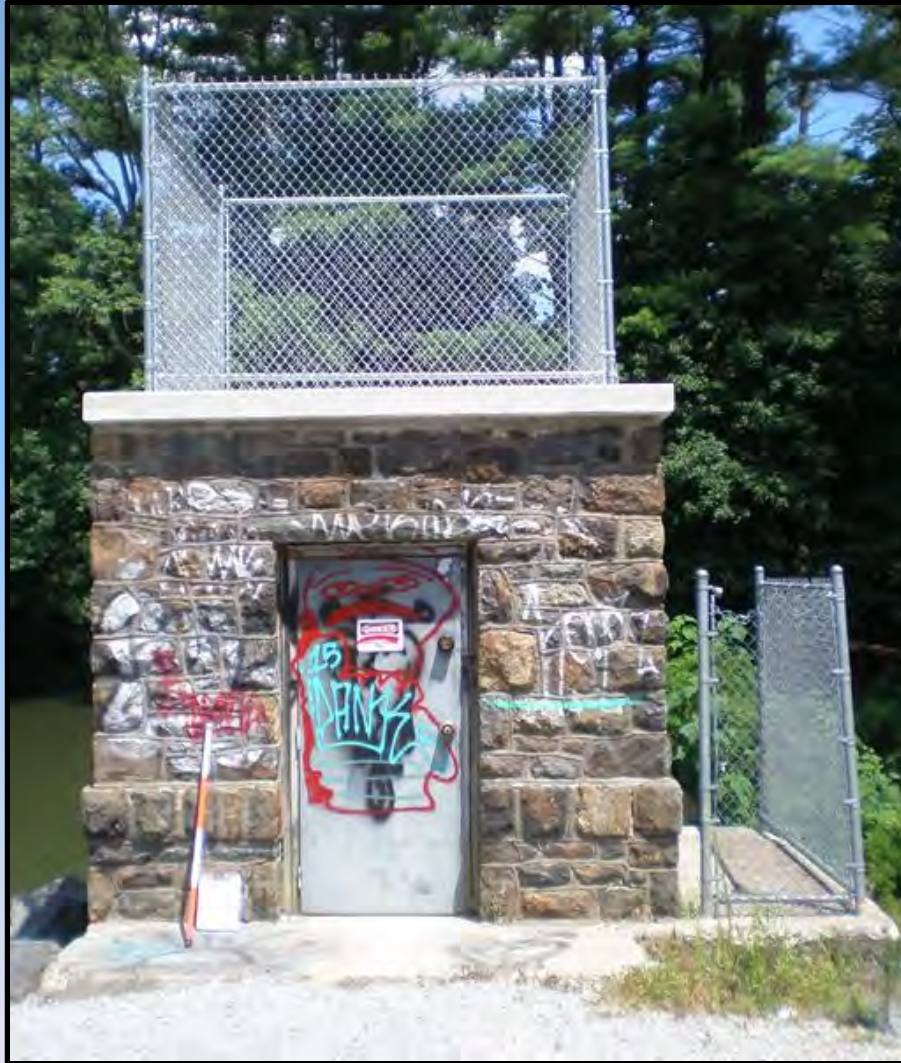
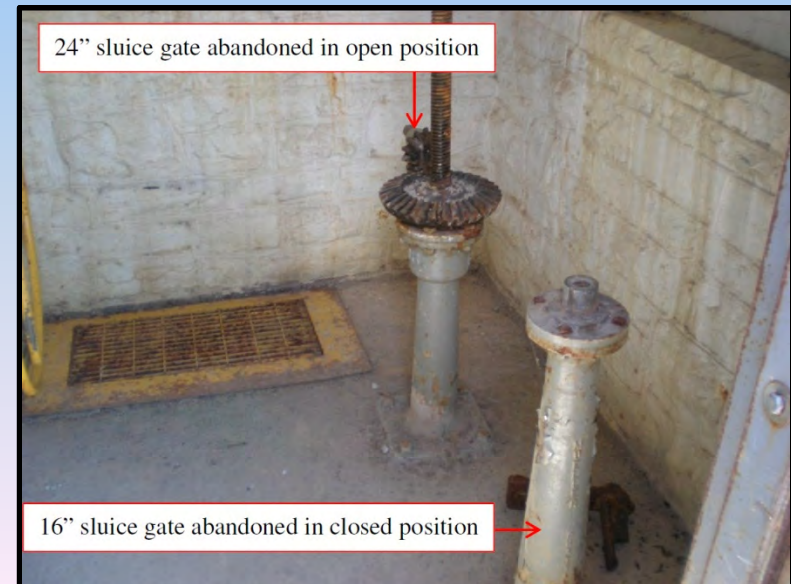
# VALVE HOUSE

Photographs Taken on August 4, 2015

Replace valve stem and stem guides on upstream 24-inch sluice gate.

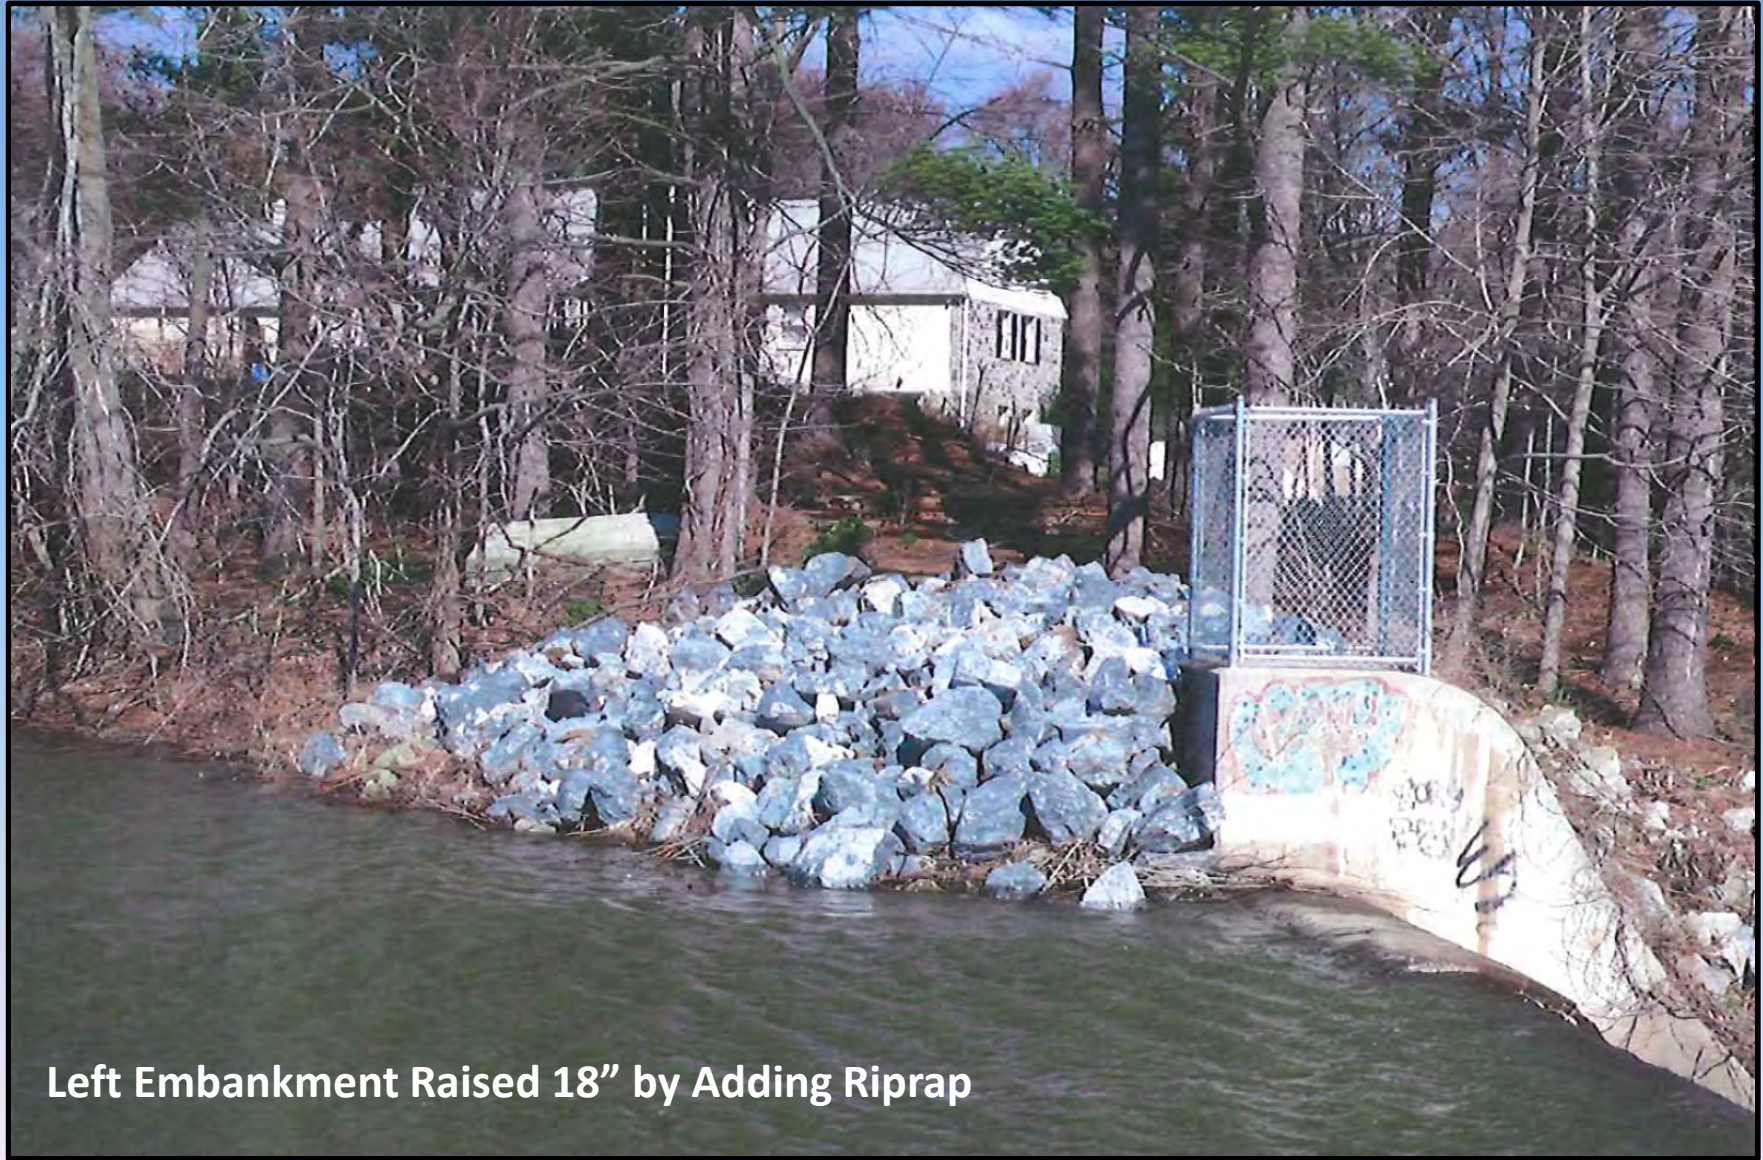
# 2008 IMPROVEMENTS

Left Embankment Raised 18" by Adding Riprap

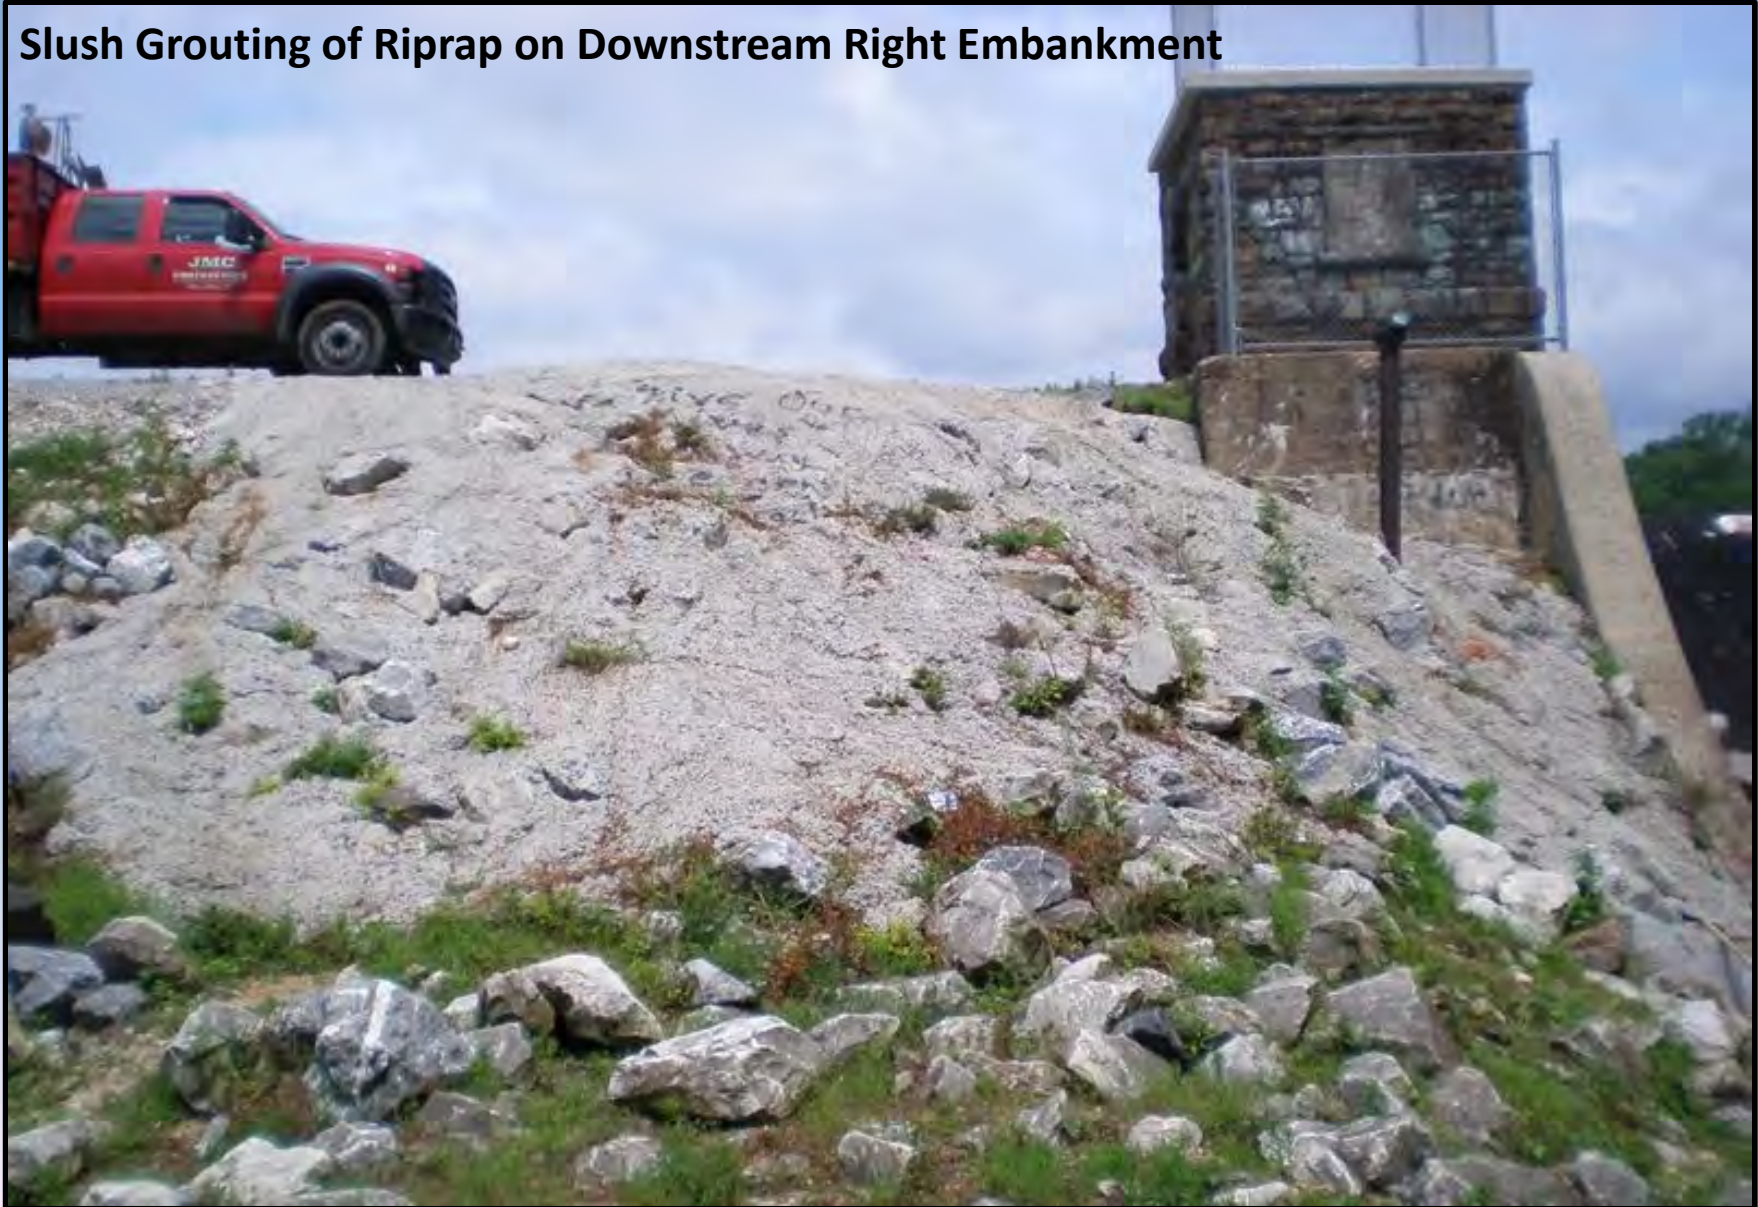
# 2012 IMPROVEMENTS

Slush Grouting of Riprap on Downstream Right Embankment

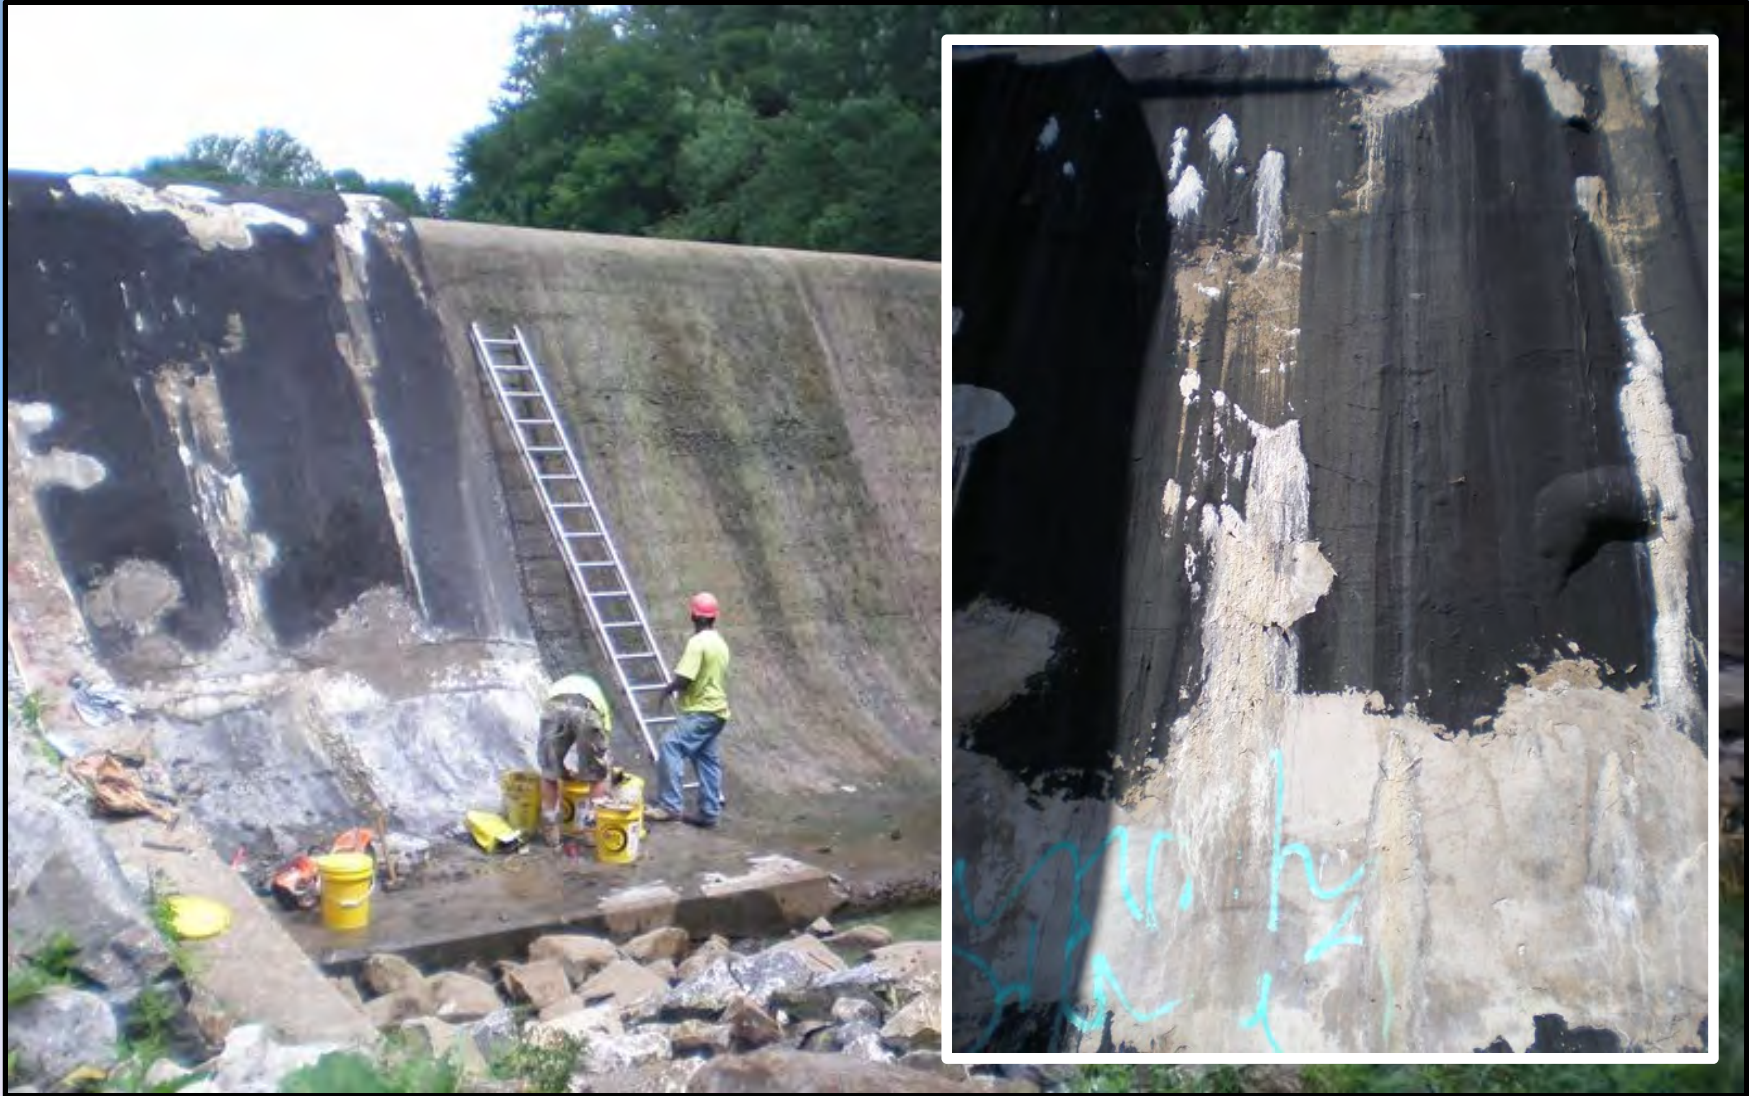
# 2013 IMPROVEMENTS

**Application of liquid applied urethane coating to principal spillway surfaces.  
CIM 1000 Product by C.I.M. Industries, Inc.**

**2013 – Surface Concrete Repairs on Principal Spillway**

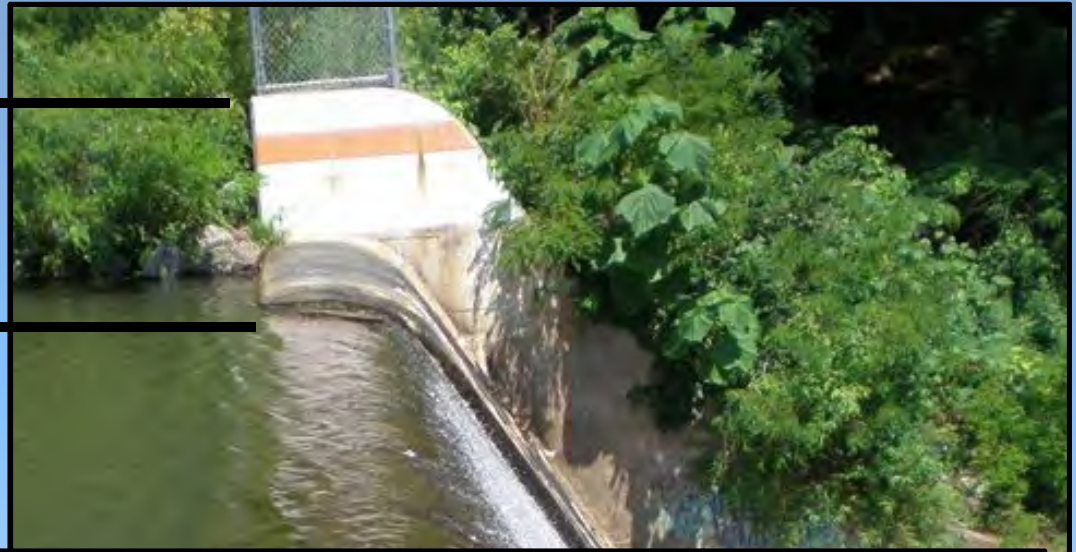
**Normal Pool El. 342.2**

**Calculated Spillway Capacity:  
3,080± cfs**

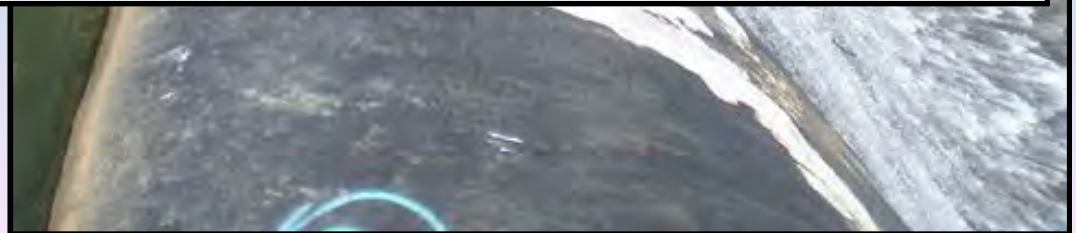
Based on the results of this “in-house” incremental analysis of breach and non-breach flood levels, the updated ½ PMF appears to be the appropriate spillway design flood as required by the Chapter 105 regulations (Section 105.98). This peak flow for this updated ½ PMF is significantly greater than the 1981 design flood. The peak inflow to Milltown Dam for the ½ PMF is 12,704 cfs, whereas spillway capacity is approximately 3000 cfs. The overtopping depth during the ½ PMF is 4.12 feet. Spillway adequacy (prior to overtopping) was determined to be 0.14 PMF.

**SDF (1/2 PMF) = 12,700 cfs  
Spillway can pass 0.14 PMF  
Dam Overtopped by 4.1 feet**

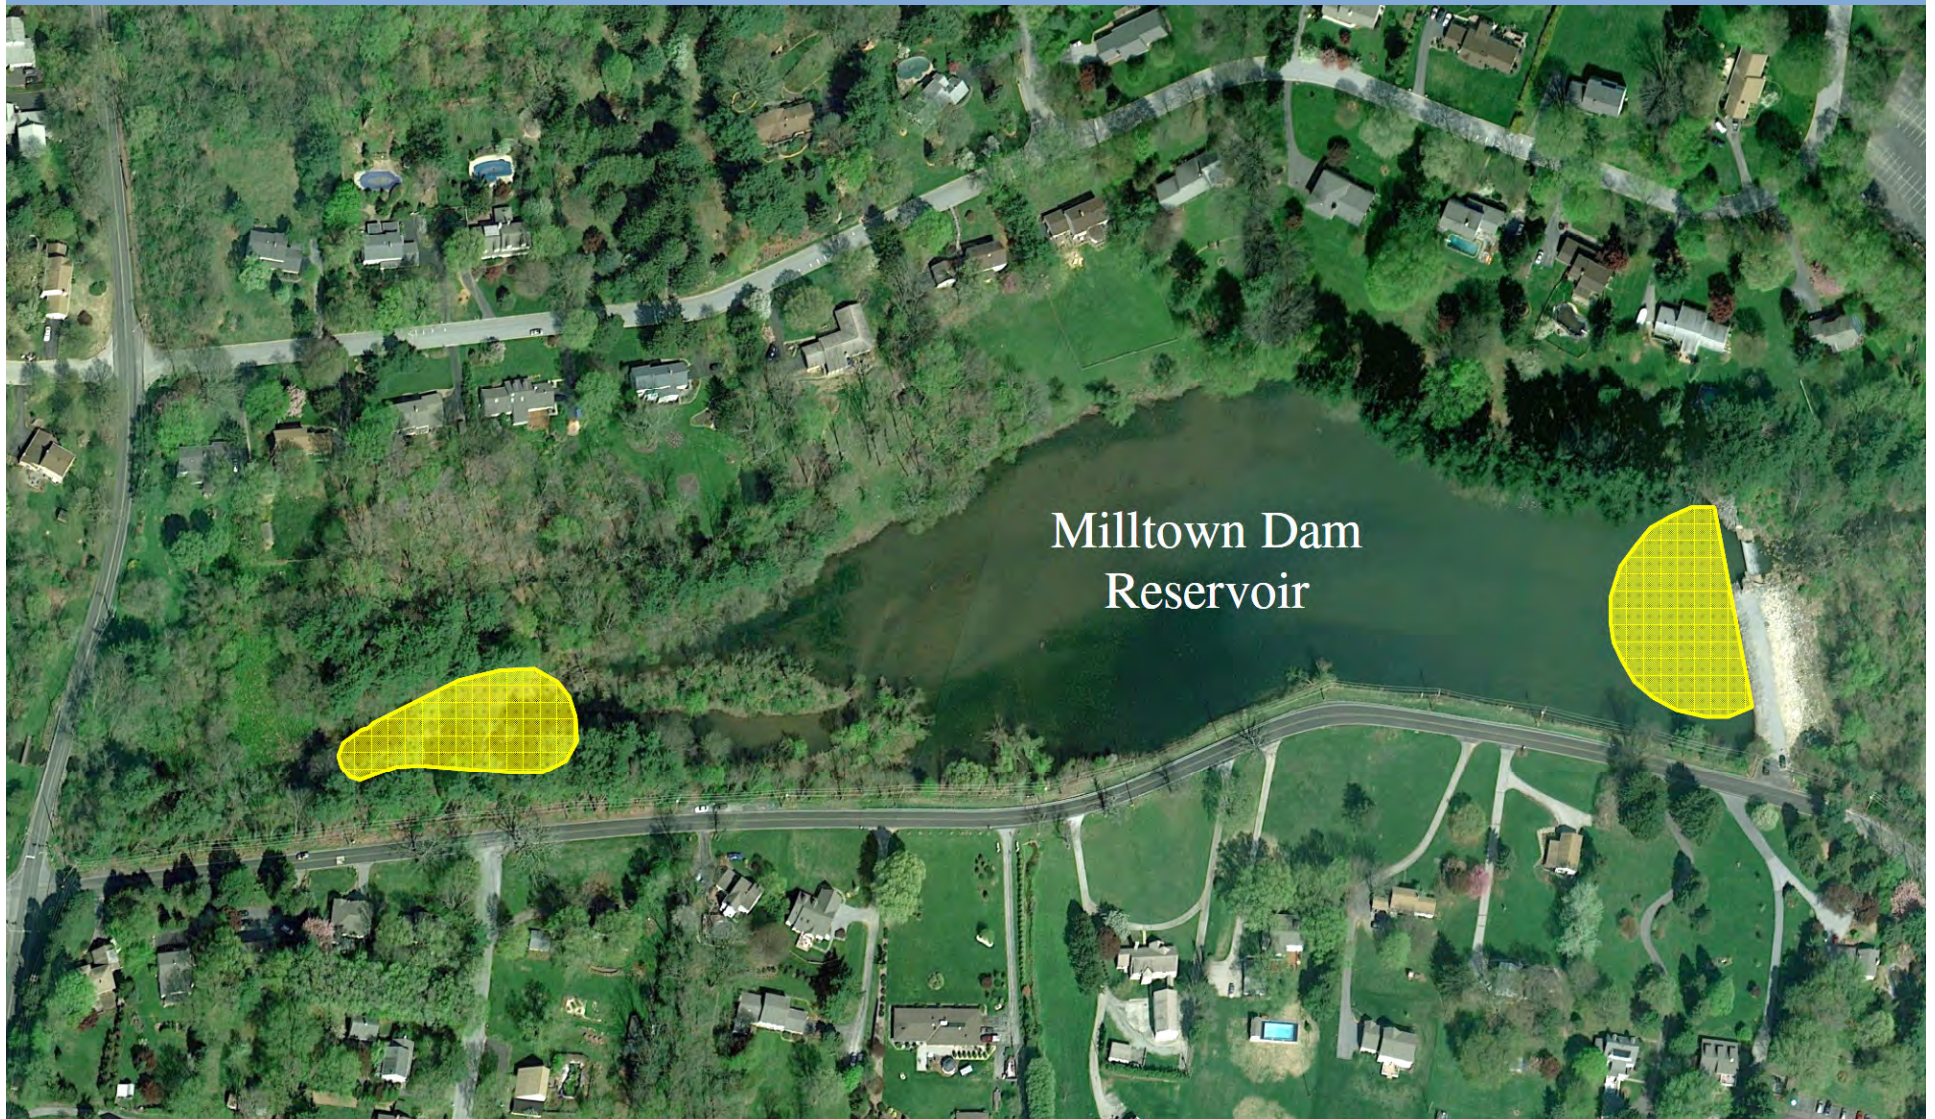
# DREDGING OF RESERVOIR

**FULL DREDGE (I.E., REMOVAL OF 46,800 CY) AT \$75/CY = \$3.5 MILLION**

**PARTIAL DREDGE AT SPILLWAY AND TO CREATE SEDIMENT FOREBAY (15,000 CY)=\$1.1 MILLION**

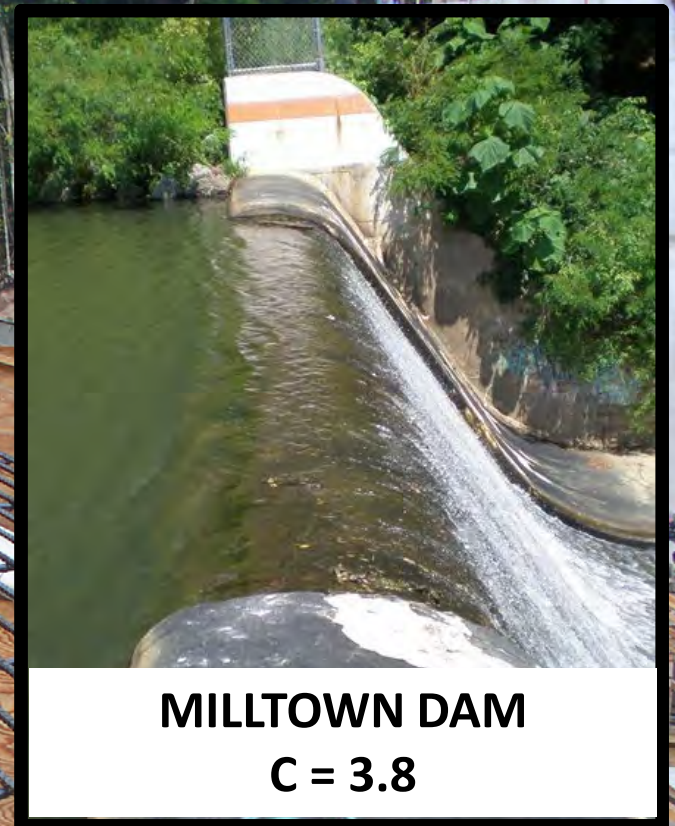
# INCREASING THE DISCHARGE/WEIR COEFFICIENT (C)

**MILLTOWN DAM**  
 **$C = 3.8$**

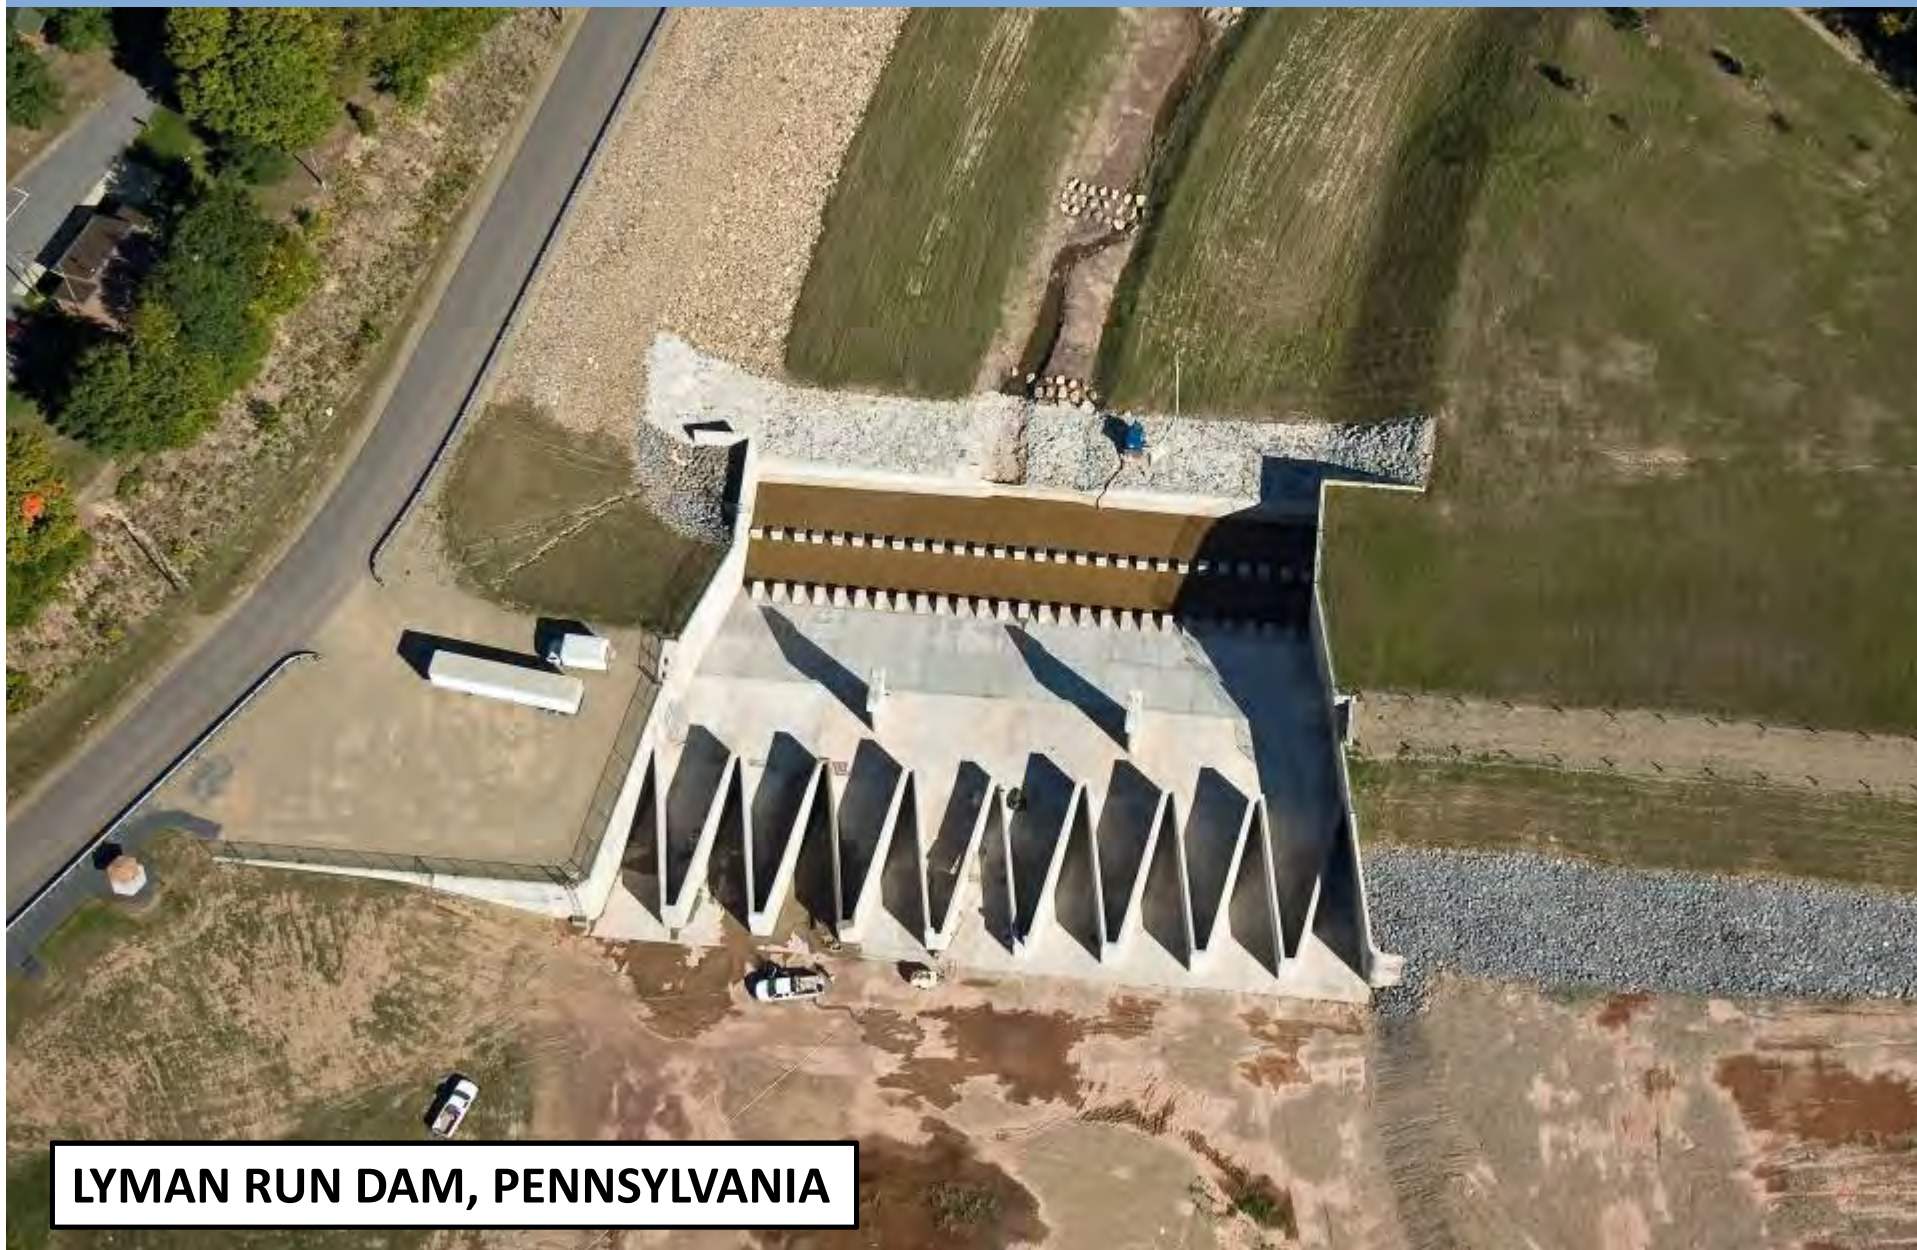
**LYMAN RUN DAM, PENNSYLVANIA**

**USE LABYRINTH TO MINIMIZE SPILLWAY  
FOOTPRINT**

# **ALTERNATIVE 5 WIDEN SPILLWAY WITH LABYRINTH**
