**EAST GOSHEN TOWNSHIP  
CHESTER COUNTY, PENNSYLVANIA  
MILLTOWN DAM (DEP ID NO. D15-146)**

**EAST GOSHEN TOWNSHIP  
BOARD OF SUPERVISORS MEETING  
MARCH 22, 2016**

# **AGENDA**

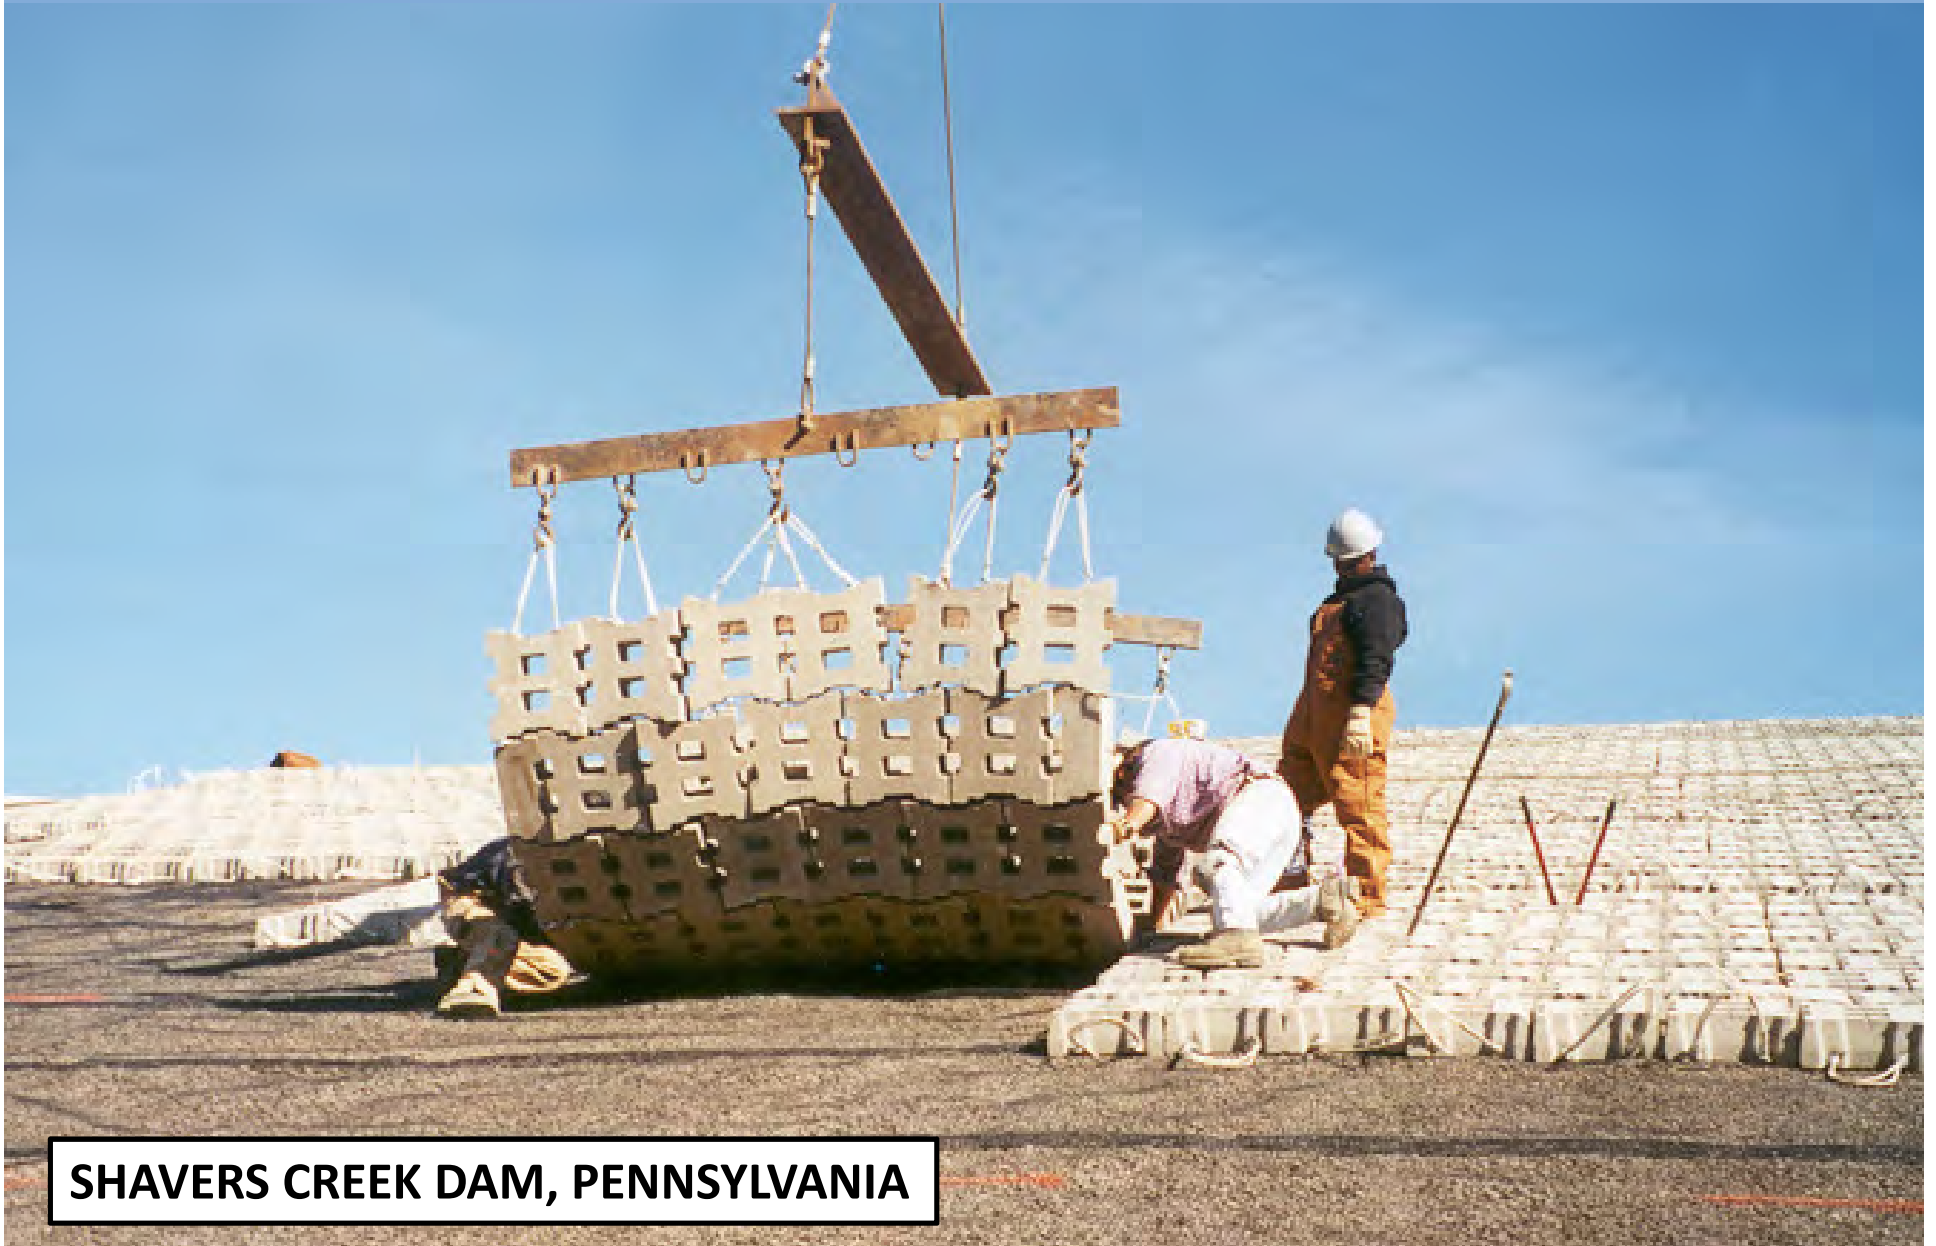
SHAVERS CREEK DAM, PENNSYLVANIA

## ACB EMBANKMENT OVERTOPPING PROTECTION

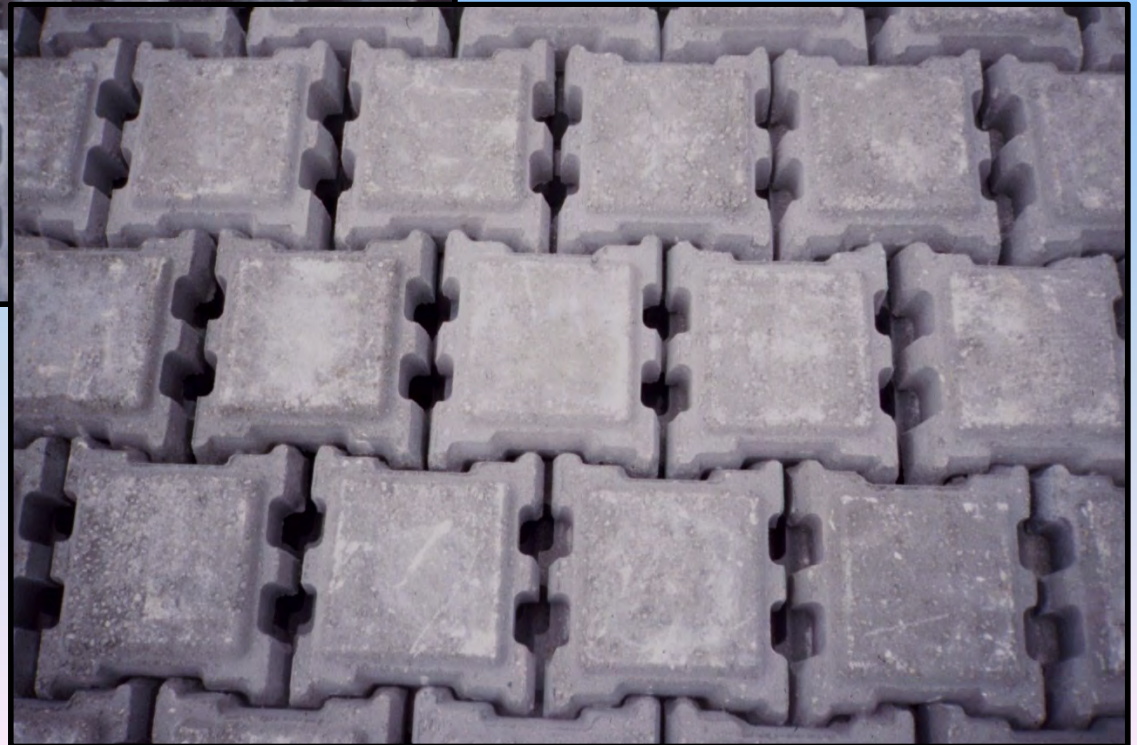
**CLOSED CELL BLOCKS  
(10% OPEN AREA)**

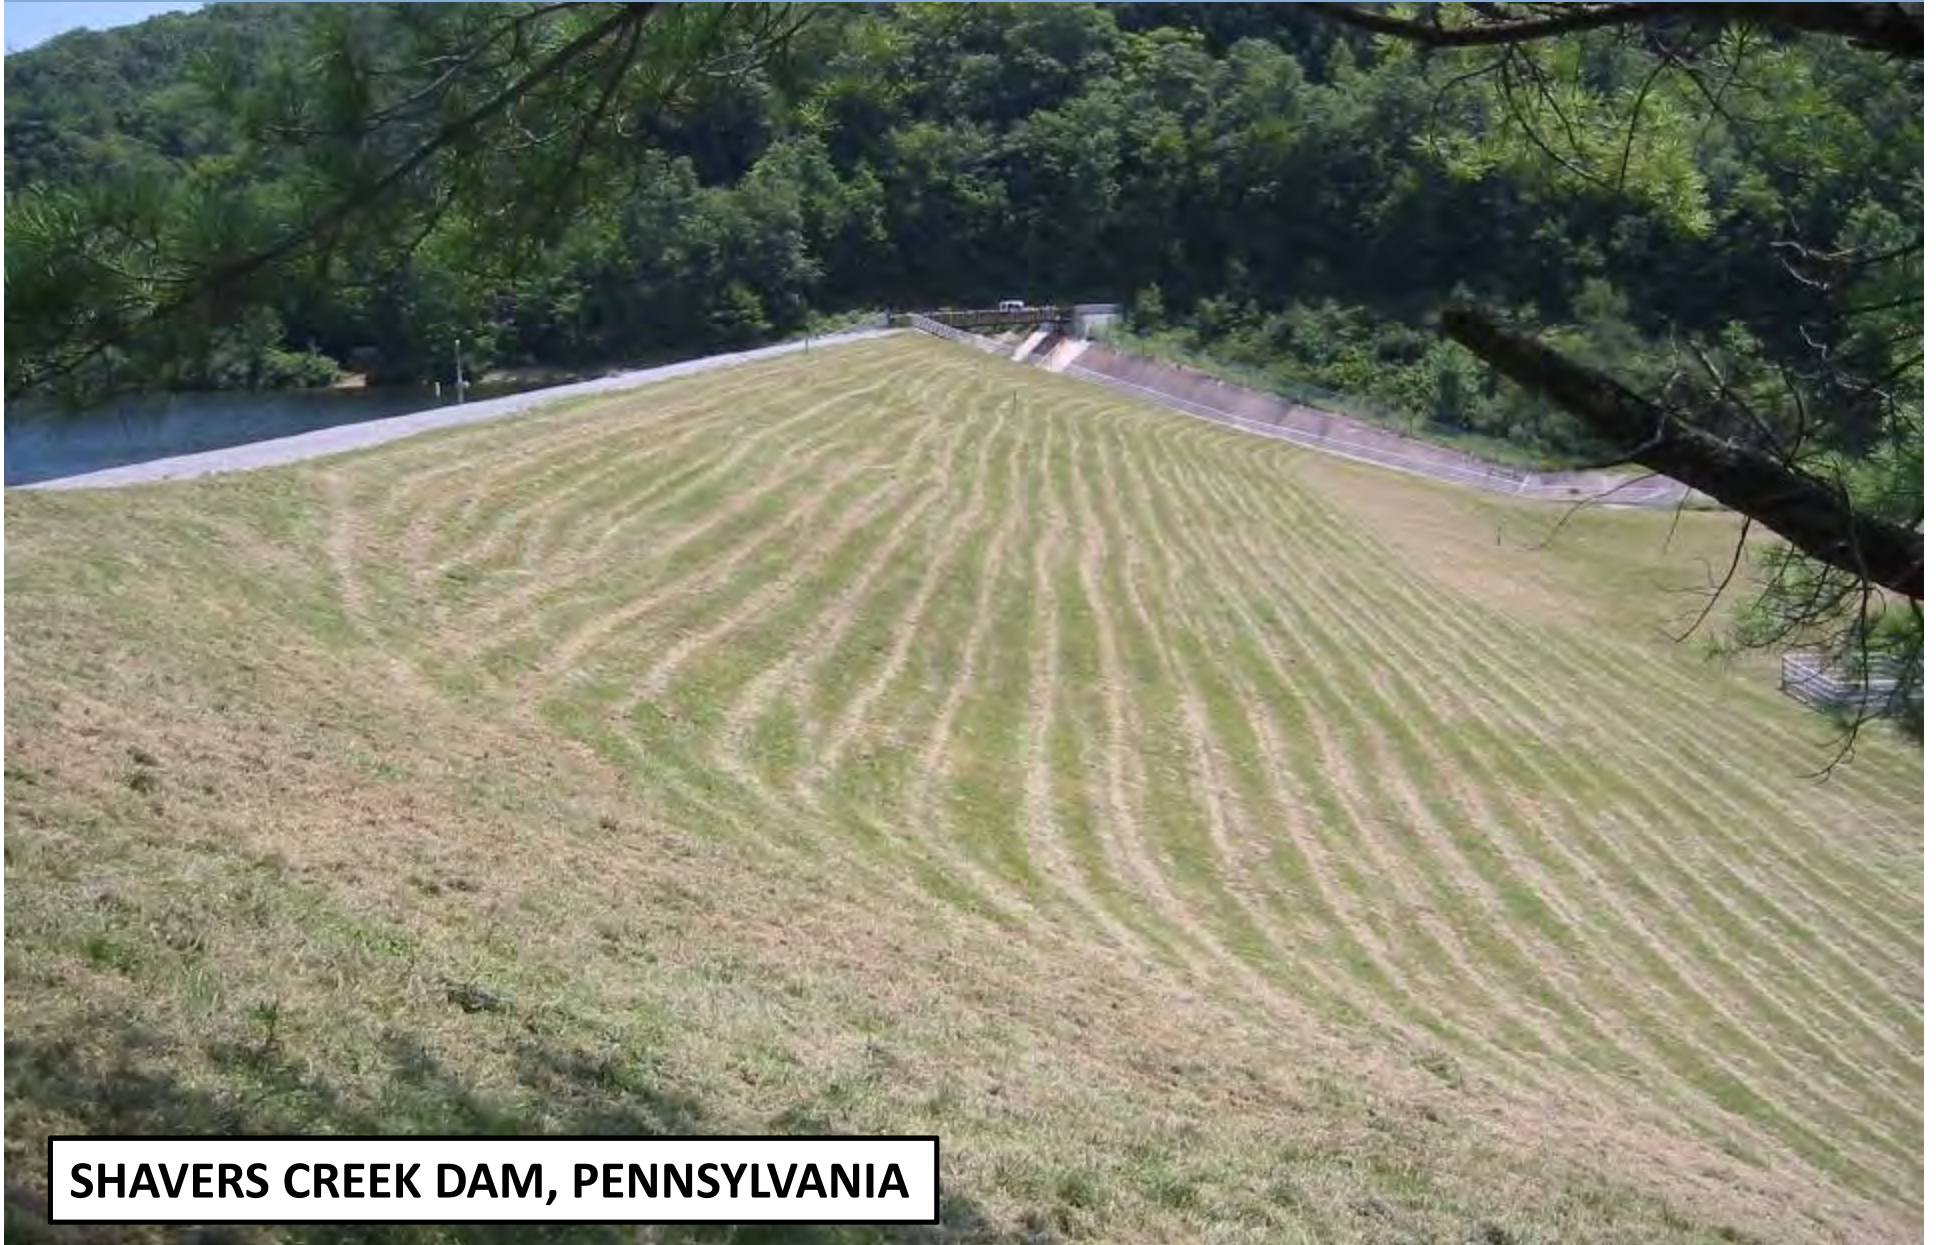
**SHAVERS CREEK DAM, PENNSYLVANIA**

## **ACB EMBANKMENT OVERTOPPING PROTECTION**

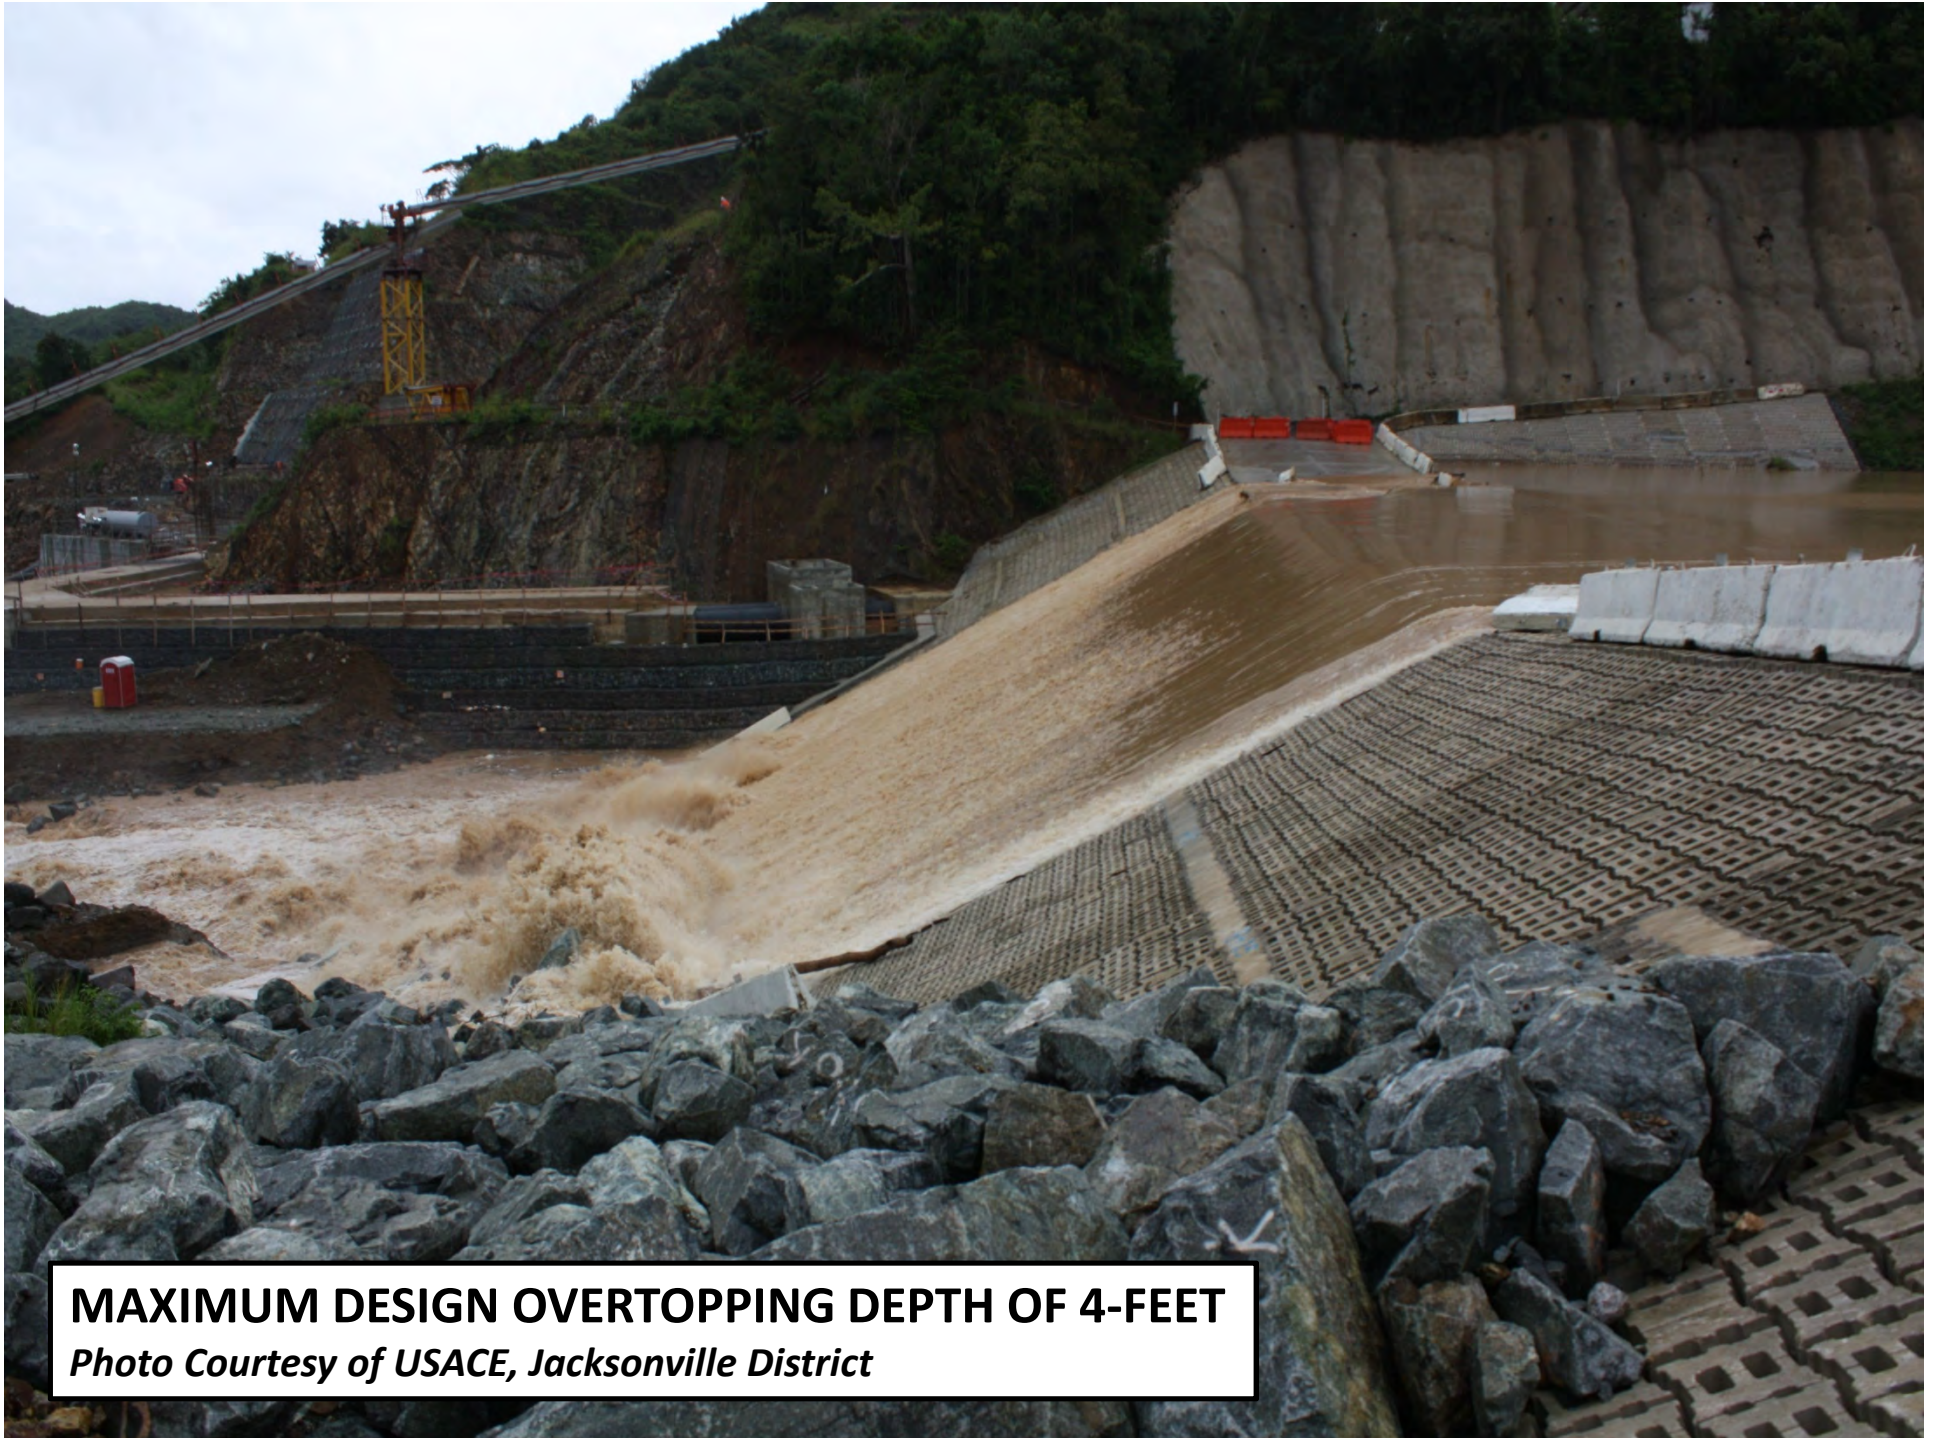
**MAXIMUM DESIGN OVERTOPPING DEPTH OF 4-FEET**

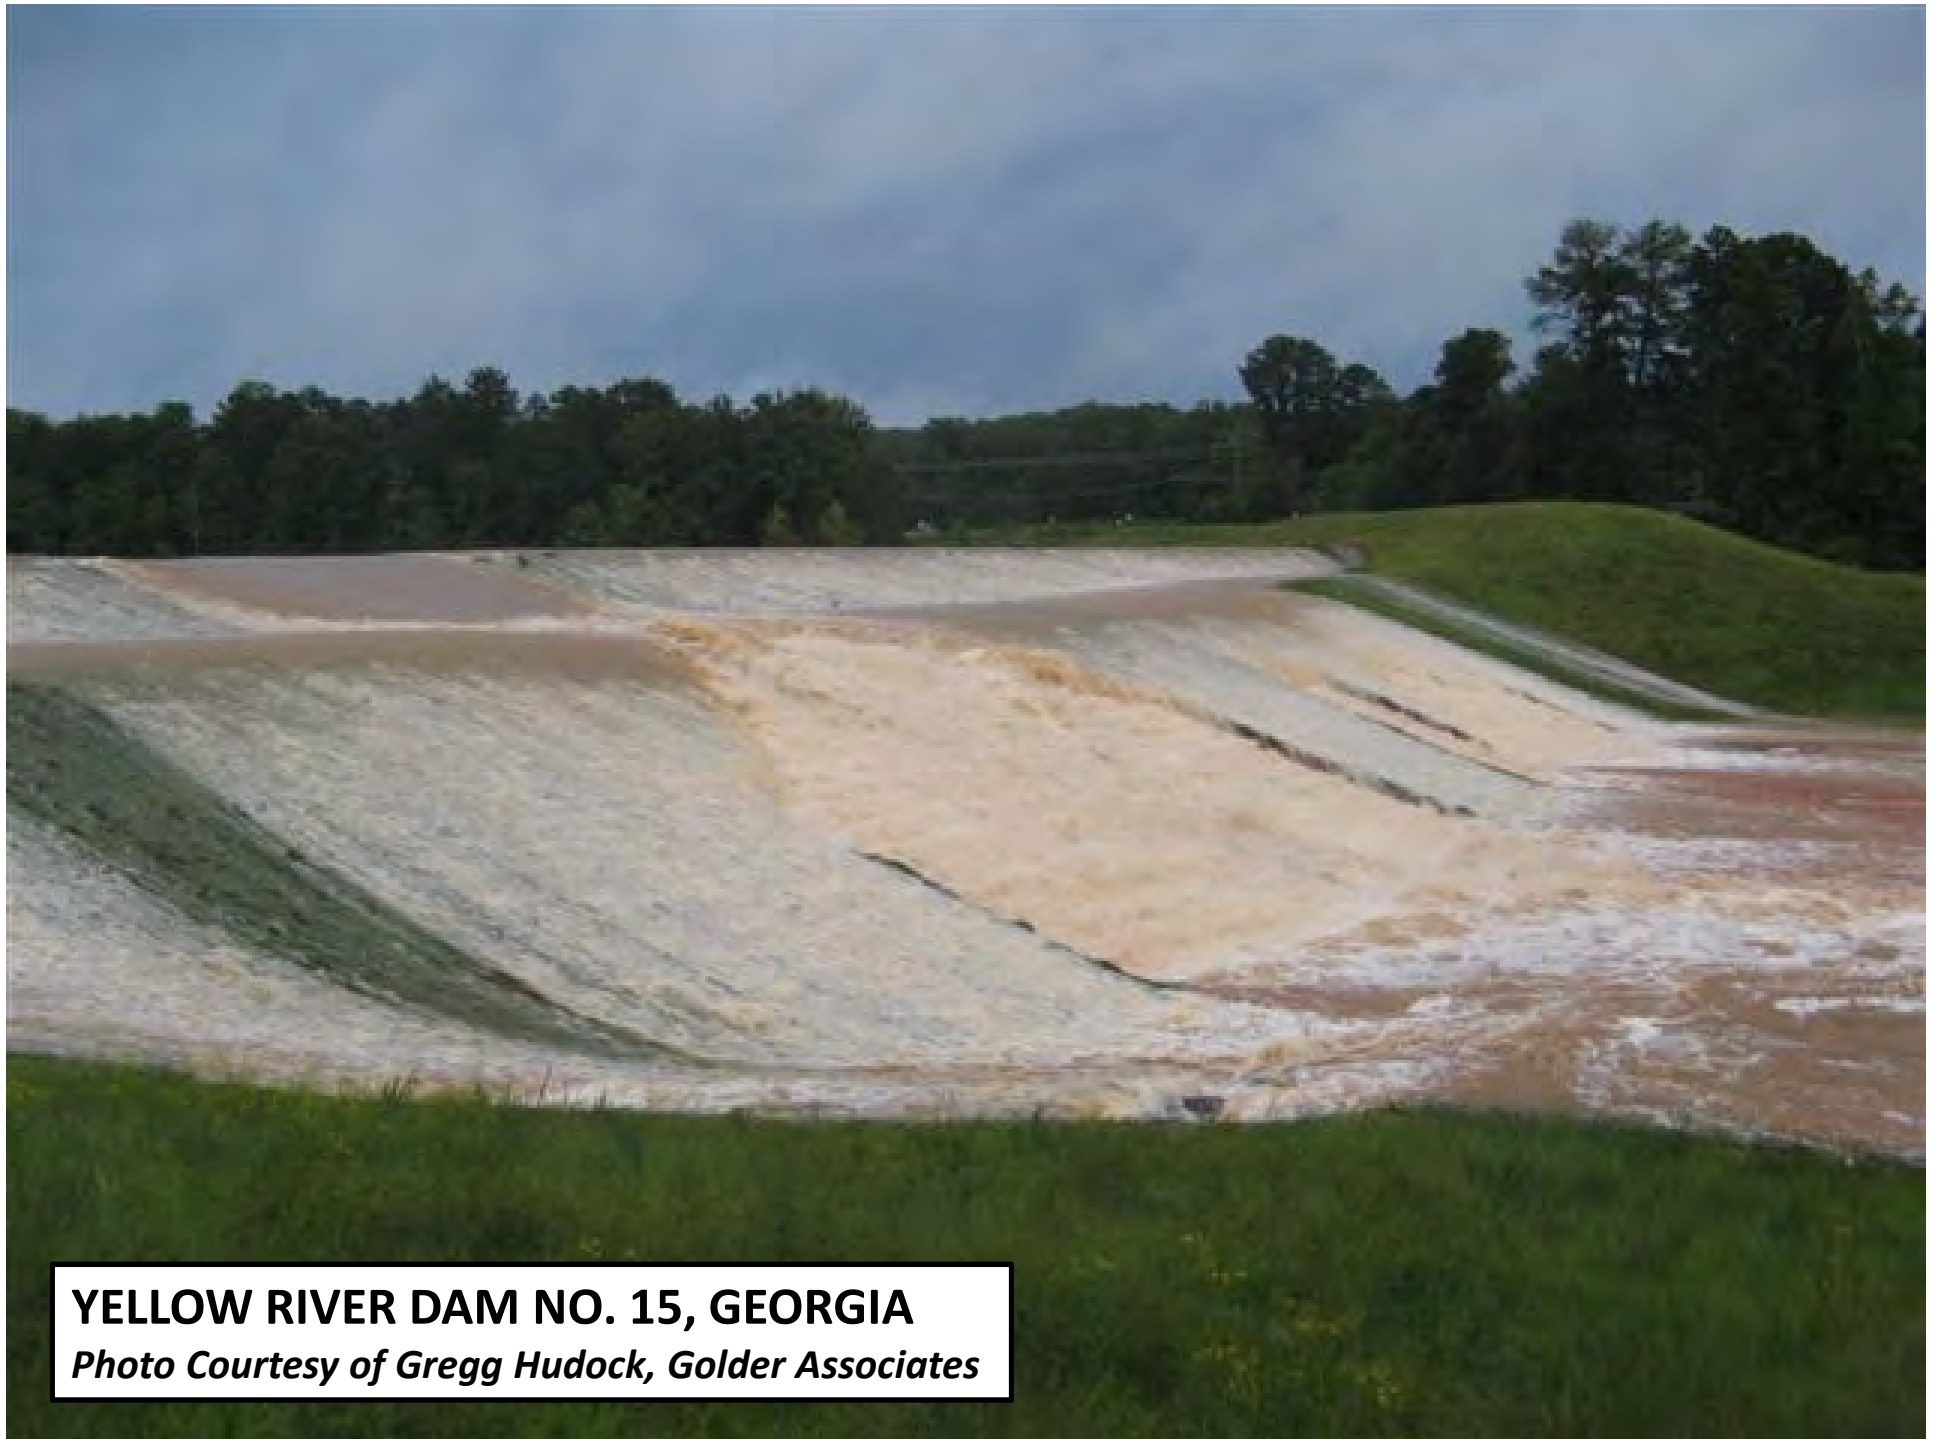
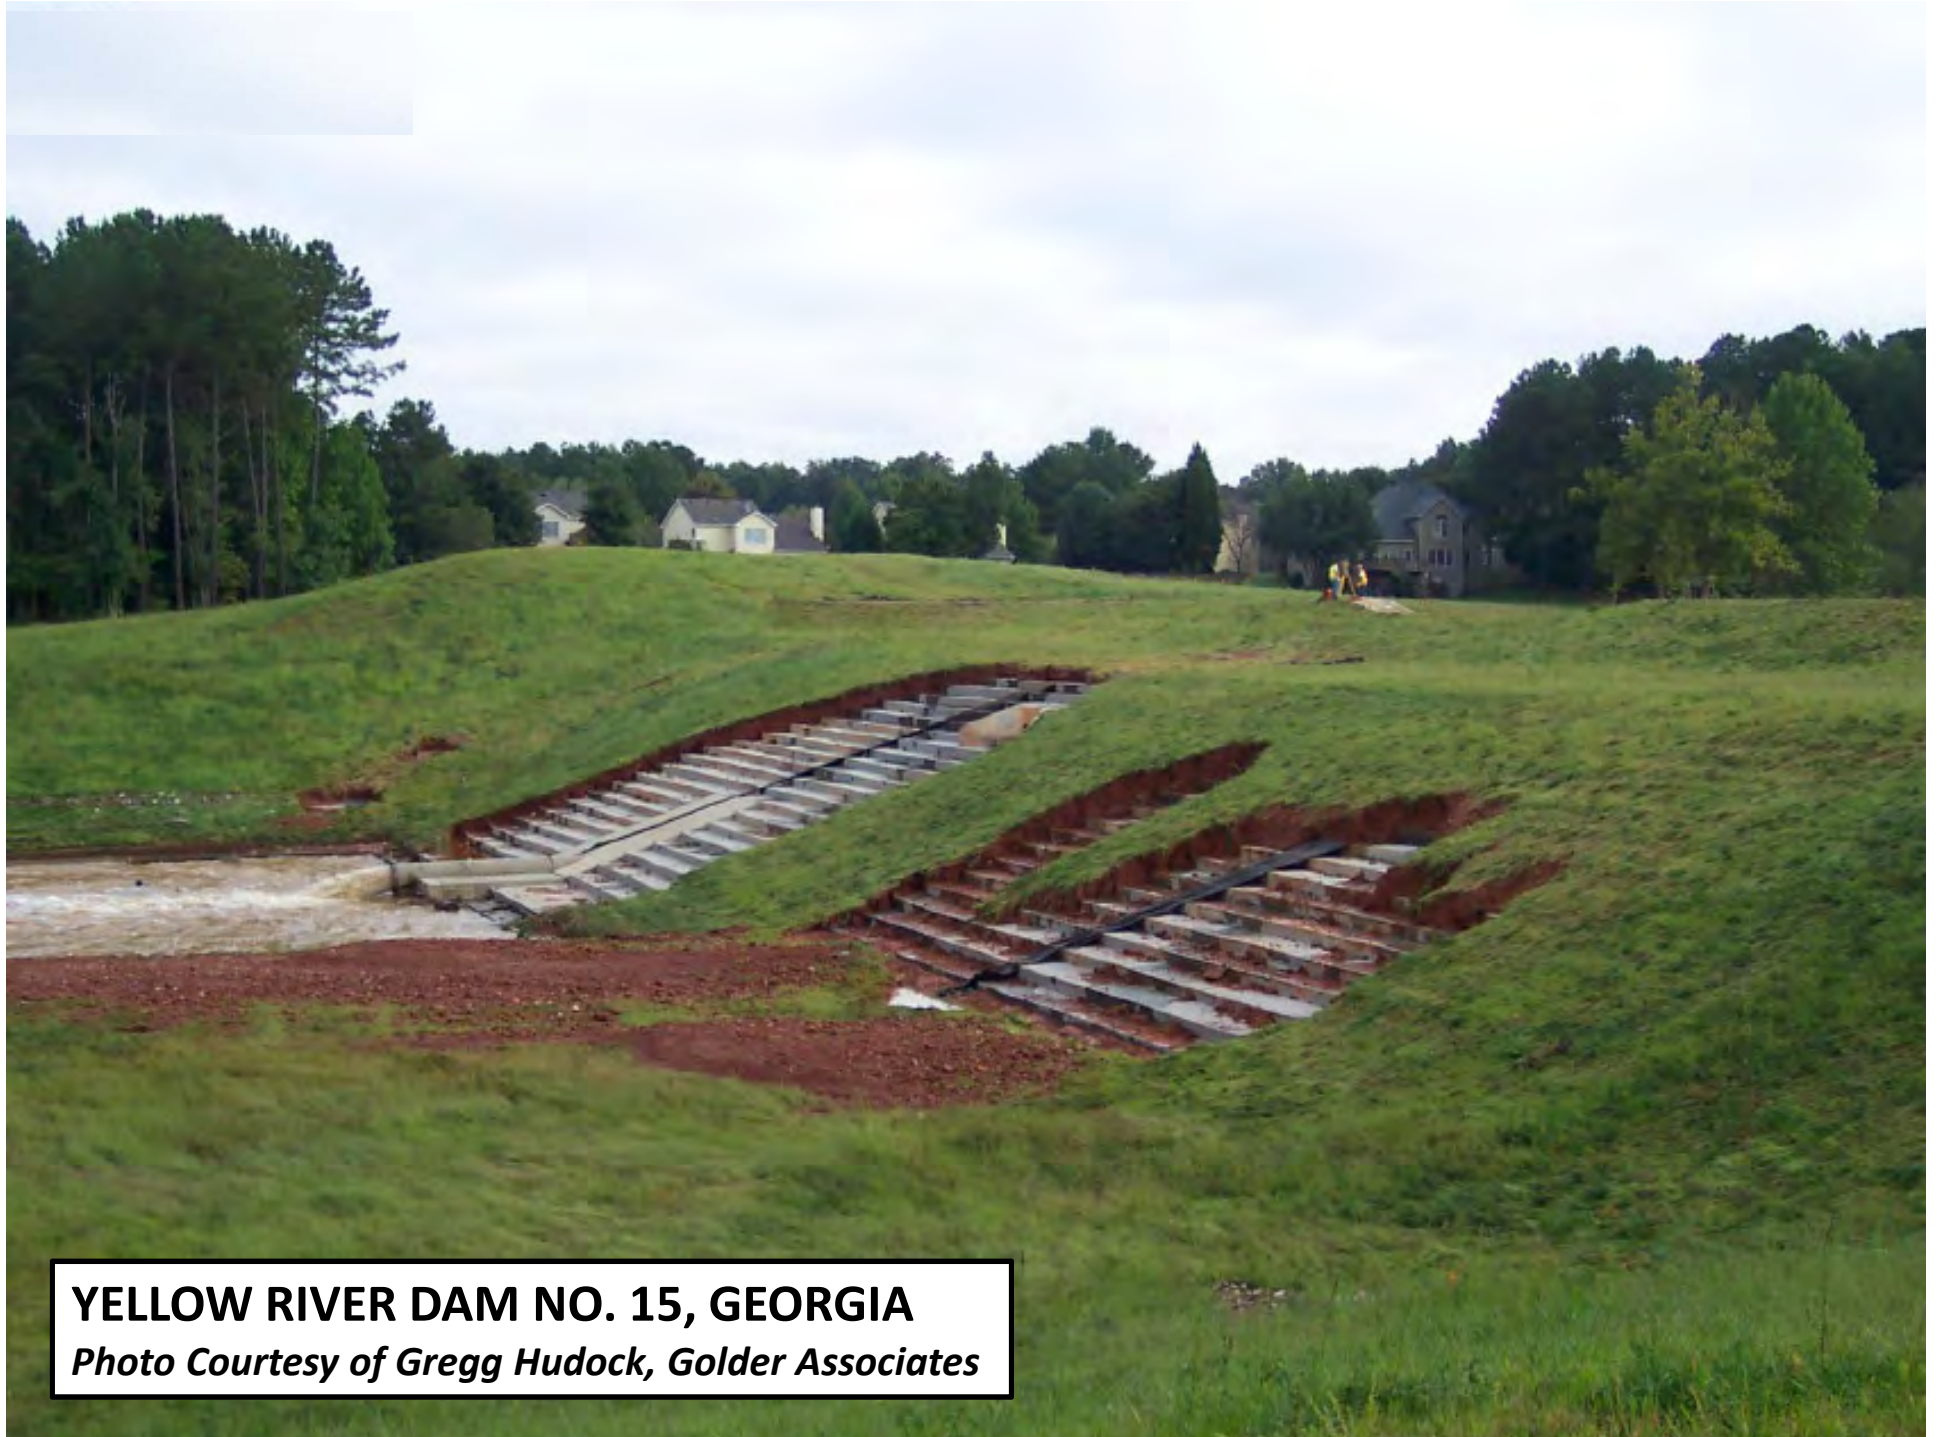
**YELLOW RIVER DAM NO. 15, GEORGIA**

## **RCC EMBANKMENT OVERTOPPING PROTECTION**

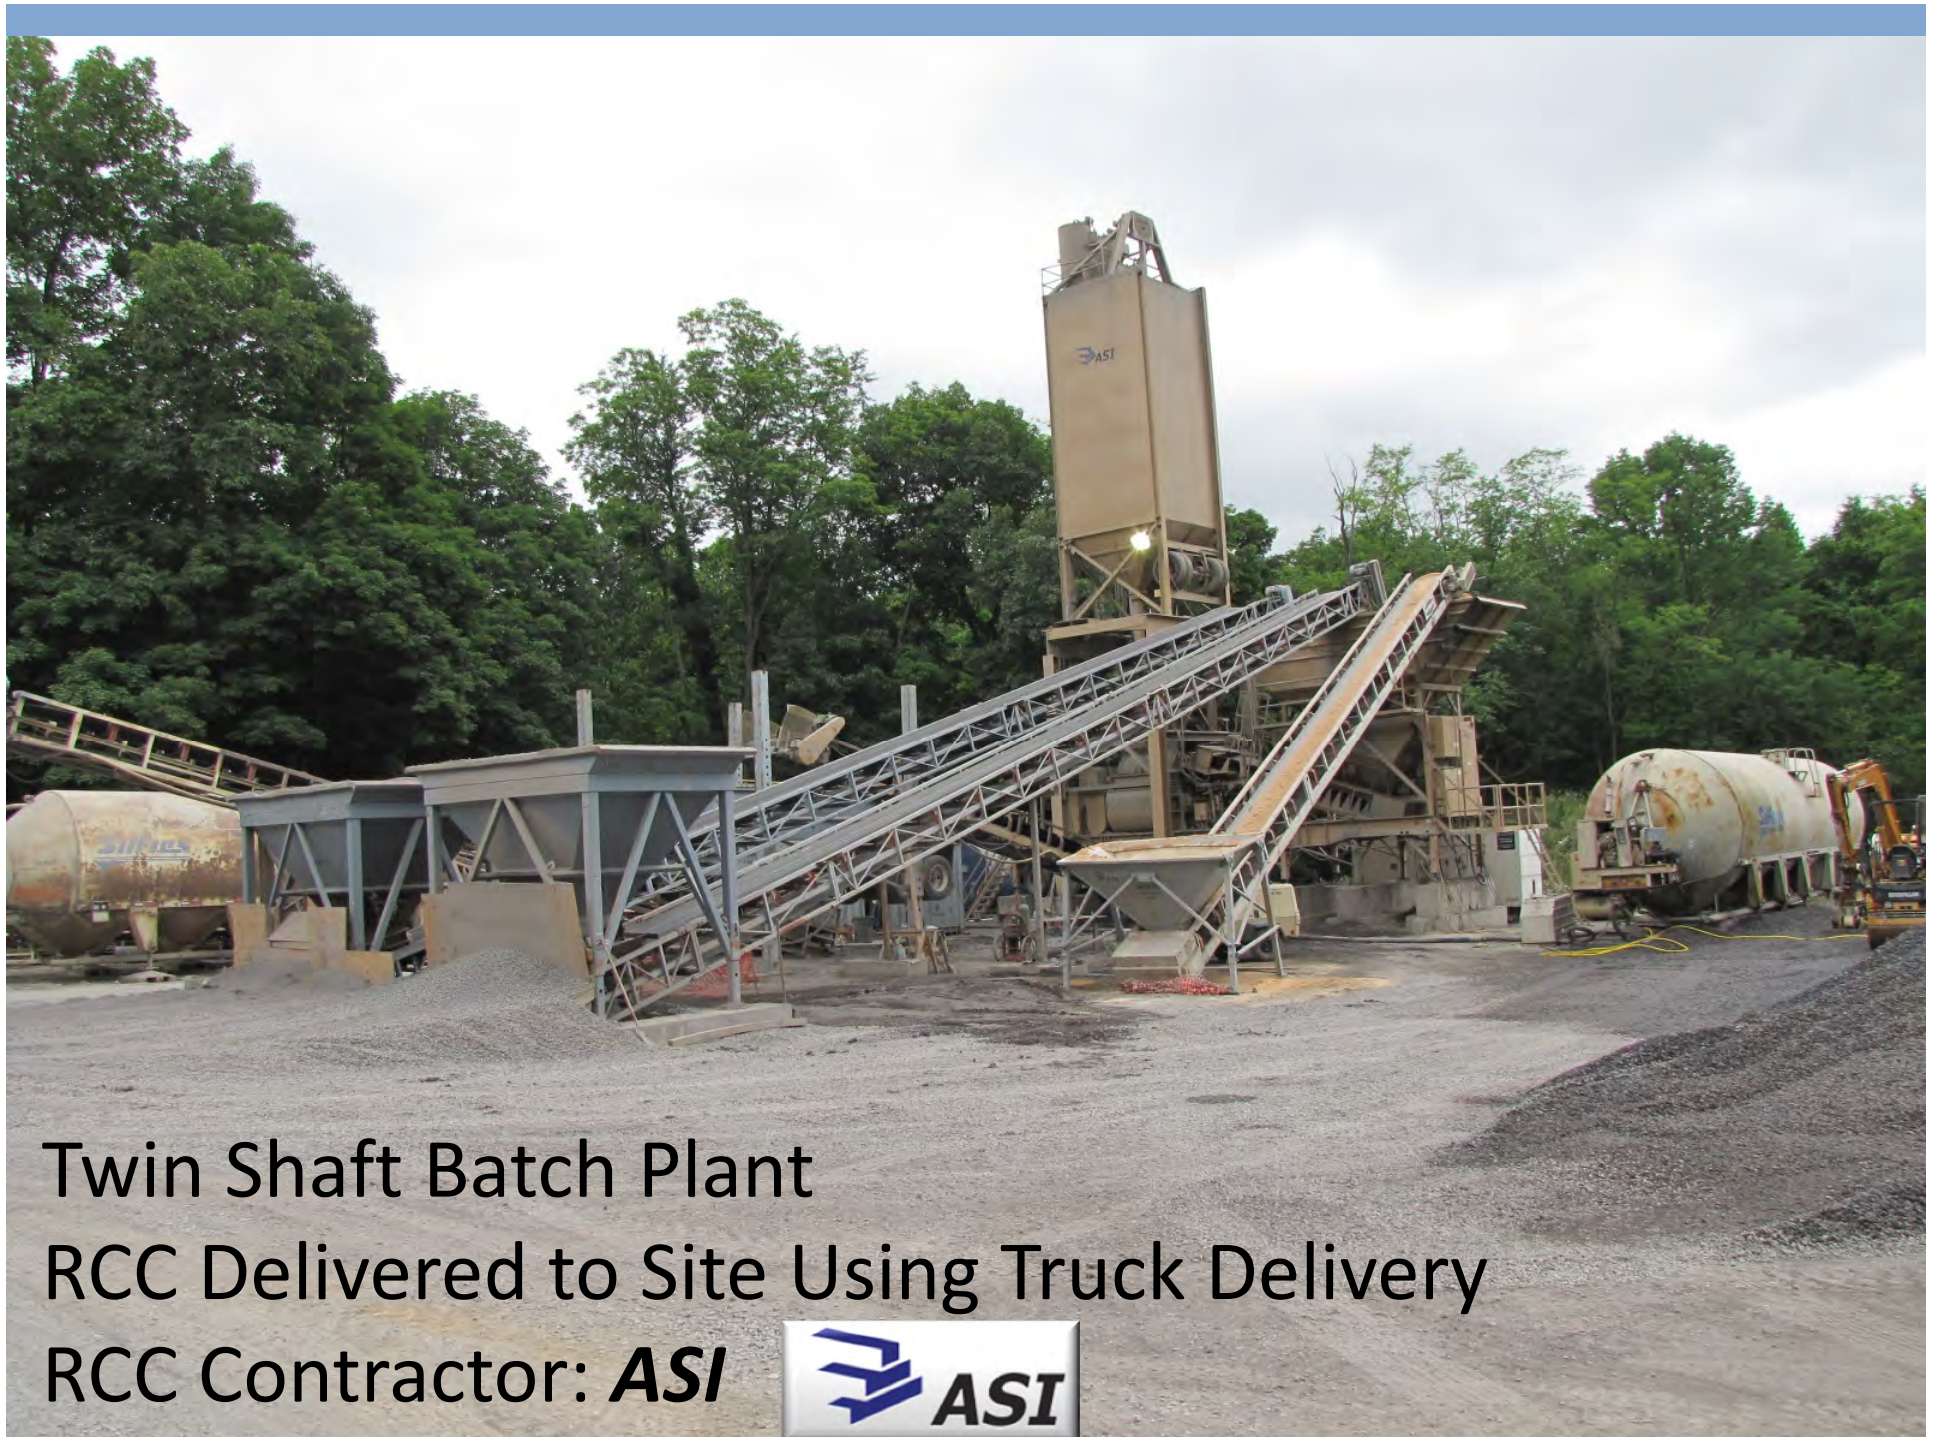
Twin Shaft Batch Plant

RCC Delivered to Site Using Truck Delivery

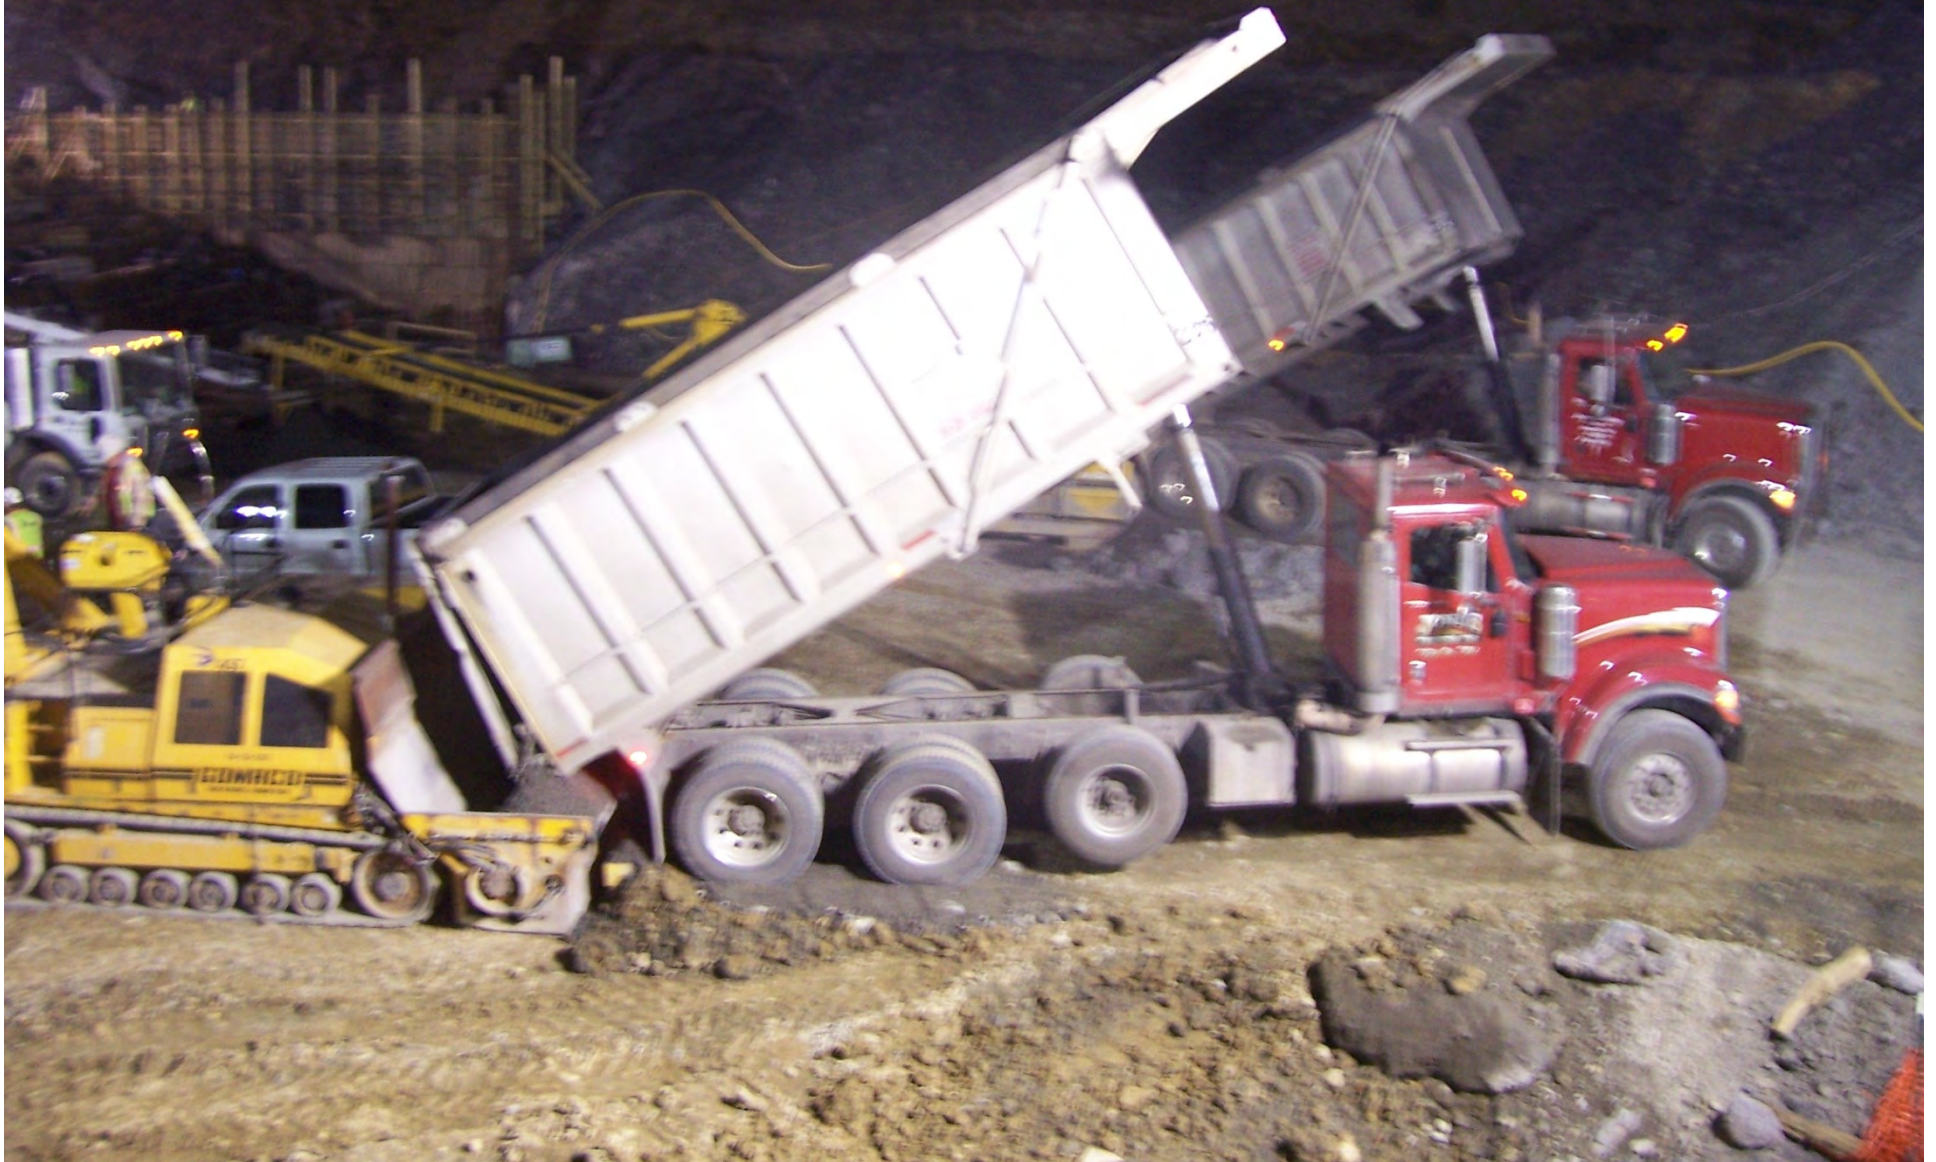
# RCC Placed at Site Using Two Gomacos & Telebelts

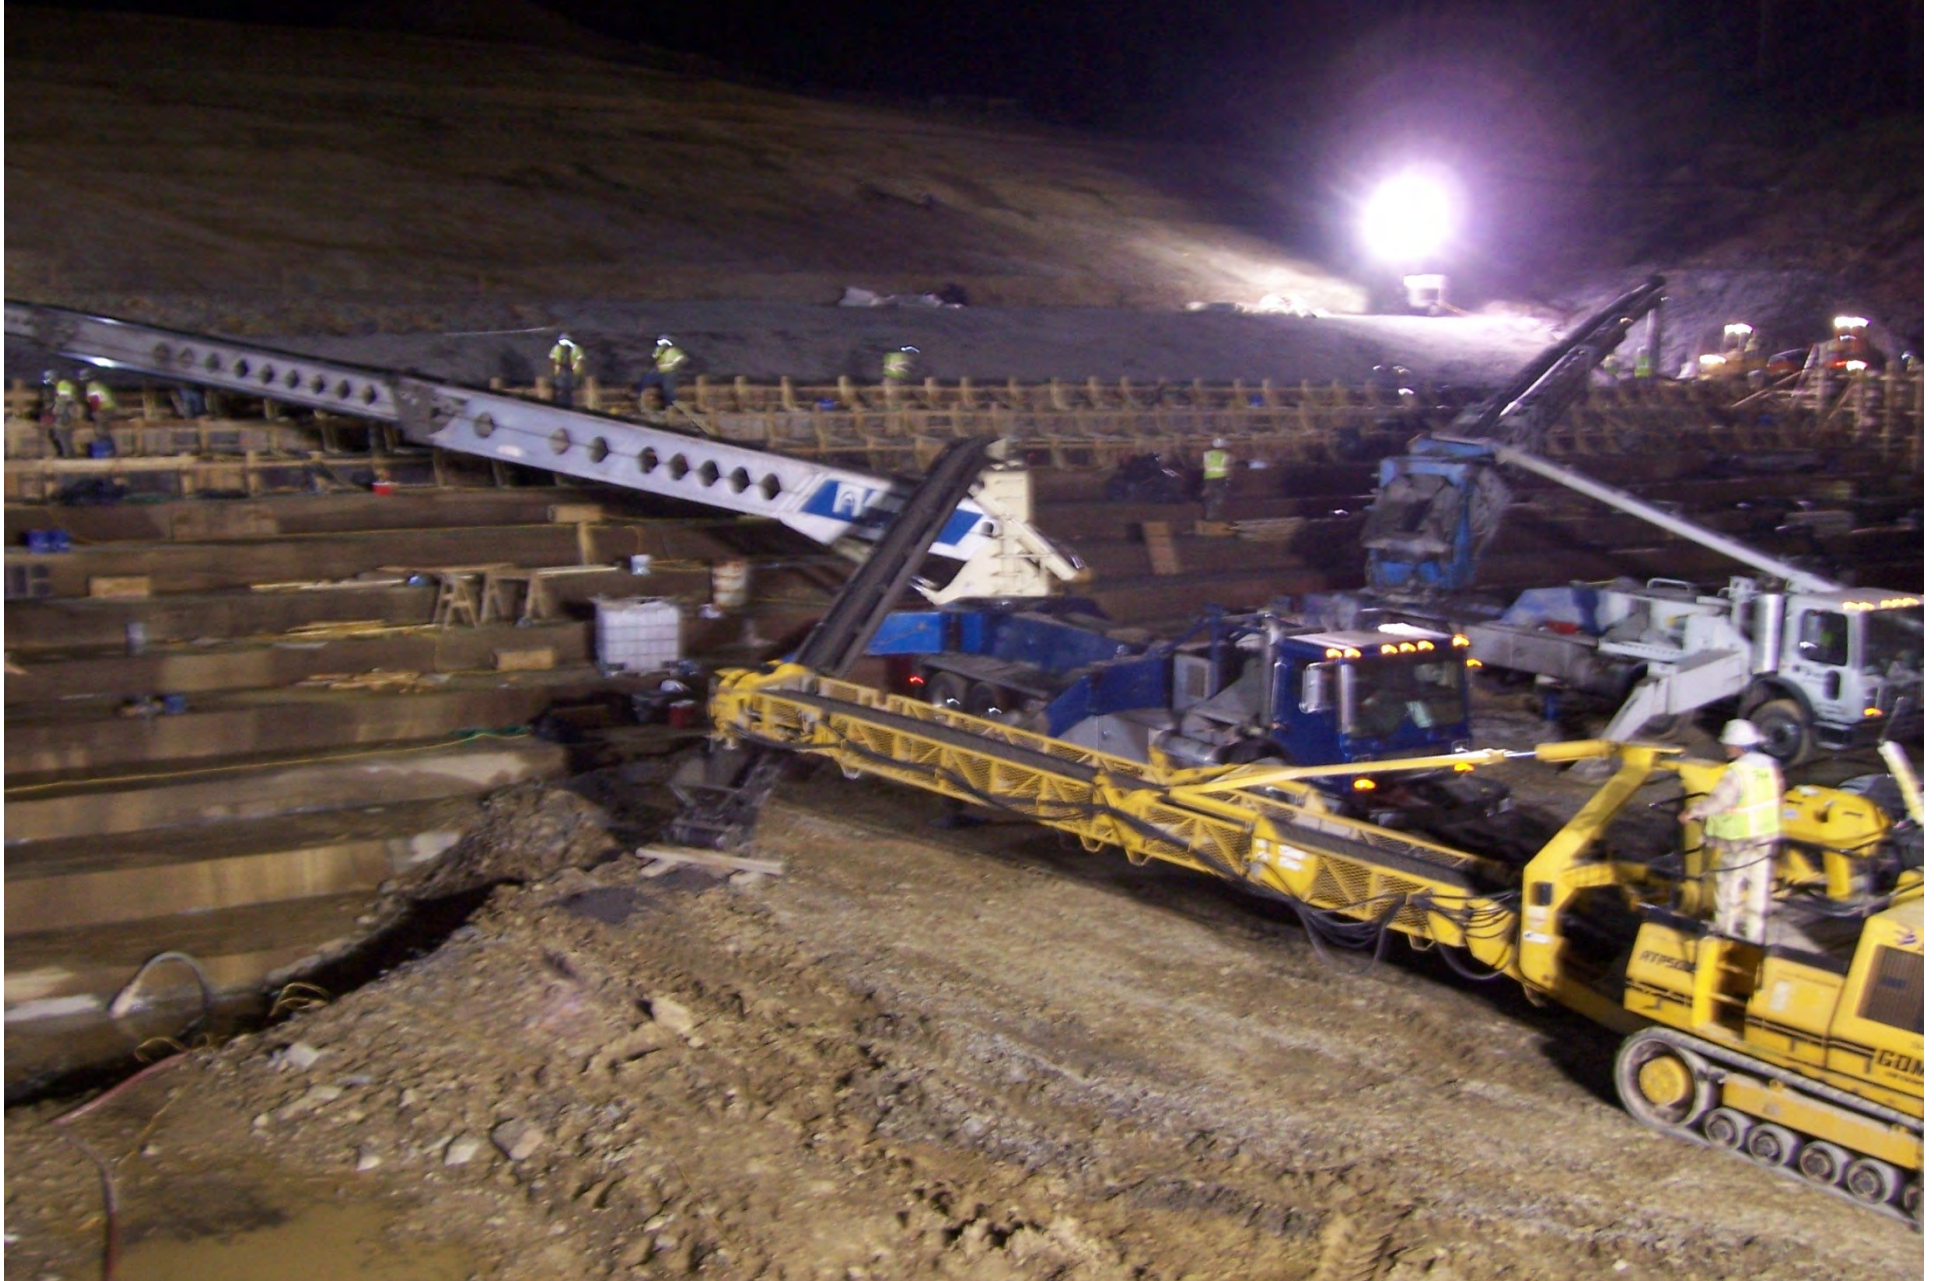
**~26,000 CY Placed**  
**8-Week Placement Time**  
**6 Nights per Week**  
**~570 CY/Day**
