**EAST GOSHEN TOWNSHIP  
CHESTER COUNTY, PENNSYLVANIA  
MILLTOWN DAM (DEP ID NO. D15-146)**

**EAST GOSHEN TOWNSHIP  
BOARD OF SUPERVISORS MEETING  
MARCH 22, 2016**

# **AGENDA**

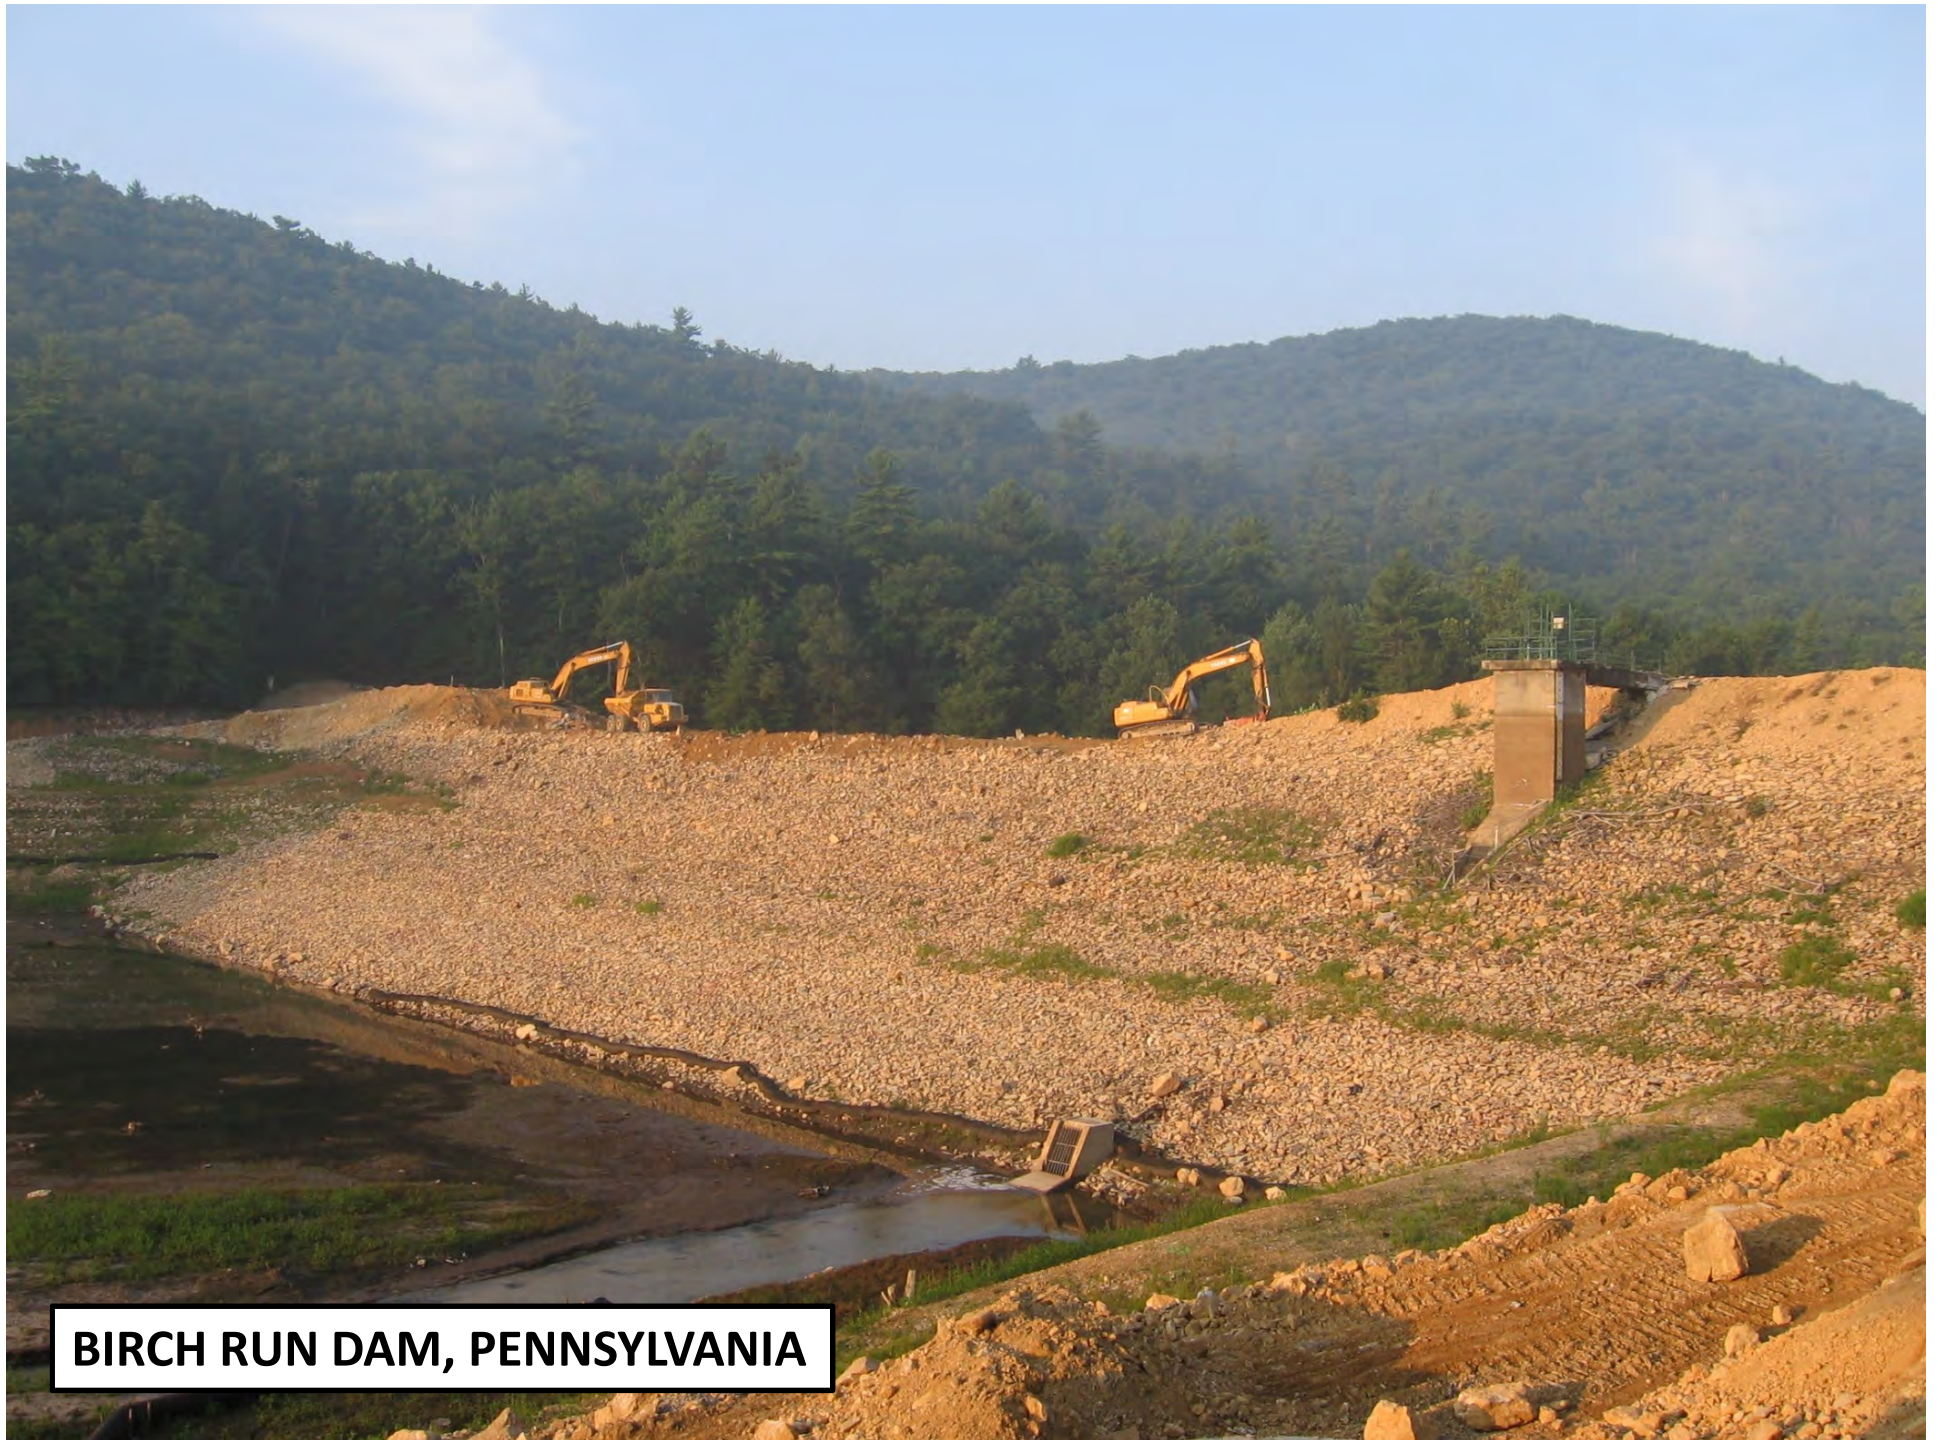
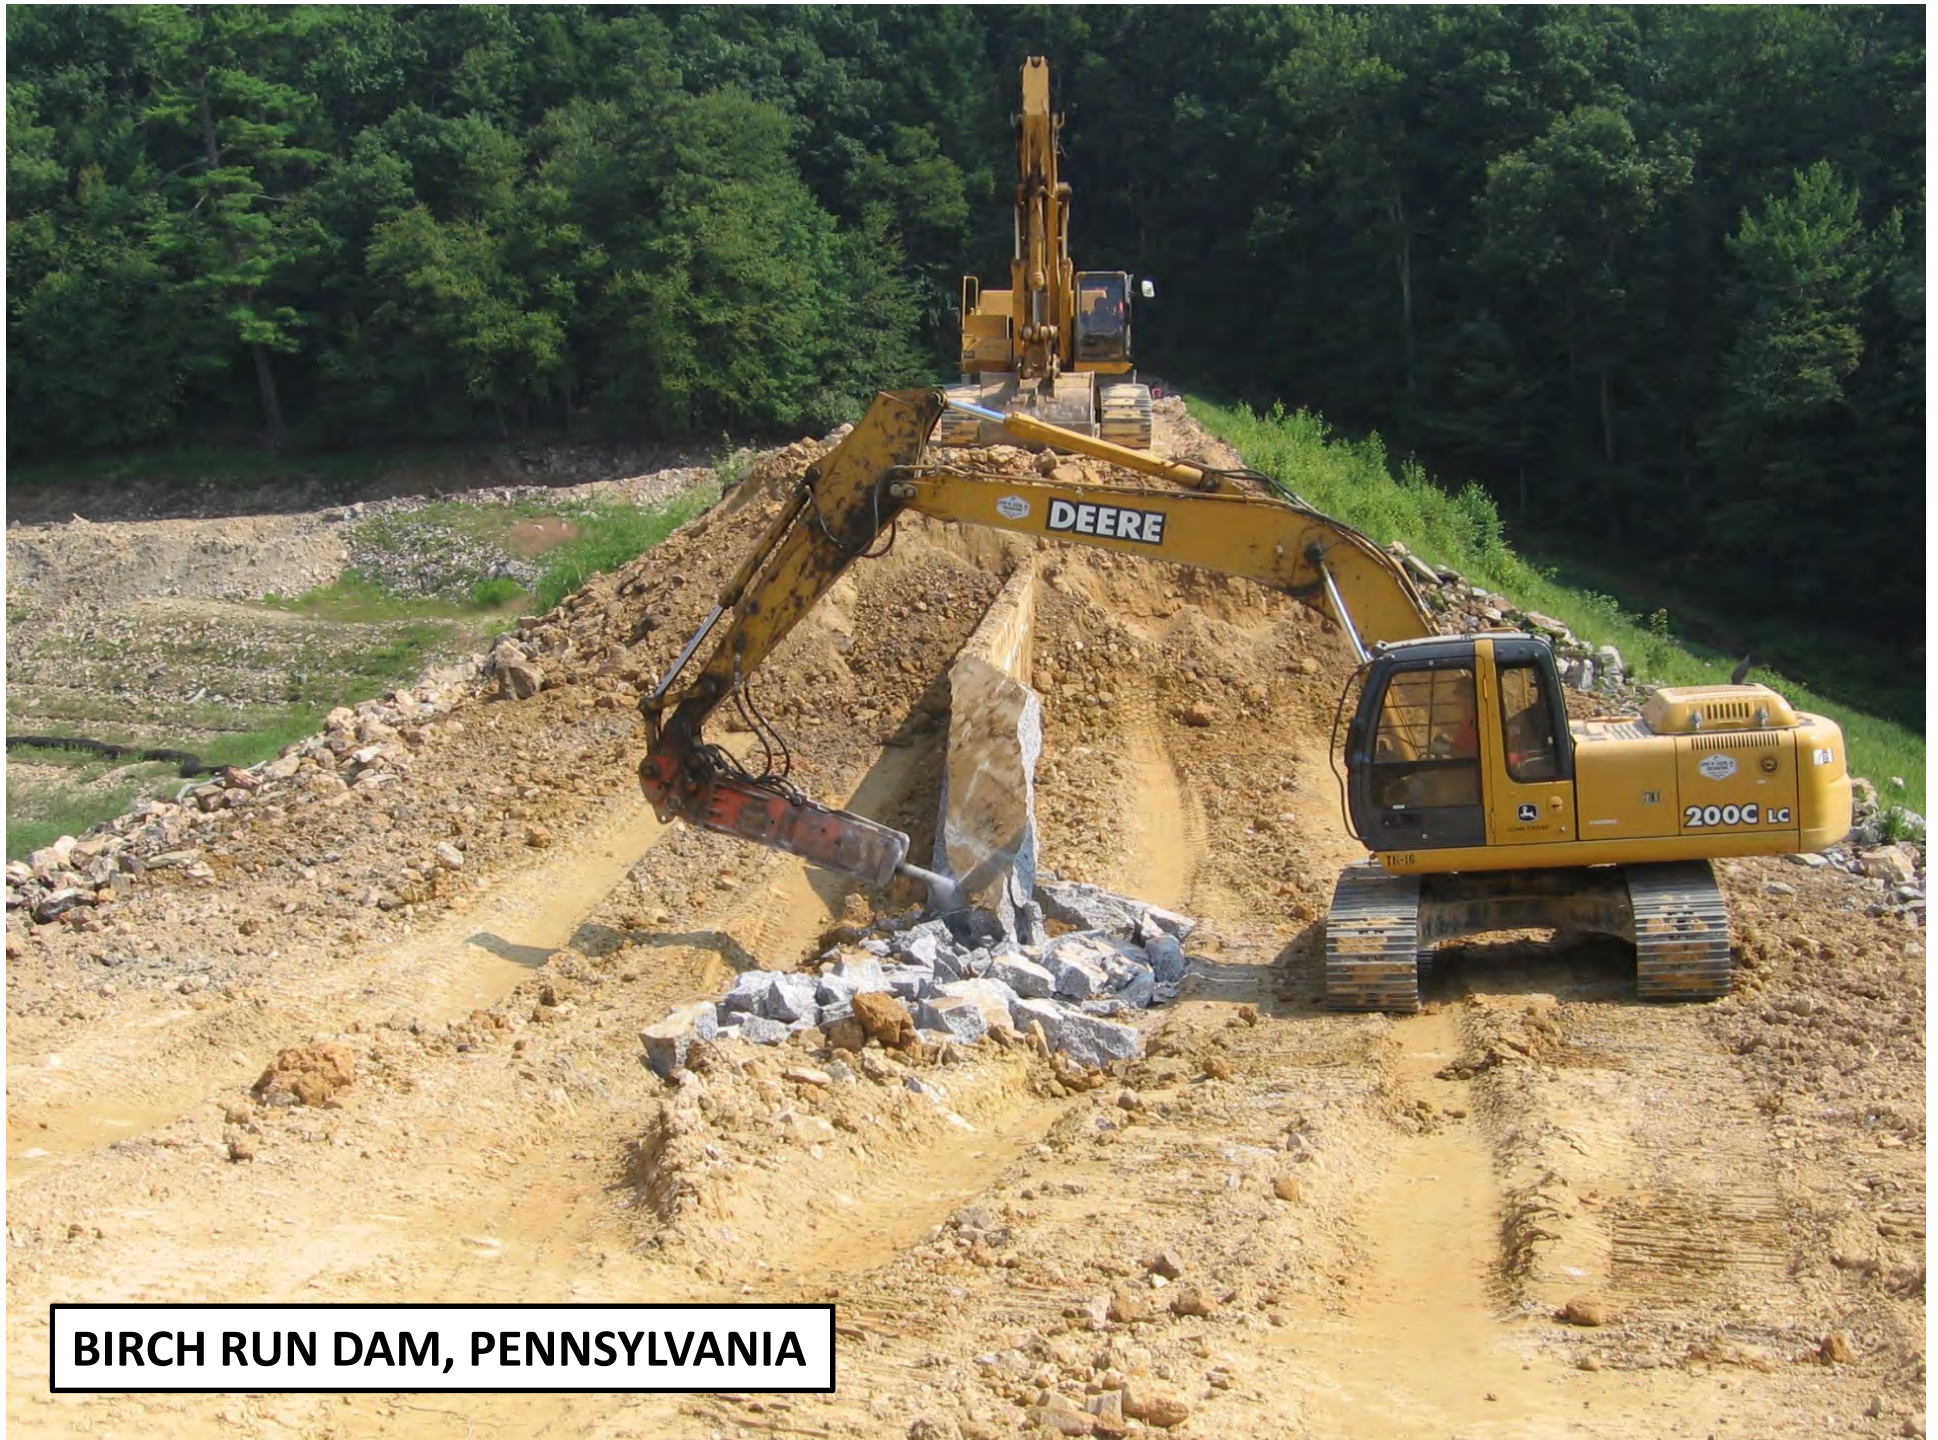
**BIRCH RUN DAM, PENNSYLVANIA**

# ALTERNATIVE 8 DECOMMISSION DAM

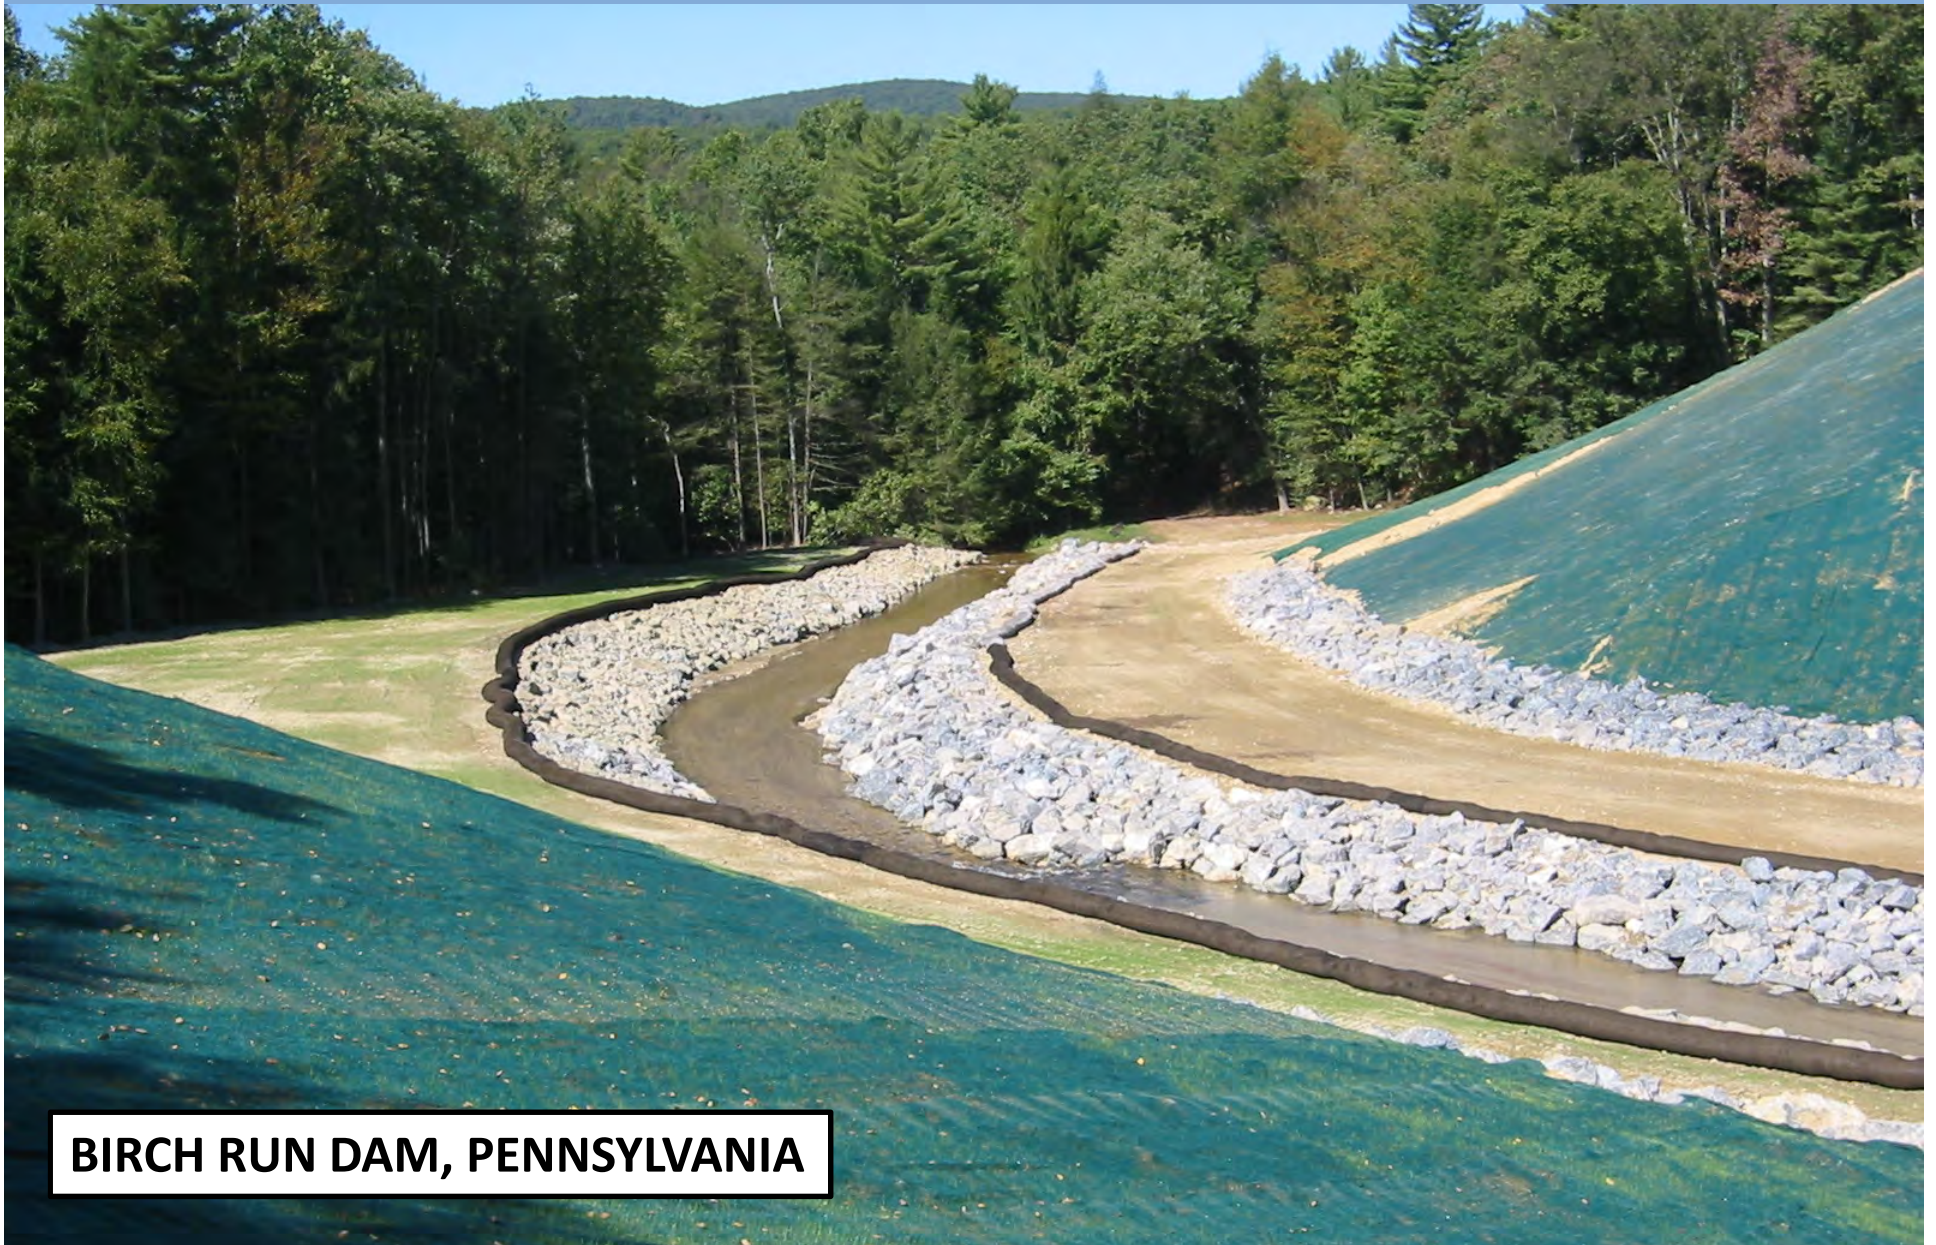
# ALTERNATIVE 8 DECOMMISSION DAM

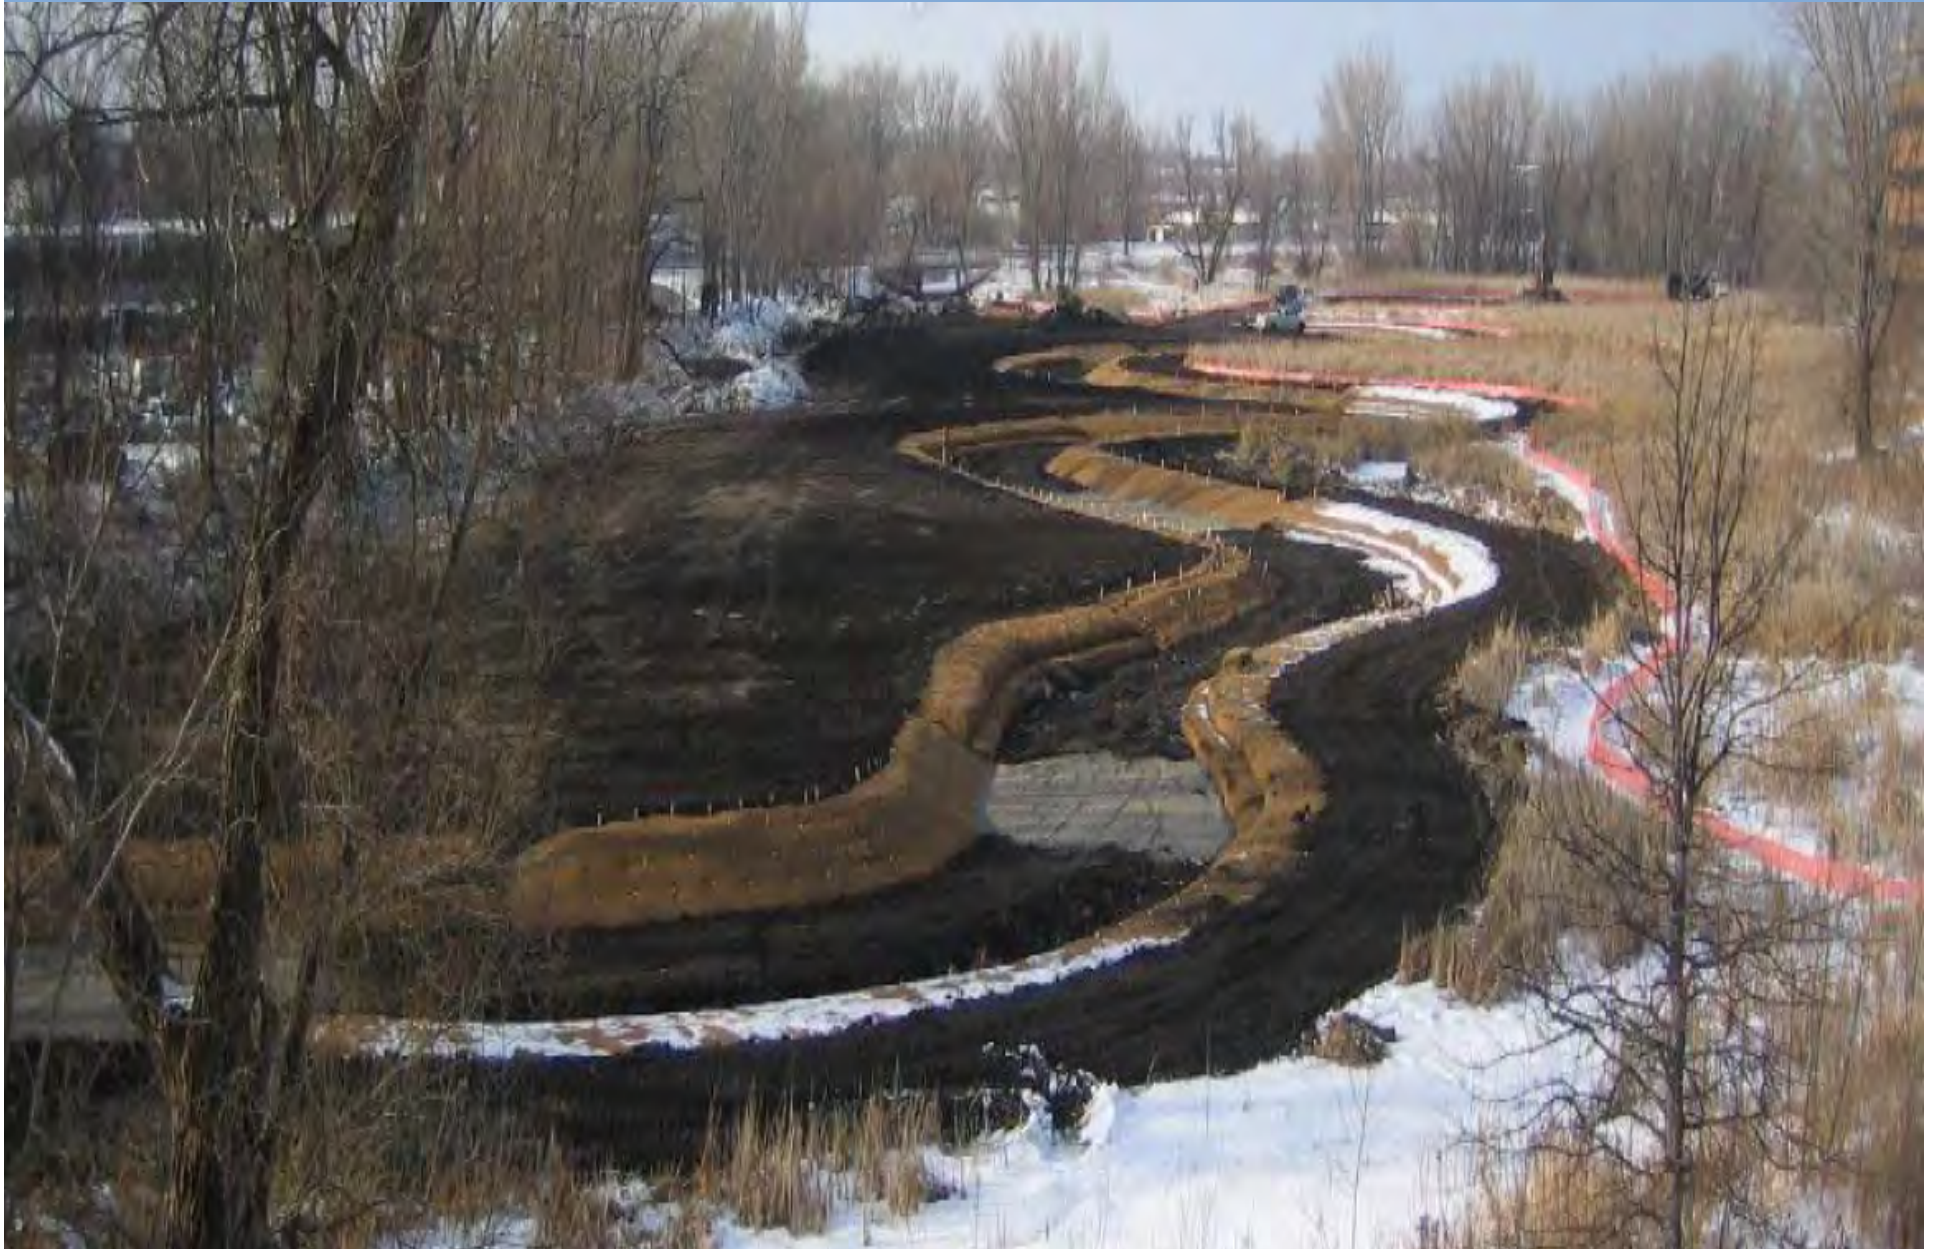
# RESERVOIR RESTORATION
